Committee Bay Project

Annual Report

2015

North Country Gold Corp.
October 2015

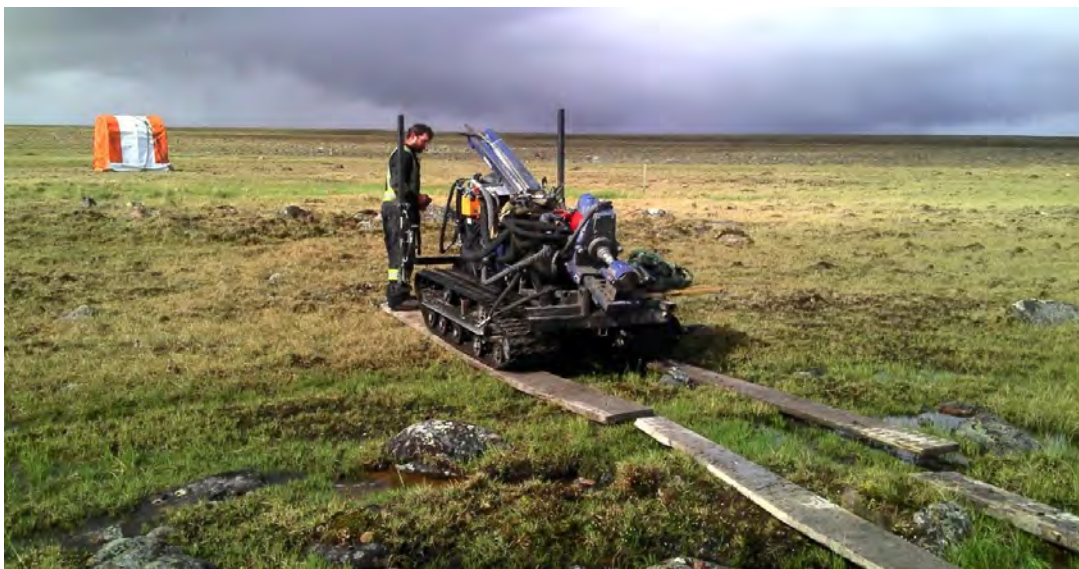
Figure 3 – Track mounted RAB drill

An innovative, track-mounted RAB drill (Figure 3) was used at the CBP in an effort to reduce drilling cost while providing good depth sampling coverage of prospective areas identified by an intensive framework study. The 2015 field season comprised 33 RAB drill holes totalling 3079.92 metres on the West Plains and Four Hills prospects, with no drilling occurring on Inuit Owned Lands ('IOL'). The 2015 drill program proved the efficacy and low environmental impact of RAB drilling while confirming previously identified mineralization at the West Plains and Four Hills prospects. A breakdown of drill coverage is summarized in Table 3 below.

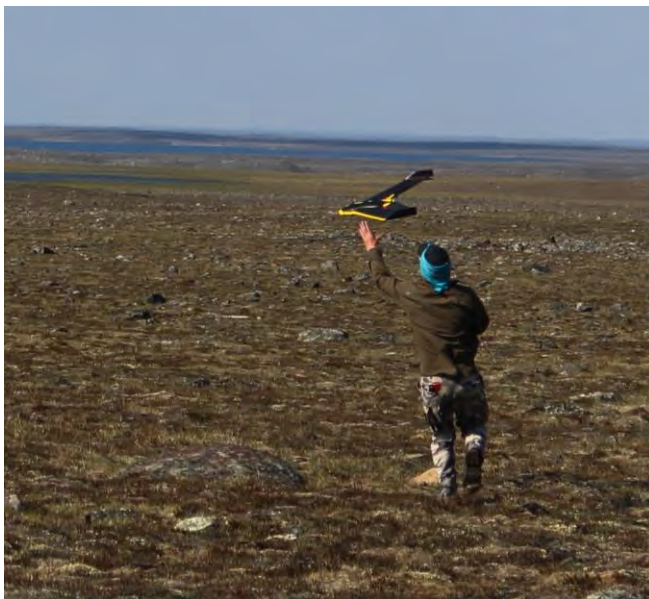
Figure 4 – Drone coming in to land

An expansive, systematic drone survey was undertaken during the 2015 field season to provide high resolution imagery and digital terrain models covering the entire Committee Bay project area. During the summer program 1600km² of imagery and digital elevation data was collected at a resolution of approximately 10cm.

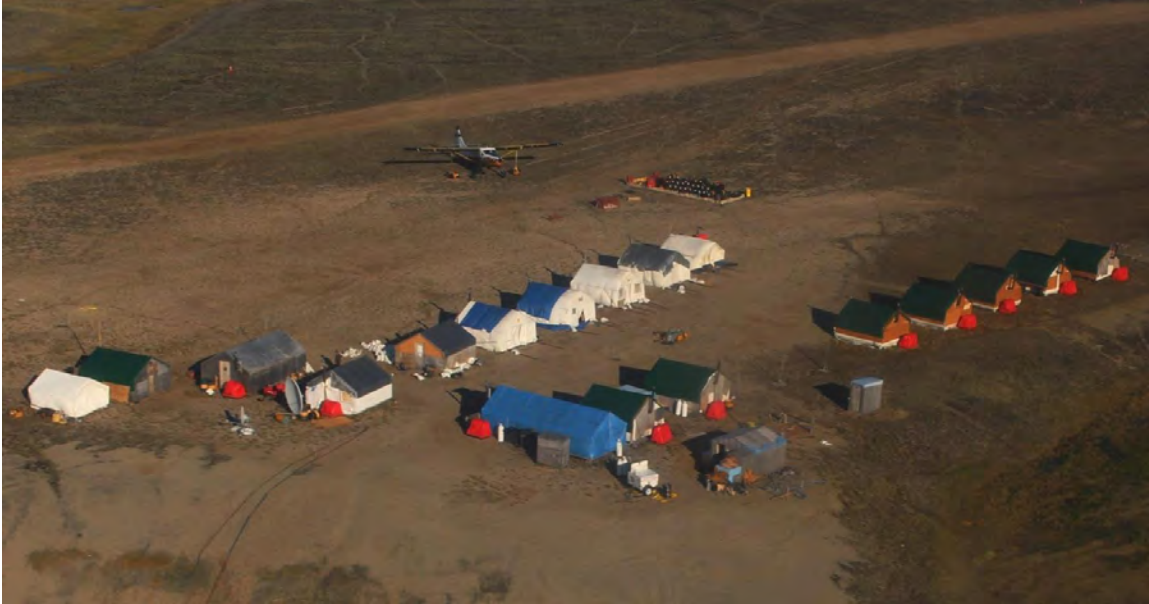
Figure 6 - Bullion Camp – 2015

- Inspection of camp and infrastructure was completed
- Fuel containment berm was inspected
- Camp buildings assessed, repaired, and reinforced to better withstand harsh conditions
- A building was constructed to store drill equipment and other gear out of the elements during shut down periods

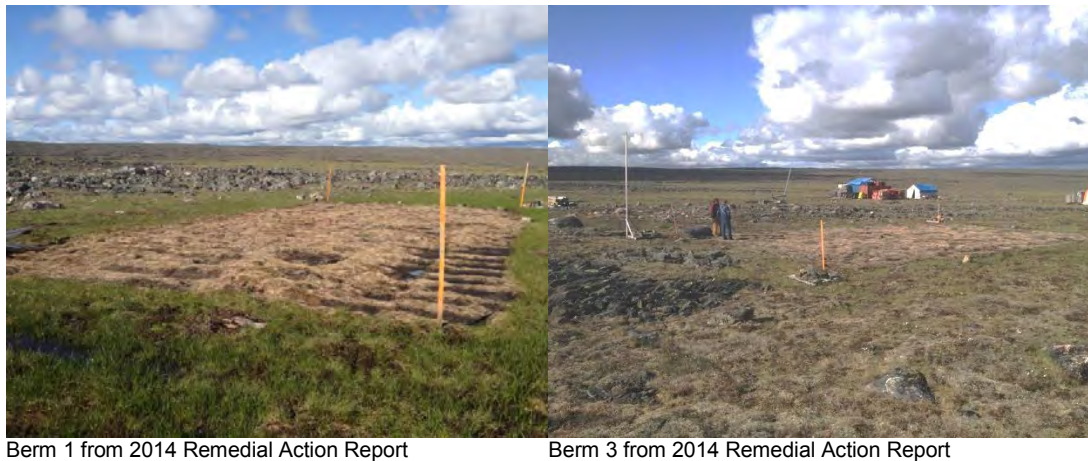
1. Two historic fuel berms and accompanying fuel were transported back to Hayes Camp from the Three Bluffs Drill Grid. Hayes Camp provides a superior storage option for fuel due to the proximity to better equipment and facilities, and a more accessible location. The areas of flattened tundra remaining after removal of the fuel berms have been marked with posts and site rehabilitation will be monitored closely moving forward (Figure 7).

Figure 7 – Flattened tundra at Three Bluffs Drill Grid

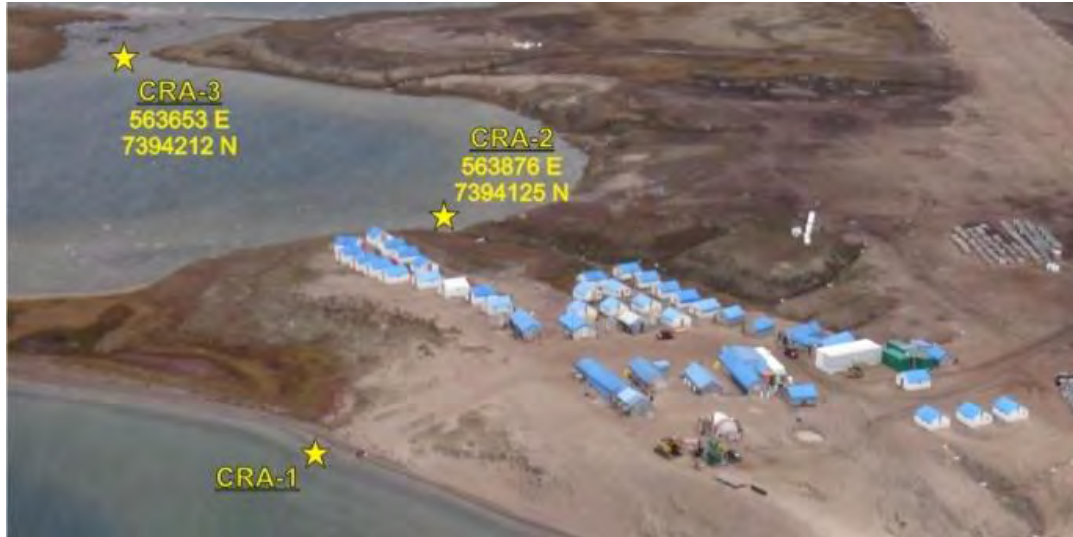
Figure 9 – Water Monitoring Station Locations

Water samples were taken from Water Monitoring Stations CRA1, CRA2 and CRA3 during the 2015 program. Water samples were also obtained from the Bullion Camp draw point. Water sampling analytical results are presented in Appendix 6.
