☒ Original
☐ Follow-Up Report

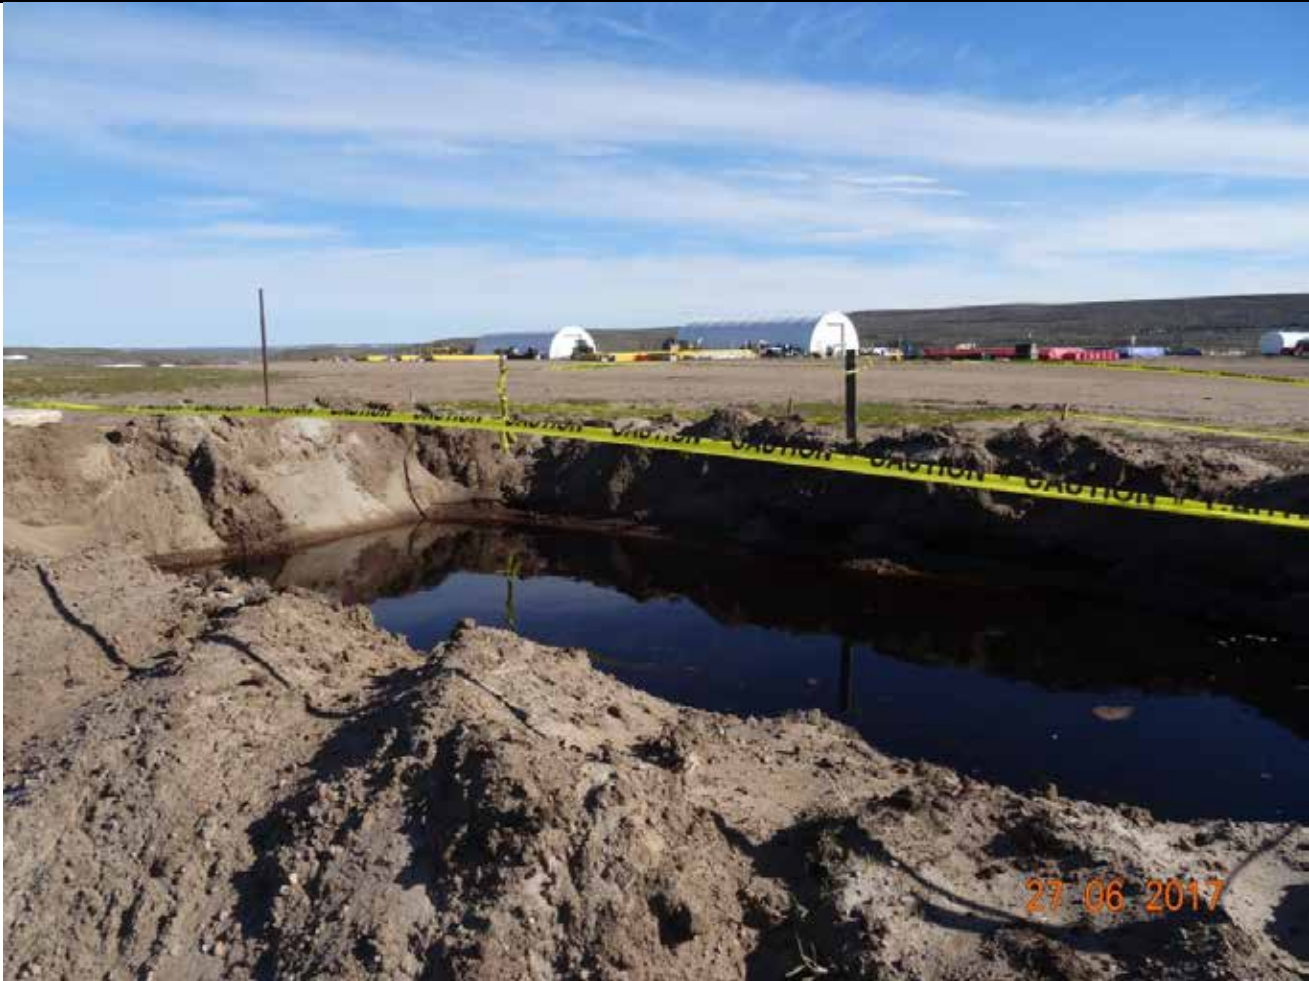
Date	Camera	Inspector	Authorization
27 June 2017	SONY DSC-HX50V	EVA PAUL	2BE-CRA1520
Photo Log # 1		Location (NAD 83 DD MM SS.SS)	
Photo DSC06591		N66 39 34.8 W91 33 07.4

Description: Temporary sump in use for storing WWTP effluent.

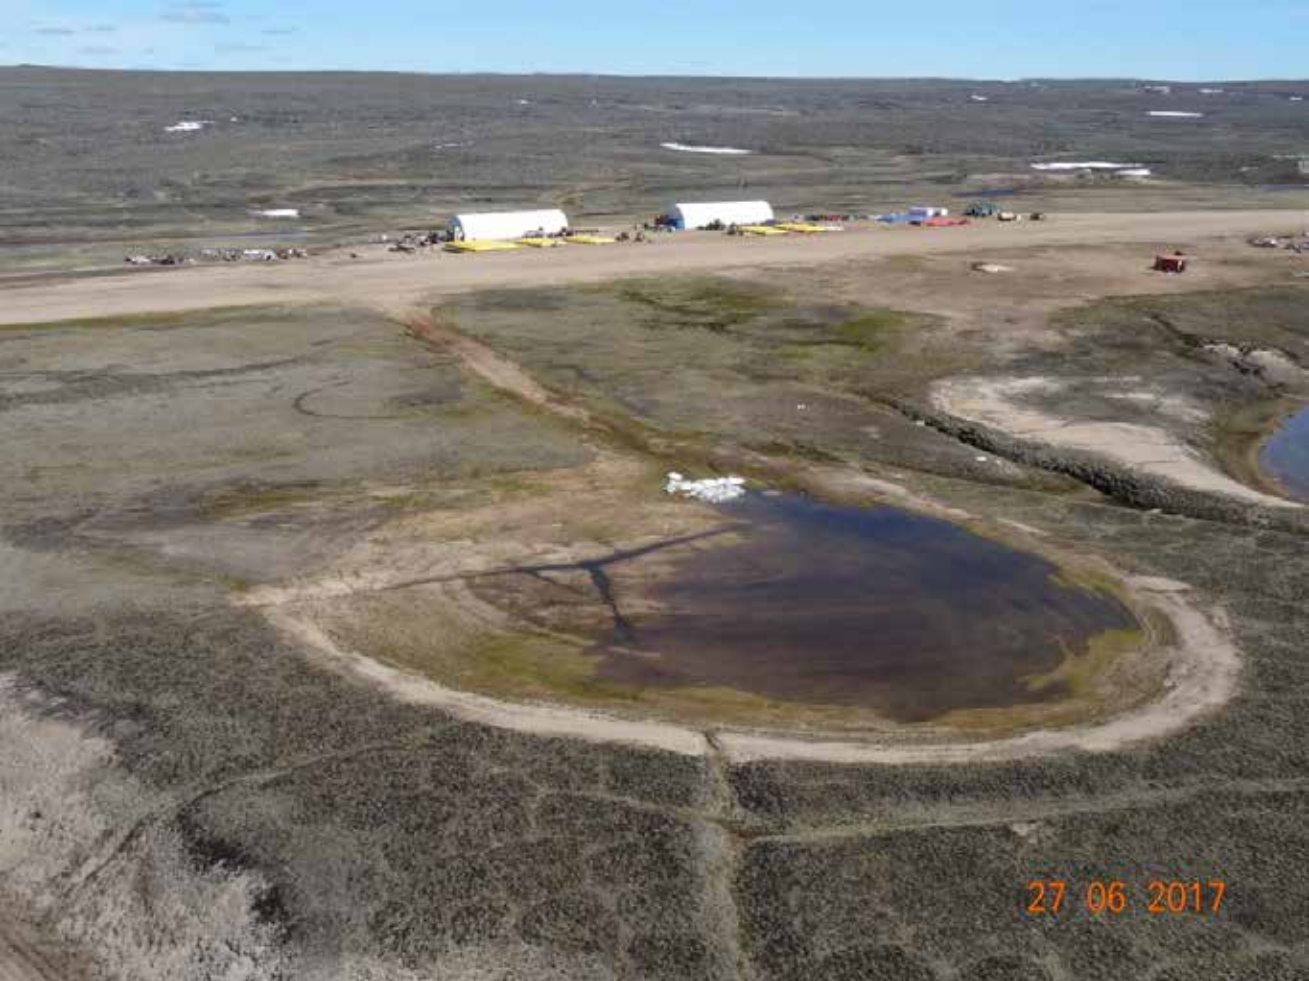
Photo Log # 2	Location (NAD 83 DD MM SS.SS)	
Photo DSC06685	N	W

Description: Borrow Area 1 is accumulating water. Historic drainage paths can be seen.

- E. A plan for restoring drainage from Borrow Area 1 is to be submitted to the Inspector and implemented upon approval. Complete closure and remediation of the quarry should be implemented if no further use is forecasted, to reduce the need for active water management.

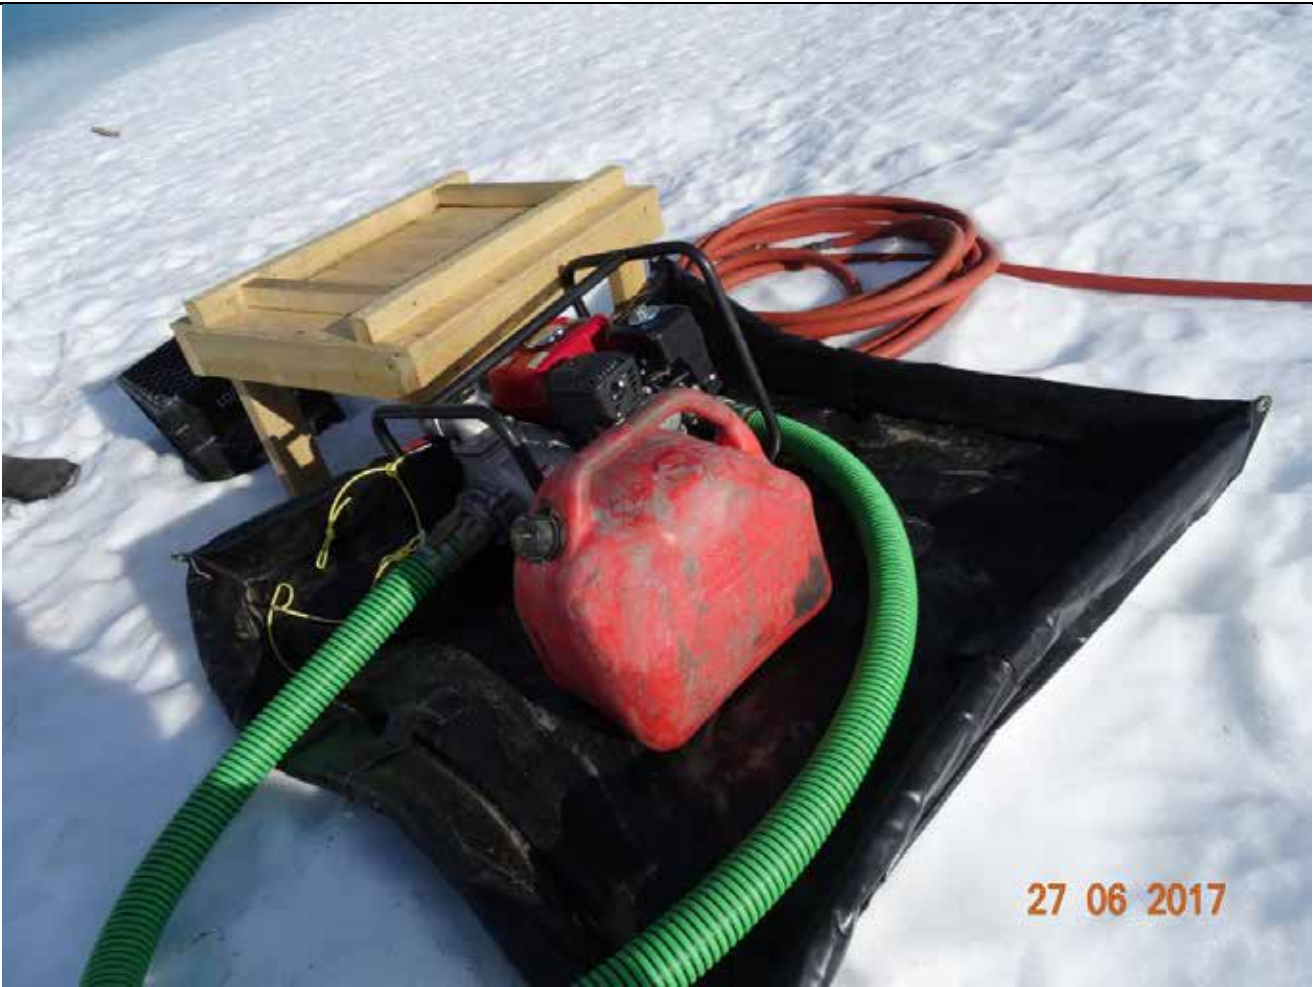
Photo Log # 3

close, and could easily slip or move, allowing the jerry can to fall into the lake.

Description: Small spill tray with jerry can by Crater Lake. The fuel is to be stored on solid ground more than 30 m from the lake.

- F. Reportable spills are to be reported both to the Spill Line and directly to the Inspector as per item H.4.c.
- G. Fuel for the water intake pump should be kept on land, >31m from the OHWM.

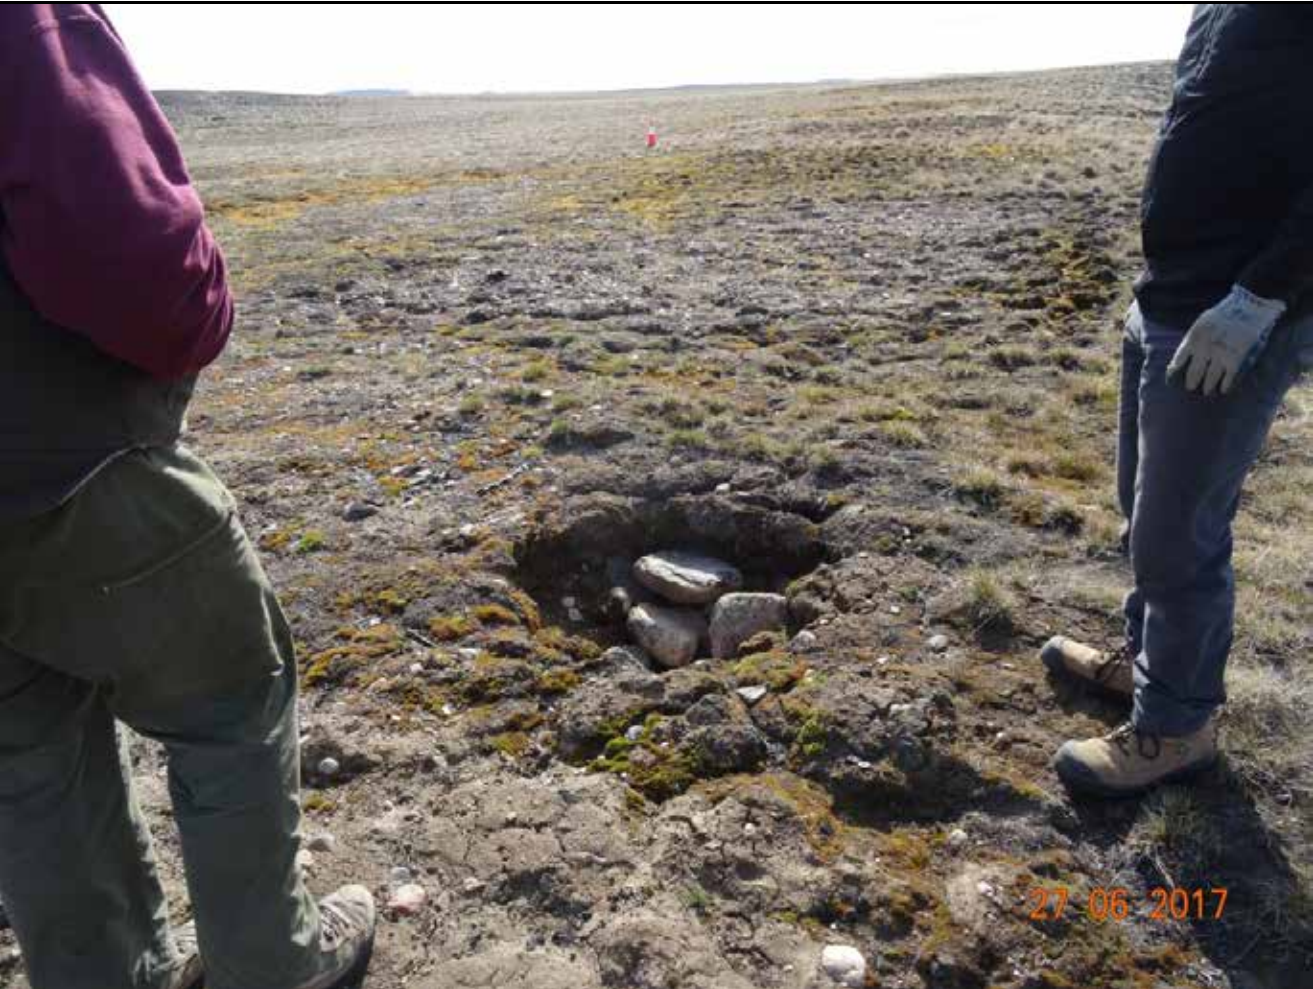
Photo Log # 4

8. The old Crater Camp site was also inspected, and it was found that burned debris is left, and the sumps have not been backfilled.
9. Monitoring stations have not yet been marked. For consistency of sampling, station locations should be staked and marked with the sampling station number.
10. Record keeping was not yet begun at Crater Camp. Only small volumes of water had yet been used, but Licensee was instructed to immediately begin recording camp water usage.

Description: One of 3 sumps remaining at old Crater Camp that are to be backfilled. Debris also to be cleaned up.

- H. The cleanup of the old Crater Camp should be completed, including removal of burned debris and backfilling of sumps.
- I. Monitoring stations are to be marked.
