ENVIRONMENTAL INSPECTION FORM

Licensee	Licensee Representative
West Melville Metals	Rory Moore
Licence No. / Expiry	Representative's Title
2BE-FBP1116	President and CEO
Land / Other Authorizations	Land / Other Authorizations
N2011J0032	
Date of Inspection	Inspector
15/07/2014	Atuat Shouldice
Activities Inspected	
<input checked="" type="checkbox"/> Camp <input type="checkbox"/> Roads/Hauling	<input type="checkbox"/> Drilling <input checked="" type="checkbox"/> Other: Water Discharge <input type="checkbox"/> Mining <input type="checkbox"/> Construction <input type="checkbox"/> Reclamation <input checked="" type="checkbox"/> Fuel Storage <input type="checkbox"/> Other:

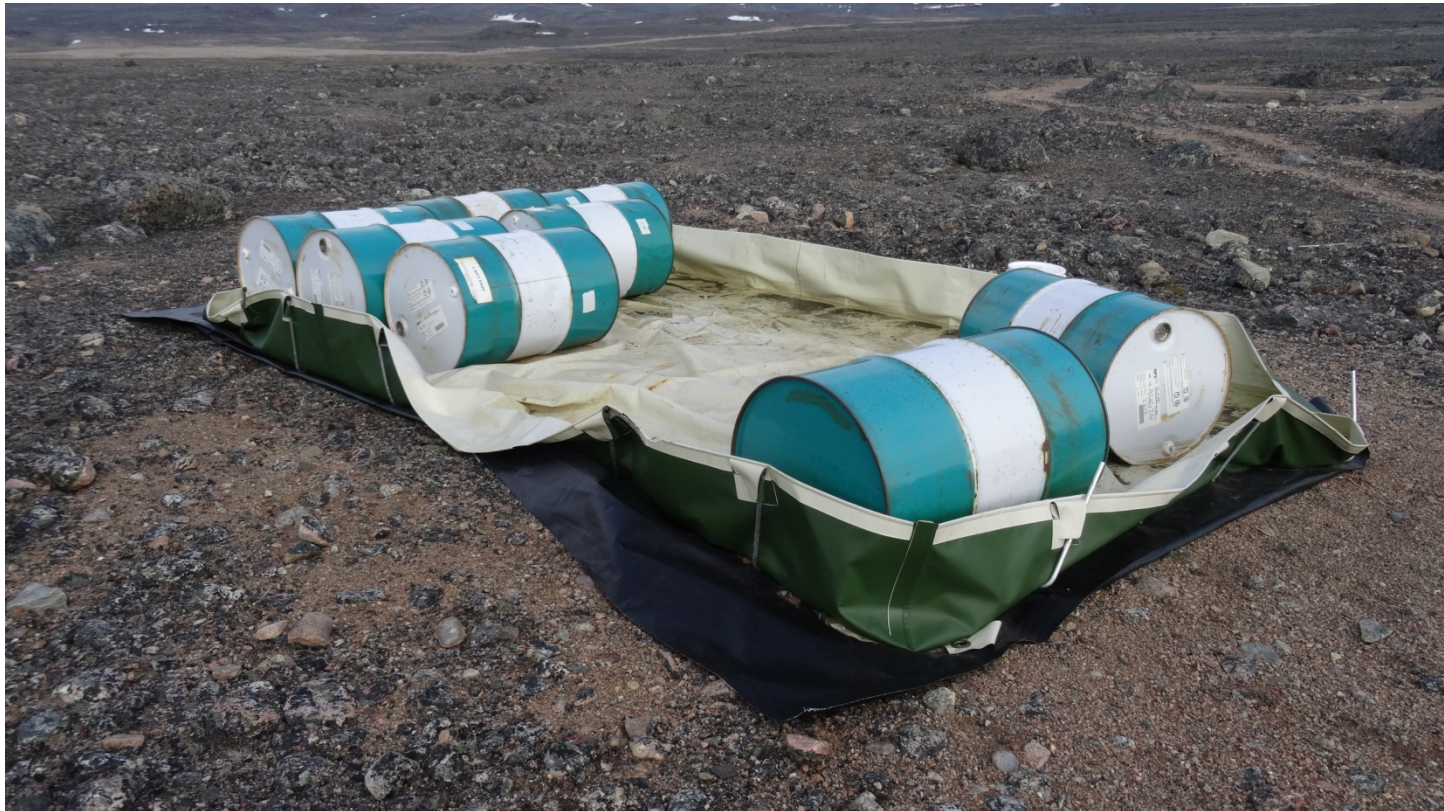
The camp was left in a clean and tidy state during shut down as required. Although the one Jet-A fuel cache did not appear to have any product spills coming from the drums, the walls of the secondary containment should be maintained on a regular basis to prevent a possible breach in the future as required in the land use permit section 31 (1) (k) item 52.

Photo 2: Jet-A fuel cache

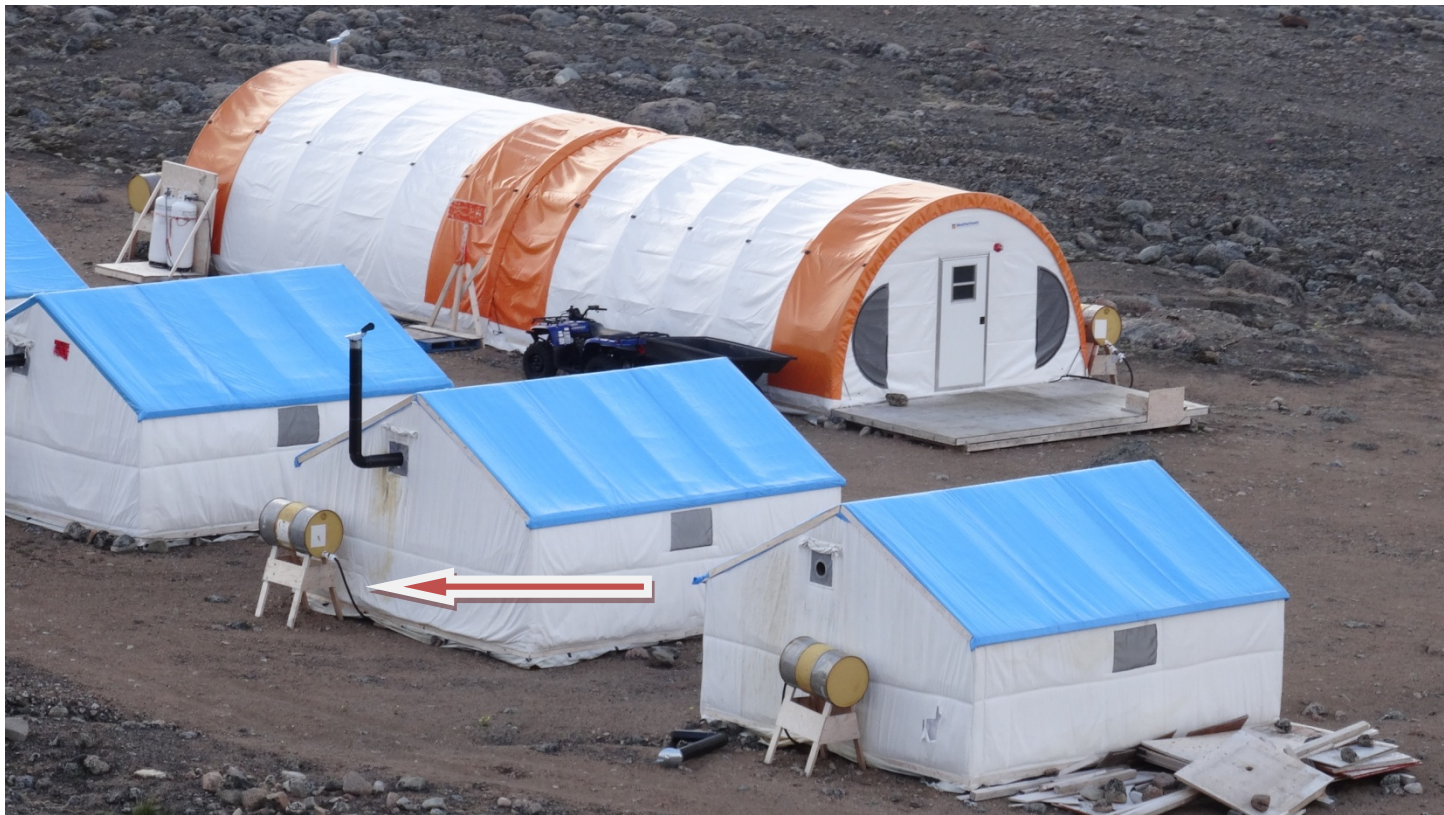
There were no spills visible around the tents and weather haven. In the future the inspector would like to see the drums on the wooden ‘fuel stands’ behind the tents and weather haven placed in secondary containment during shut down and seasonal closure.

Photo 3: Drums behind tents used for heating fuel tanks not in secondary containment.
Arrow identifying wooden fuel stand.
