Memorandum

SUBJECT: Fuel Containment Area Water Sampling

Starfield Resources Inc. (Starfield) constructed and operated a lined embankment secondary containment fuel storage area as part of their Ferguson Lake Project. Rescan Environmental Services Ltd. (Rescan) visited the Project area September 3 - 5, 2012 to assess the quality of the impounded water and to provide recommendations on its management.

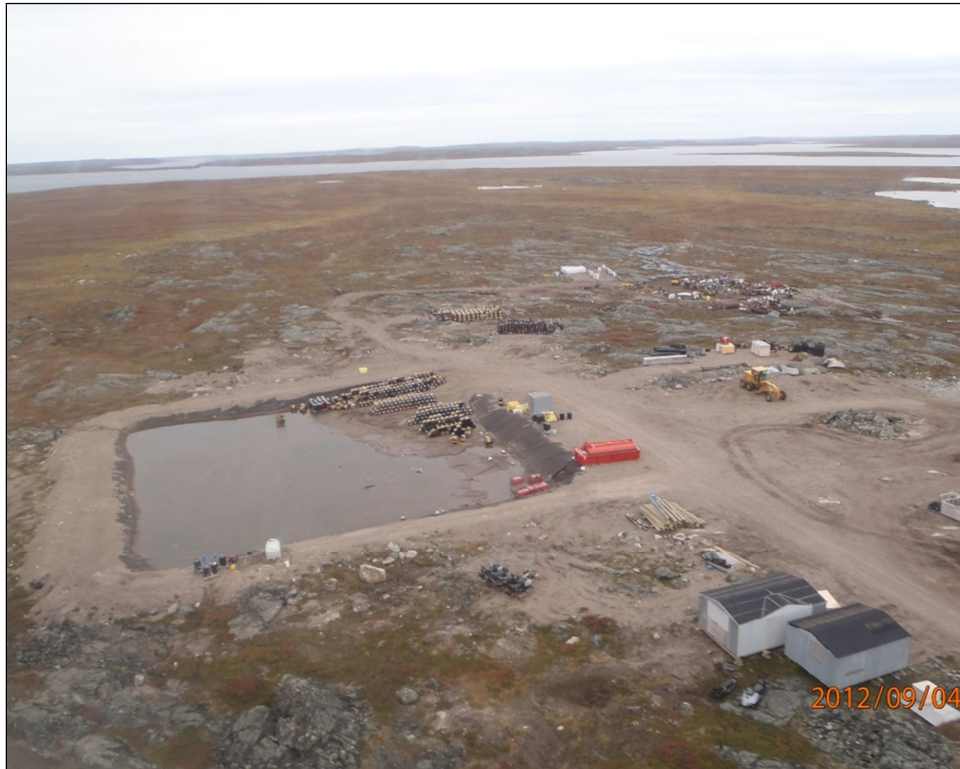
The fuel containment area (FCA) is approximately 40 m × 40 m (Plates 1 and 2). The containment area was constructed using local materials for the embankments and a HDPE liner was welded as the impermeable membrane. The liner was keyed in to the top of the embankment and was covered with a non-woven geotextile fabric. A layer of sand and gravel was placed on top of the fabric to form a ramp and a working area within the embankment.

Plate 1. Aerial view of flooded fuel containment area looking east.

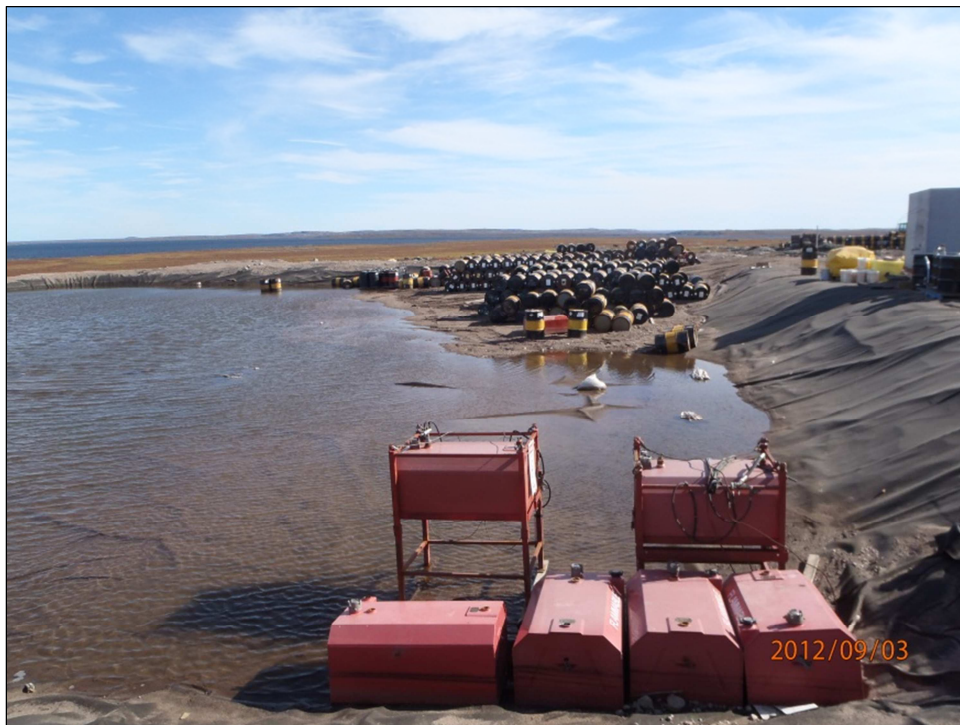
Plate 2. Fuel barrels stored on site at the time of sampling.

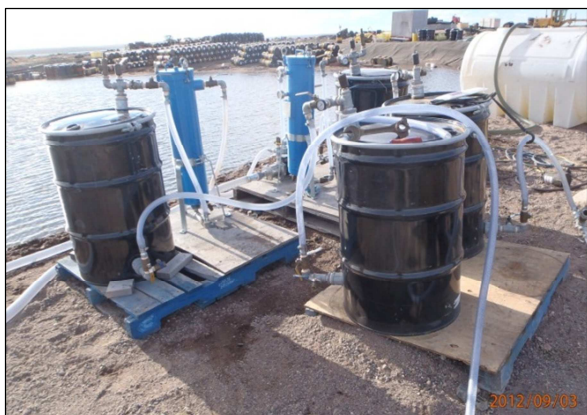
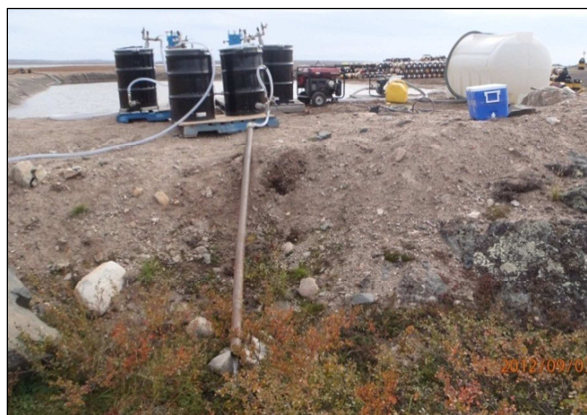
Contact water from snowmelt and rainfall collects seasonally in the containment area. Regular management of this contact water involves filtering the water through a series of 200 L steel open top drums full of filter media (activated carbon) connected in series to a pressure vessel which is also filled with filter media (shredded spill pads; Plate 3). Treated water is then discharged from two points west and north of the FCA (Plate 4).

Plate 3. Oil water separator used to treat water pumped out of the fuel containment area. Water is pumped through pressurized vessels containing activated carbon.

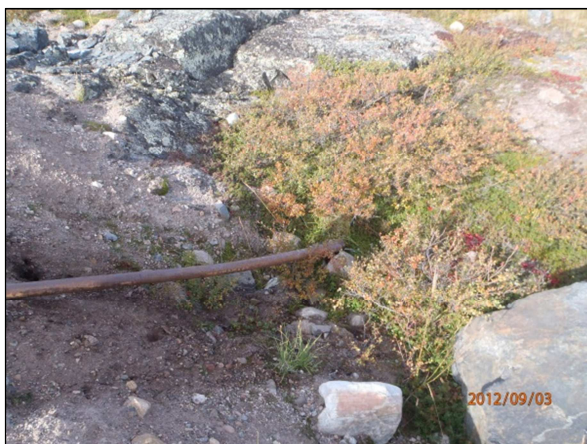
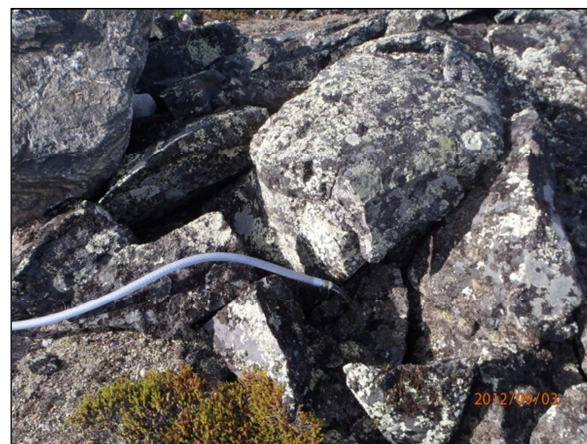
Plate 4. Western (left) and northern (right) treated water discharge points.

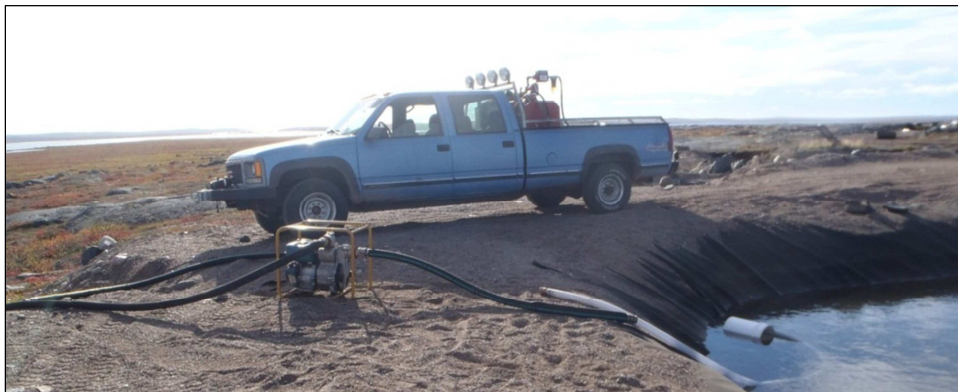
The second sampling event occurred on September 4, 2012. Untreated water samples were collected from the FCA and samples were collected from treated water being discharged from the OWS. Two untreated samples were collected from the middle of the water column in the FCA 1.25 hours apart (Plate 5). A clean, plastic bucket was used to collect this water for sampling purposes (Plate 6). Treated OWS water was collected at the northern and western discharge sites. At the time of sampling, the discharge rate was 13.3 L/min and 12.0 L/min at the northern and western discharge points respectively. For QA/QC purposes, duplicate samples of untreated and treated water were collected.

Plate 5. Hose and pump used to collect untreated water sample from the FCA being set up (not yet connected in this photo).

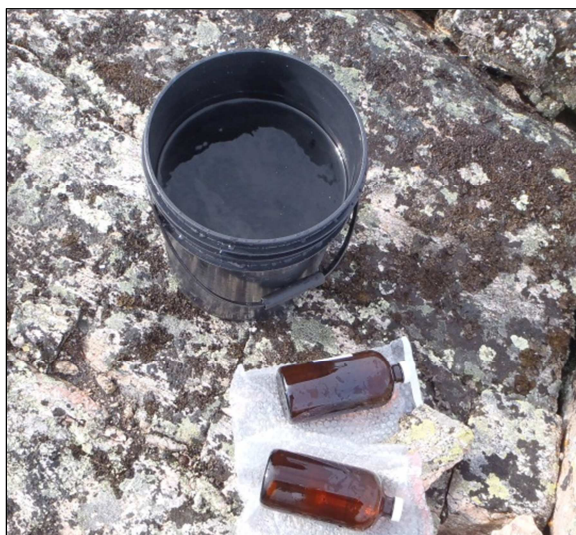
Plate 6. Water collection bucket used for sampling from FCA.
