Assessment of Soil Hydrocarbon Contamination at Ferguson Lake

Rescan™ Environmental Services Ltd.
Vancouver/Yellowknife

November 2007

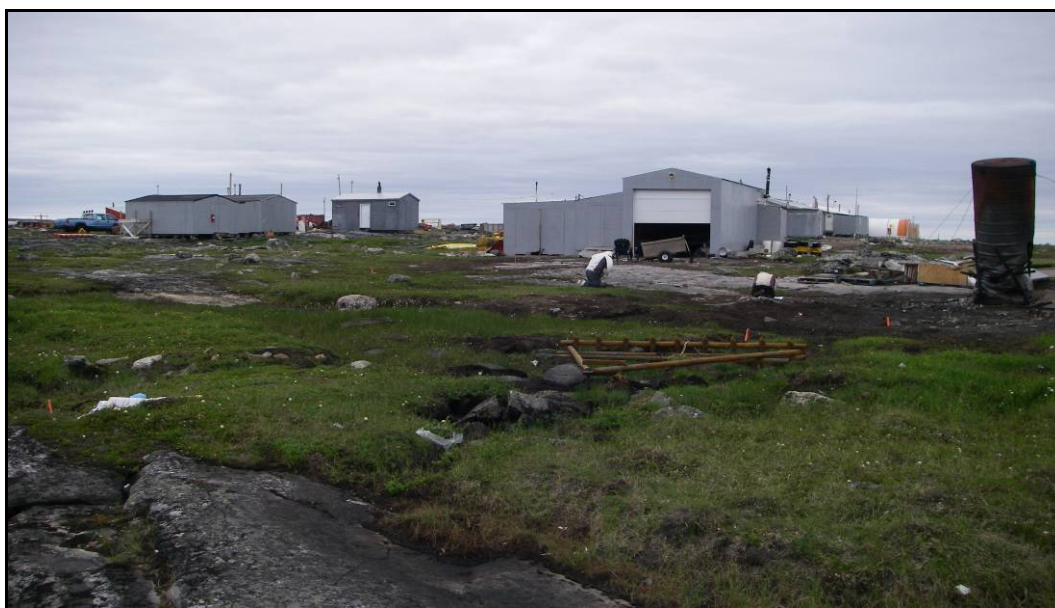
Plate 1.1-1. Old Ferguson Camp location on bedrock outcropping.

Ferguson Lake camps (old and new) and airstrip are located on bedrock outcropping with soils in depressional areas (Plate 1.1-1). Vegetation consists of mosses, lichens, dwarf birch, alder, Labrador tea, and an assortment of low groundcover. Migratory wildlife such as caribou, Arctic

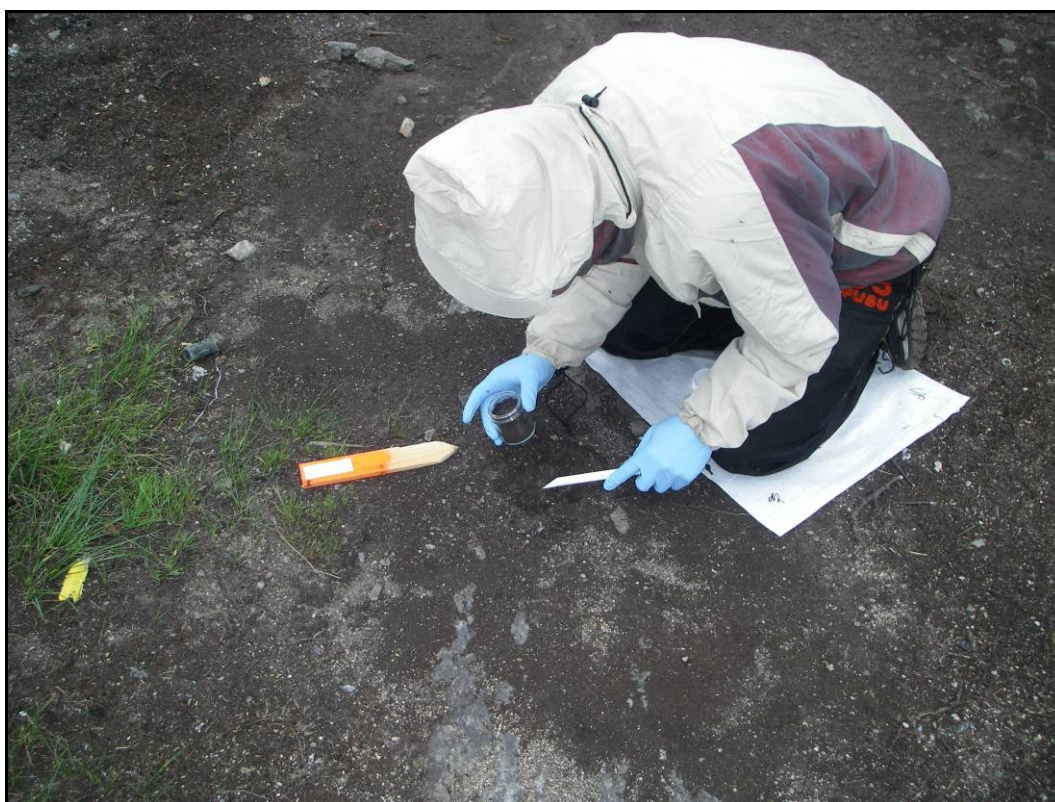
Plate 2.1-1. Sampling Equipment.

To avoid cross contamination, a clean plastic scoop was used for each sample collected (Plate 2.1-1). Samples were placed into glass jars and sent to ALS Environmental Services in Vancouver, British Columbia. Samples were analysed for soil texture and hydrocarbon content. Samples were analyzed within the 14 day holding time limit required for hydrocarbon analysis. All analytical methodologies and certificates of analysis are provided in Appendix 2.

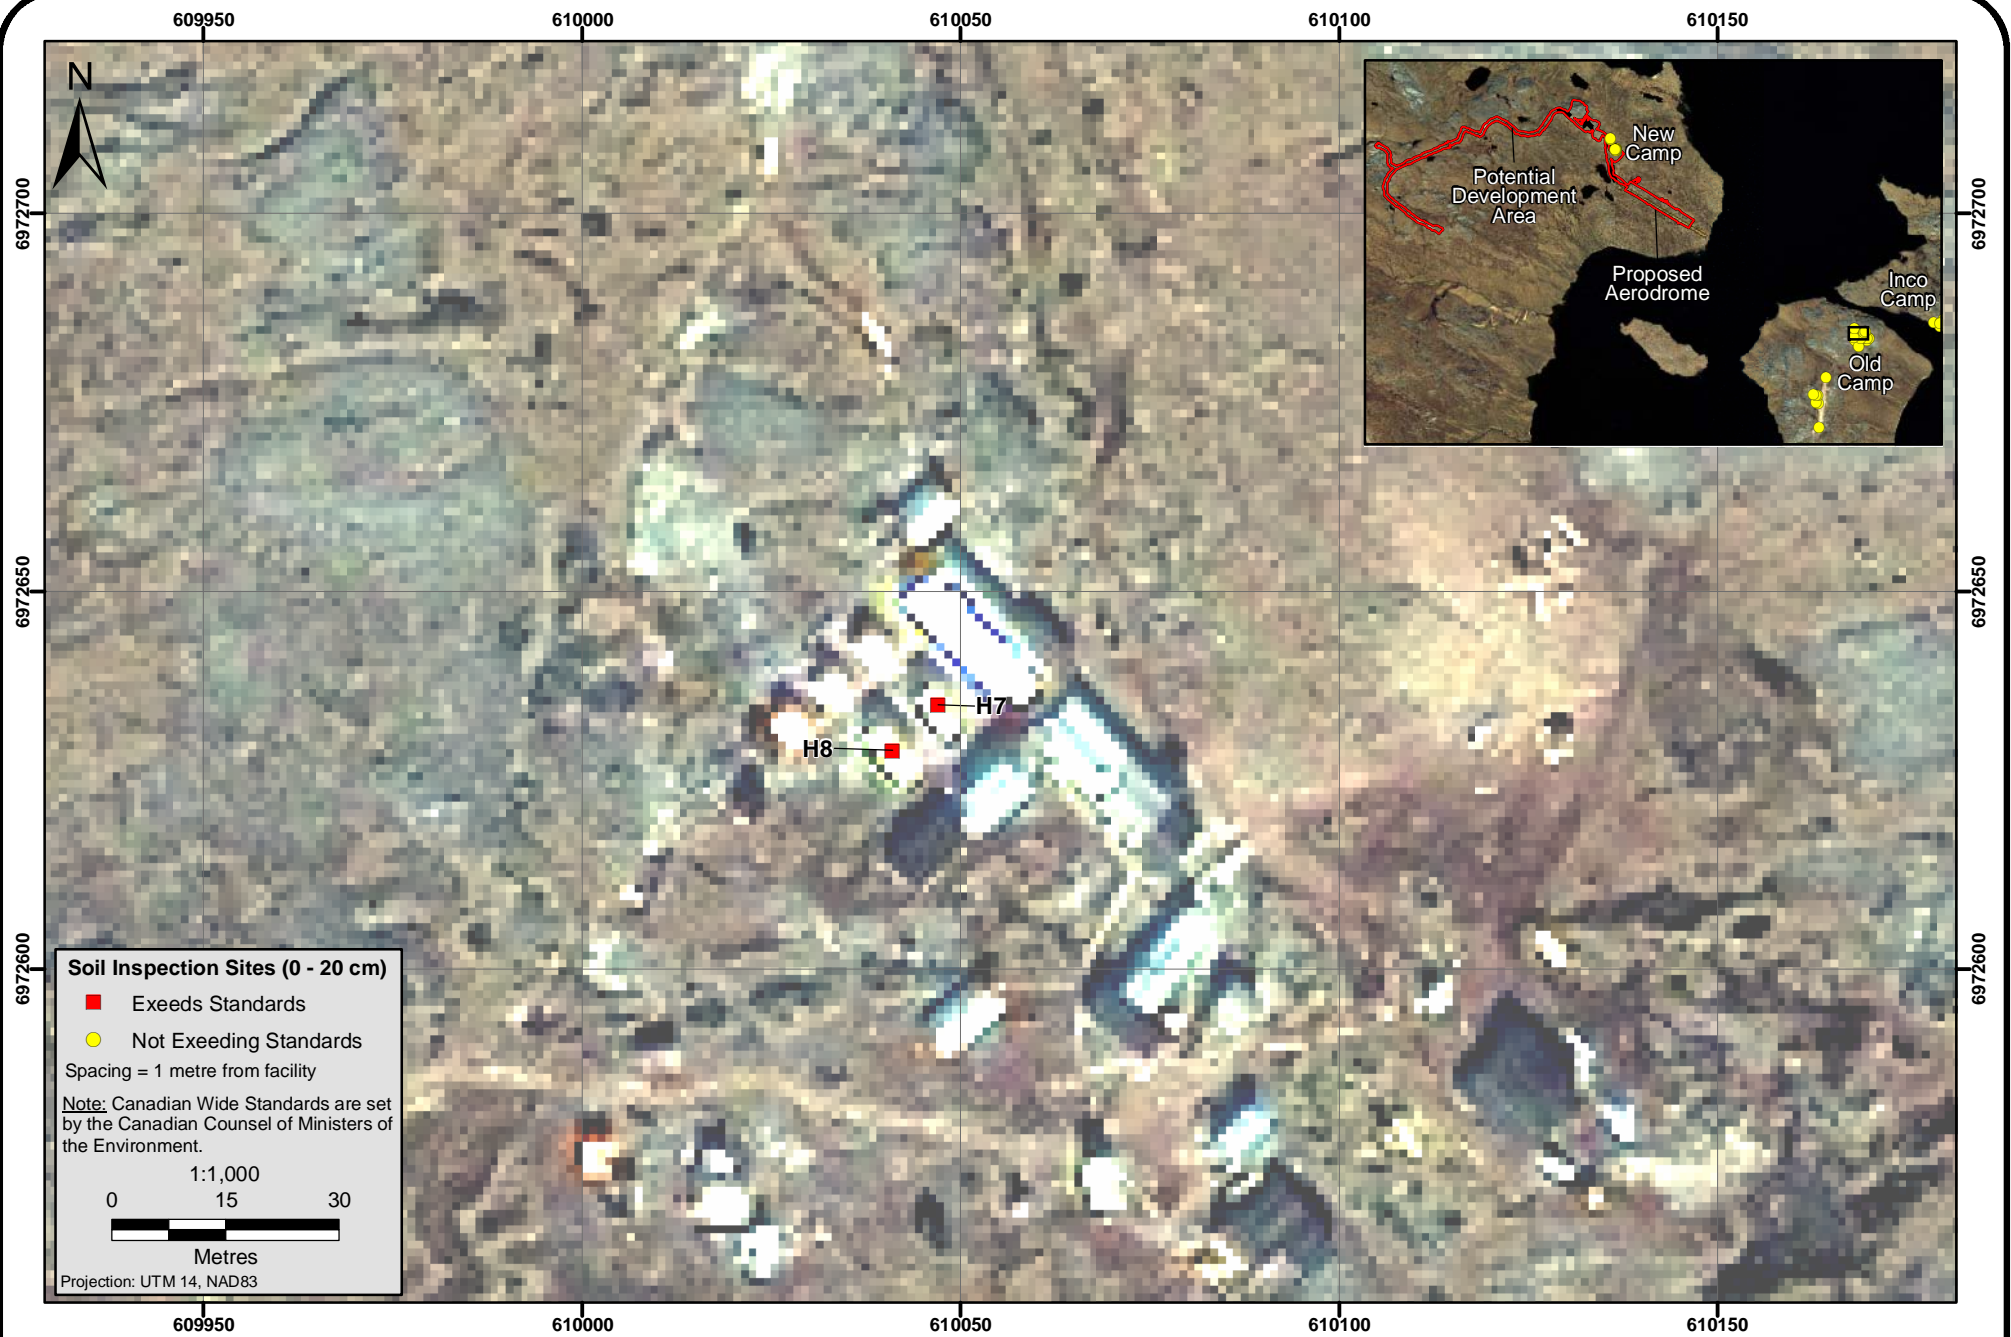
Both samples collected at Hut 7 and Hut 8 exceeded CCME standards for F3, and F4 products (Figure 3.1-5). F1 and F2 standards were also exceeded by soils collected from Hut 7 (Table 3.1-6) which suggest that additional contaminants (gasolines, mineral spirits, paint thinners, kerosenes, and/or jet fuels) were present at this site. Contaminants that may be present at both locations include: diesel, furnace, and lubricating oils, greases, waxes, heavy fuels, and asphalts.

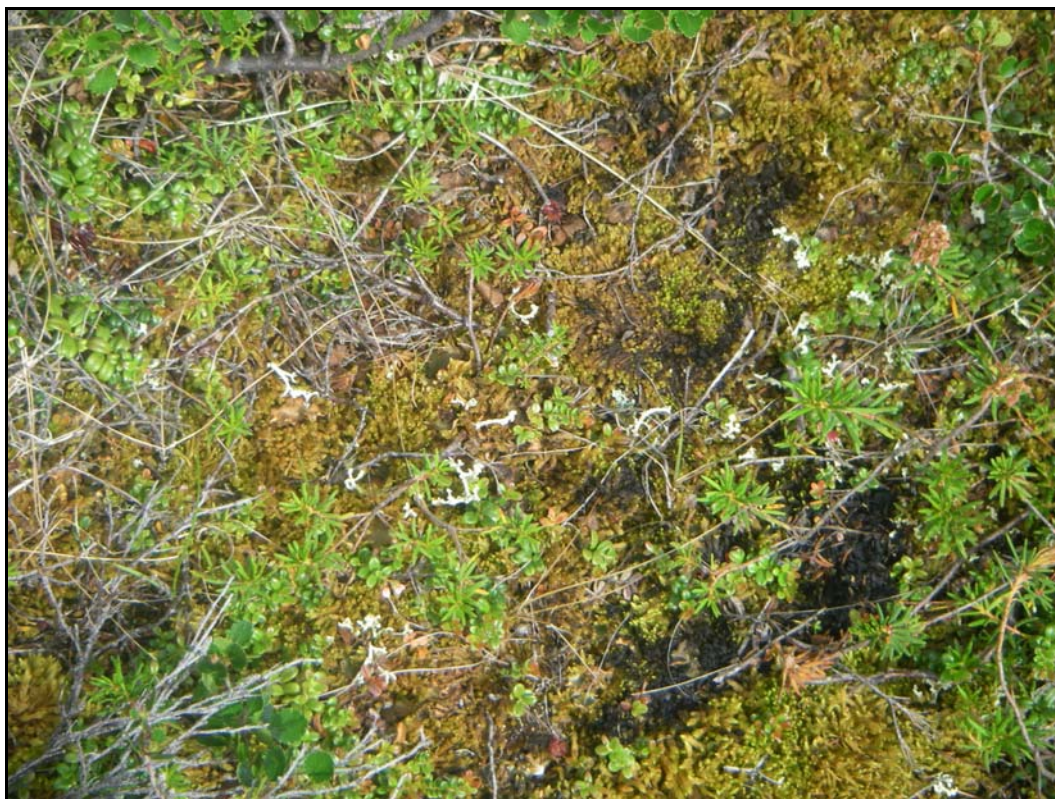
Plate 3.2-1. Soil stained by a barrel that was leaking.

One out of 14 samples exceeded CCME standards, but only one fraction (F2) was exceeded by the sample collected at NC13 (Table 3.2-1). Since this sample was taken where the soil was stained by a fuel barrel that had leaked (Plate 3.2-1), the soil is most likely contaminated with diesel oil.
