DATE: July 20, 2011 Refer to File No.: Document1
TO: Elizabeth Sherlock, Environmental/Permitting Coordinator
FROM: Kirsten MacKenzie, M.Sc., R.P.Bio. (Fish Biologist)
Deborah Muggli, Ph.D., M.Sc., R.P.Bio. (Project Manager)
SUBJECT: Back River Airstrip Fish and Fish Habitat Assessment

DATE: October 4, 2011
TO: Elisabeth Sherlock, Environmental/Permitting Coordinator
FROM: Greg Sharam (Manager, Terrestrial Group); Deborah Muggli (Project Advisor)
CC: Stephen Monninger (Project Manager), Tara Wight (Project Coordinator)
SUBJECT: Ecosystem Overview at Proposed Goose Camp Airstrip

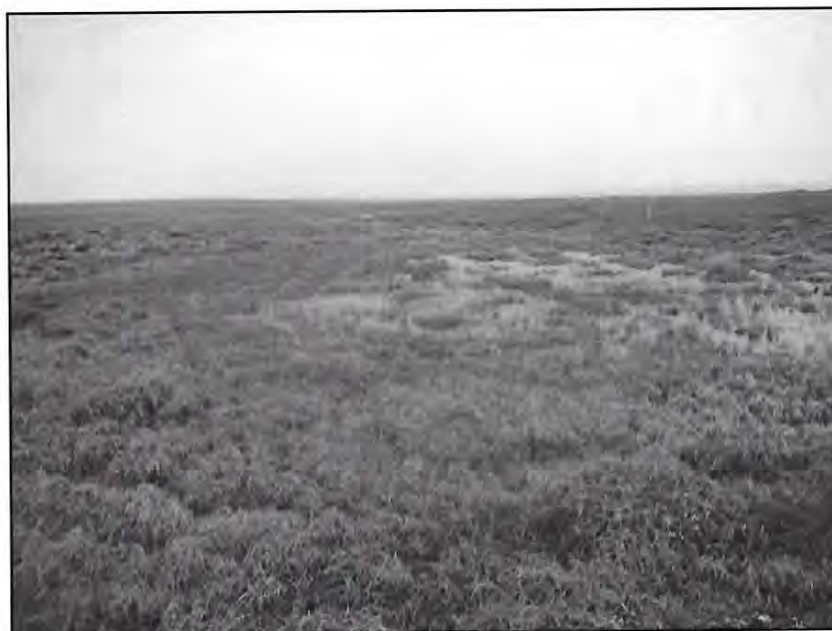
Site AS-1 is located just east of Goose Lake Camp. The area is characterized as a non-classified drainage (NCD) because it has no defined channel and no alluvial deposits. The area consists of ponded and pooled water in a low, wide drainage with no connectivity to surrounding water bodies (Plate 3.1). Several ponds up to 50 m² were observed, but no channels connected the ponds. The maximum depth of the ponds measured was 0.5 m, indicating that the area has no overwintering potential for fish. The lack of connectivity between water bodies, even at the high water levels observed, indicate that the area does not provide any suitable fish habitat.

Electrofishing was conducted for 257 s over a 100 m distance in several ponds and pools. No fish were captured or observed. This area is thus classified as non-fish-bearing, and a culvert crossing is suitable for the access road.

Plate 3.1 View looking west of AS-1 non-classified drainage

From a fish and fish habitat perspective, the airstrip and access roads are proposed for suitable locations. No fish habitat exists between the airstrip and camp; therefore a culvert crossing of the non-classified drainage (AS-1) is suitable. Bridge crossings should be considered for the sites upstream and downstream of Gander Pond (AS-2 and AS-3) due to the presence of fish and potentially high flows. Site AS-4 is likely suitable for a culvert crossing due to the poor fish habitat potential; however, installing an open-bottom crossing such as an arch culvert would avoid the uncertainty of requiring approval from DFO. No fish habitat was present along the airstrip centreline.

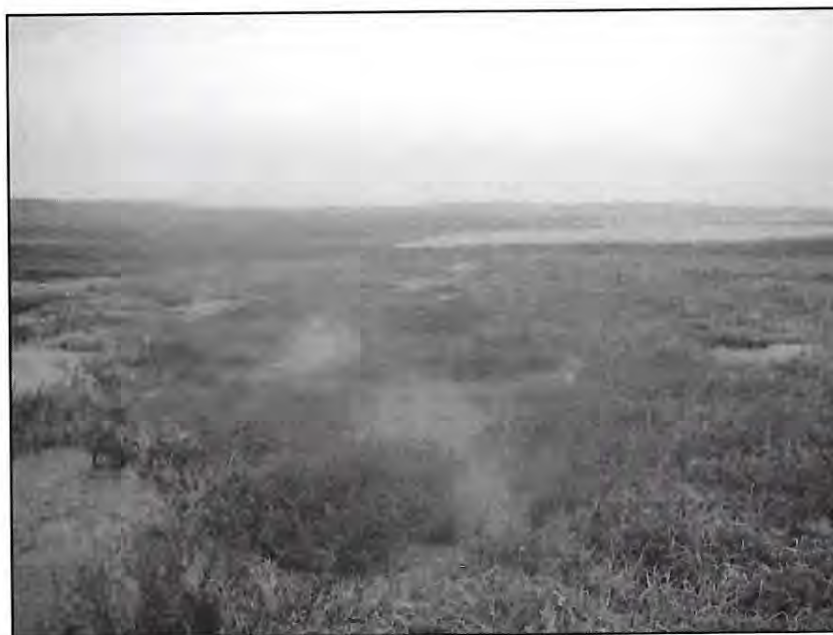
Site AS-2 is located approximately 100 m upstream of Gander Pond, east of the proposed airstrip. It is a stream with poorly defined banks and multiple channels (Plate 3.2). The bankfull width ranges from 1.5 m to 6.7 m, while the wetted width ranged from 1.6 m to 8.8 m (larger than bankfull because the

stream was in flood). The stream displays pool-riffle morphology; however, there were few deep pools. Most of the habitat units were glides or riffles. The substrate was dominated by boulder and cobble, while the cover was dominated by instream vegetation and boulders. Stream temperature was 6°C, conductivity was 4 µS/cm and pH was 8.0. The water was clear with no noticeable turbidity.

Site AS-2 was electrofished for 728 s over 100 m. One slimy sculpin (*Cottus cognatus*) was observed, but could not be captured because it retreated into the boulders along the bottom of the stream. No other fish were seen; however, the site has good connectivity to Gander Pond and has high habitat complexity due to the abundance of boulders and instream cover. The habitat in this area is suitable for rearing; however, no spawning habitat or overwintering habitat was seen.

Plate 3.2 Site AS-2 looking downstream towards Gander Pond. Note the multiple channels and poorly defined banks.

This site is considered to be fish-bearing and should be crossed with an open-bottom structure such as a bridge. The most suitable crossing location from a fish habitat standpoint is located approximately 100 m upstream of Gander Pond at 13W.433377.7269435. At this location, the stream is relatively confined between areas of raised tundra. Elsewhere, the stream is poorly confined and floodwaters extend far beyond the banks of the stream.

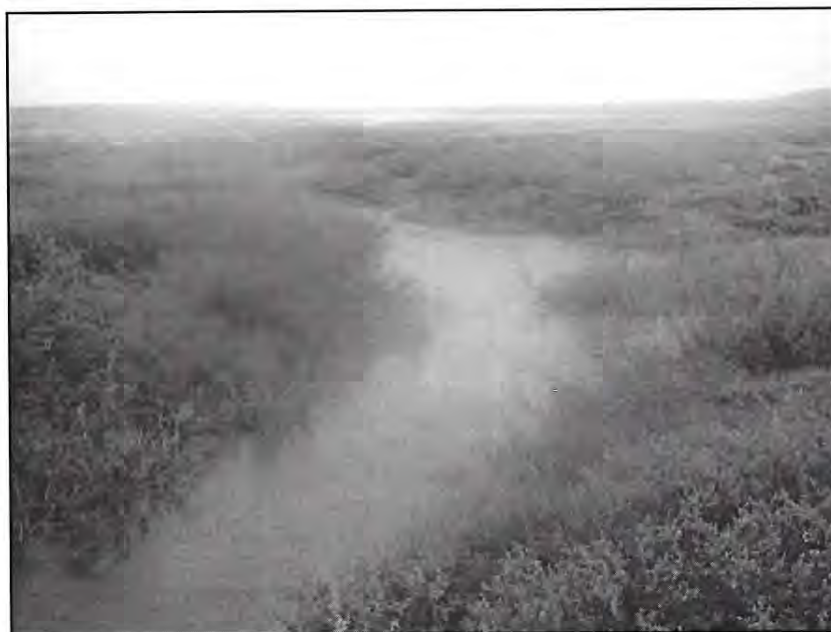
Site AS-3 is located approximately 100 m downstream of Gander Pond near the existing hydrology station. The stream in this location is well-defined with stable banks and a deep channel (Plate 3.3). The morphology is riffle-pool; however, most of the channel was characterized by deep glides and riffles. The bankfull width ranged from 2.0 to 3.2 m, and the wetted width ranged from 2.0 to 6.2 m. Cover was dominated by instream vegetation and deep water, while the substrate was dominated by fine sediment and boulders. The habitat in this area has good potential for rearing, but no spawning habitat was observed. The channel is not likely deep enough to support overwintering.

Site AS-3 was electrofishing for 450 s over 100 m. No fish were captured or seen; however, electrofishing conditions were difficult due to the deep channel and swift flow. The stream was followed downstream to Goose Lake to look for potential barriers to fish migration. No permanent barriers to migration were observed; however, the stream becomes more poorly defined as it approaches Goose Lake and it flows through a wide swath of scrub birch and willow.

Plate 3.3 Site AS-3 looking upstream near the hydrology station. This area is suitable for a bridge crossing due to the confined channel and high banks.

This reach should be considered fish-bearing due to the observation of a fish upstream at site AS-2. The confined channel and high banks near the hydrology station (UTM 13W.432870.7269944) make it suitable for a bridge crossing.

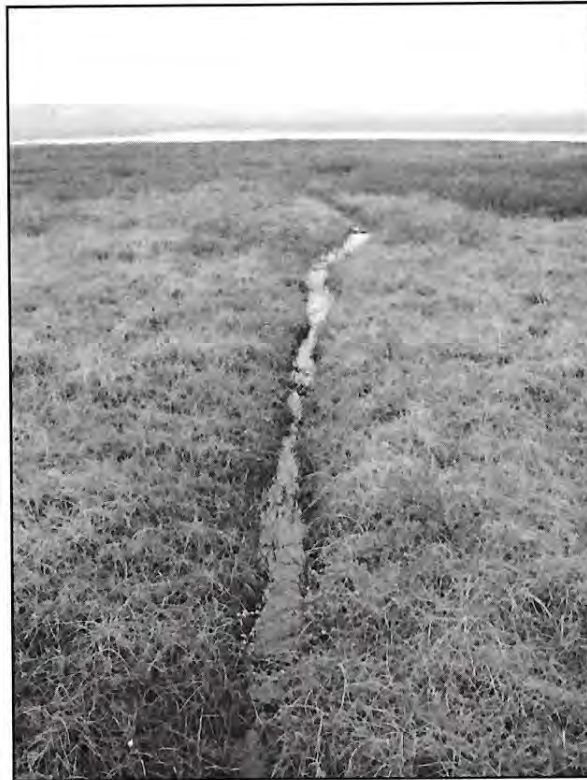
Site AS-4 is a very small stream that also drains Gander Pond into Goose Lake. It has a defined channel approximately 0.3 m wide and 0.1 m deep (Plate 3.4). It is ephemeral and while it is accessible to fish at high flows, it does not provide any suitable habitat for any life stage. It is likely suitable for an arched culvert crossing due to the poor habitat quality. No sampling was conducted at this crossing.

Plate 3.4 Site AS-4 looking downstream towards Goose Lake.

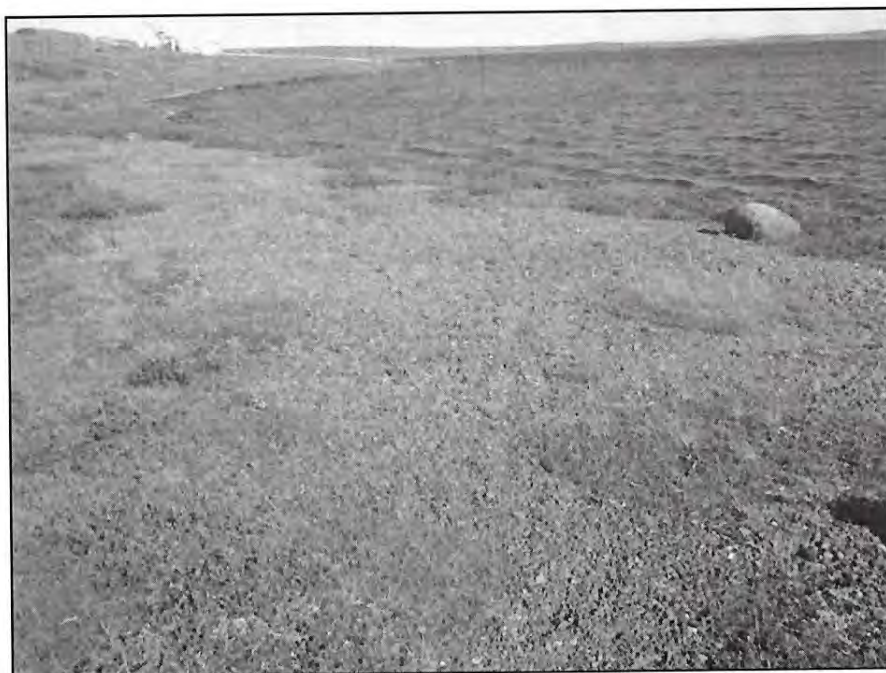
Plate 1. Example of Beach in the airfield study area.

Gravel beach with sparse vegetation. Limited in extent and rare in study area. No soil development. See Plate 1.

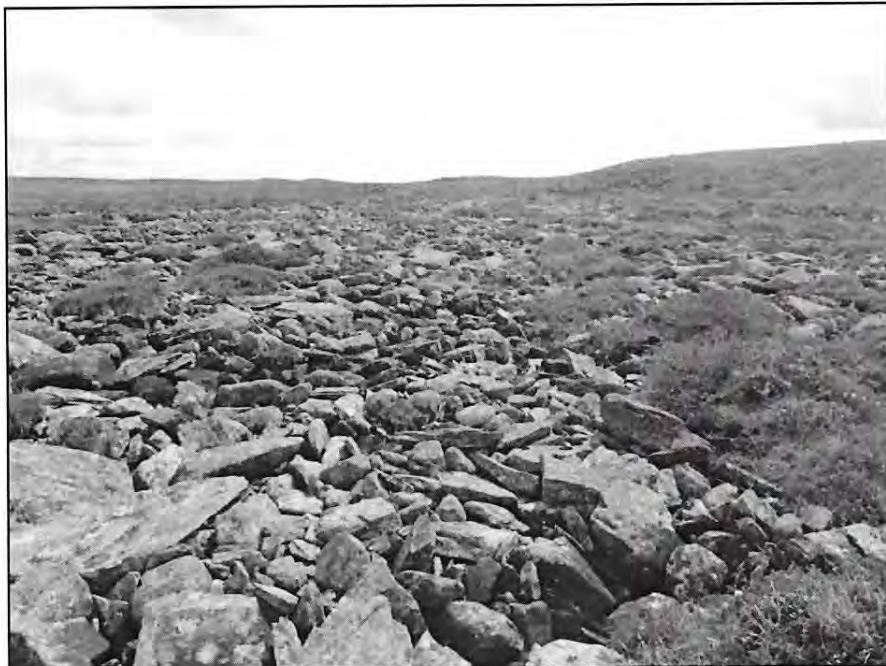
Plate 2. Example of Blockfield in the airfield study area.

Areas dominated by shattered bedrock or till boulders. Vegetation and soil largely absent, or represented by 'floating' mats of organics (organic mat on large boulders with no mineral soil) with diverse herb, shrub and lichen communities (Lichen-Rock Community). Occurs in a variety of locations and slope positions. See Plate 2.

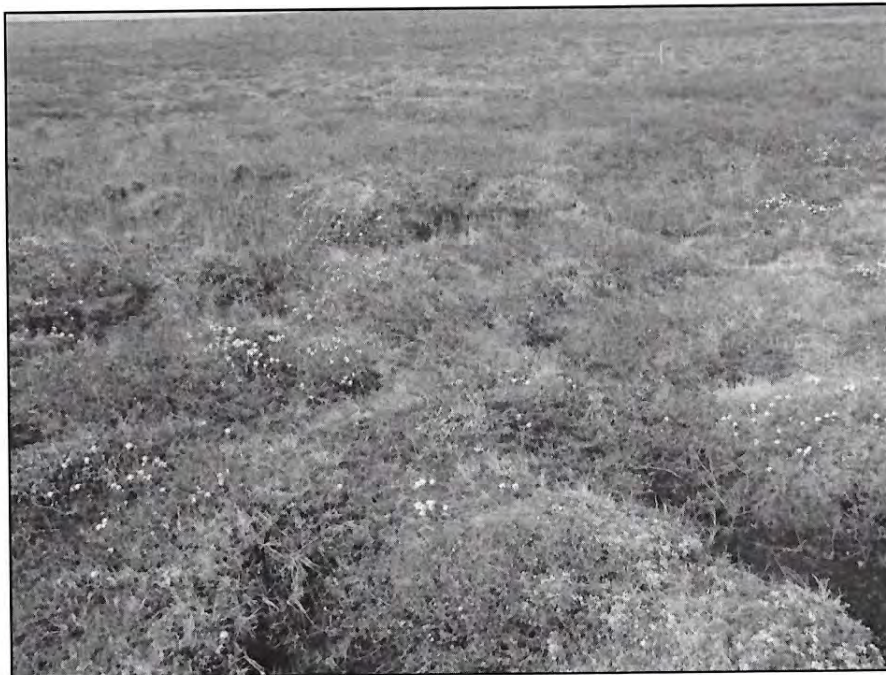
Plate 3. Example of Betula-Ledum-Lichen in the airfield study area.

Hummocky areas dominated by prostrate to low shrub dwarf birch, northern Labrador tea, cottongrass and diverse assemblage of dry (on palsa mounds) and wet (depressions between mounds) species. Occurs on thin fibric organic layers over slightly finer (relative to dry communities such as SH) textures till blankets. Flat to gently sloping. Common, but rarely extensive and typically mixed with WM, BM or SH. Occasionally occurring in small patches in depressions at the base of rock outcrops. Soil moisture ranges from submesic to mesic (subhygric in depressions), soil nutrients are poor to medium. See Plate 3.

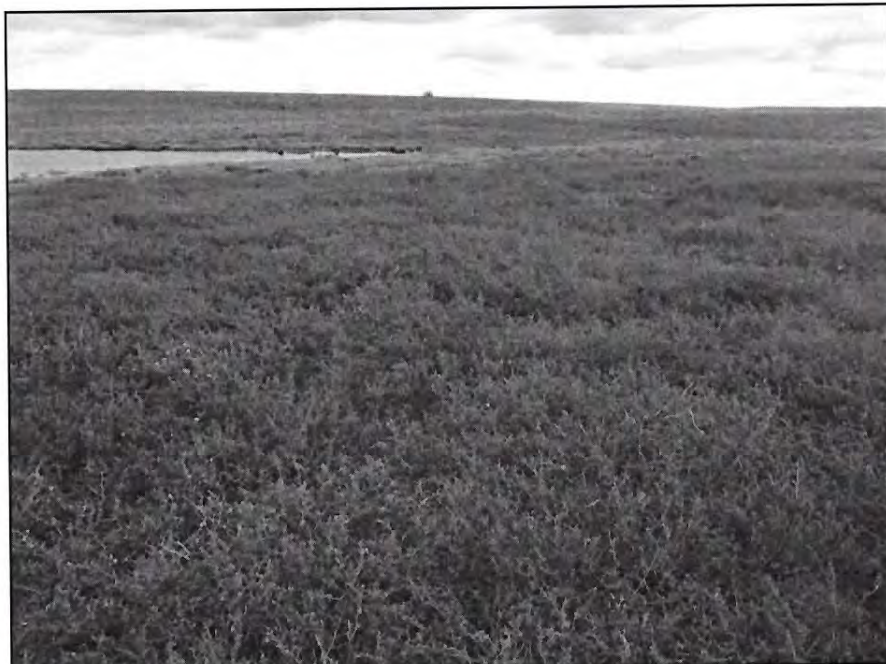
Plate 4. Example of Betula-Moss in the airfield study area.

The Betula Moss (BM) ecosystem unit occurs on level to slightly sloped till blankets, often on slightly elevated microsites. Always occurs near WM or standing water. Soil moisture and nutrients are generally mesic and medium. It is characterized by a thick cover of dwarf birch, and a low diversity and cover of other shrubs and herbs. A thick cover of moss is always present. See Plate 4.

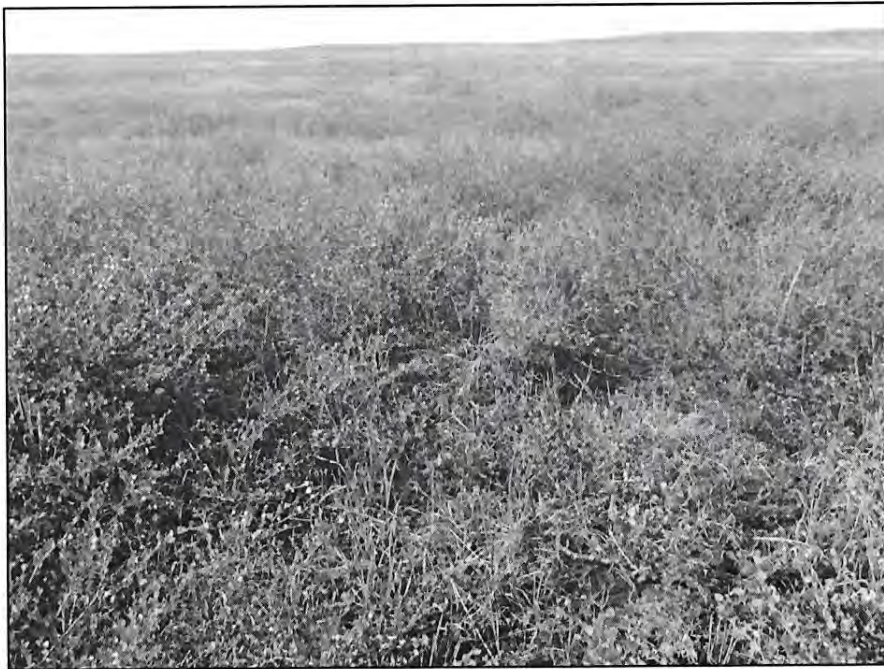
Plate 5. Example of Birch Seep/Shrub in the airfield study area.

Common in study area, but unsure if it should be a distinct ecosystem unit. Occurs on flat till areas that are generally water receiving. Sites are dominated by dwarf birch, along with a diverse (but sparse) cover of other dwarf shrubs and herbs. Moss and lichens noticeably absent (distinguishes BS from BL). Soil nutrients medium, and moisture subhygric. Often occurs with small depressions with thick sedges. See Plate 5.

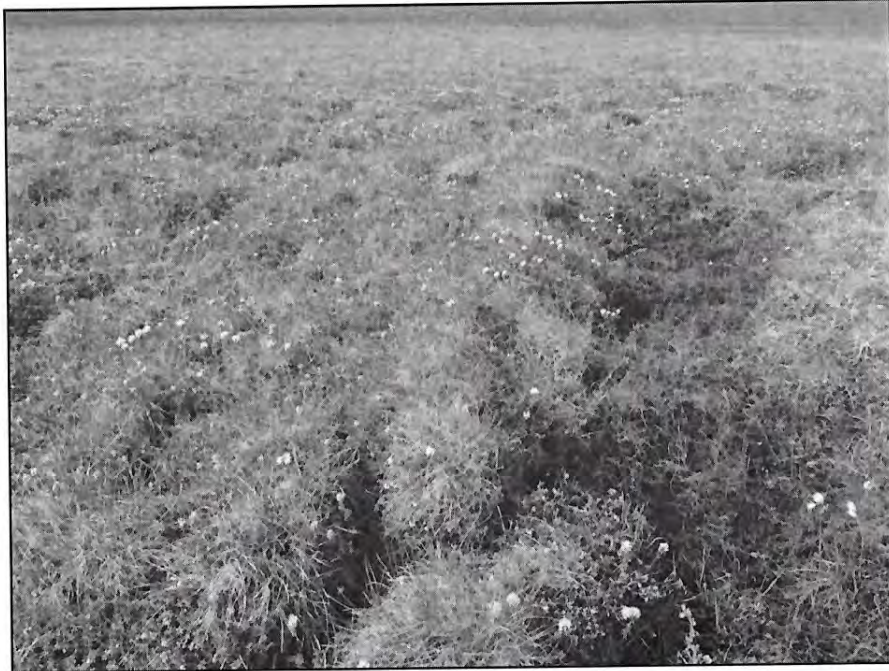
Plate 6. Example of Birch-Ledum Tussock in the airfield study area.

Small tussocks of cottongrass with a significant cover of northern Labrador tea, and a generally low cover of other dwarf shrubs. Limited extent and uncommon in area. Typically mixed with other wet communities such as WM, EM and BL. Occurs on firbic organic veneers (17 cm deep) over fine textured (silty) till (maybe lacustrine) material with no coarse fragments. Underlain by permafrost (uncommon at shallow depths in study area) at the transition from organic to mineral soil. Soil nutrients rich and moisture subhygric. See Plate 6.

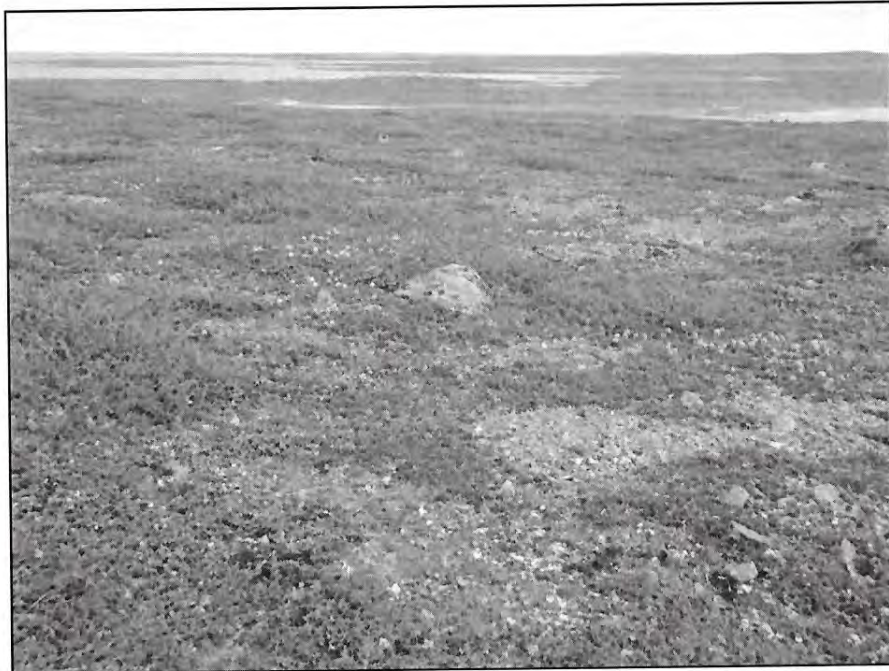
Plate 7. Example of Dryas Herb Mat in the airfield study area.

Dryas Herb Mats are restricted to windswept rocky crests and bedrock outcrops. Soils are thin and coarse; typically thin layers over bedrock. Soil moisture is xeric and nutrients very poor to poor. Vegetation is sparse. Shrubs are lacking. Dwarf shrubs are common and dominant. Mountain avens are common, but species assemblages are diverse in response to microsites. Lichens are common, but not extensive while mosses are generally absent. Exposed mineral soils frost boils, solifluction and rock outcrops are common. See Plate 7.

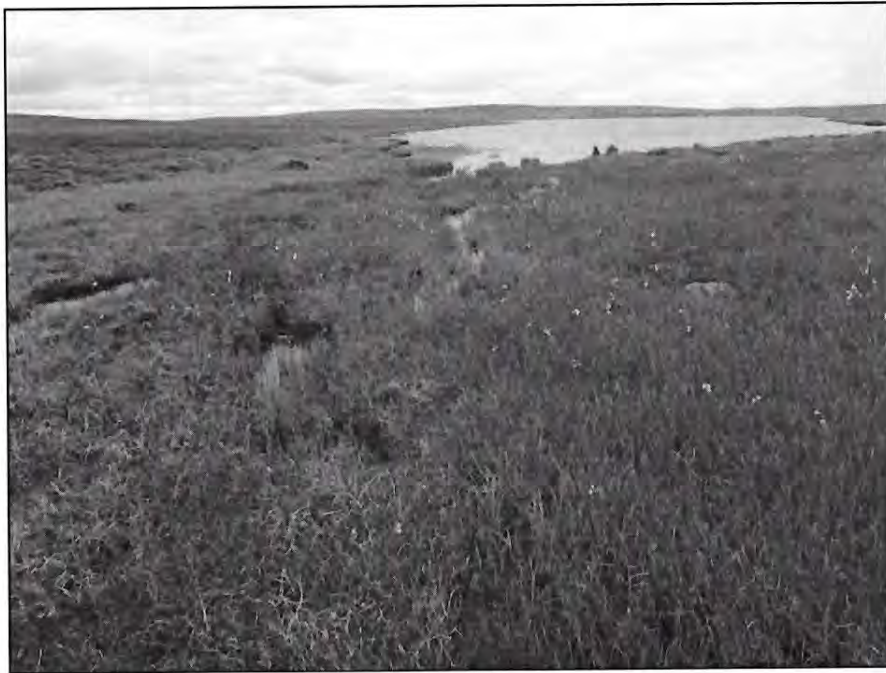
Plate 8. Example of Emergent Marsh in the airfield study area.

Not sampled. Emergent marsh is the wettest ecosystem unit in the study area, with standing water always present. It is uncommon and never extensive. It is dominated by a thick, continuous cover of sedges, with small occurrences of cottongrass. Other species may occur, but they never have a significant cover. Always occurs in depressions, generally in complexes of WM and on the edge of standing water. See Plate 8.

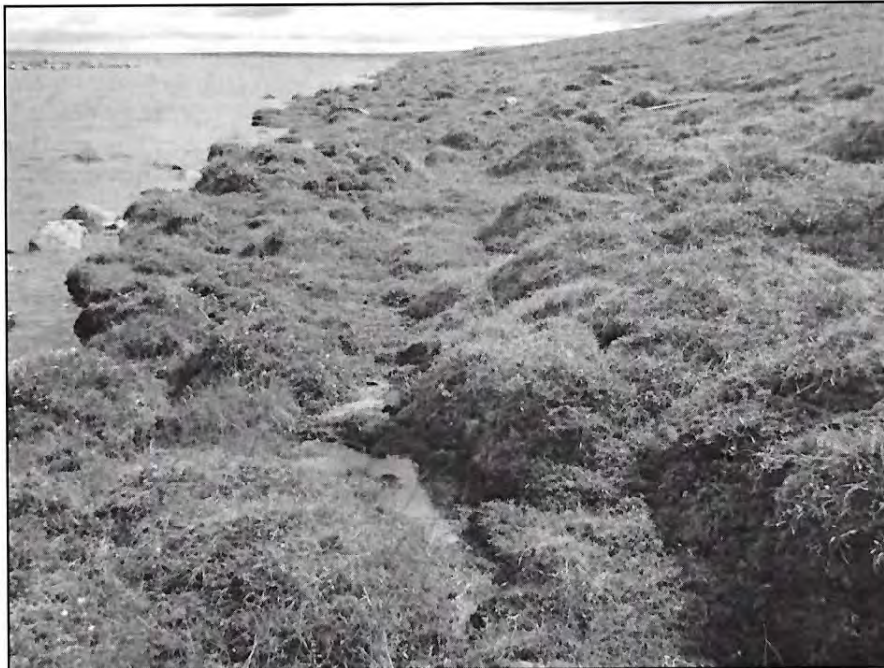
Plate 9. Example of Low Bench Floodplain in the airfield study area.

Low bench floodplains occur on the edges of large waterbodies that seasonally flood. Vegetation is diverse, likely in response to parent material and duration of inundation, and forms a continuous cover. It is never extensive and typically occurs in narrow linear strips on small flat toes. Think organic soils may be present. Mineral soils are strongly mottled and gleyed. See Plate 9.

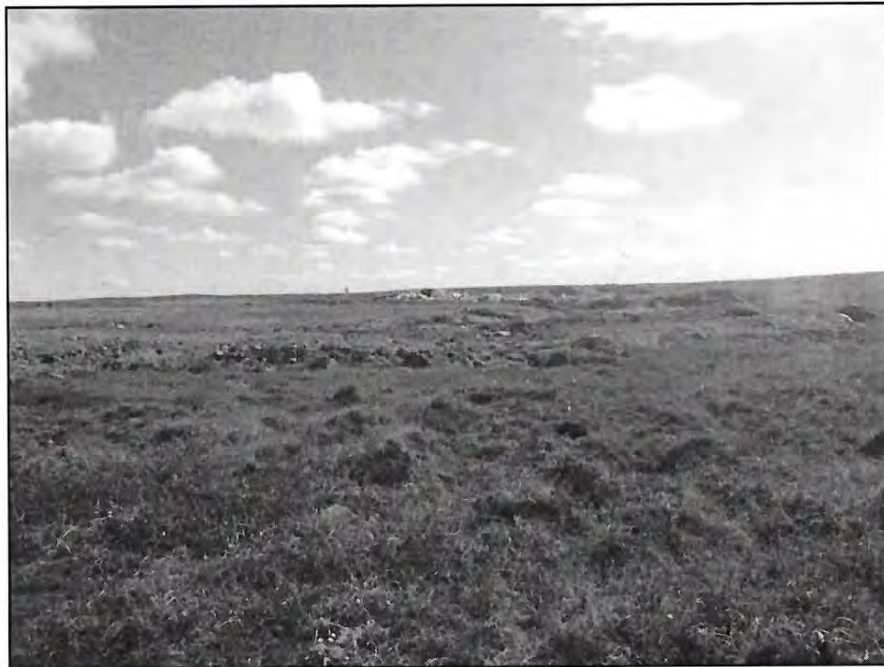
Plate 10. Example of Mine & Rubbly Mine Spoils in the airfield study area.

Not sampled. Camp, sludge pit, old drill pads. Various types of permanent or temporary disturbance from exploration activities. Generally exposed soils with remnant vegetation and profusion of grasses. See Plate 10.

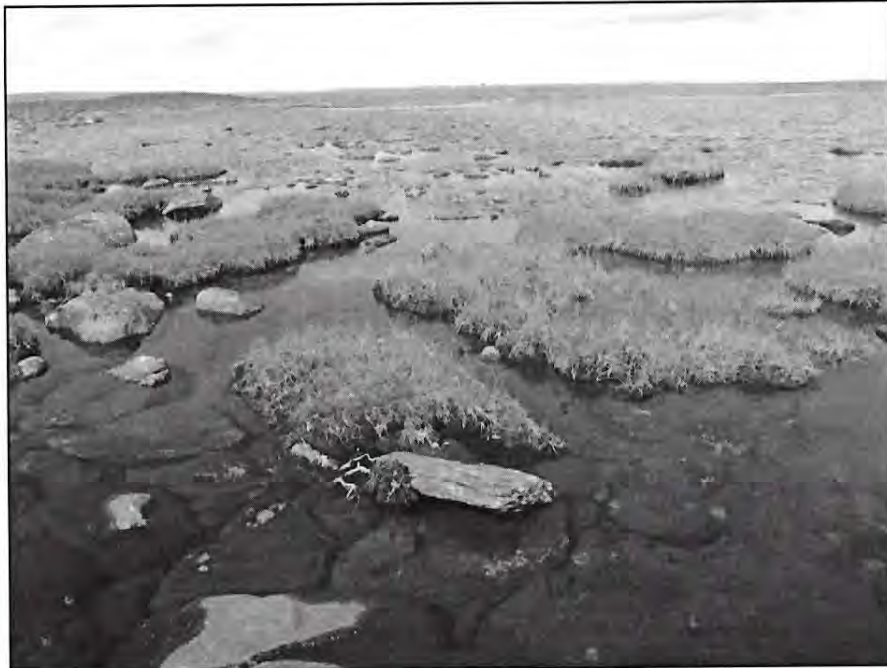
Plate 11. Example of Open Water / Pond in the airfield study area.

Not sampled. Shallow open water and pond with no aquatic vegetation and sparse emergent vegetation. Substrates range from fines/organics to cobble/boulder. See Plate 11.

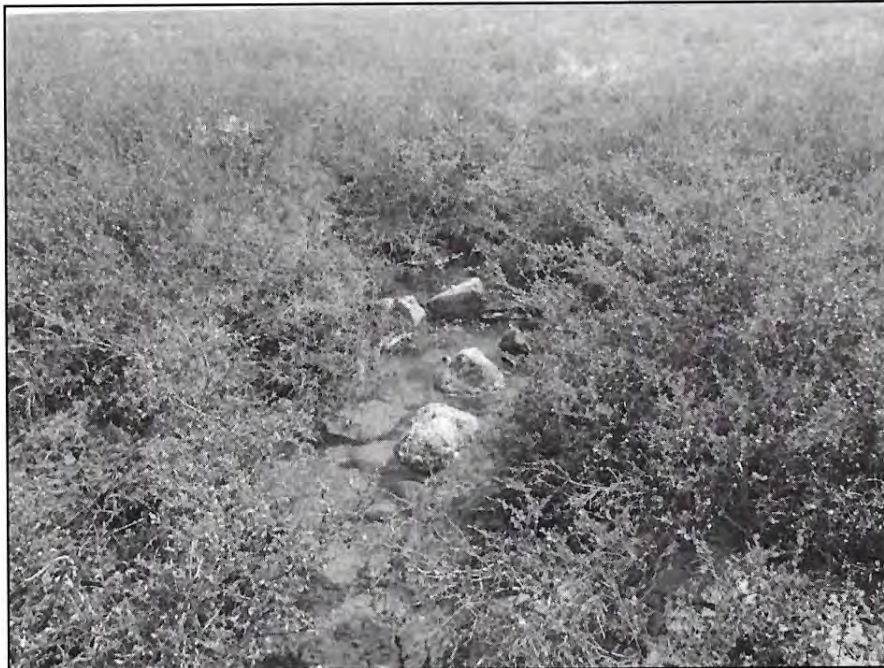
Plate 12. Example of Riparian Birch in the airfield study area.

Thick, tall (over 0.5m) birch with minor occurrences of willow. Herbaceous and dwarf shrubs generally lacking. Occurs on sandy, water washed (active flooding) till along small creeks and streams. On slopes and depressions shrub growth is 0.5m or greater, while on flatter, exposed areas shrubs are stunted allowing for more substantial herbaceous and dwarf shrub cover. Soil nutrients poor to medium, moisture hygric to subhydic. See Plate 12.

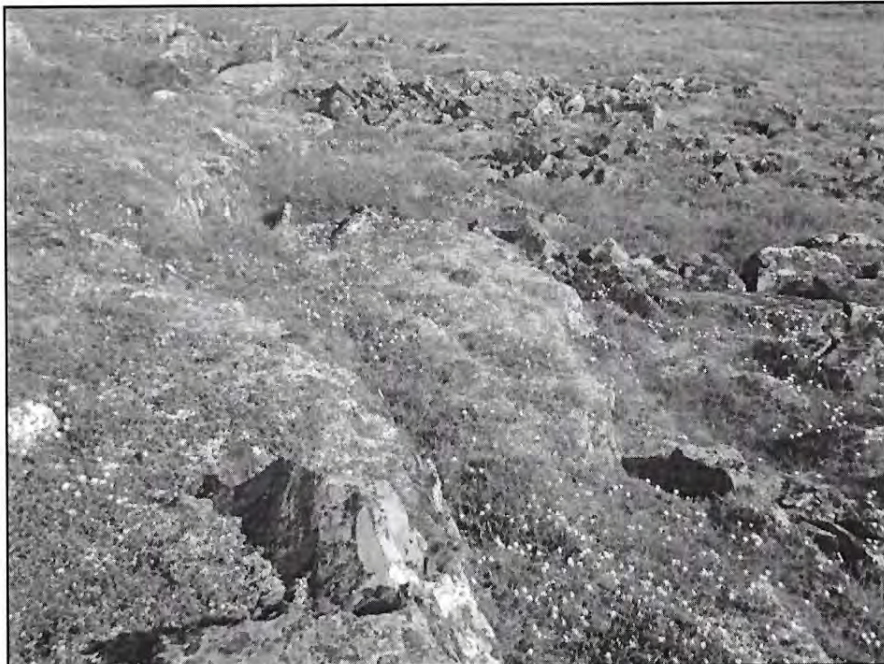
Plate 13. Example of Snowbank Community in the airfield study area.

Unsure if this should be a distinct community. Uncommon and not extensive. Sheltered sites on banks of rock outcrops where snowpack is deeper, or persists, and wind exposure is limited relative to open sites. Vegetation is diverse as soil development is inconsistent, ranging from dwarf shrub dominated sites on floating organic layers (organic mats over rock), and sheltered areas with thick willow growth. See Plate 13.

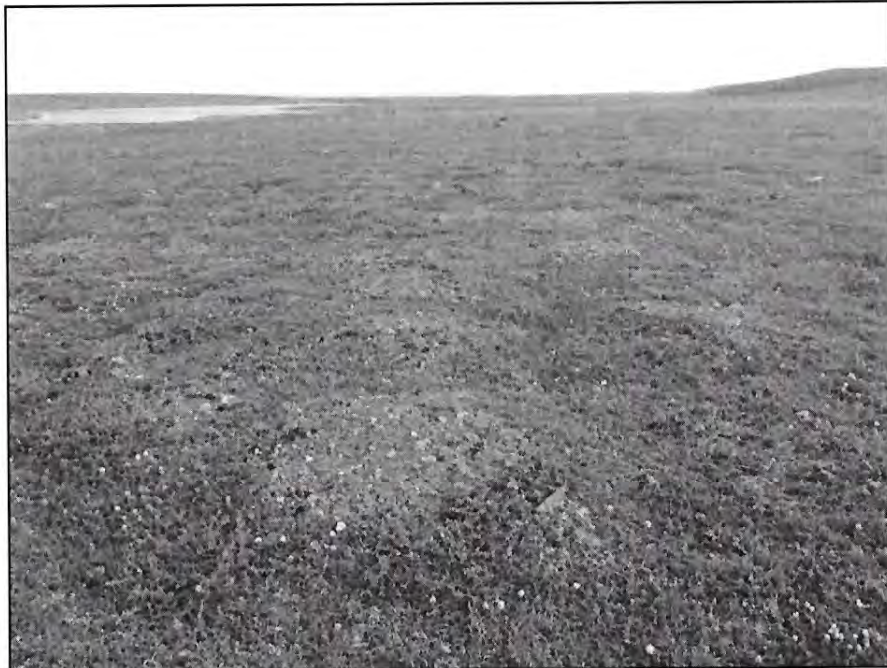
Plate 14. Example of Dwarf Shrub Heath in the airfield study area.

This typical tundra plant community typically occurs on flat to moderately sloping veneers and blankets of glacial till, often with a shallow fibric organic layer. Permafrost is generally deep, but frost boils and solifluction lobes are common. It is dominated by stunted dwarf shrubs such as northern birch, northern Labrador tea, bog and dwarf blueberry, alpine azalea, reindeer lichen, as a variety of herbaceous species. The SH community is the most common and extensive in the study area. See Plate 14.

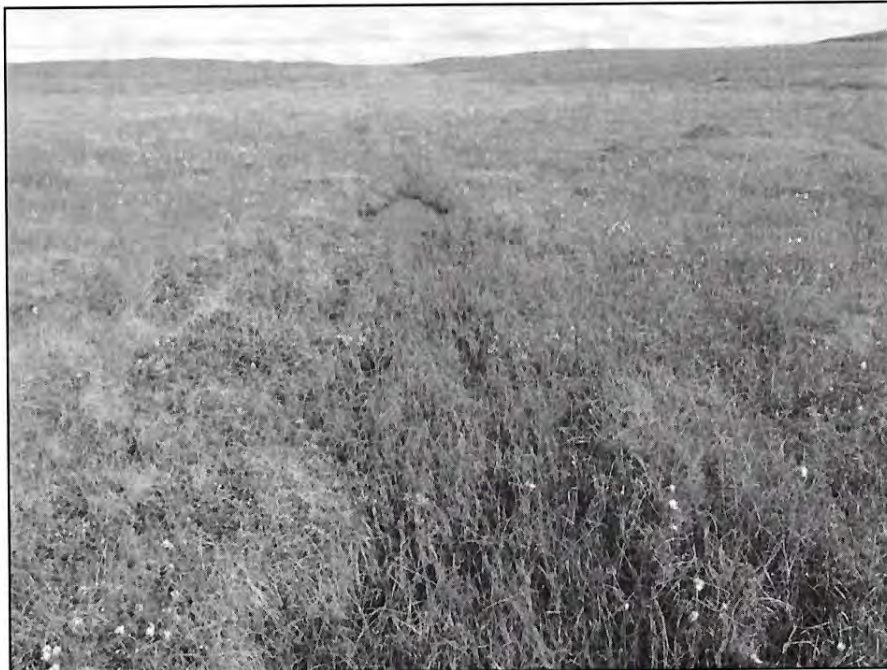
Plate 15. Example of Wet Meadow in the airfield study area.

Wet community type that occurs in small depressions, often complexed with other vegetation types. Small palsa mounds are common. Vegetation is dominated by sedges and cottongrass, with small dry elevation mounds common. Lichens are absent (with the exception of elevated dry sites where vegetation is quite random; can include dwarf shrubs, lichens, herbs and mosses). Standing water is present much of the year, but unlike EM, sites can be muddy or dry. Higher cover of cottongrass than EM, and typically does not occur in similar landscape positions as EM (adjacent to waterbodies). Soil moisture hygric to subhydryc; nutrients medium to rich. Relatively thick fibric organic layers common over strongly gleyed till. See Plate 15.
