Attachment 7 - Greywater Disposal Details

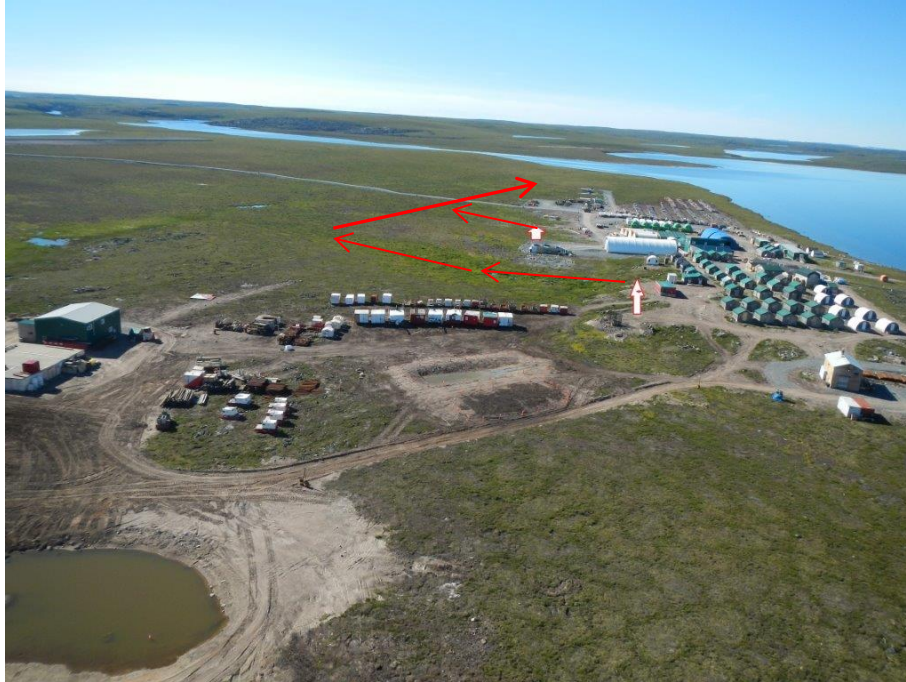
The north-facing photo below shows the two greywater discharge locations at the Goose Camp, as follows:

- Lower arrow in foreground in photo (more southerly red and white arrow) – greywater discharged from the kitchen and men’s and women’s wash facilities.
- The upper arrow in the background (more northerly red and white arrow) – greywater discharged from the medical clinic and a second men’s and women’s wash facility

Currently, the greywater pipes discharge to a sump excavated in permeable soils within the active layer, underlain by permafrost. Discharged greywater both infiltrates into the active layer soils and overflows to wetland drainages that lead away from the camp (to the left in the photo) and eventually toward Goose Lake in the background in the approximate direction shown by the thicker red arrow. The minimum distance from the more northerly discharge to Goose Lake is in excess of 150 m.

Some enrichment of the vegetation within the greywater flow paths through the wetland is evident. The Water Licence Inspector noted that the discharges are nutrient rich, causing algal blooms. Sabina believes that this is in reference to increased vegetation growth near the discharges, as well as elevated nutrient parameters in ponded water within the wetland flow path. There is no indication of enrichment of the wetland as it approaches Goose Lake.
