Water Licence Inspection Report

On October 21, 2025 Resource Management Officer Isaiah James Bolt (Inspector) for Crown Indigenous Relations and Northern Affairs Canada (CIRNAC), conducted an inspection of 2BE-GOO2028 (License) issued to B2Gold (Proponent) to ensure compliance against their license.

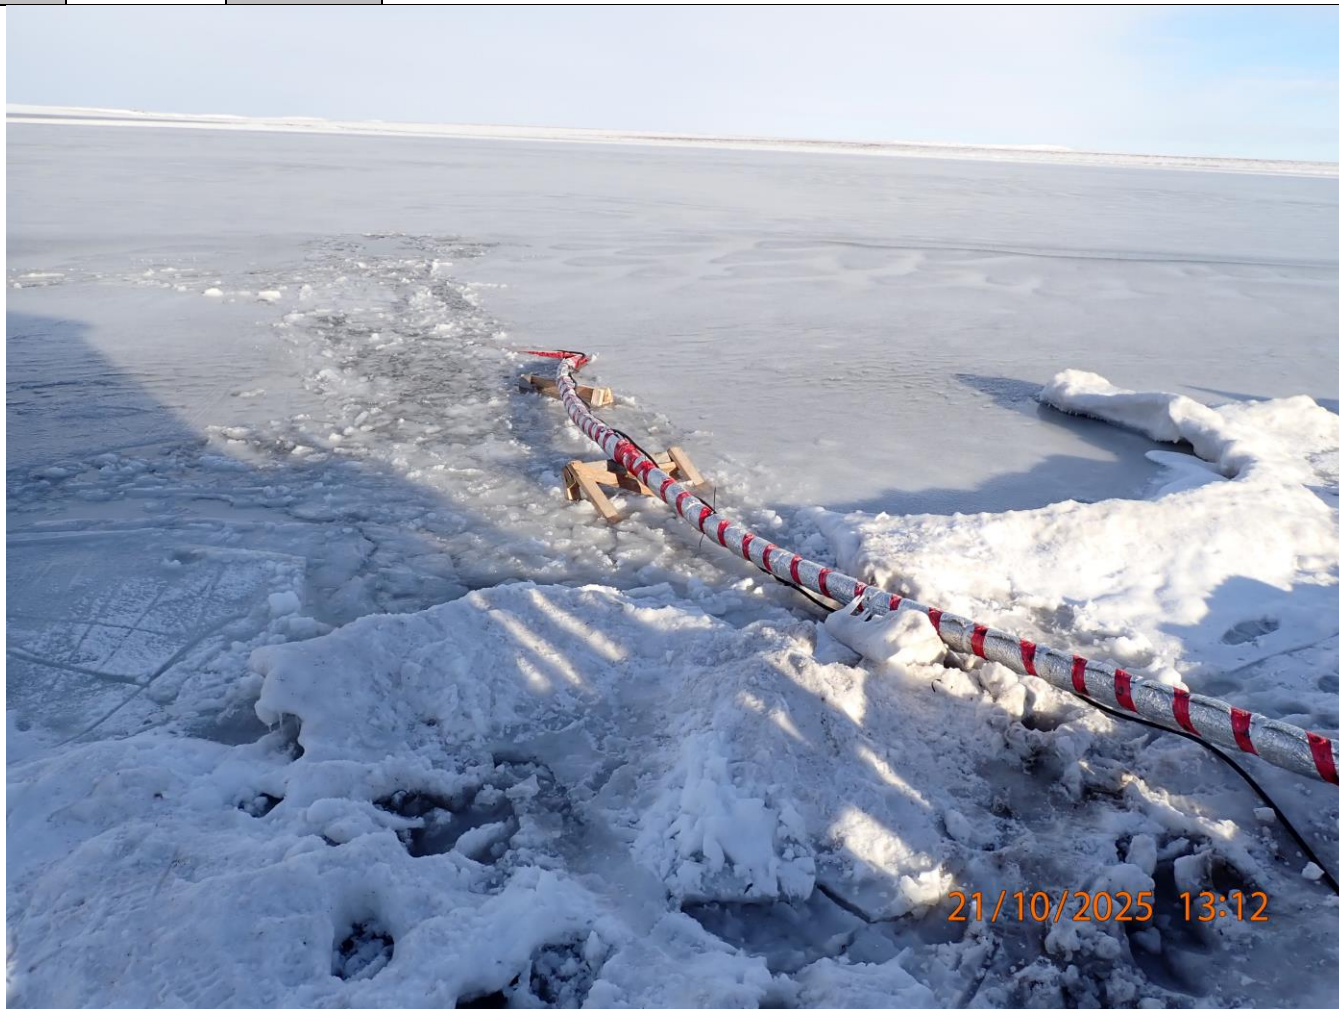
Date:	Authorization Number:	Camera/Model:	Inspector
October 21, 2025	2BE-GOO2028	Olympus Tough TG-6	James Bolt
Photo #	1	Coordinates:

1. The water withdrawal location was inspected (Photo #1). Inspector noted no signage present at the withdrawal location (Photo#2). No other concerns noted at the time of inspection.

Water intake location at Exploration Camp.

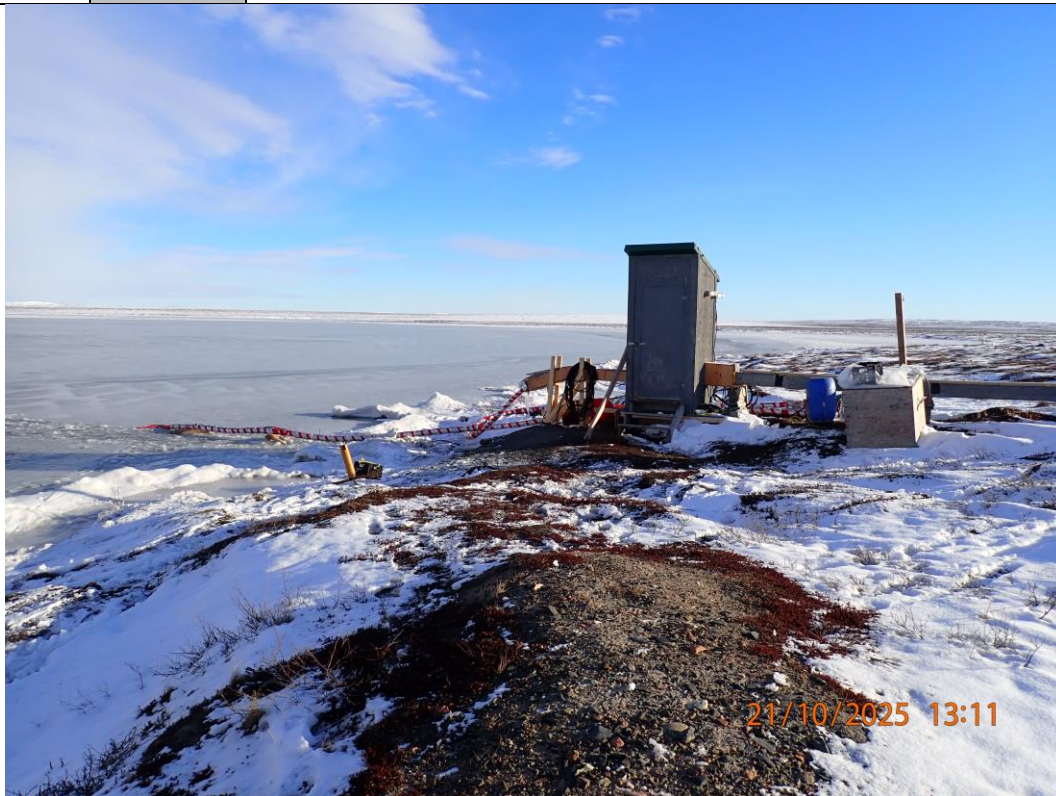
Photo # 2

Water Intake location, viewing the pipeline from the lake to the camp.

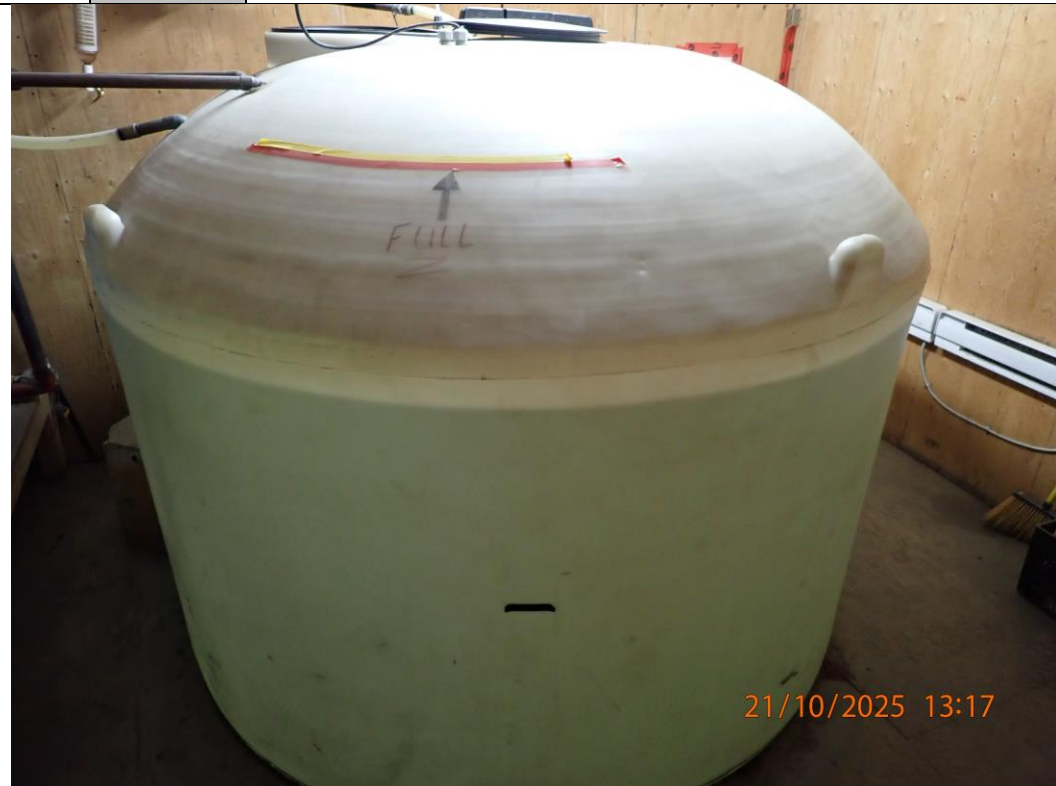
Photo # 3

2. The water storage tank inside the main dry was observed (Photo #3).
3. The water meter for the exploration camp was inspected (Photo #4). The water meter was rolled over from last year and was confirmed through the water log provided to Inspector Bolt from B2gold. The October water usage numbers from that log are shown on (Photo #5).

Water storage tank at exploration camp.

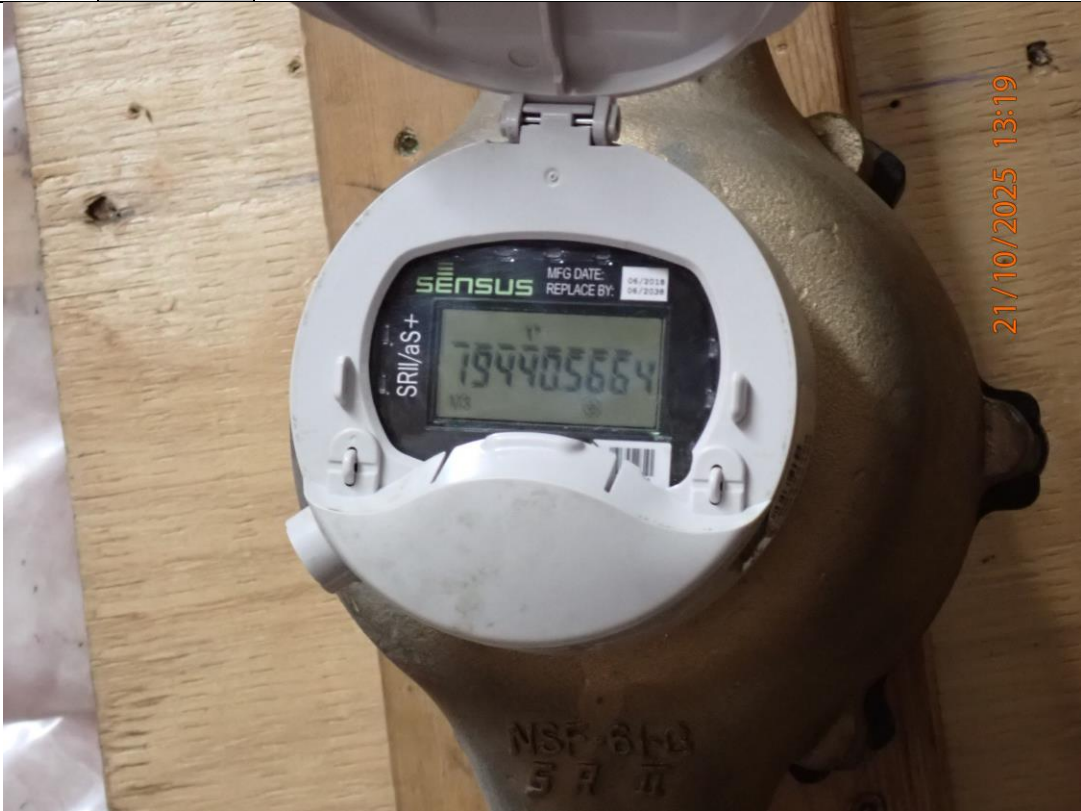
Photo #4Coordinates:

Water meter that is attached to the storage tank inside the main dry.

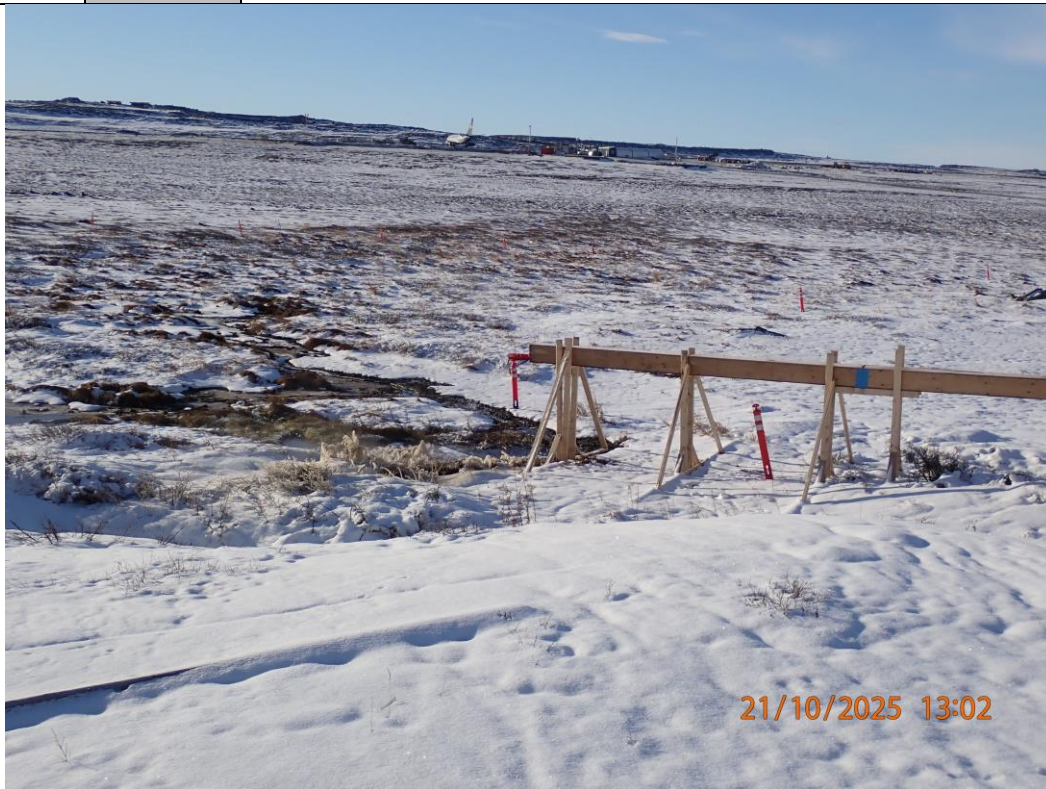
Photo # 6

4. 2 grey water effluent discharge locations were inspected. 65° 32'38.68"N 106° 25'38.54"W and 65° 32'40.68"N 106° 25'49.22"W. No concerns were noted with either location (Photo #6 and #7).

Grey water discharge from exploration camp onto wetland. Located at 65° 32'38.68"N 106° 25'38.54"W

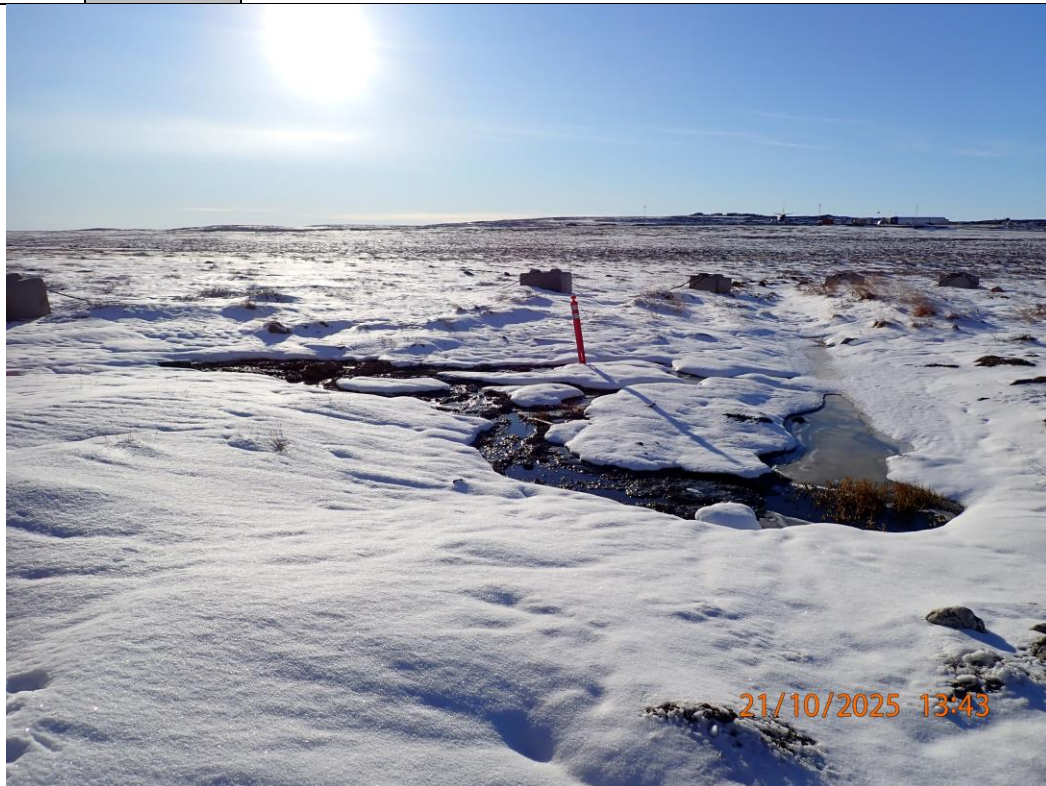
Photo # 7

A different grey water discharge from exploration camp onto land. Located at 65° 32'40.68"N 106° 25'49.22"W

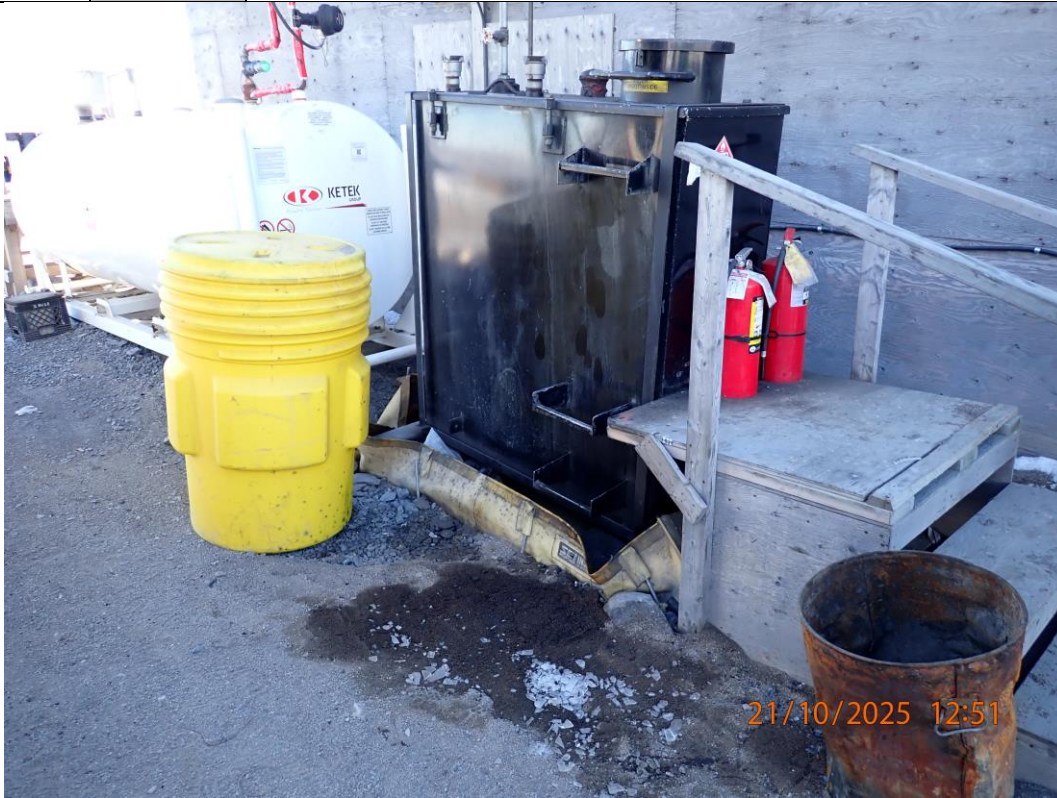
Photo # 8

5. A spill at the incinerator fuel tanks was observed (Photo # 8). A strong smell of diesel was noted coming from the stain.
6. At the Major Drilling hazardous waste sorting area, 2 buckets of waste oil were observed outside of containment. The buckets were located in front of the designated waste oil tote.

- Spill at Incinerator, Part H Item 2 of 2BE-GOO2028.
- Buckets out of containment, Part H Item 2 of 2BE-GOO2028.

Fuel staining outside of the Incinerator building at exploration camp. Soil smelled of diesel.

- Clean up spill at incinerator
 - Ensure all hazardous wastes/hydrocarbons are stored in secondary containment.
- Please complete all actions required and provide an updated photo of the spill at the incinerator by December 13, 2025

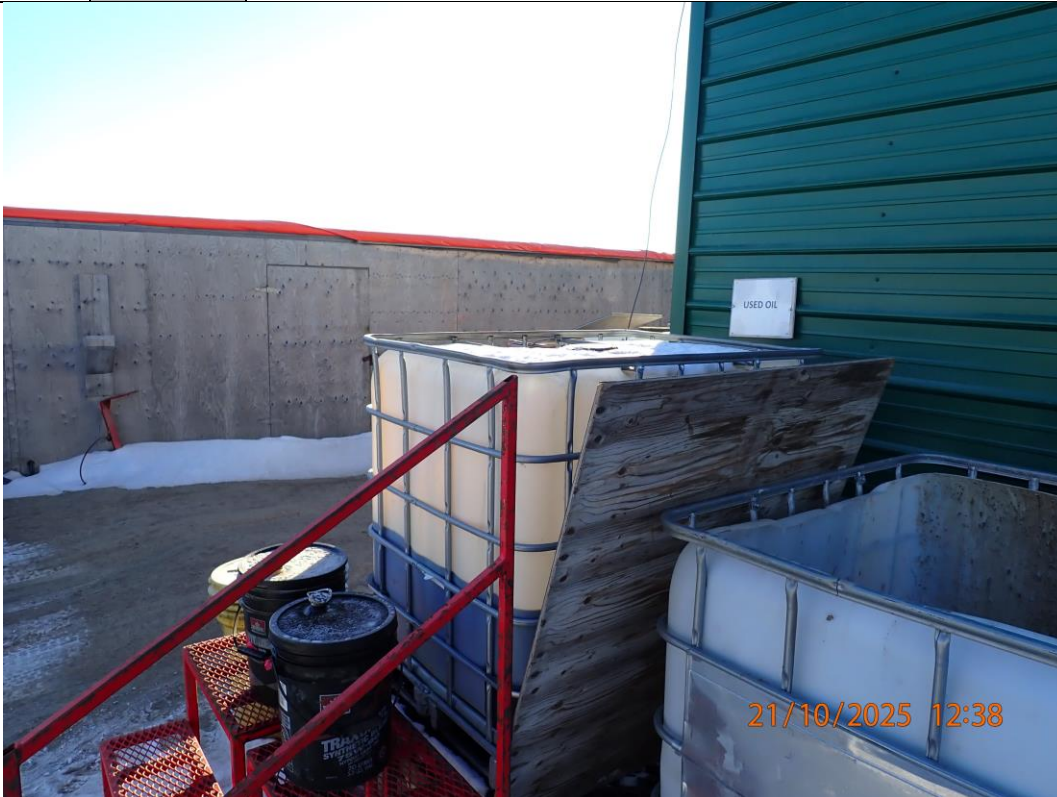
Photo # 9

Buckets of oil outside of containment. This sorting area is at the Major Drilling shop at the south end of exploration camp.
