Land Use Permit Inspection Report

Authorization	Representative
B2Gold Corporation	Dan Gagnon
Authorization No. / Expiry	Representative's Title
2BE-GOO2028/February 18, 2028	General Manager
Inspection Date	Inspector
March 03, 2026	Isaiah James Bolt
Other Authorization/s	
2AM-BRP18 ,N2024F0027,076J712-7-2, 2BE-GEO2025,2BE-GOO2028,2BE-MLL2328, 076G/9-1-2	
Activities Inspected	
<input type="checkbox"/> Municipal <input checked="" type="checkbox"/> Camp, Commercial <input type="checkbox"/> Drilling <input checked="" type="checkbox"/> Mining <input type="checkbox"/> Construction <input type="checkbox"/> Reclamation <input checked="" type="checkbox"/> Fuel Storage <input type="checkbox"/> Roads/Hauling <input checked="" type="checkbox"/> Winter Hauling <input type="checkbox"/> Camp, Private <input type="checkbox"/> Other <small>Click or tap here to enter text.</small>

On March 03, 2026 Resource Management Officer Isaiah James Bolt (Inspector) for Crown Indigenous Relations and Northern Affairs Canada (CIRNAC), conducted an inspection of 2BE-GOO2028 (License) issued to B2Gold (Proponent) to ensure compliance against their license.

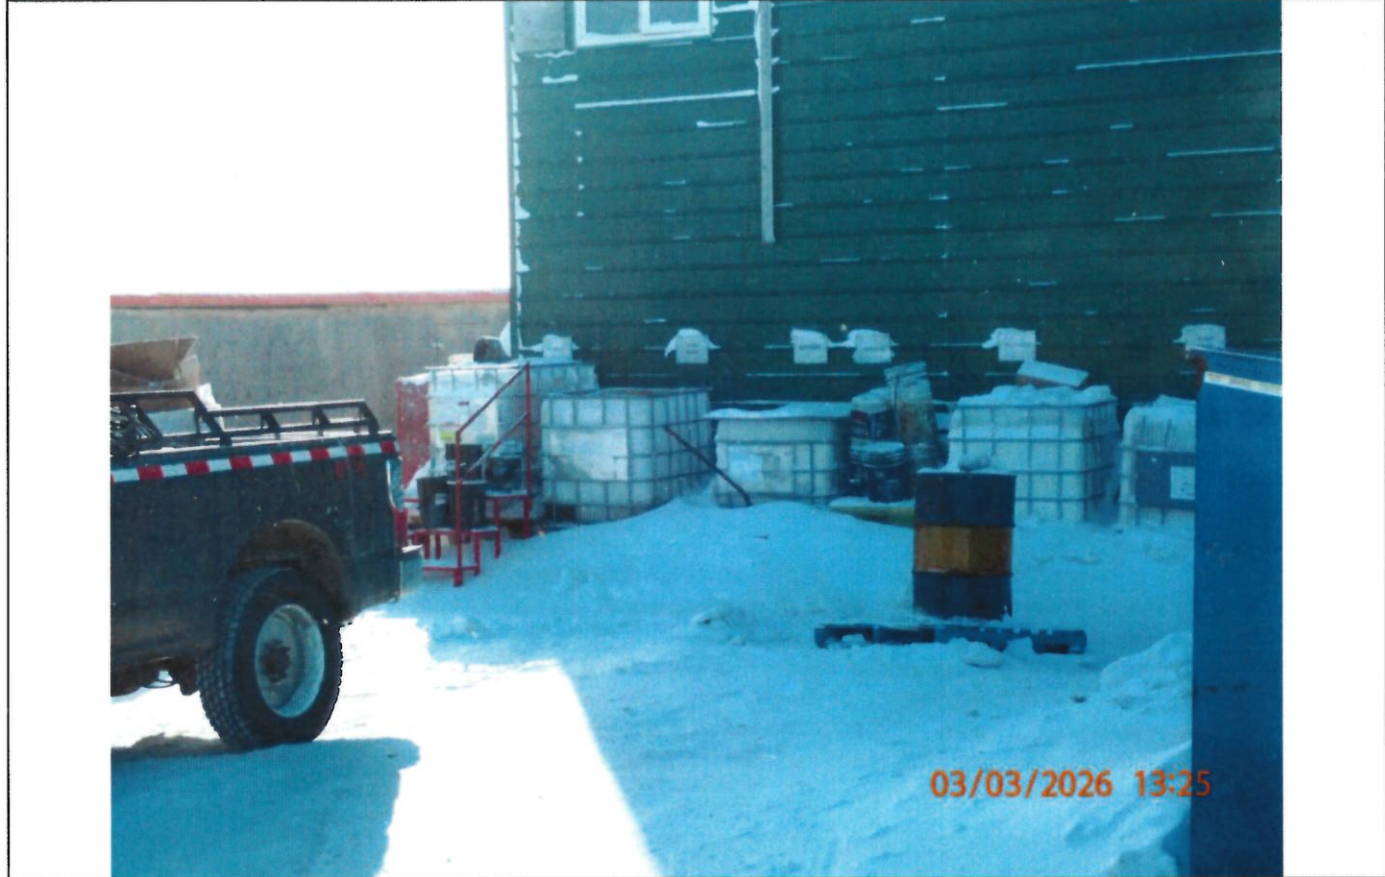
Date: March 03, 2026	Authorization Number: 2BE-GOO2028	Camera/Model: Olympus TG-6	Inspector Isaiah James Bolt
Photo # 1	Coordinates:

- At the Major drilling laydown, Inspectors observed pales outside of containment as well as a drum out of containment (Photo #1). Inside the drum were used oil filters, the drum was not covered and was exposed to the elements.

Description:
 Buckets seen on the stairs outside of containment. An open drum on the pallet is filled with used oil filters, no covering, exposed to the elements, snow accumulating inside.

Ensure all Hazardous materials/waste containers are placed in secondary containment.

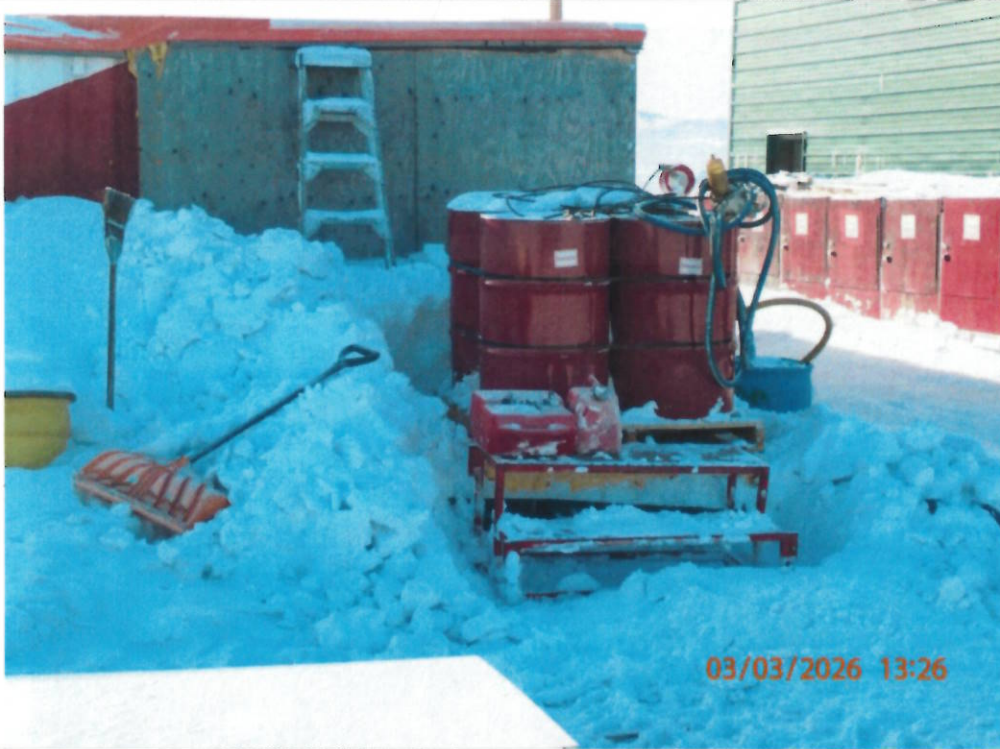
Photo # 2

- Photo #2 shows 2 jerry cans outside of containment at major drilling laydown.
- Inspectors observed a wooden box used as secondary containment and a fuel drum stand, the box was full of snow (Photo #3)

Jerry cans outside of containment.

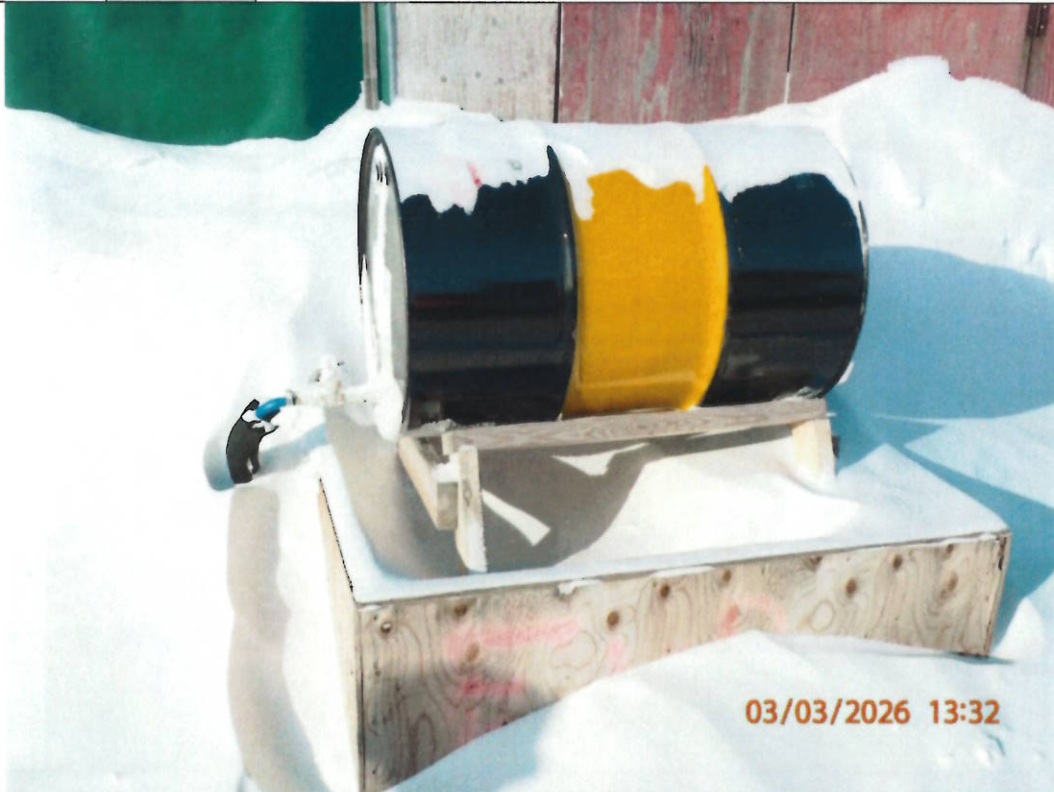
Photo # 3

Heating fuel stand filled with snow.

Ensure snow built up in the fuel stands that are used as "Secondary containments" is removed and treated as contaminated snow.

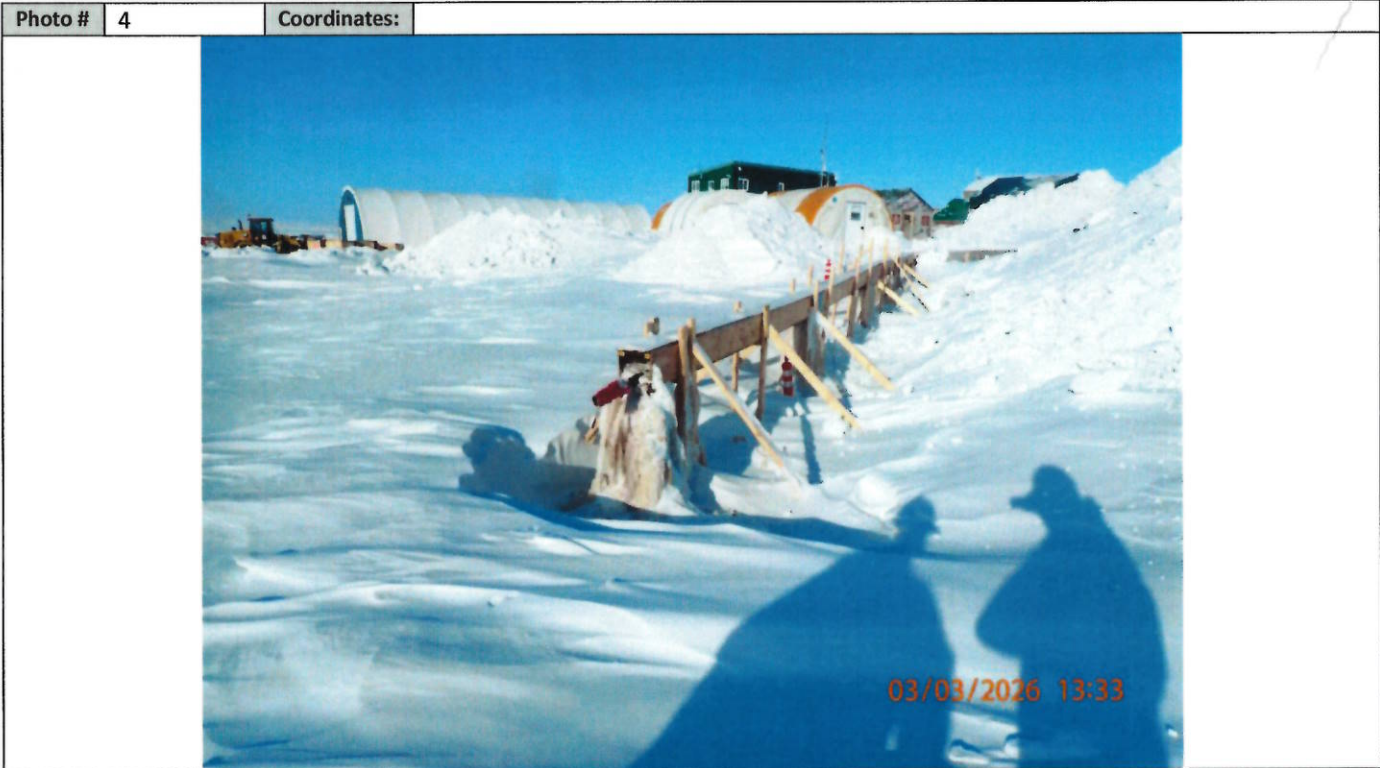
- The south side grey water discharge location for 2BE-GOO2028 (Exploration camp) was observed to be backed up with ice. Grey water was observed flowing out of the line upstream of the discharge location. (Photo #4 and #5). No signage was posted at this discharge location.

Description:
 South side grey water discharge location at exploration camp. No signage.

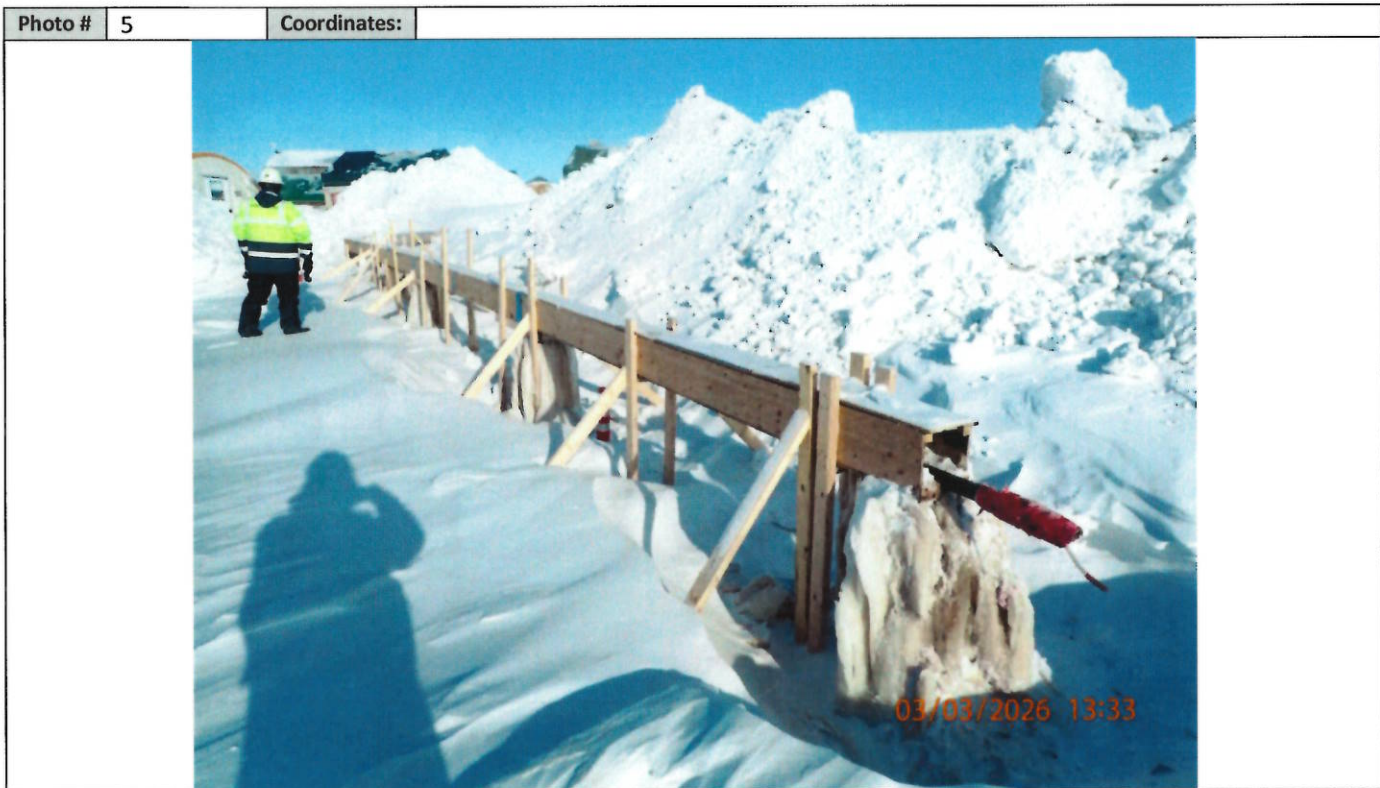
Description:
 South side grey water discharge location, the person at the back is seeing where grey water is flowing out from.

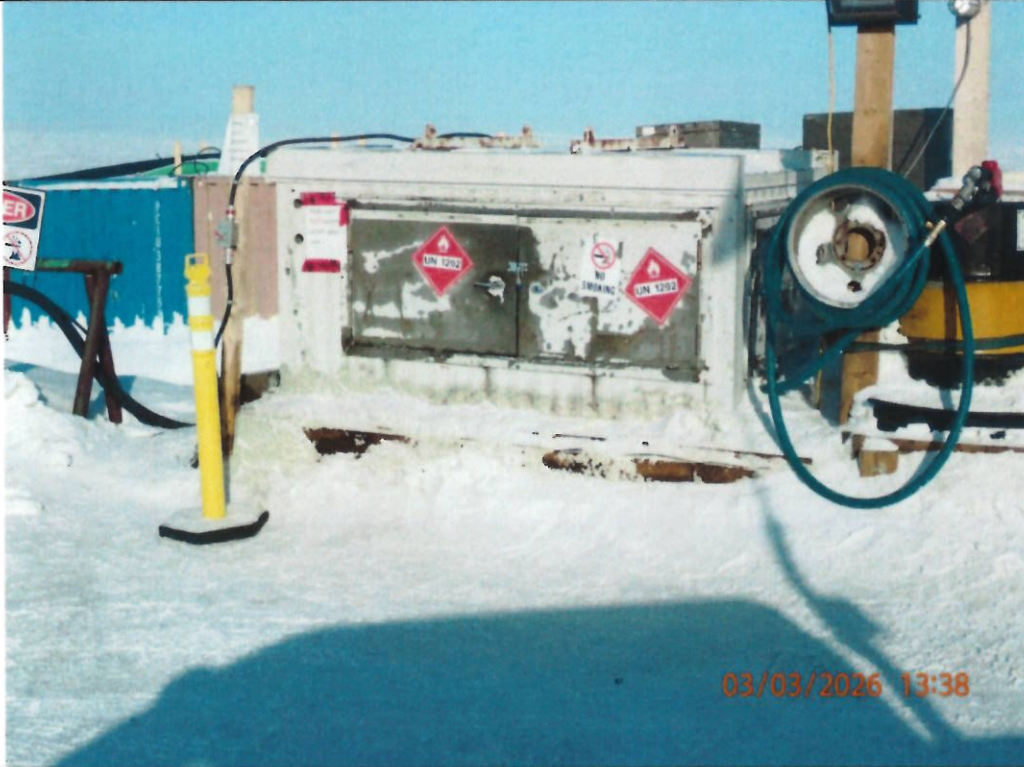
Photo # 6

- The truck refuelling station at exploration camp was inspected (Photo #6). Snow saturated with fuel was observed along the base and up the wall of the fuel transfer box.

Snow saturated with fuel seen at the base of the refuelling station.

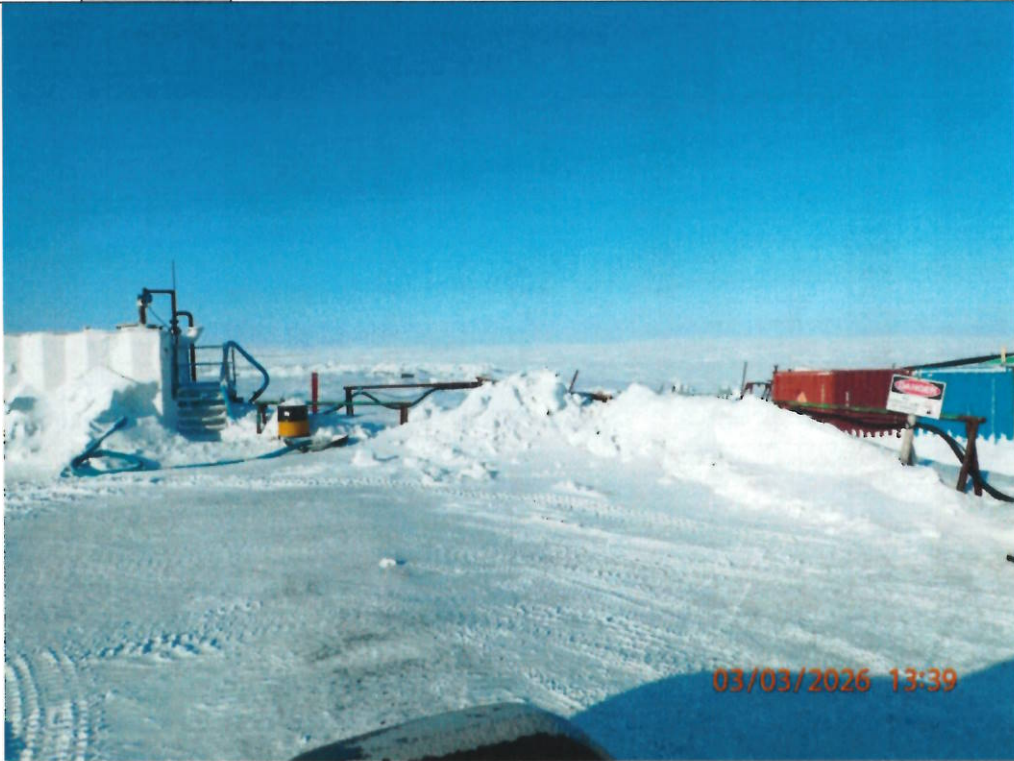
Photo # 7

Fuel drum out of containment at the truck refill station at exploration camp.

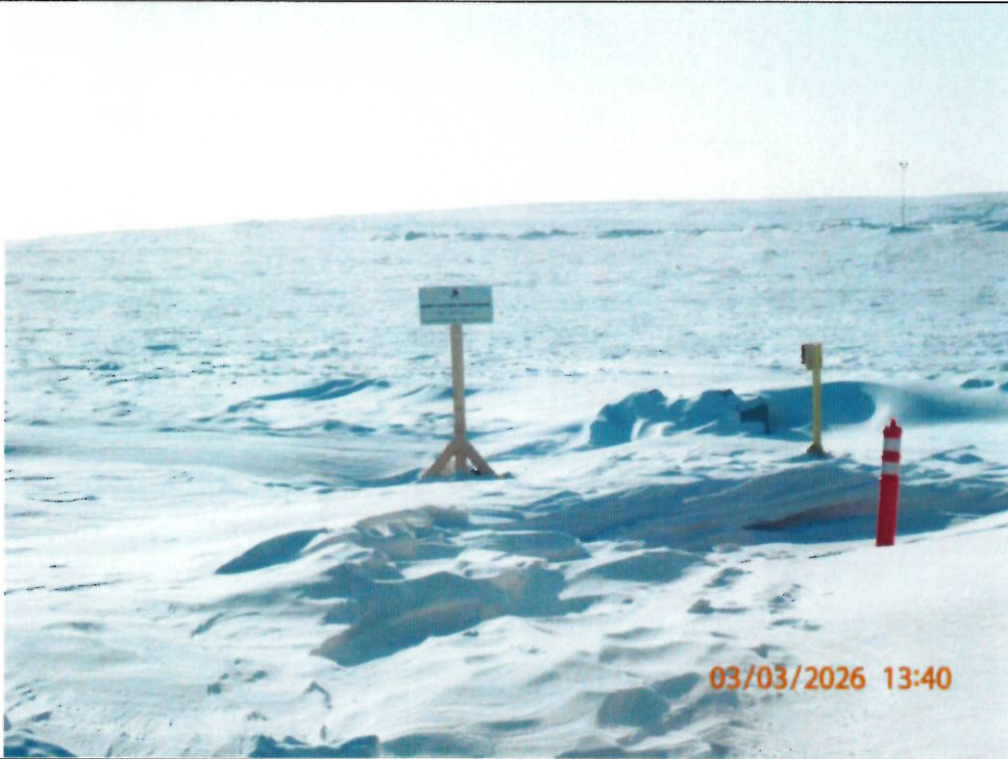
Photo # 8 Coordinates:

- The North grey water discharge for 2BE-GOO2028 location was inspected (Photo #7). Signage was posted at this location.
- Exploration camp's water log is provided on (Photo #8). The photo also shows the number of people in camp at the time of inspection.

Description:
North side exploration camp grey water discharge Location.
