NWB Annual Report

Year being reported: 2011 ▼

License No: 2BE-GOO1015 Issued Date: March 26, 2010  
Expiry Date: March 31, 2015

Project Name: Back River Project - Goose

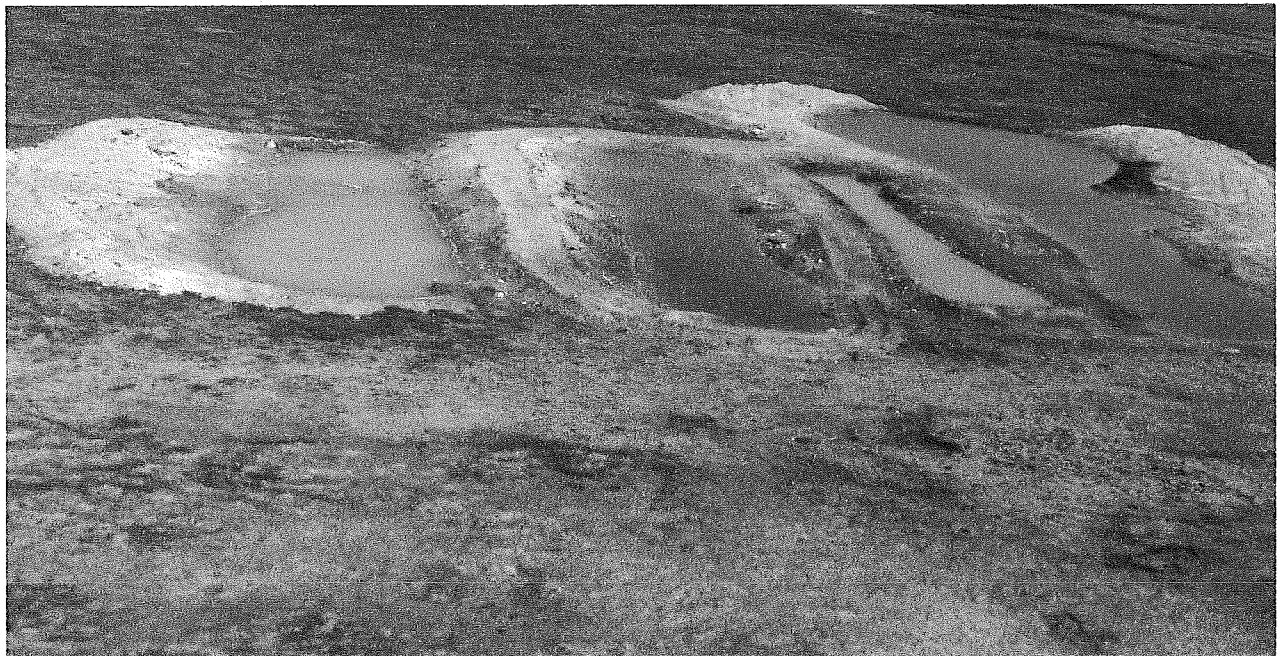
*Goose Lake Trenches before Reclamation. August 2009.*

In August 2009, work was started to reclaim the mechanically excavated trenches located immediately southeast of the camp, which was reported in the 2009 Annual Report. In September 2010, work started on the remaining trench (trench 4) to be reclaimed. Overburden material from the original excavation was used to fill in the trench to approximately 70%. The remaining work was completed in 2011.

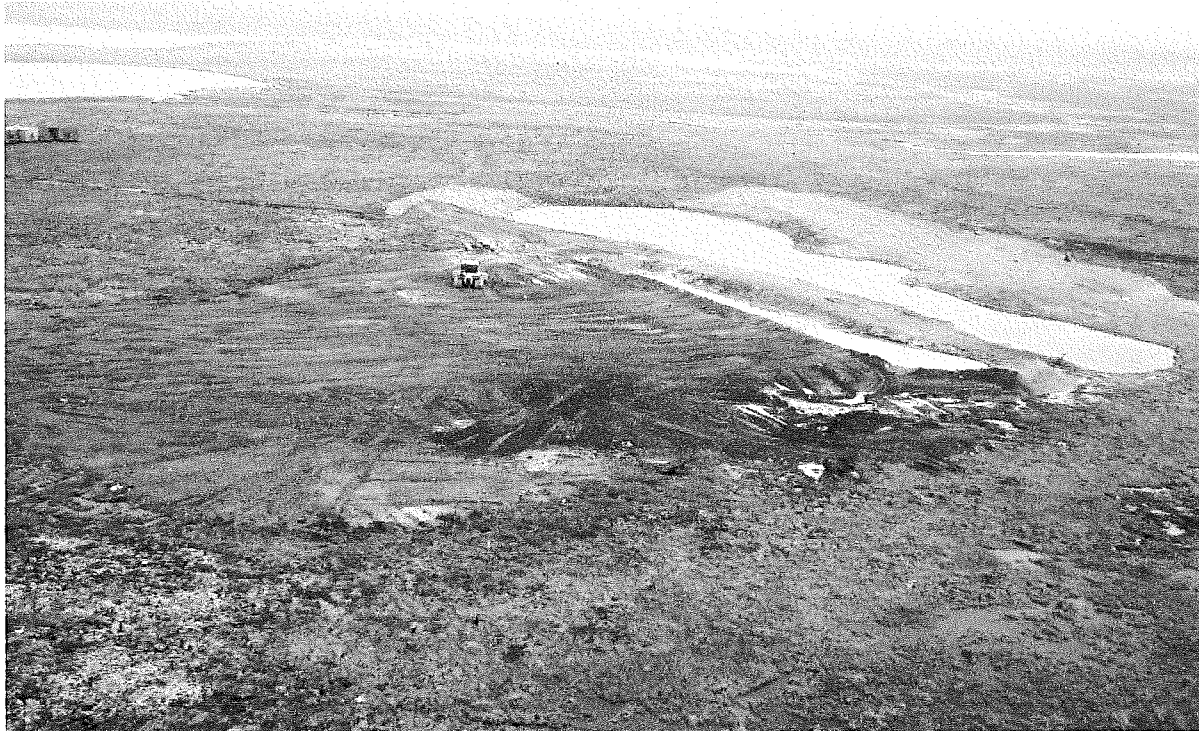
*Goose Trenches post reclamation. September 2009.*

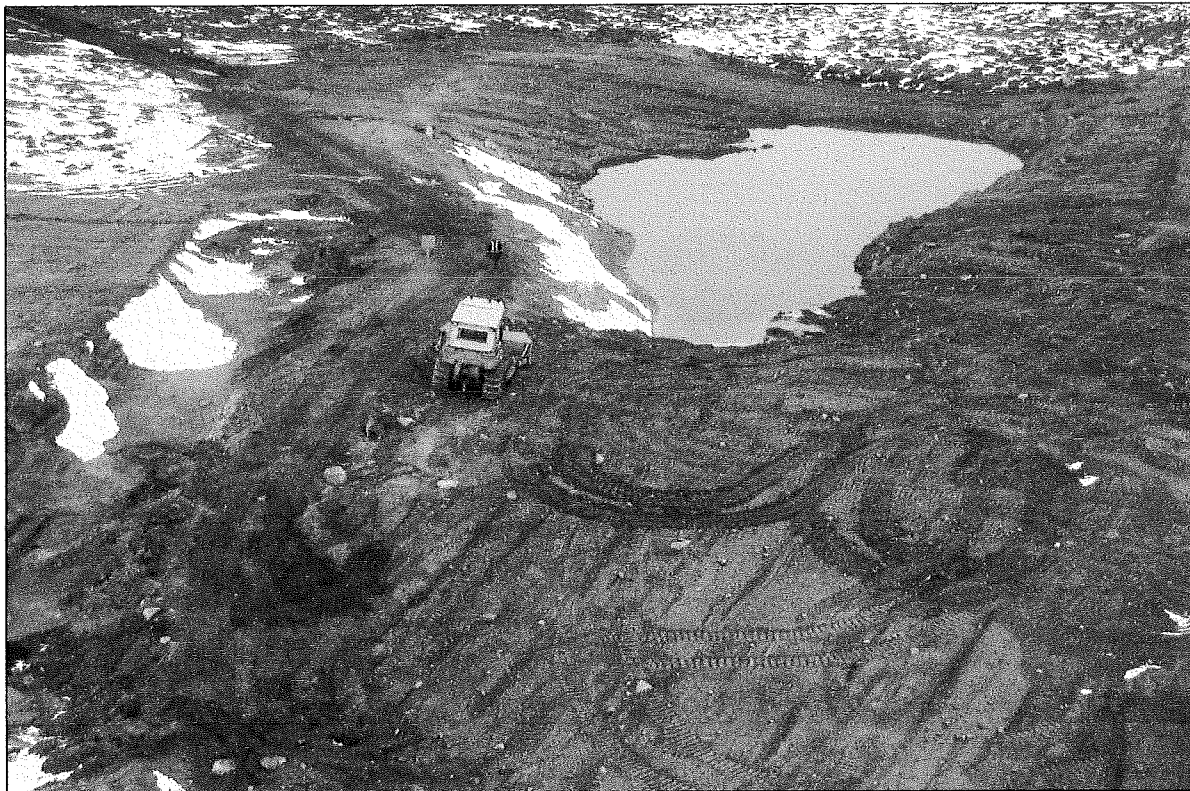
*Aerial view of reclamation of Trench #4, approximately 70% completed. Remaining trench for drill cuttings visible at middle left. View to the north. September, 2010.*
