Back River Airstrip Fish and Fish Habitat Assessment Memorandum

By Rescan Environmental Services Inc.
July 20, 2011

SUBJECT: Back River Airstrip Fish and Fish Habitat Assessment

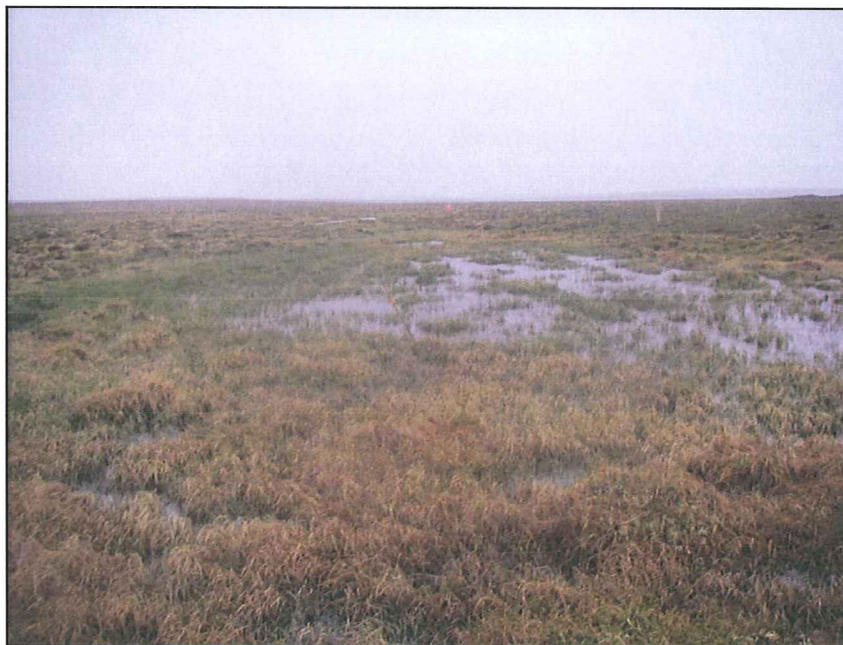
Site AS-1 is located just east of Goose Lake Camp. The area is characterized as a non-classified drainage (NCD) because it has no defined channel and no alluvial deposits. The area consists of ponded and pooled water in a low, wide drainage with no connectivity to surrounding water bodies (Plate 3.1). Several ponds up to 50 m² were observed, but no channels connected the ponds. The maximum depth of the ponds measured was 0.5 m, indicating that the area has no overwintering potential for fish. The lack of connectivity between water bodies, even at the high water levels observed, indicate that the area does not provide any suitable fish habitat.

Electrofishing was conducted for 257 s over a 100 m distance in several ponds and pools. No fish were captured or observed. This area is thus classified as non-fish-bearing, and a culvert crossing is suitable for the access road.

Plate 3.1 View looking west of AS-1 non-classified drainage

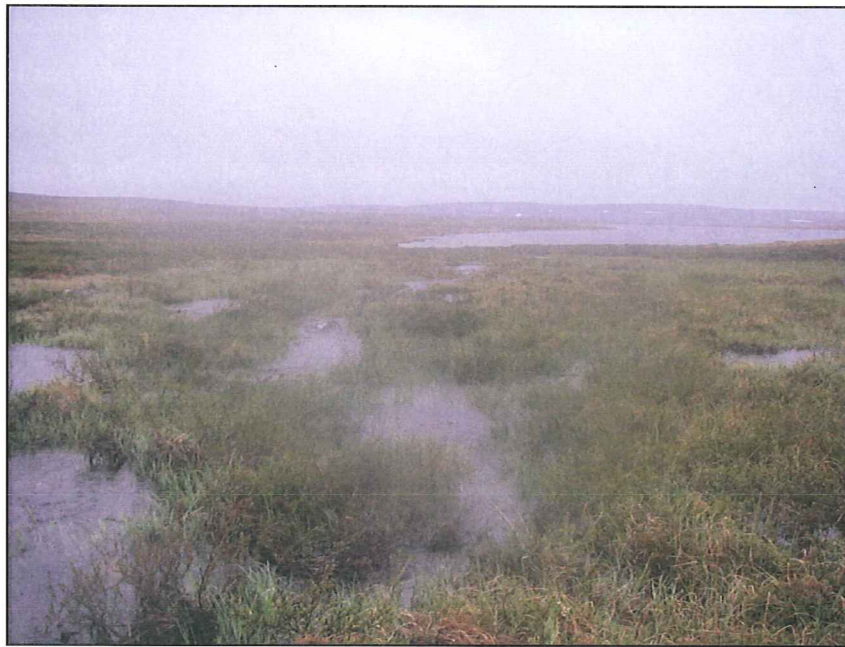
Site AS-2 is located approximately 100 m upstream of Gander Pond, east of the proposed airstrip. It is a stream with poorly defined banks and multiple channels (Plate 3.2). The bankfull width ranges from 1.5 m to 6.7 m, while the wetted width ranged from 1.6 m to 8.8 m (larger than bankfull because the

stream was in flood). The stream displays pool-riffle morphology; however, there were few deep pools. Most of the habitat units were glides or riffles. The substrate was dominated by boulder and cobble, while the cover was dominated by instream vegetation and boulders. Stream temperature was 6°C, conductivity was 4 µS/cm and pH was 8.0. The water was clear with no noticeable turbidity.

Site AS-2 was electrofished for 728 s over 100 m. One slimy sculpin (*Cottus cognatus*) was observed, but could not be captured because it retreated into the boulders along the bottom of the stream. No other fish were seen; however, the site has good connectivity to Gander Pond and has high habitat complexity due to the abundance of boulders and instream cover. The habitat in this area is suitable for rearing; however, no spawning habitat or overwintering habitat was seen.

Plate 3.2 Site AS-2 looking downstream towards Gander Pond. Note the multiple channels and poorly defined banks.

This site is considered to be fish-bearing and should be crossed with an open-bottom structure such as a bridge. The most suitable crossing location from a fish habitat standpoint is located approximately 100 m upstream of Gander Pond at 13W.433377.7269435. At this location, the stream is relatively confined between areas of raised tundra. Elsewhere, the stream is poorly confined and floodwaters extend far beyond the banks of the stream.

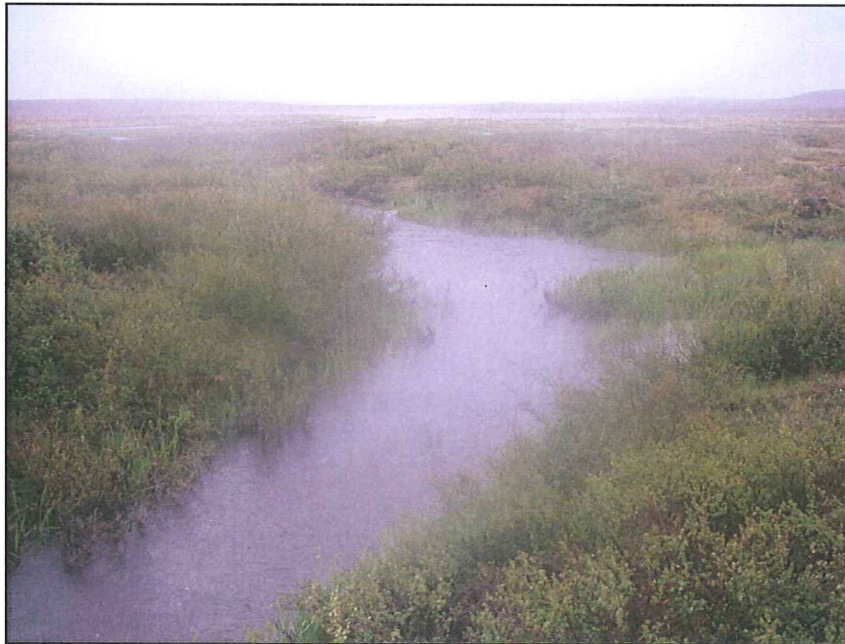
Site AS-3 is located approximately 100 m downstream of Gander Pond near the existing hydrology station. The stream in this location is well-defined with stable banks and a deep channel (Plate 3.3). The morphology is riffle-pool; however, most of the channel was characterized by deep glides and riffles. The bankfull width ranged from 2.0 to 3.2 m, and the wetted width ranged from 2.0 to 6.2 m. Cover was dominated by instream vegetation and deep water, while the substrate was dominated by fine sediment and boulders. The habitat in this area has good potential for rearing, but no spawning habitat was observed. The channel is not likely deep enough to support overwintering.

Site AS-3 was electrofishing for 450 s over 100 m. No fish were captured or seen; however, electrofishing conditions were difficult due to the deep channel and swift flow. The stream was followed downstream to Goose Lake to look for potential barriers to fish migration. No permanent barriers to migration were observed; however, the stream becomes more poorly defined as it approaches Goose Lake and it flows through a wide swath of scrub birch and willow.

Plate 3.3 Site AS-3 looking upstream near the hydrology station. This area is suitable for a bridge crossing due to the confined channel and high banks.

This reach should be considered fish-bearing due to the observation of a fish upstream at site AS-2. The confined channel and high banks near the hydrology station (UTM 13W.432870.7269944) make it suitable for a bridge crossing.

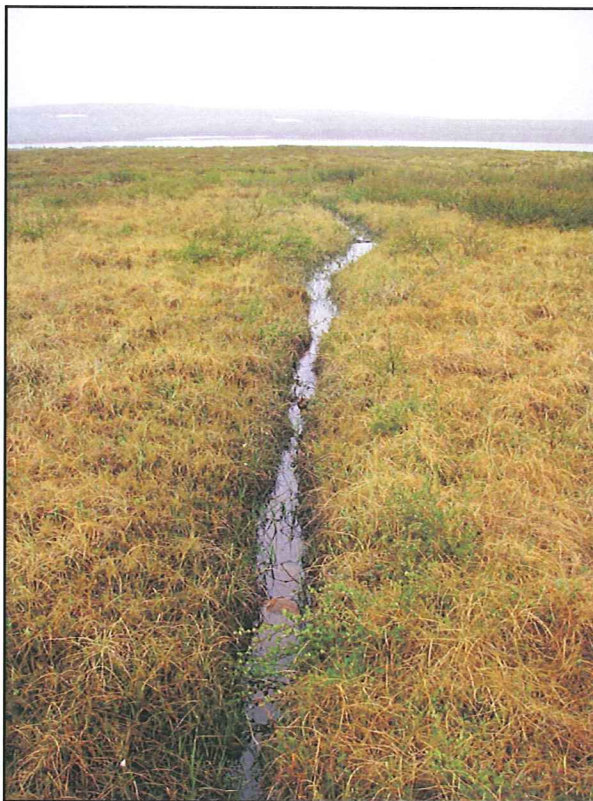
Site AS-4 is a very small stream that also drains Gander Pond into Goose Lake. It has a defined channel approximately 0.3 m wide and 0.1 m deep (Plate 3.4). It is ephemeral and while it is accessible to fish at high flows, it does not provide any suitable habitat for any life stage. It is likely suitable for an arched culvert crossing due to the poor habitat quality. No sampling was conducted at this crossing.

Plate 3.4 Site AS-4 looking downstream towards Goose Lake.
