**Diamondex Resources Ltd.**

**Revised  
Final Restoration and  
Abandonment Plan**

**Heeqou Project  
Kitikmeot Region, Nunavut**

June 20, 2011

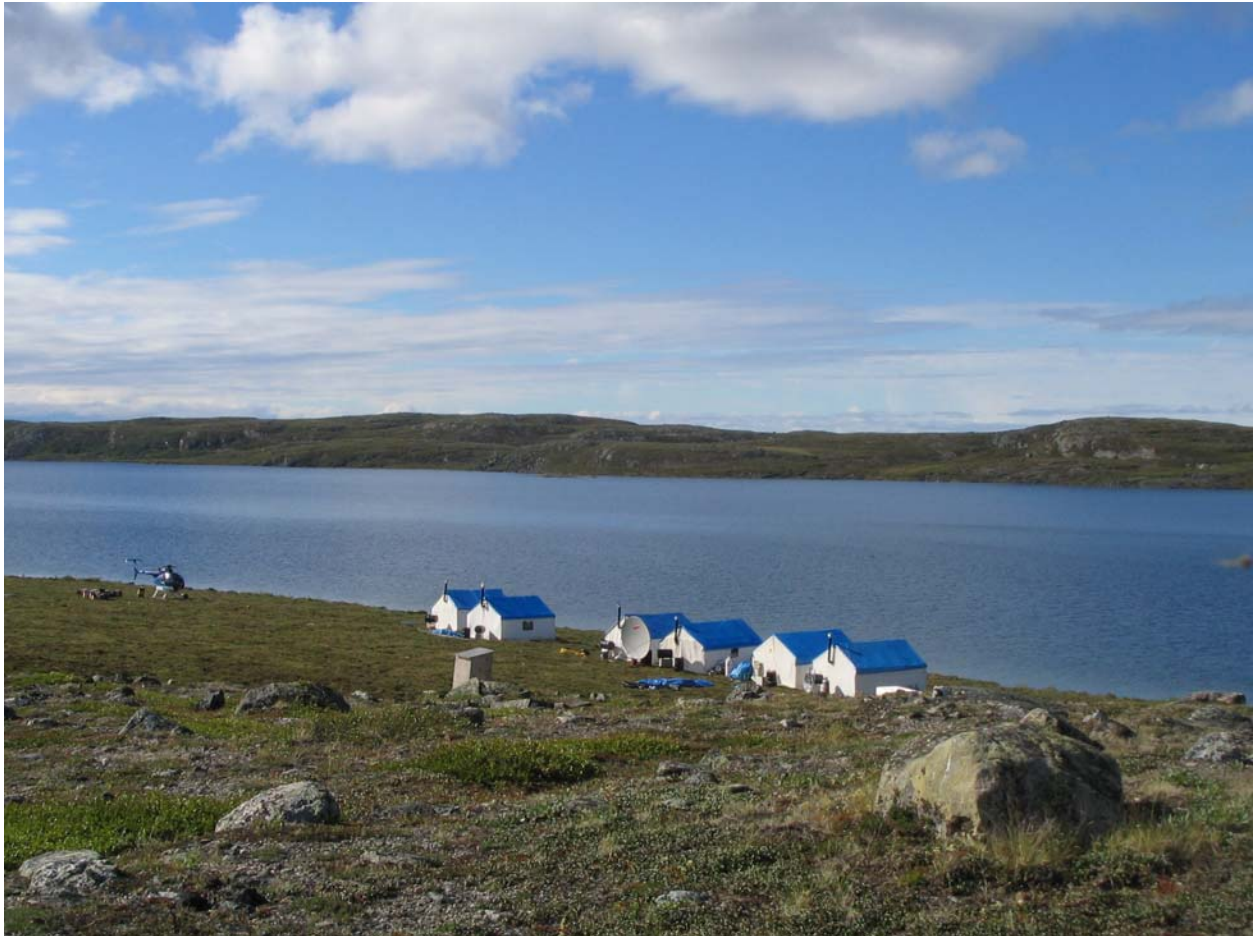
#### **Camp (August 2006)**

Heeqou camp site is located at 65° 59′ N and 112° 45′ W (420900E/7319300N, UTM Zone 12, NAD 83). First constructed in 2002, the total number of tents and tent floors remained unchanged during its temporary existence. In all, there were six, 14′ x 16′ insulated canvas tents built on plywood floors which themselves were elevated above the ground on wooden blocks. Three of these tents served as crew sleeping quarters and the remaining three were allocated as a combined kitchen/dining, a dry facility, and an office tent. Other temporary wooden structures include a shack used to shelter a 14kW diesel powered generator and an outhouse facility built over a sump.
