NWB2HOP0002

July 12, 2000 Water Licence Inspection - Report

INDUSTRIAL WATER USE INSPECTION REPORT

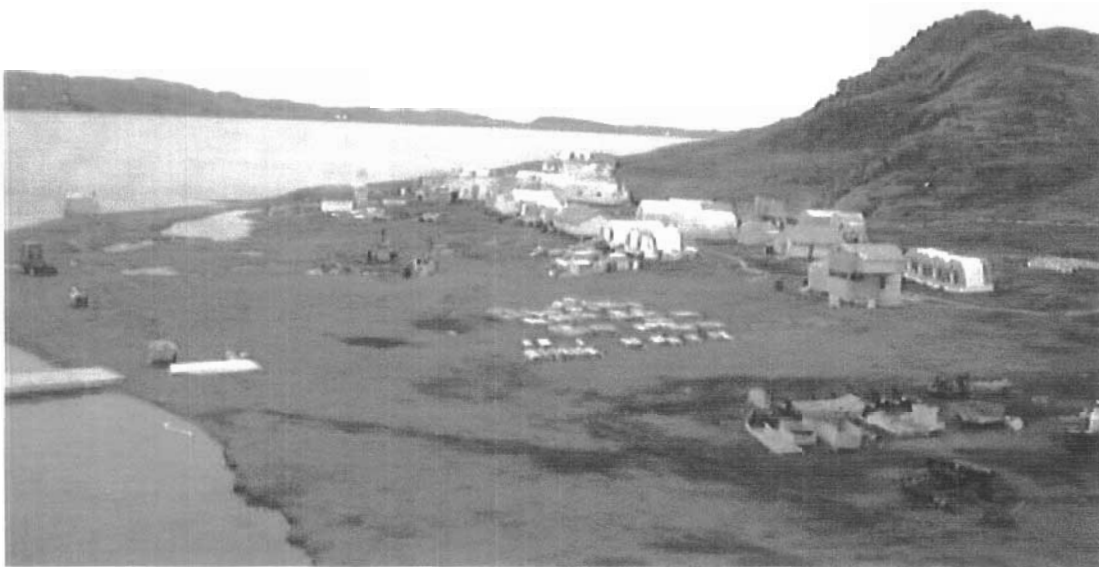
- **Sewage disposal:** The Inspector praises the Permittee's request, now duly approved by the Nunavut Water Board, to upgrade the sewage disposal system from latrines to a Rotodisk treatment unit. In light of the overall proximity of the campsite to Windy Lake (figure 1), such initiatives aimed at minimizing the impact of waste discharges to the receiving freshwater body are quite pertinent.

General Comments: The general proximity of the campsite to Windy Lake mandates particular care on the Permittee's part, as discharges of waste are likely to reach a freshwater body.

figure 1. Aerial view of Windy Lake camp; 2000/07/12.

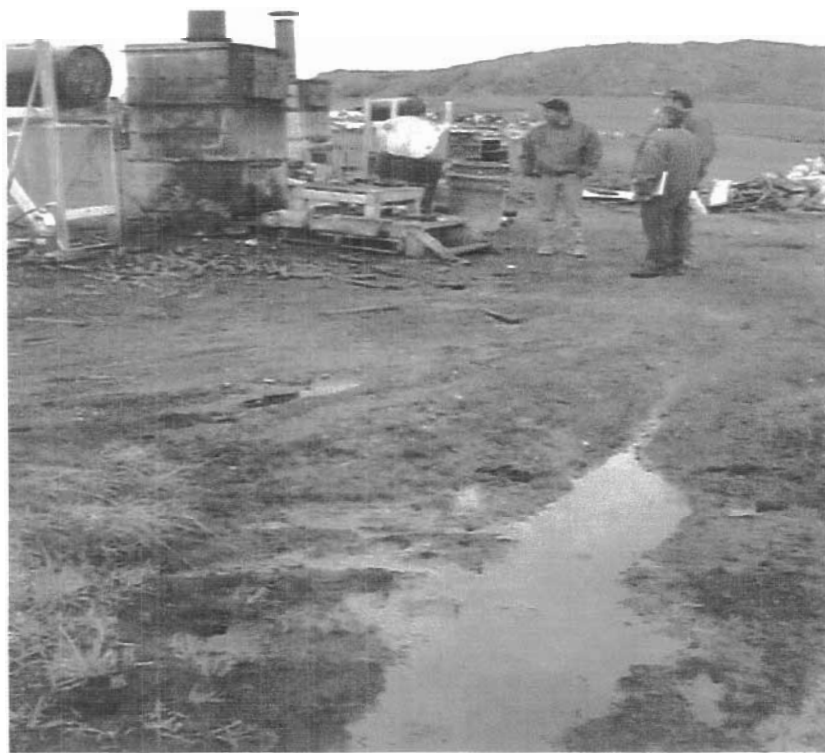
Comments: In the process of upgrading sewage disposal systems from latrines to a Rotodisk treatment unit. Incinerators not in ideal location, although likely further than 30m away from the watermark. Numerous, although relatively minor, spills have occurred during the current field season.

figure 2. Combustible wastes disposal area; 2000/07/12.

- **Solid waste disposal:** While the Inspector recognizes that the camp's general layout restricts potential site locations, the Permittee may wish to proactively consider relocating the combustible waste disposal area (figure 2) further away from the watermark.

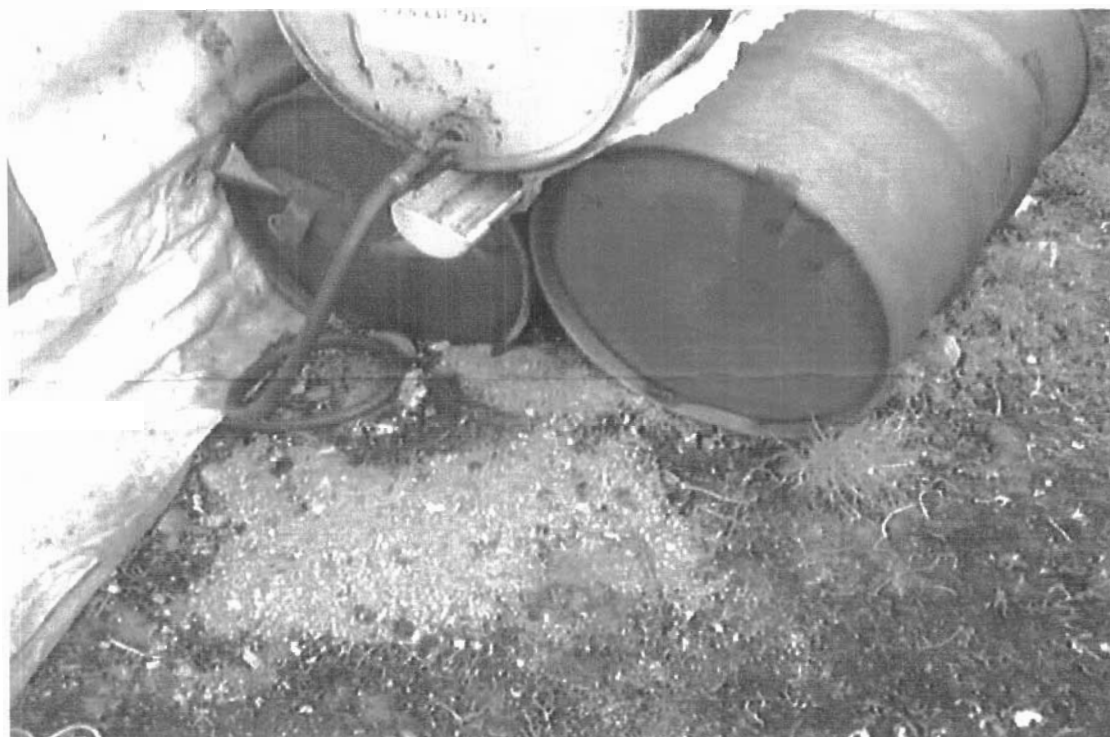
Comments: Fuel spillage observed in the vicinity of several housing units.

figure 3. Housing units fuel supply system; 2000/07/12.

- **Fuel storage:** During the inspection, signs of fuel spillage in the vicinity of several housing units were observed (figure 3). Although it is understood that the Permittee has taken measures to mitigate these types of fuel spillage, the Inspector nevertheless encourages the Permittee to implement further measures/upgrades which will ultimately eliminate such spills.
