INSPECTION/REQUESTS (DIAND, NWB & KIA)	Field visit conducted by Scott Stewart, Water Resource Inspector, DIAND
SITE/WUP LICENSE NUMBERS	Windy Lake (NWB2HOP0207) & Boston (NWB1BOS0106)
REPORTING YEAR	2005
DATE SENT	December 02 2005
ATTENTION	Scott Stringer, General Manager Northern Operations
FROM	Matthew Kawei, Senior Environmental Coordinator

Windy Lake Camp – License # NWB2HOP0207

Boston Camp License # NWN1BOS0106

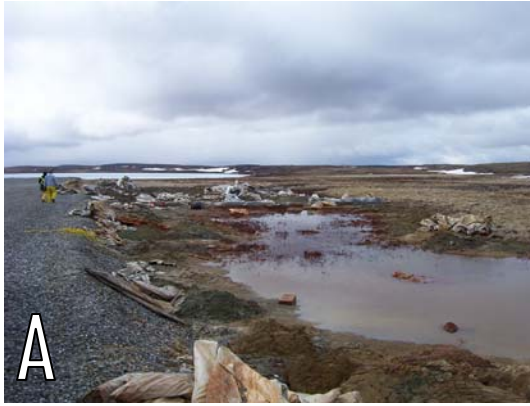
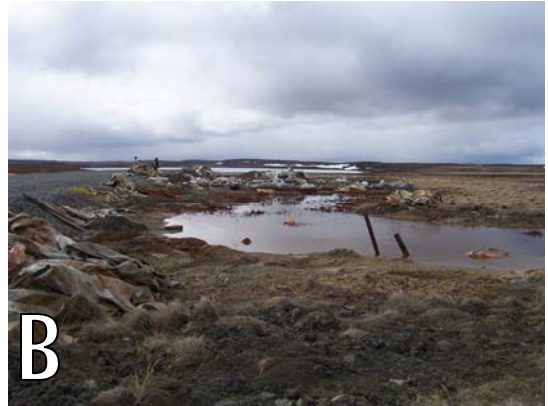
Photographs A & B: Pictures showing mega bags containing drill cuttings lay down area along the airstrip at Boston camp. These pictures taken after initial work done and therefore do not show all previous exposed bags.

- In the short period at Boston, environmental work focused on solid waste management. This involved removing drill-cutting mega bags from the lay down site along the airstrip. Approximately 200 empty bags disposed off in the burn pit on site. (See pictures in Appendix 1).

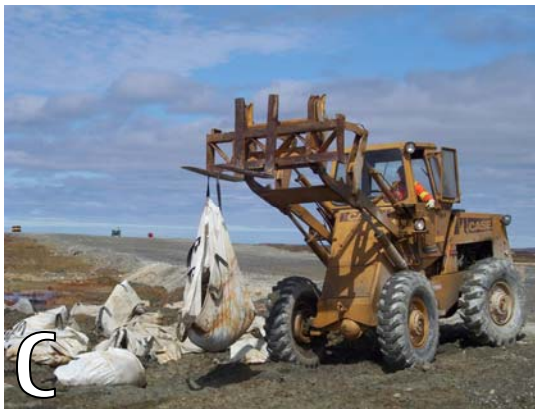
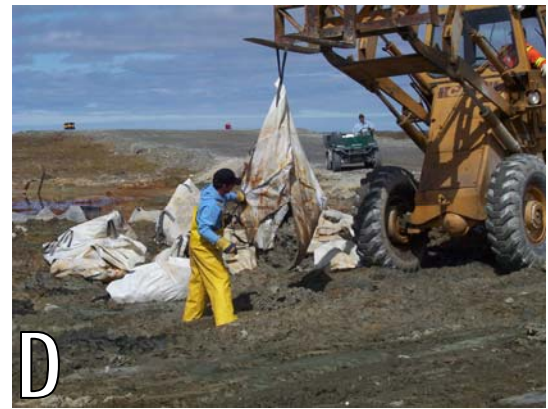
Photographs C & D: Picture C showing a mega bag lifted by the front loader, while picture D showing the bag sliced open to let the drilling cuttings out of the bag.

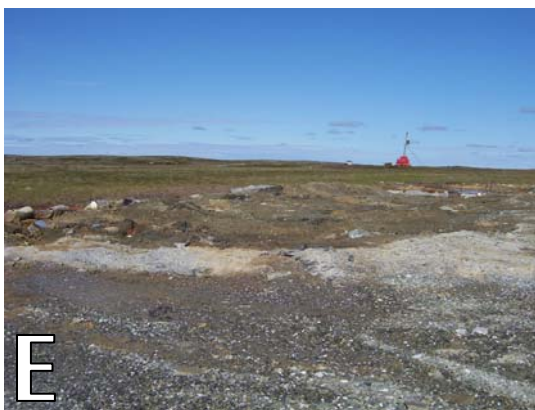
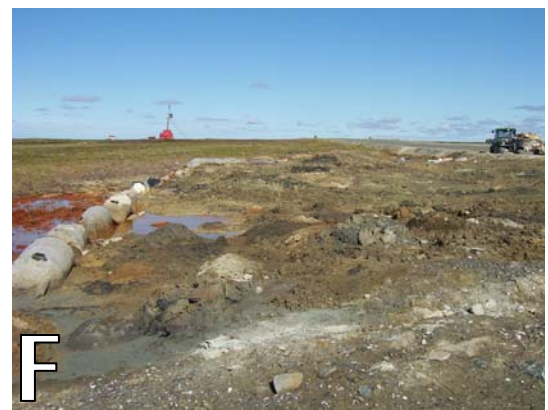
Photographs E & F: Pictures E & F showing the current outlook of the drill cutting lay down area along the airstrip. Approximately 200 mega bags were sliced in 3 half days of work. A much-desired view on the area.

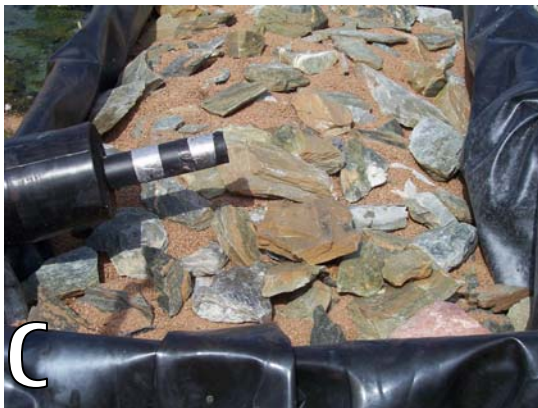
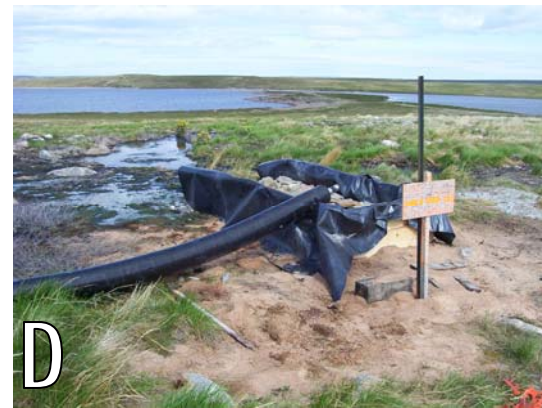
Photographs C & D: Photo C showing peat moss and corncobs laid over the gravel bed. Rocks were then placed on the peat moss and corncobs. Photo D showing the general location with corncobs spread to absorb sludge and remove odour emitting from the discharge area. The application was effective in reducing foul odour.

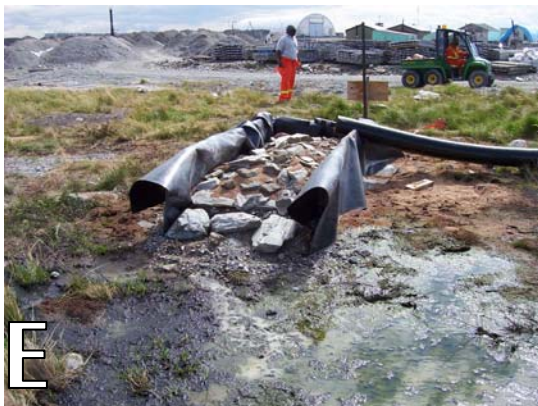
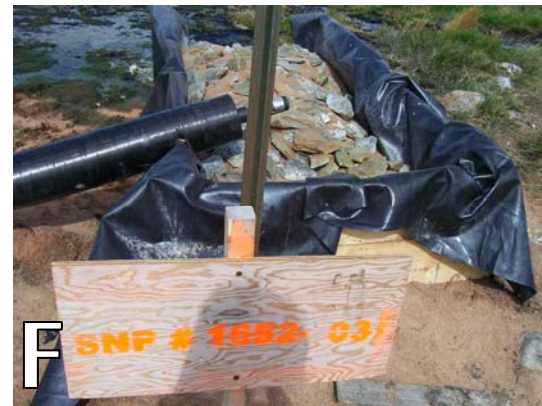
Photographs E & F: Photographs showing the final discharge area. Testing of the system was not possible due to less loading entering into the system.

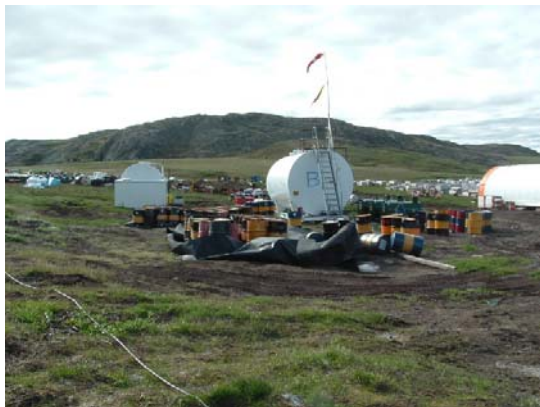
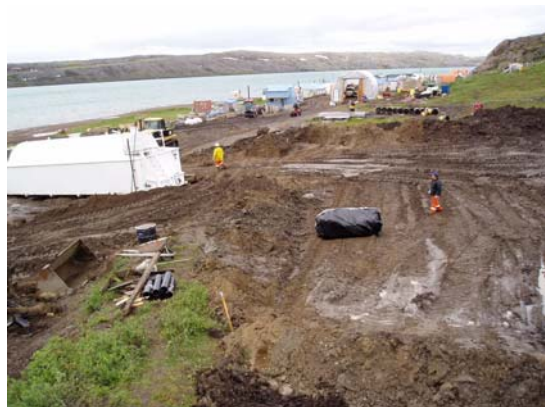
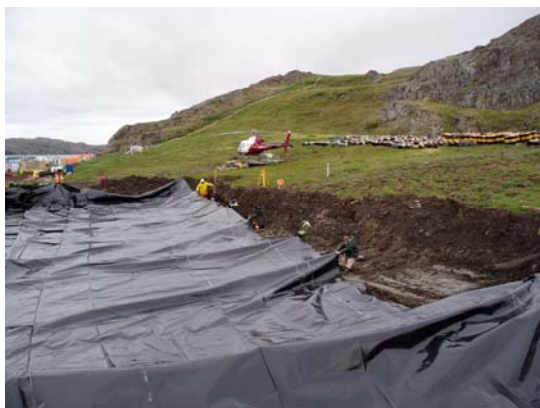
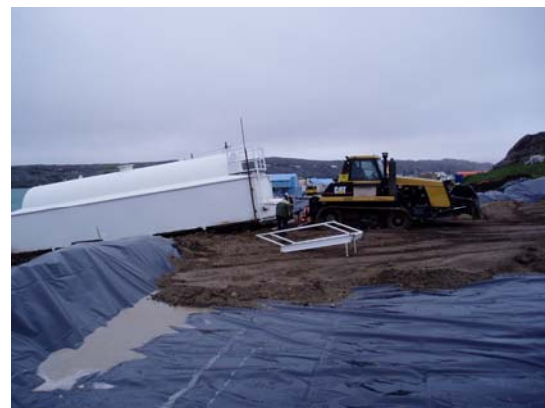
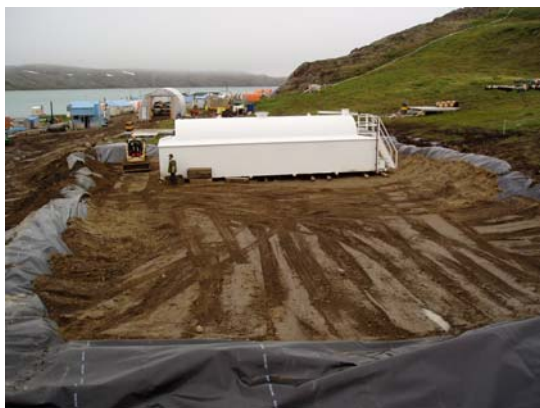
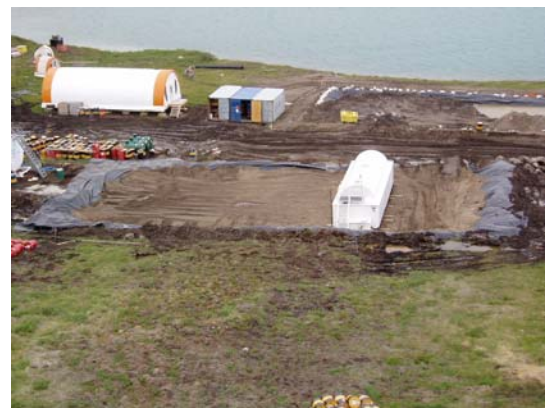
Appendix 4: Windy Lake Lined Secondary Berm Construction

- Construction at Windy immediately (see pictures in Appendix 4). Kitnuna Construction personnel supervised by Biogenie Consulting engineers carried out the construction.

- After completion of the farm, the 70,000 L AST tank was placed inside the berm. The empty 50,000 L AST tank will be re-located to Patch Lake during winter of 2006 (see pictures in Appendix 4).

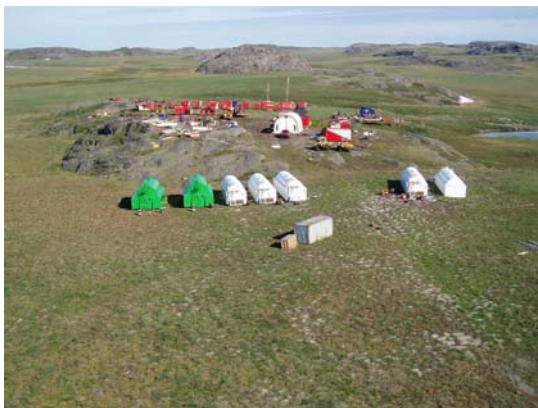
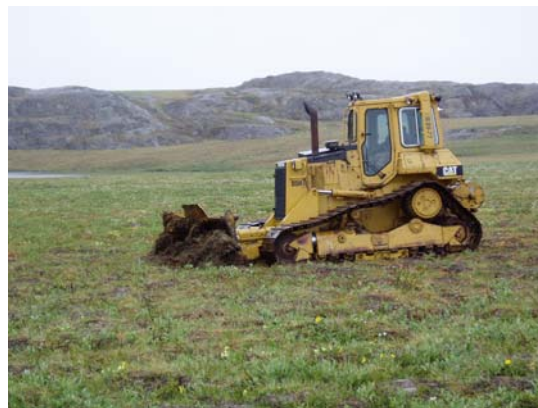
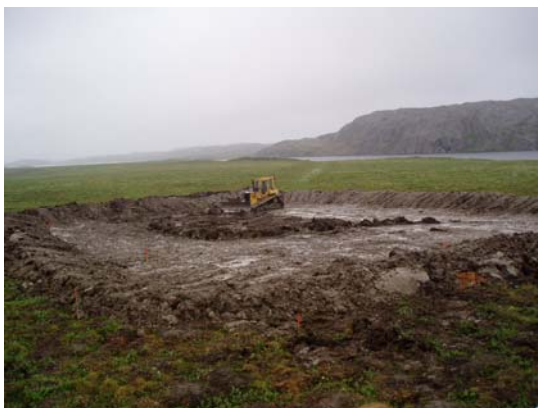
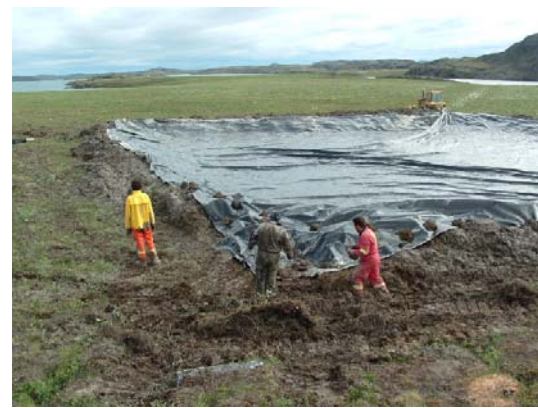
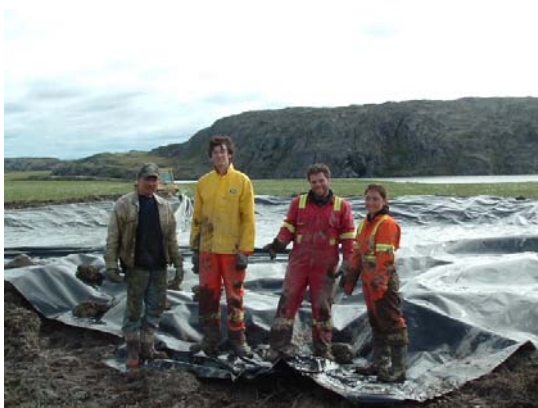
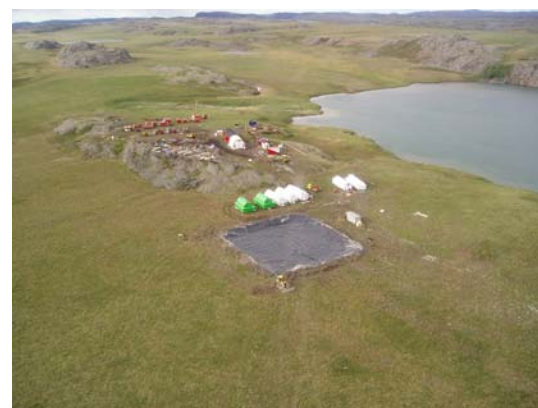
Appendix 5: Patch Lake Lined Secondary Berm Construction

- Environmental work at Patch Lake focused on building the lined secondary containment berm (see pictures in Appendix 5). Major Drilling personnel supervised by Biogenie Consulting engineers carried out the construction.
- It took approximately 3 days to complete construction of the berm. However, progress was slow due to the bad weather that lasted for a couple of days during the earth-moving period. A more challenging issue was to find enough cover material for the protection of the liner before eight (8) AST tanks can be moved into the lined berm. During construction, it was observed that not enough materials would be generated for both the walls and cover. Operations personnel are currently looking at various options for cover material to complete the task.

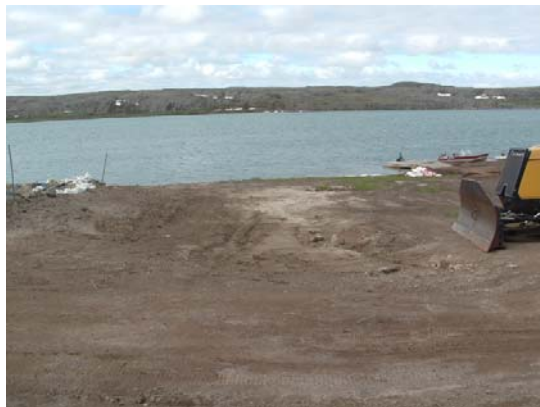
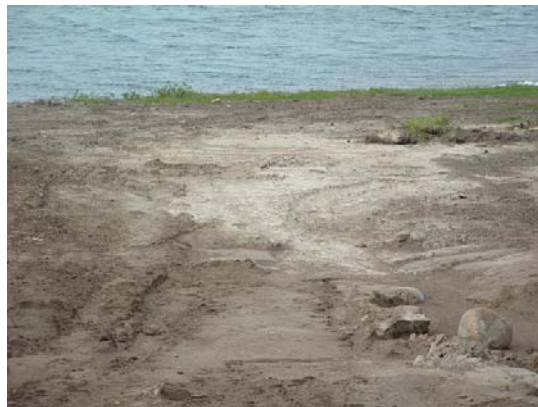
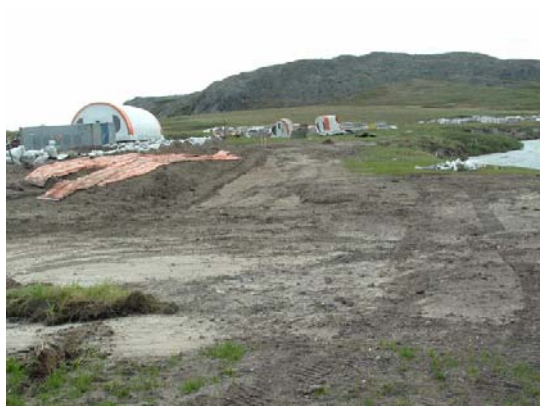
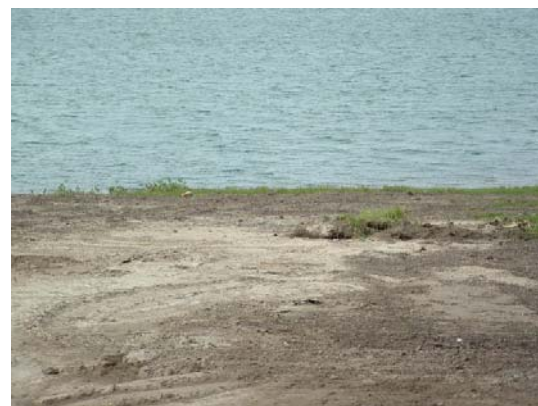
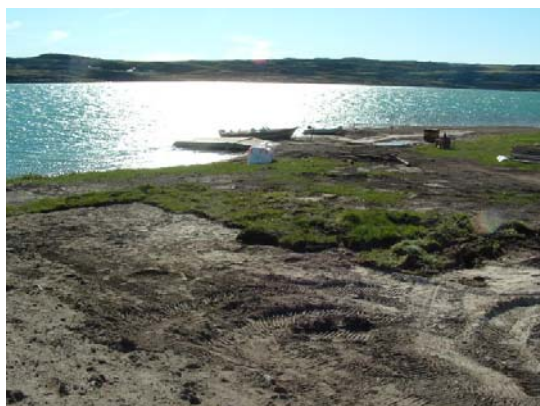
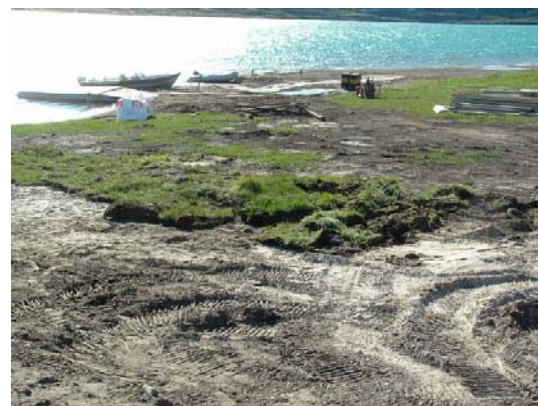
Appendix 6: Topsoil erosion/sedimentation runoff control using local grass cover

- Clean up of impacted areas as a result of the June spill, building of the LTA in 2004, moving AST tanks and building of a lined secondary in July 2005 disturbed many areas. Activities in summer of 2005 concentrated on use of native grass species to help with slope stabilisation and erosion control. This work was carried in high sediment areas to slow down the rate of run offs into Windy Lake. To prevent further disturbances, barricades were set up to prevent vehicles from entering onto the reclaimed disturbed areas. Pictures in Appendix 6 show what was done in areas of concern.

- To manage this challenge, grass cover materials removed from the construction site was placed along areas identified as being sensitive north of the LTA. The objective was to form a natural barrier with materials locally available to: (i) slow down sediment runoffs (see photos in Appendix 6); (ii) apply corncobs and peat moss over the natural barrier to absorb any petroleum products carried by the runoffs; and (iii) utilize natural grass and shrubs as a means for erosion mitigation process. The natural barrier was effective in achieving the above objectives.
