NWB Annual Report

Project Name: Hope Bay Regional Exploration Project

**2012 2BE-HOP1222 Type B Water Licence
Annual Report
Supplemental Document**

Windy Camp

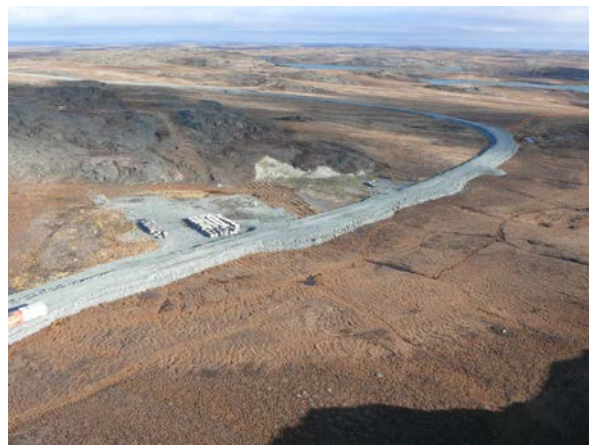
- Cuttings bags to be removed from Windy Camp.
 - Cuttings bags were removed from the tundra at Windy Camp

Windy Upper Laydown Area on Sept 29, 2012, after removal of cuttings bags
