2013 2BE-HOP1222 Type B Water Licence Annual Report Supplemental Document

Hope Bay Regional Exploration Program

Nunavut Water Board

Prepared by TMAC Resources Inc. Toronto, ON

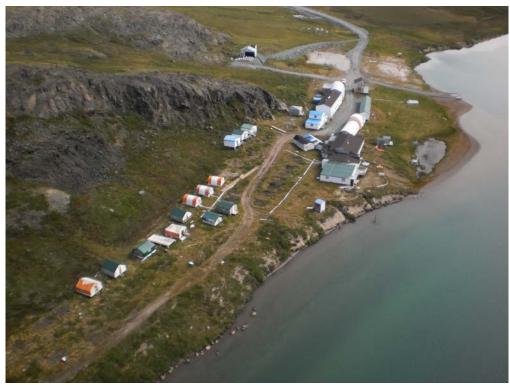
Figure 1 - Tent Removal and Clean-up at Windy Camp

From Windy Camp, there was clean-up and removal of general debris, including tent dismantling and removal. A description of activities is provided at Item 6 below.
