NWB Annual Report	Year being reported: 2014							
License No: 2BE-HOP1222	Issued Date: June 30, 2012							
<u> </u>	Expiry Date: June 30, 2022							
Project Name:	Hope Bay Regional Exploration Project							
Licensee:	TMAC Resources							
Mailing Addres	95 Wellington St. W. Suite 1010, PO Box 44 TD Centre Toronto, Ontario M5J 2N7							
	pany filing Annual Report (if different from Name of Licensee ationship between the two entities, if applicable):							
Effective June	HOP1222 was issued June 30, 2012 to Hope Bay Mining Ltd. 18, 2013, the NWB authorized the assignment of Licence 2BE- n Hope Bay Mining Ltd. To TMAC Resources Inc.							
General Background Inform	nation on the Project (*optional):							
exploration dril	IOP1222 allows TMAC to carry out activities in support of ling at the Hope Bay Regional Exploration Project and the Windy supports exploration activities.							
Licence Requirements: the accodance with	licensee must provide the following information in

### 2014 2BE-HOP1222 Type B Water Licence Annual Report Supplemental Document

### **Hope Bay Regional Exploration Program**

March 2015

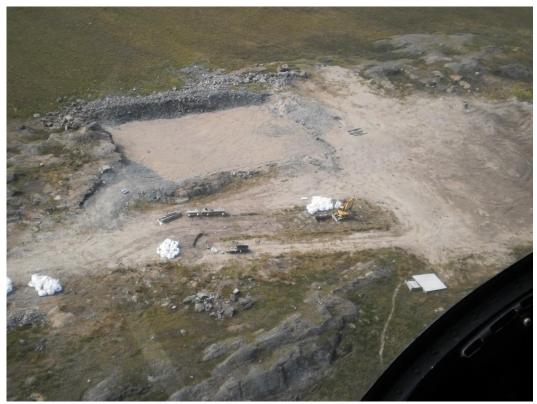
Figure 1. Patch Laydown Contaminated Soil Clean-up Mega Bags Staged for Removal

In February, 203 mega bags of contaminated soil were removed from the closed Patch Lake facility. This soil had been excavated in 2013 under supervision of EBA and site ESR staff (Figure 1) in accordance with the Phase III contaminated site assessment report prepared in 2012. The bags were removed from the site and stored in Quarry D until September, when they were loaded into sea cans for transport to the Doris North waste management area for staging until they can be shipped offsite. The estimated volume of material removed was approximately 150m<sup>3</sup>.

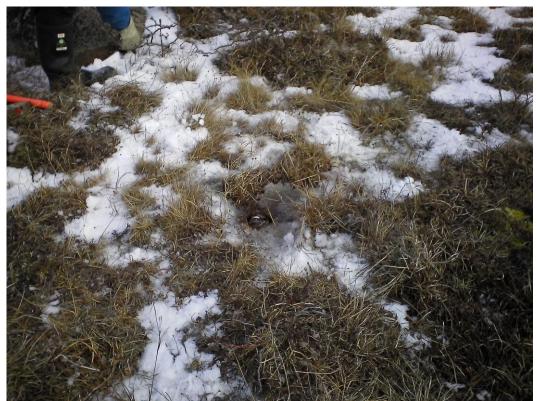
Figure 2. Historical Drill Site Reclamation at hole 07KNK003 with casing cut and hammered closed

Work continued in 2014 on reclamation of historic exploration drill holes (Figure 2). A total of 43 sites were fully reclaimed and work is anticipated to continue in 2015 as personnel and resources permit. Current exploration drill holes are remediated once drilling is completed and sites are inspected to document complete clean-up and restoration of each collar location.
