**NWB Annual Report****Year being reported:**

**License No:** 2BE-HOP1222**Issued Date:** June 30, 2012**Expiry Date:** June 30, 2022**Project Name:** Hope Bay Regional Exploration Project**Licensee:** TMAC Resources**Mailing Address:**  
95 Wellington St. W.  
Suite 1010, PO Box 44  
TD Centre  
Toronto, Ontario M5J 2N7**Name of Company filing Annual Report (if different from Name of Licensee please clarify relationship between the two entities, if applicable):**

**2015 2BE-HOP1222 Type B Water Licence  
Annual Report  
Supplemental Document**

**Hope Bay Regional Exploration Program**

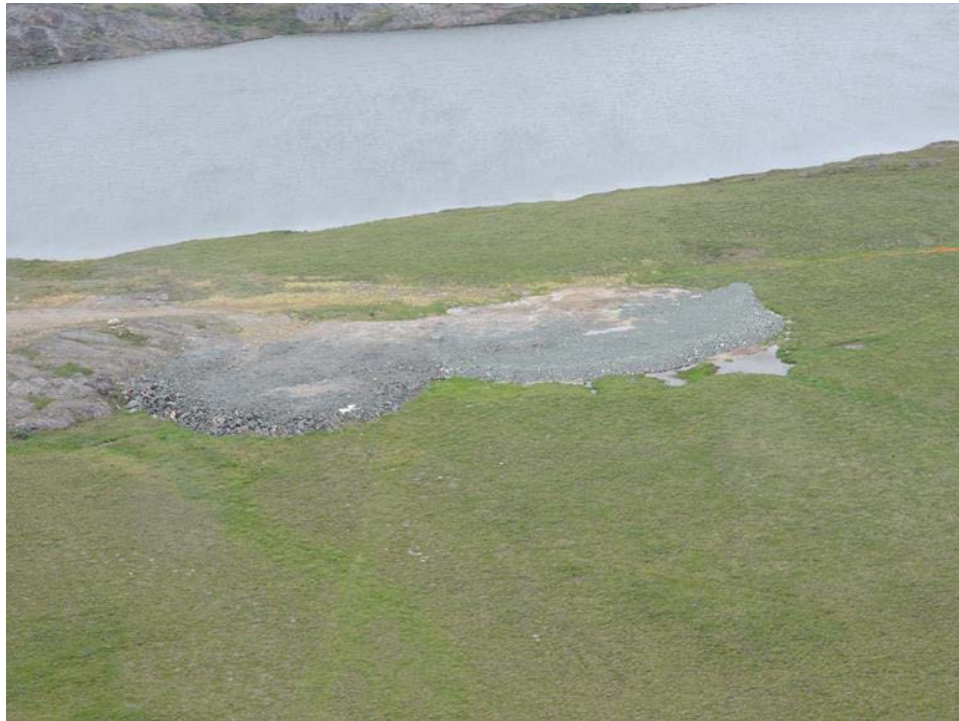
recovery (see Figure 1). Similar monitoring will be undertaken in 2016 to confirm continued improvement and effectiveness of mitigation applied in 2015.

**Figure 1. August 2015 aerial view of Patch Cuttings Sump with cap (right side of pad above) showing vegetation recovery. Photo looking East.**

Inspection under the Hope Bay Regional Exploration Licence was conducted by INAC on July 18 and 19, 2015. No non-compliances were noted. One action was recorded as being required: to determine the effectiveness of the remediation measures taken for spill 13-357 and whether further action was required. This spill refers the historical Patch Cuttings Sump seepage. TMAC provided a response to the NWB on this INAC inspection on Sept 21, 2015 indicating that monitoring would be undertaken seasonally. 2015 conductivity measurements taken near the sump from the surface and shallow groundwater indicated improvement in comparison to 2013 and 2014 results (i.e. the years prior to sump capping), and vegetation in the area has shown

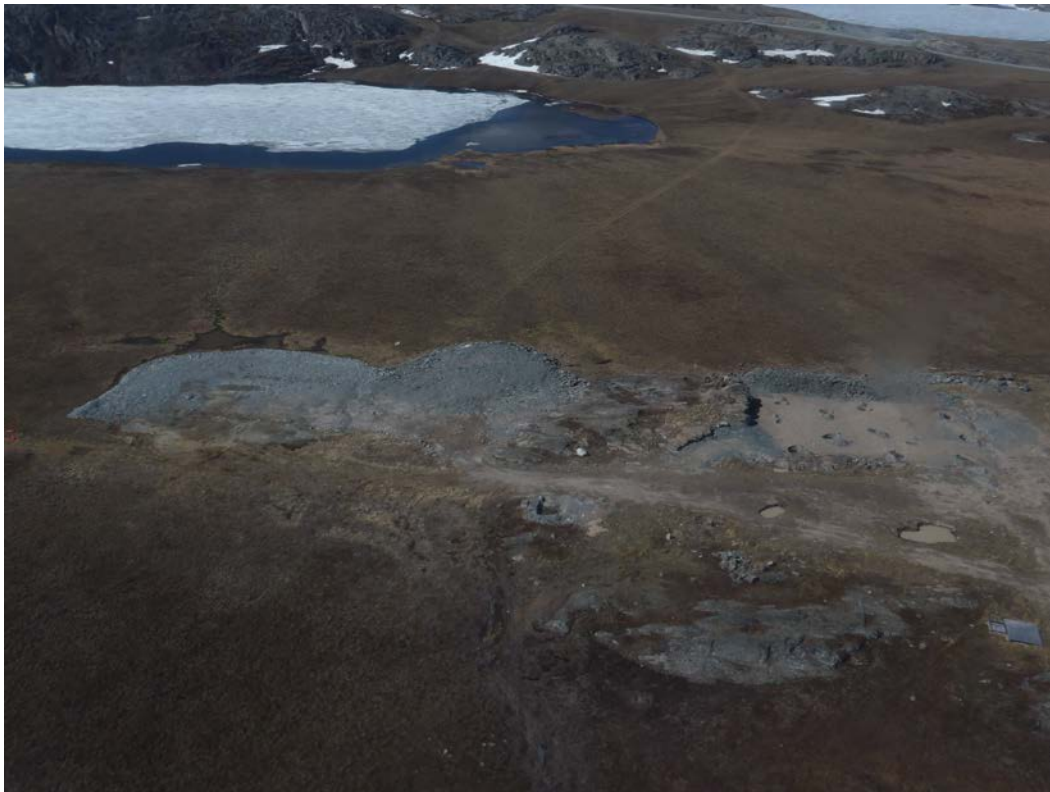
transported from Quarry 2 near Doris Camp to the sump via an ice road constructed over Patch Lake. Approximately 744 m<sup>3</sup> of quarry rock was placed over the sump (Figure 2).

Figure 2. Thermal barrier placed over sump (far left) at Patch Lake Laydown facility. Photo looking West.

In March and April 2015, reclamation work was conducted on the Patch Lake Laydown cuttings sump facility. The reclamation work included the placement of quarry rock over the cuttings sump area where historically saline drill cuttings were stored. The quarry rock is intended to create a thermal barrier and prevent further migration of salts downstream of the sump. Quarry rock was
