HOPE BAY PROJECT 2019 Nunavut Water Board Annual Report

2019 Nunavut Water Board Annual Report

Prepared by
TMAC Resources Inc.
Toronto, ON

Prepared for
Nunavut Water Board

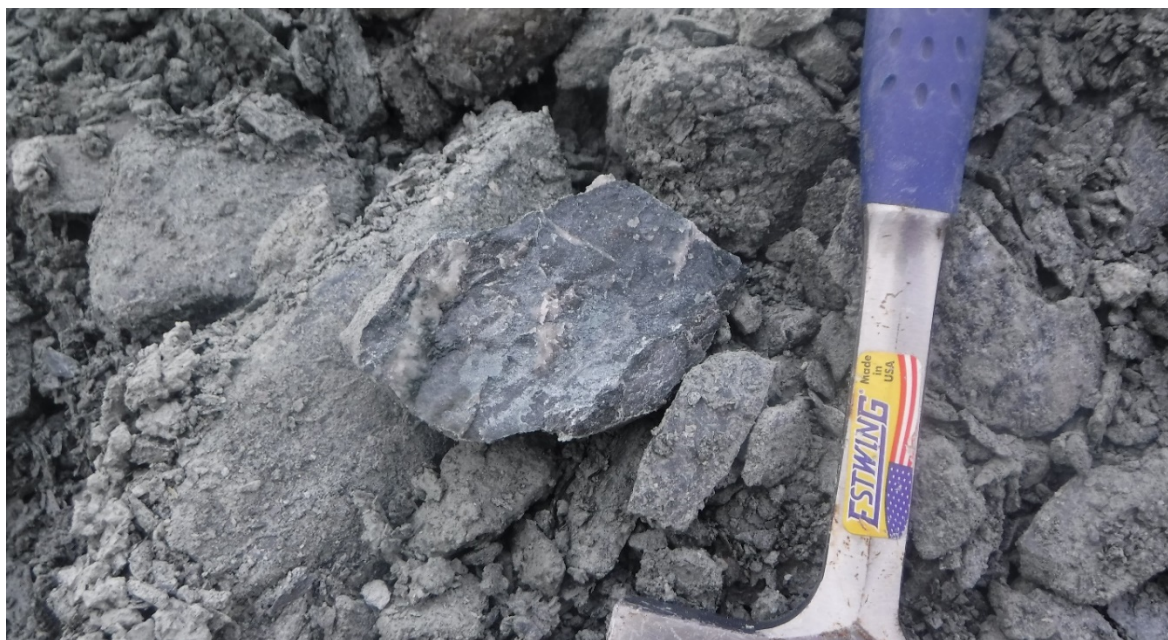
Figure 3-4: Dark Green Mafic Metavolcanics (1a) with Quartz Veining (SRK19-WR03)

Both rock types, mafic metavolcanics (1a) and altered mafic metavolcanics (1as), had quartz and calcite veinlets (up to several cm thick) with rare occurrences of very-fine grained disseminated cubic pyrite ($\leq 1\%$), and variable hematite staining. The altered mafic metavolcanics were less competent than the dark green mafic metavolcanics which occurred as boulders of variable size. Fizz test was strong for mafic metavolcanics (1a) and moderate to strong for altered mafic metavolcanics (1as). The quartz veins (12q) were associated with greater very-fine grained disseminated cubic pyrite content (5%) than the mafic metavolcanics. The fizz test was moderate for quartz (12q).

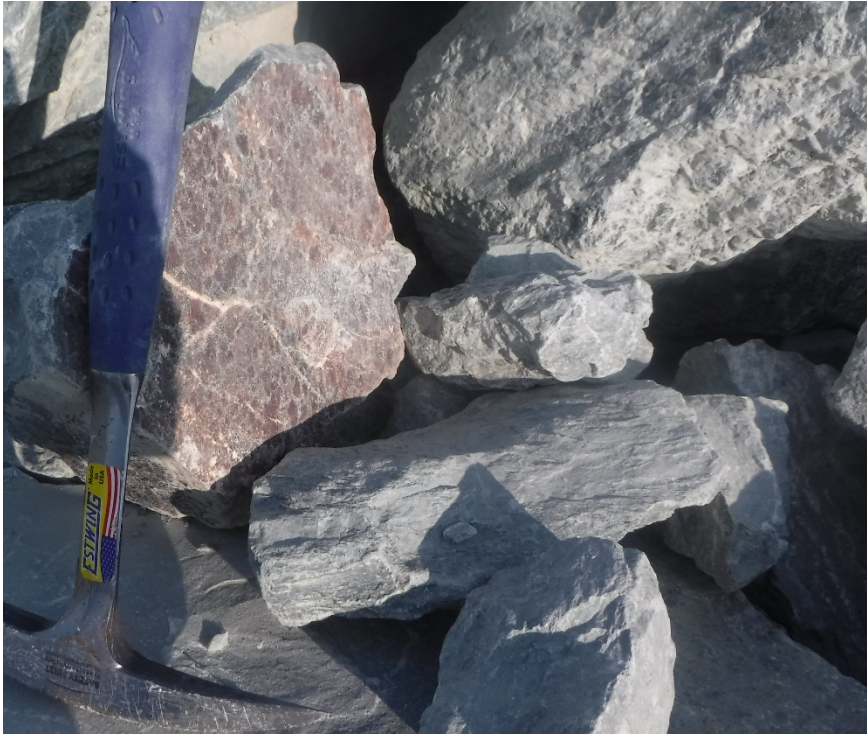
Figure 3-7: Mafic Metavolcanic (1a) with Hematite Staining (near SRK19-CR05)

Typical construction rock observed in infrastructure at Madrid North was dark green mafic metavolcanics (1a) with no to trace ($< 1\%$) visible sulphides in the form of cubic pyrite. The mafic metavolcanics contained rare to few quartz-carbonate vein that were typically < 1 cm wide. In all surveyed areas, $< 5\%$ of construction material contained hematite (Figure 3-7). An estimated 5% of construction material was granitic boulders observed in all areas (Figure 3-8). These fragments were often well-rounded and are interpreted to represent glacial erratics. Rare epidote veins were observed in construction material at the overburden pad berm. A single rock (< 15 cm) of graphitic argillite (5a) was observed along the access road to the Madrid North CWP, near where the SRK19-CR06 sample was collected (Attachment C).

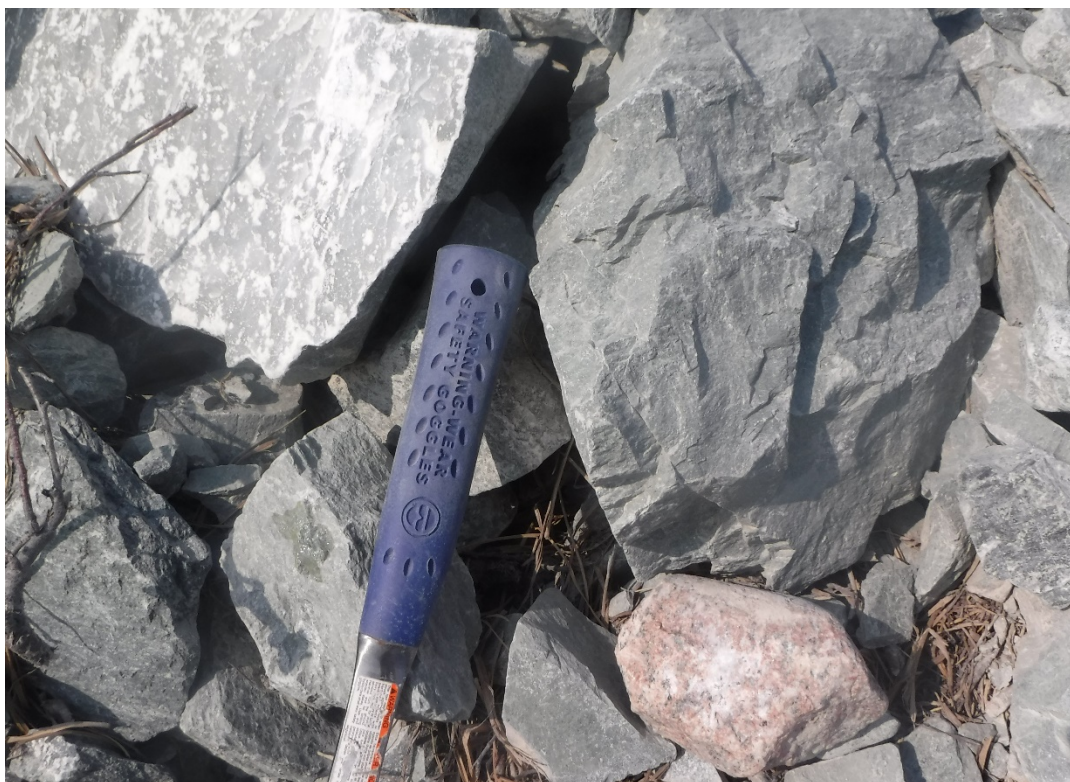
Figure 3-8: Mafic Metavolcanics with a Granitic Boulder and the Plan View of a Quartz Vein in the Top-right (near SRK19-CR03)

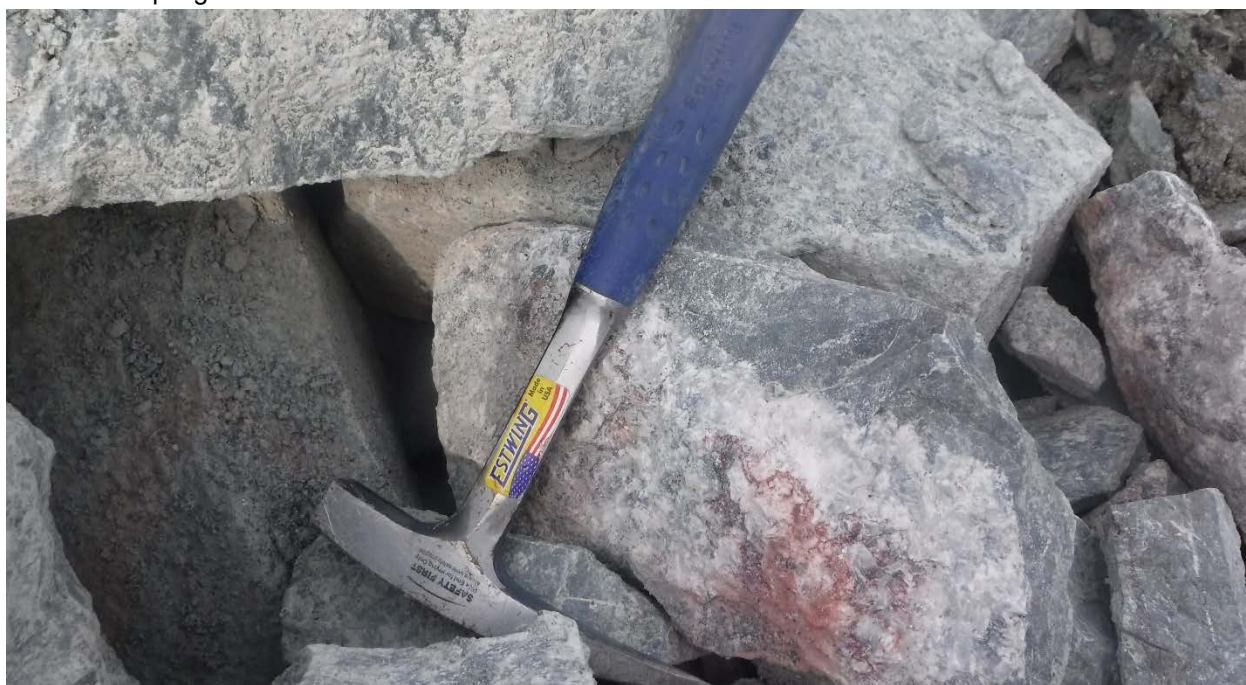
Photo: Calcite vein with hematite staining among rock type 1a at sampling location for SRK19-CR-08

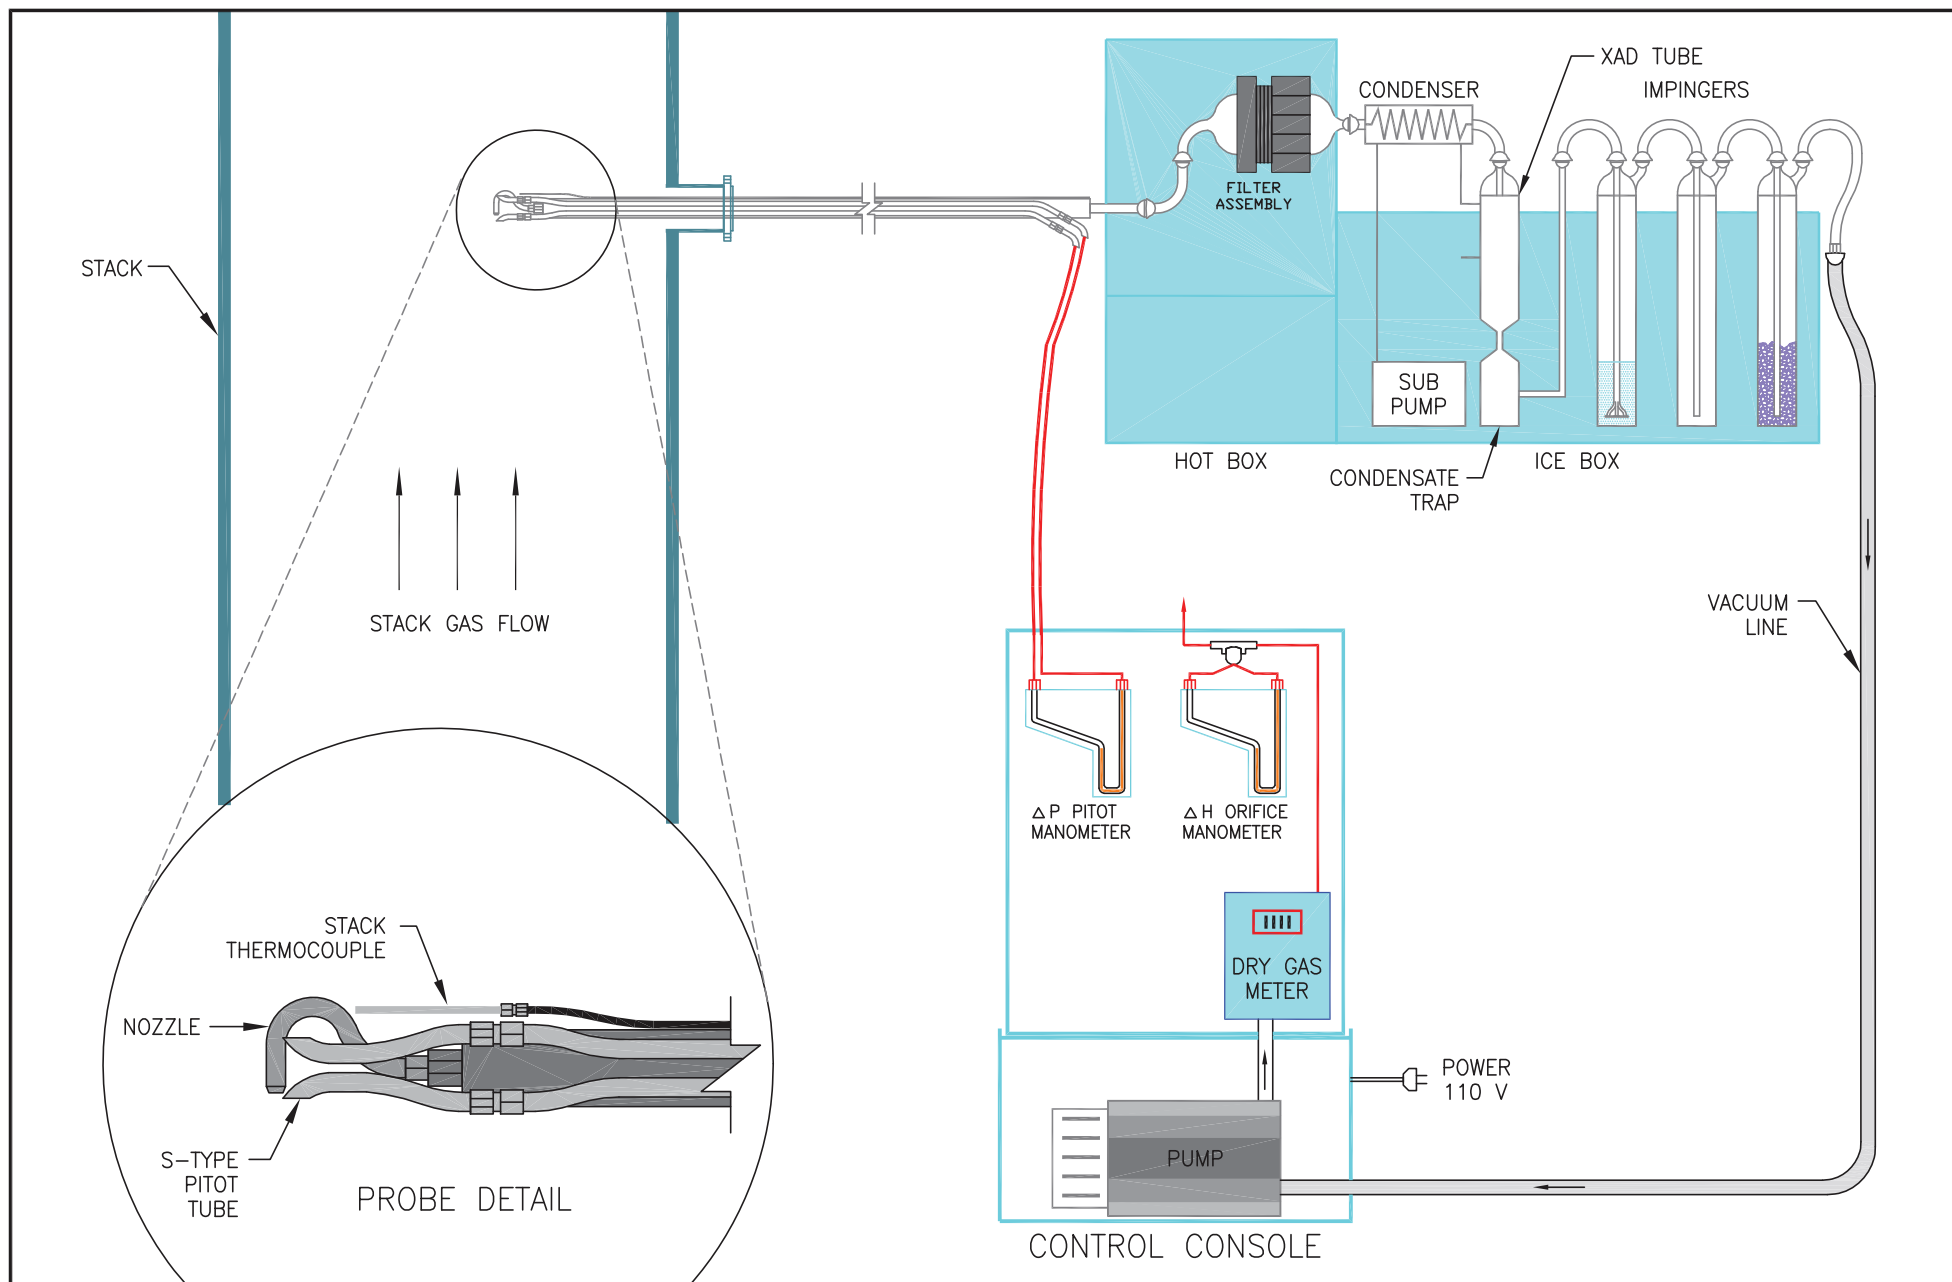
Fig. No.: 3-1

SOURCE EMISSIONS TESTING
EPS 1/RM/2 SAMPLING TRAIN

Following testing, the amount of particulate matter present on the filter and in the probe rinse was measured gravimetrically in the laboratory and used in the determination of total particulate matter emissions from the sources tested. The particulate matter samples captured in the probe and filter, and the impinger solutions were analyzed for mercury.
