Agnico Eagle Mines Limited

HOPE BAY PROJECT 2021 Nunavut Water Board Annual Report

March 2022

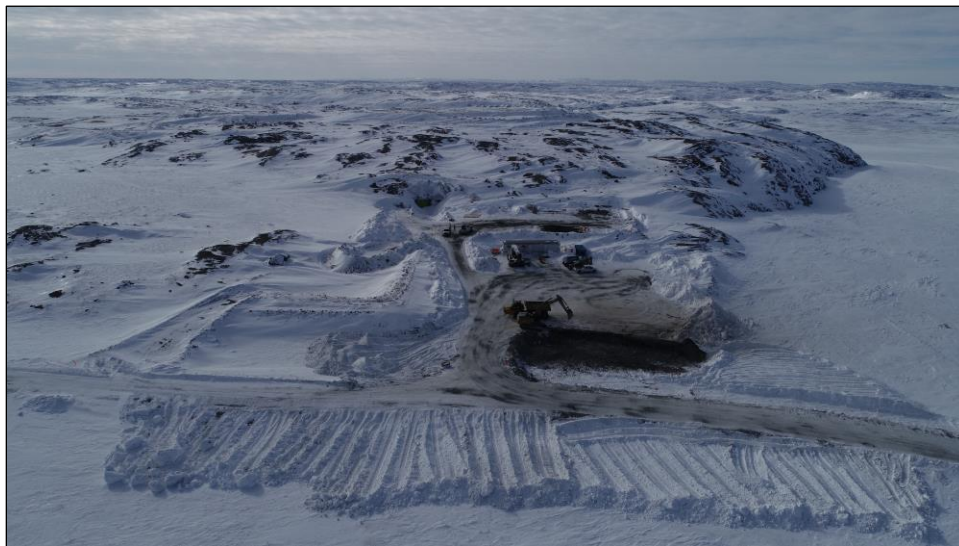
Figure 13-1. Madrid North Portal Pad Excavation

The eastern portion of the Madrid North Portal Pad and Madrid North Portal Laydown, collectively referred to as the Portal Pad, was reclaimed in 2021. The eastern portion was removed down to the pre-existing natural grade. Although construction rock used for the portal pad was classified as non-PAG with arsenic content below the criterion for classifying suitable waste rock, removing the eastern portion is anticipated to reduce the source of ammonia and chloride that may remain entrained in the material of the pad. Efforts were made during excavation to minimize impact to the underlying tundra (Figure 13-1). Material excavated from the eastern portion of the pad was used as backfill in the Naartok East Crown Pillar Recovery Trench.

The western side of the pad remains in place and was graded to allow positive drainage. The geochemical field surveys will continue to monitor runoff from the remaining pad area and downstream of the excavated area. Erosion control measures including coco matting and silt fencing have been put in place to minimize sediments in runoff from the excavated area and the remaining pad area. Routine inspections of the area will be conducted throughout the snow-free period to monitor stability of the excavated area and ensure positive drainage is maintained.
