June 16, 2011

Re: 2BE-HOP0712 Unauthorized Discharge from Bulk Fuel Storage Facility HOP-5

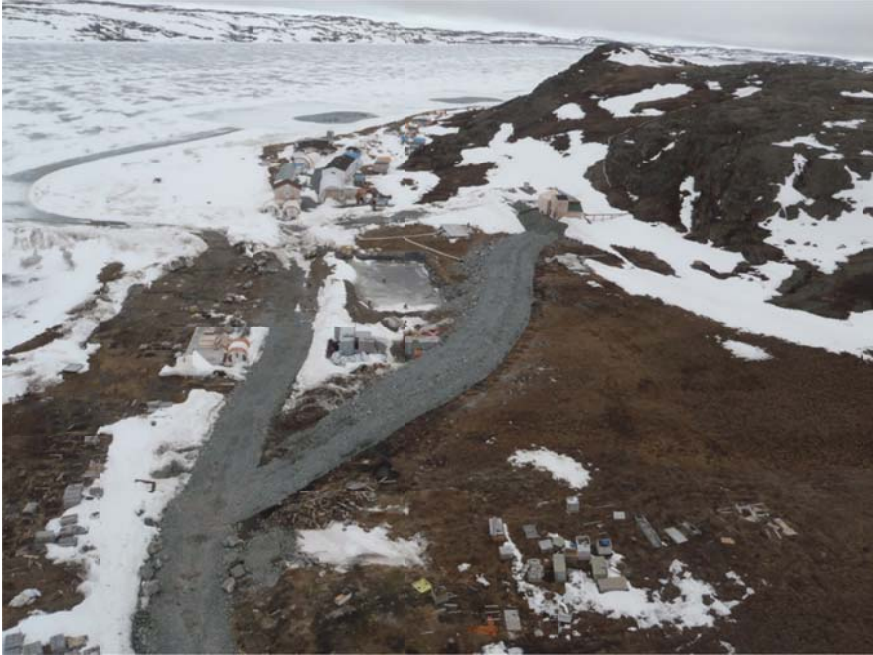
June 4, 2011. Looking north at newly constructed diversion berm and frozen HOP-5 containment facility

In April 2011, a diversion berm was constructed to divert water from running off of the hill into the containment berm to avoid having excess water entering the facility. The snow was also removed from the area when the diversion berm was constructed. The containment berm was destined to be dismantled in 2012; however, HBML is now expediting the schedule to remove this facility as early as possible in 2011 instead.

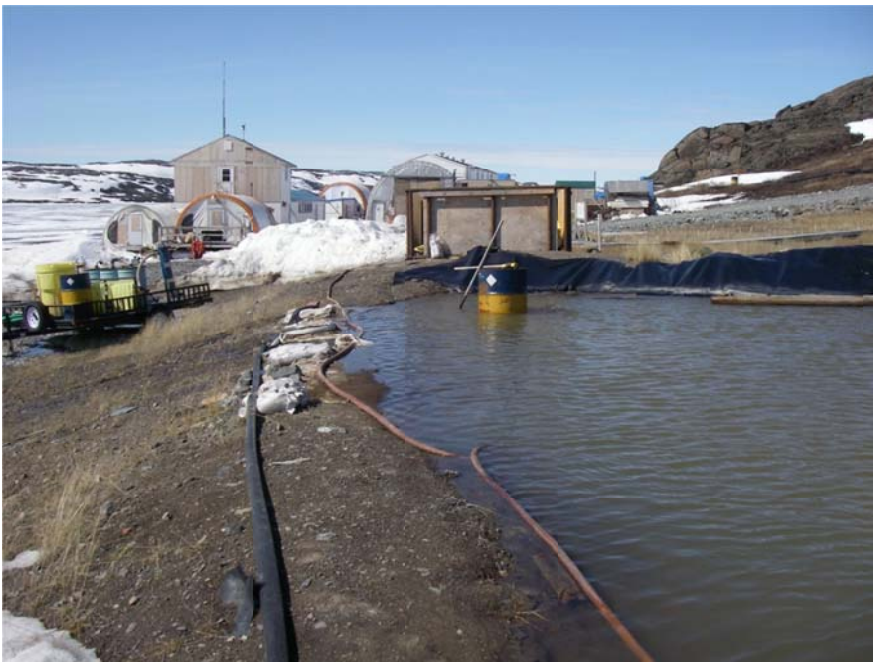
On June 13, 2011, HBML detected overflow of run-off water from the HOP-5 containment facility located at old Windy Camp. It is unknown how much water overflowed the berm. Immediately upon detecting the seepage, a crew was dispatched to build up the low corner of the berm using polyethylene plastic sheeting and sandbags. The flow over the liner appears to have stopped; however, water still appears to be seeping from underneath the liner. Water samples were sent to ALS Laboratories for rush analysis. Preliminary results are expected to be available by June 17, 2011.

June 13, 2011. Looking north at the low corner of HOP-5 containment facility where the seepage was detected. Note the oil-water separator already in place in preparation for dealing with the water when the pond was thawed.

Portable containment berms are being gathered and set-up at Windy Camp to draw down the water in the HOP-5 containment facility. As an immediate action, 20 000 L of untreated water was pumped into a temporary containment berm, which dropped the water level in the containment facility by approximately 5 inches. The oil-water separator pump will be used to transfer additional water from the containment facility to the portable berms, where the water will be held until the sample results are received. If the results show that the untreated water is compliant with the water licence and other relevant legislation, it will be released. Otherwise, it will be run through the oil-water separator into the portable berm. Water samples will also be collected from the treated water in the portable berms and it will be released once it is demonstrated to be compliant.

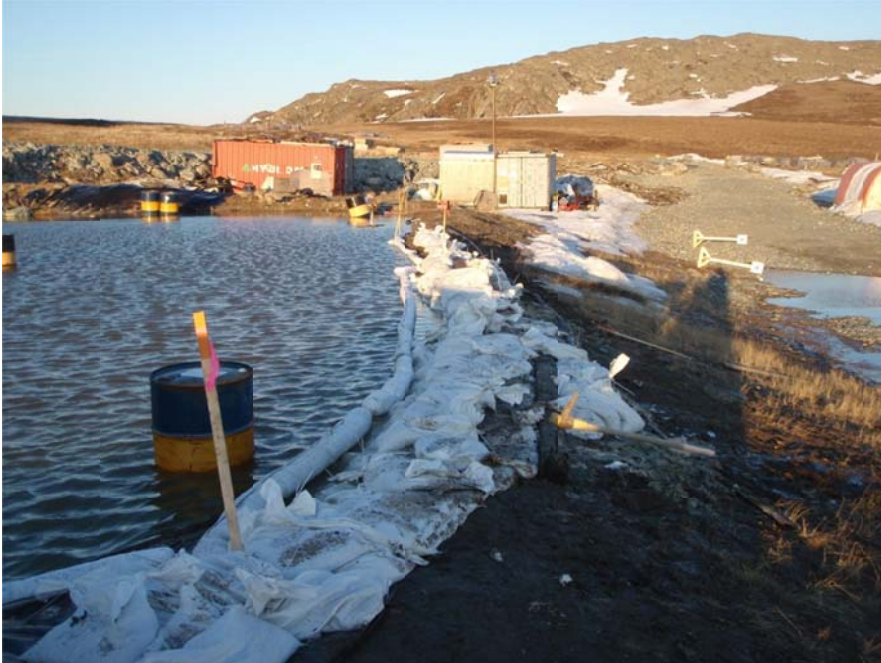
June 14, 2011. Looking south at the polyethylene sheeting and sandbags installed on June 13, 2011 to prevent further seepage from within the berm. Absorbant booms were also placed as a precaution since the containment facility was the former fuel containment.
