**Subject: Interim Report – Windy Lake Fuel Spill – Spill Number 04-388**

## Diesel Fuel Spill Assessment and Remediation

## **SPILL ASSESSMENT AND REMEDIATION WINDY CAMP, NUNAVUT**

**1740065.003**

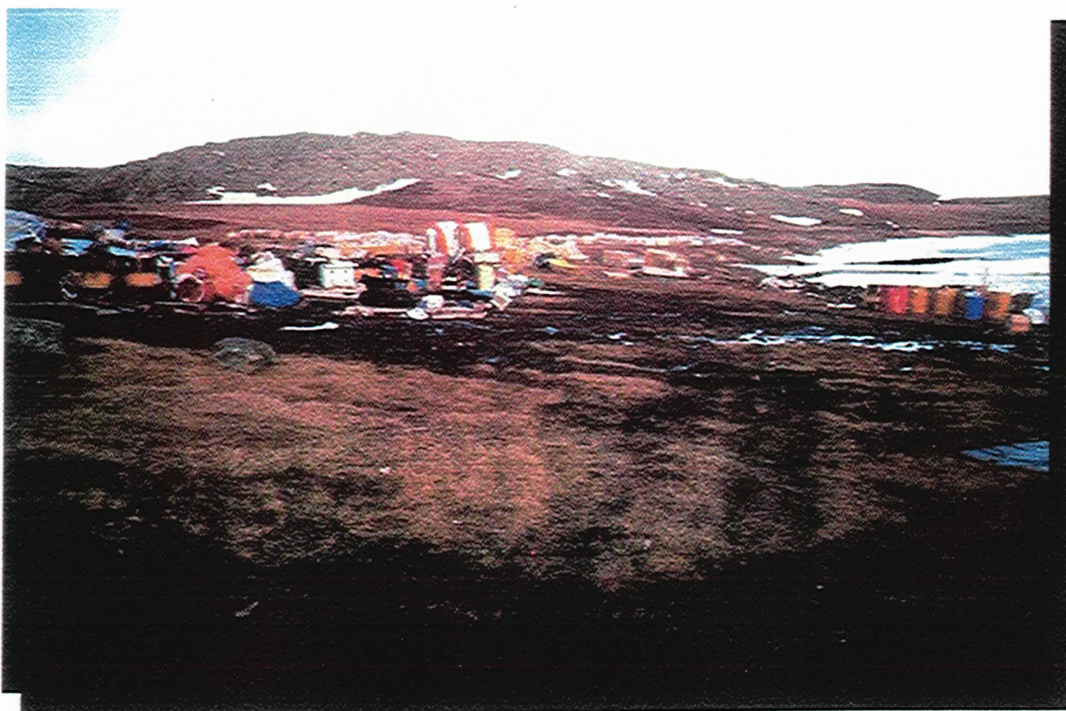
- Booms, containment barriers and absorbent pads had been installed on the frozen lake surface around melt-water pools.
- Approximately 0.25 cm to 6 cm of free diesel fuel was present on the nearshore ice surface and melt-water pools of Windy Lake, within the area of the containment booms.

- The thickest area of diesel fuel was located on the southwest side of the containment area (approximately 10% of the total area) as a result of wind blowing from the northeast.

**Photo 1**  
Spill area at the time of EBA's arrival.

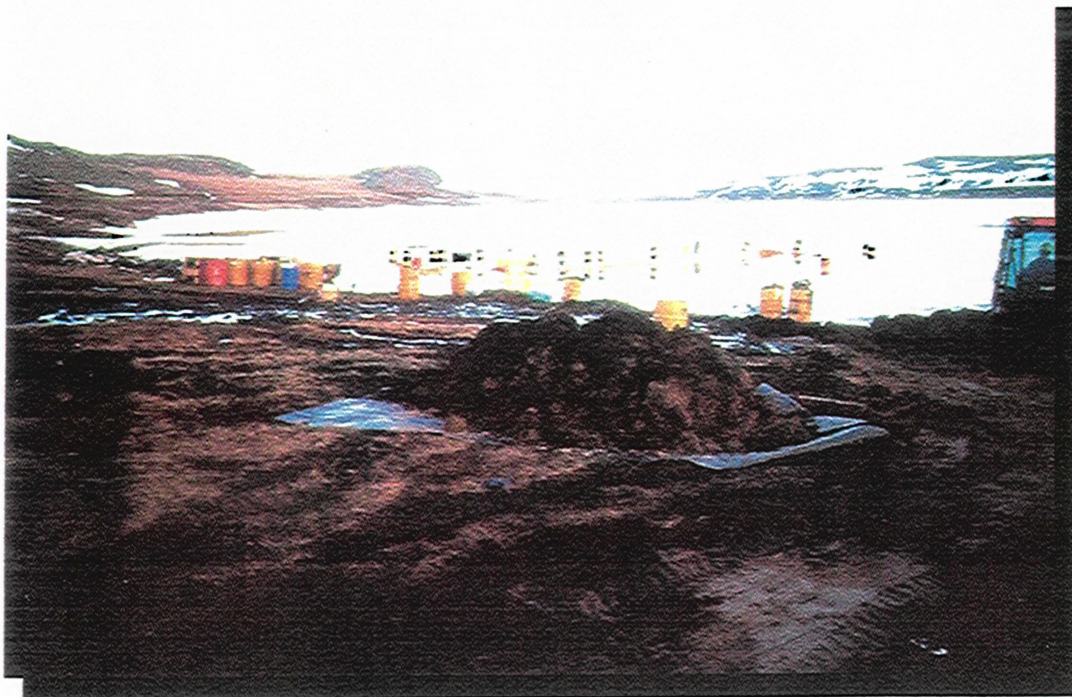
**Photo 2**  
Spill area hours after EBA's arrival.

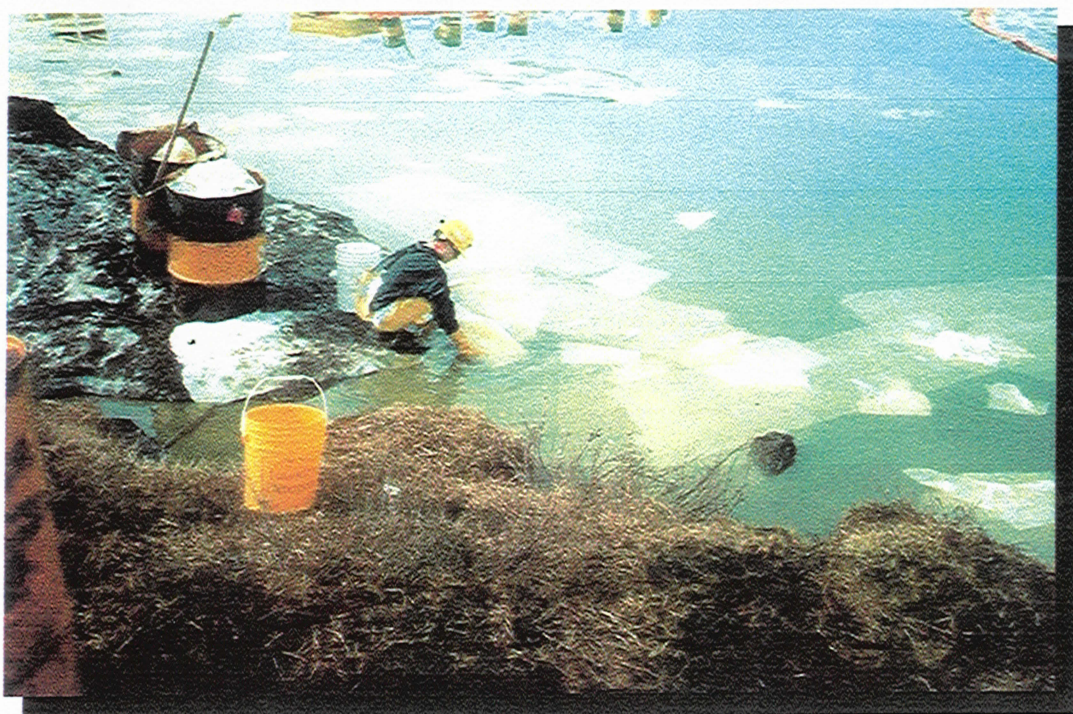
**Photo 4**  
Removal of liquid hydrocarbon, using absorbent pads, prior to in situ incineration.

Free diesel fuel was manually recovered using absorbent pads placed on the surface of the melt-water pools. Coffee cans were also used to skim the diesel fuel from the surface of the melt-water pools and the recovered product was placed into 205 litre barrels for future treatment and

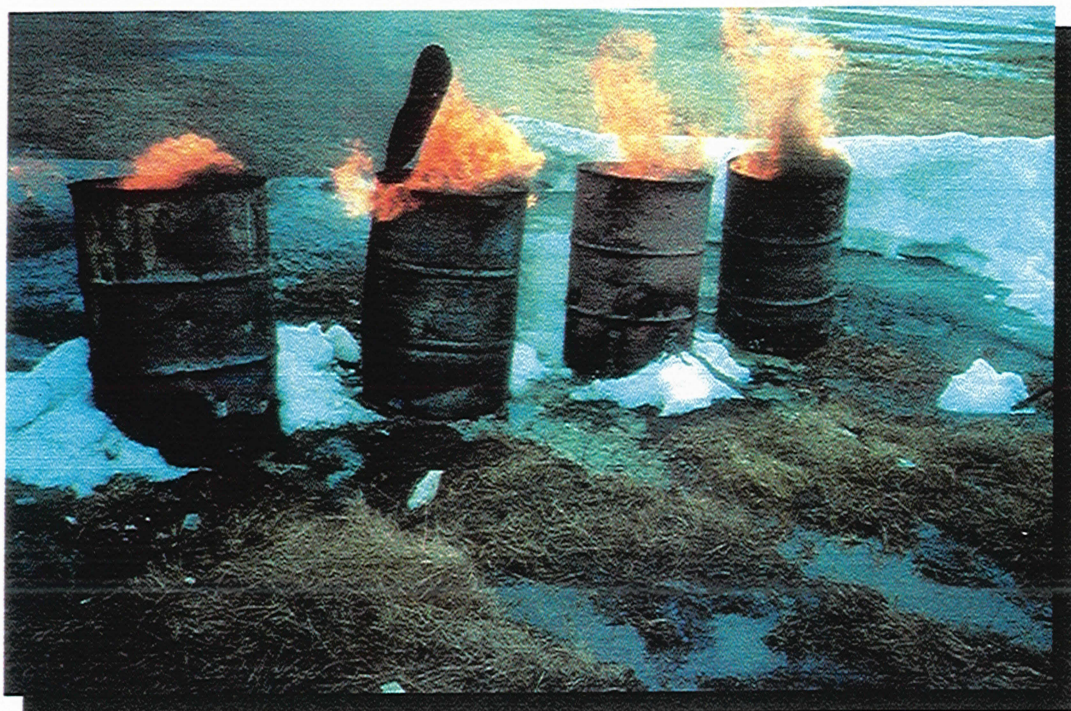
**Photo 5**  
Incineration of used hydrocarbon-absorbent material.

In addition, approximately 1,000 absorbent pads and 25 absorbent booms were incinerated. Some free product was manually removed from the surface of the melt-water on the ice prior to incineration. Approximately 1,550 litres of diesel fuel was recovered in this manner and stored onsite in above ground tanks. Thus, in total, approximately 8,250 litres of free diesel fuel was recovered by physical means.

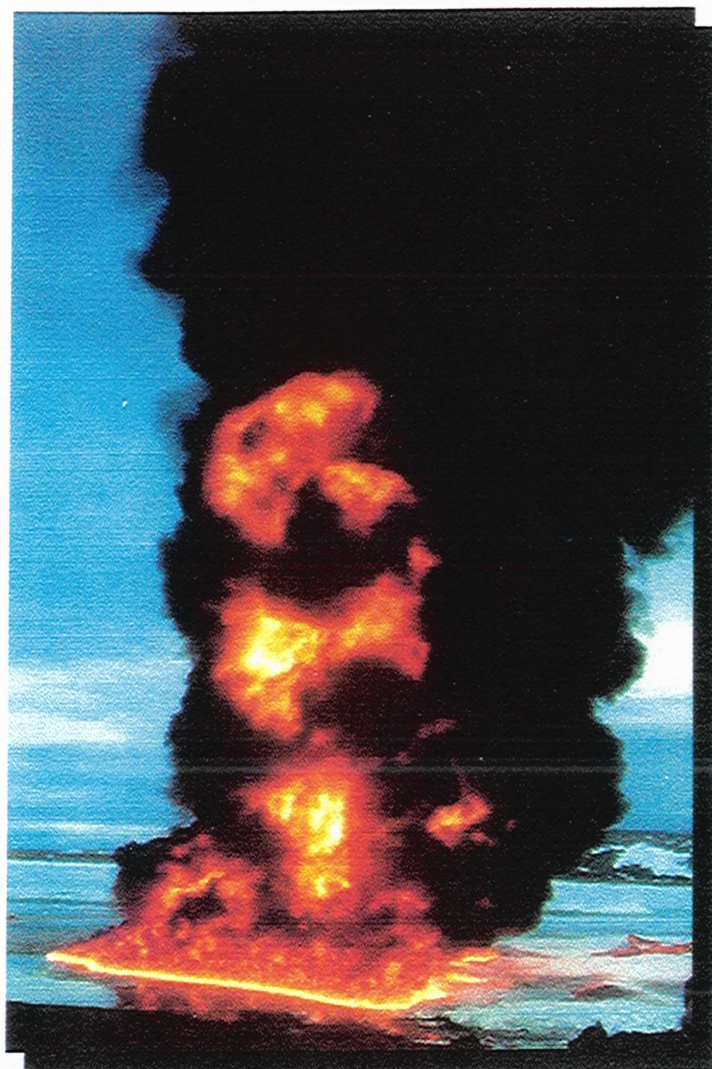
**Photo 6**  
In situ incineration of liquid hydrocarbons on surface of water.

At 12:30 a.m. on June 20, 2004, after obtaining authorization from the on-site regulatory authorities, and when the environmental conditions were observed to be ideal, the free diesel fuel present in the contained melt-water pool area located on the frozen lake surface was ignited. The initial point of ignition was located along the northwest perimeter of the contained area. Following ignition, the flames swept over the entire containment area at a rate of approximately 125 cm per minute and terminated at the western corner, by the shoreline, at 1:30 a.m. on June 20, 2004. Based on the estimated surveyed area (1,100 m<sup>2</sup>) and the observed heating oil thickness (0.25 to 0.5 cm average) in the melt-water on the lake ice surface, the approximate volume of free diesel fuel product that was consumed during incineration was estimated at between 2,750 to 5,500 litres.

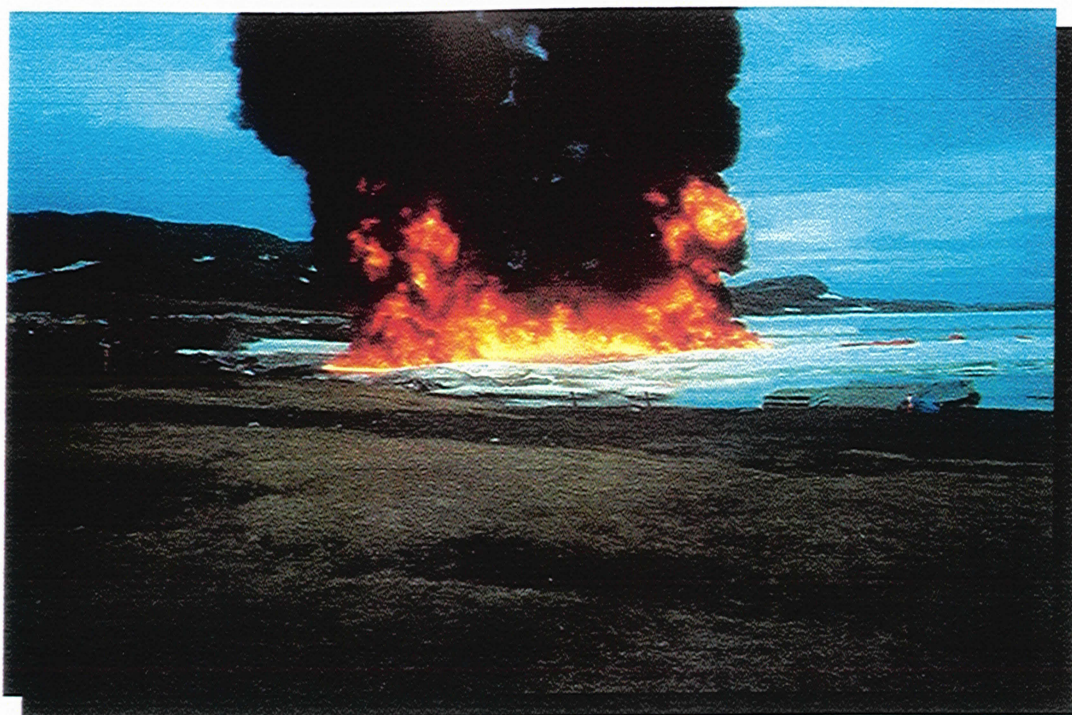
**Photo 7**

In situ incineration of liquid hydrocarbons on surface of water.

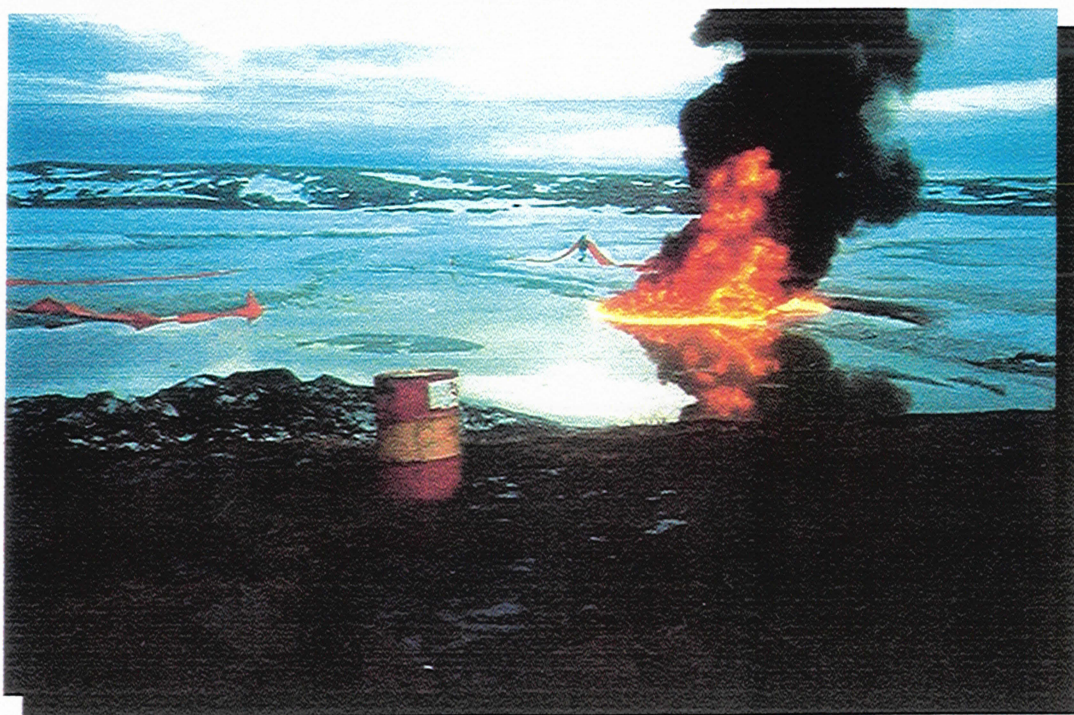
**Photo 8**

In situ incineration of liquid hydrocarbons on surface of water.

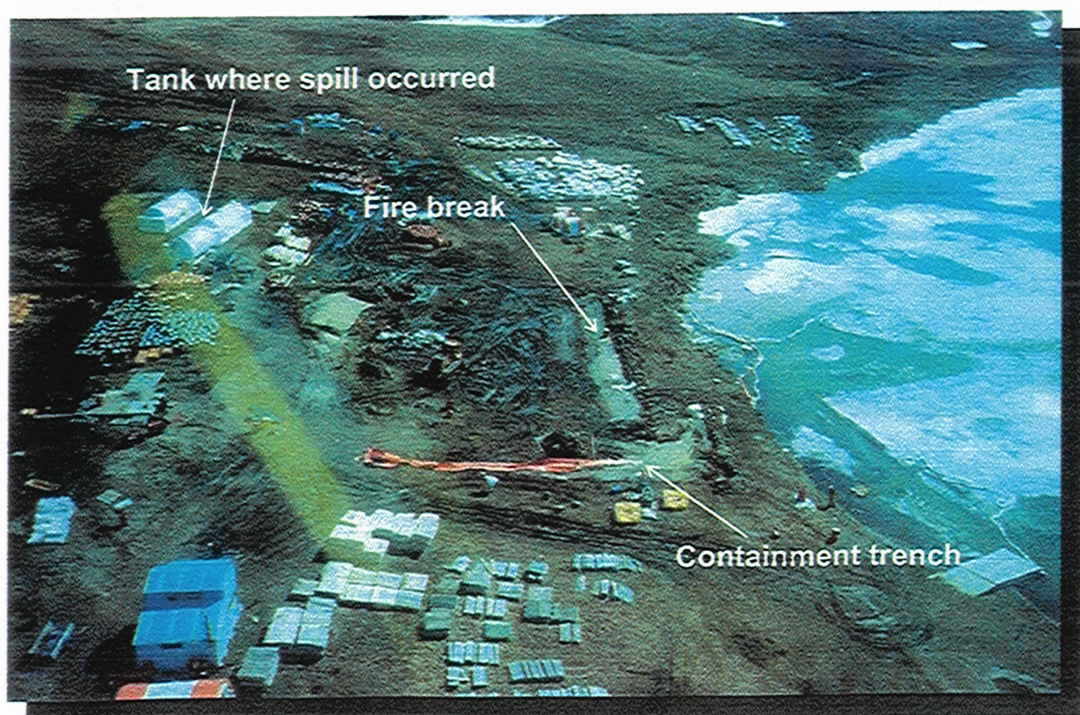
**Photo 10**  
Aerial photo of spill area.

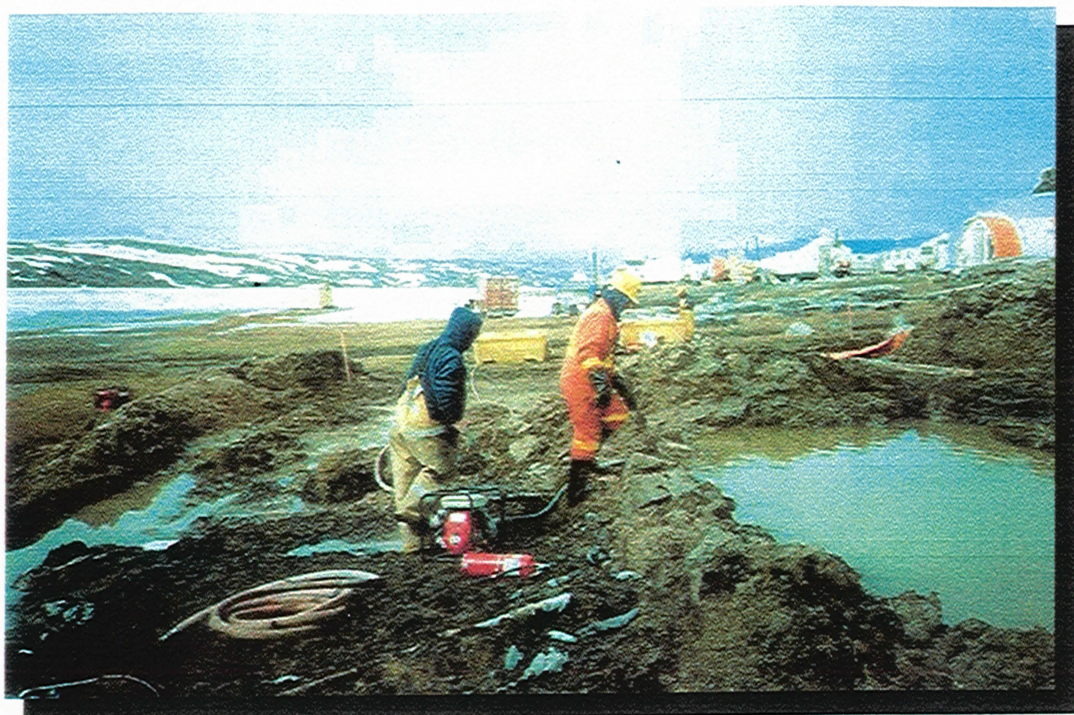
**Photo 11**  
Removal of water within firebreak for treatment and disposal.

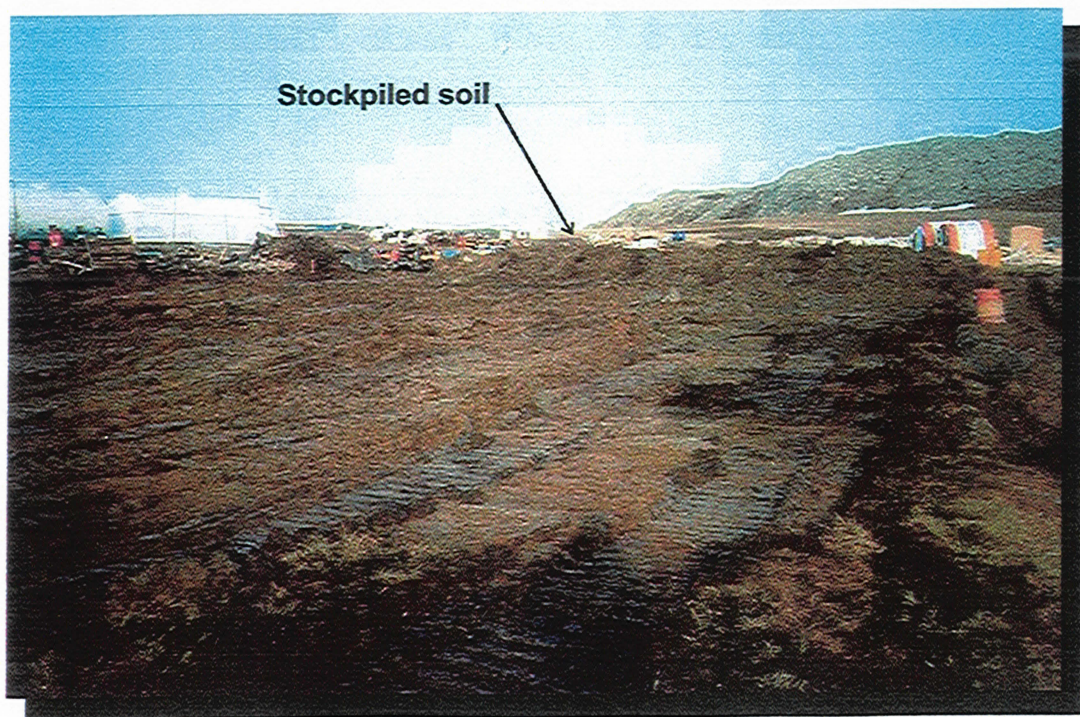
The hydrocarbon-impacted soil was stripped from the area where hydrocarbon odours and staining were detected. The soil was stripped using a D5 CAT Dozer to an approximate depth of 10 cm below surface grade where frozen ground was encountered.

**Photo 14**  
Spill area with impacted soil removed and stockpiled.

Diesel fuel-impacted soil located immediately below the tank was not excavated due to the proximity of the tank and the concern that, by removing the material, the soil stability could be compromised, resulting in damage to the tank. Therefore, it is recommended that this area be dewatered using a series of diversion trenches installed upslope to control surface runoff through the area. The impacted soil in this area should also be covered with waterproof material prior to snowfall to further limit melt water migration through the soil. These methods are recommended until such time as the soil can be safely excavated and placed into the LTA for remediation.

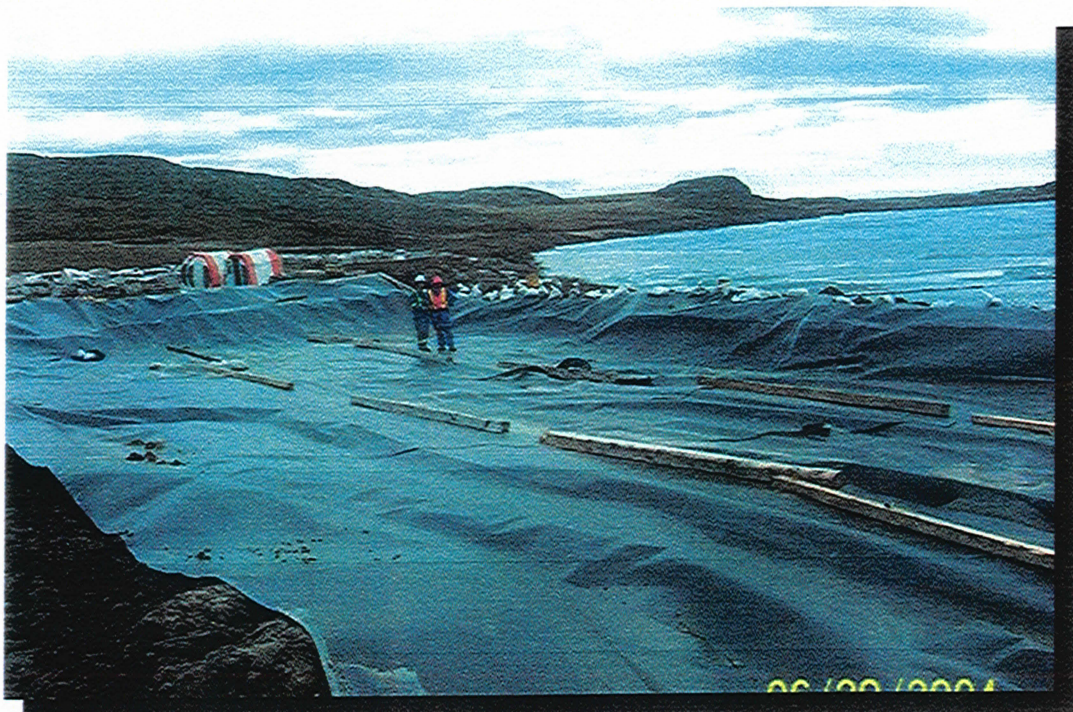
**Photo 15**  
Land treatment area.

Soil within the LTA should be cleared of all large objects, segregated based on the date the material was placed in the LTA, and periodically aerated to promote remediation.

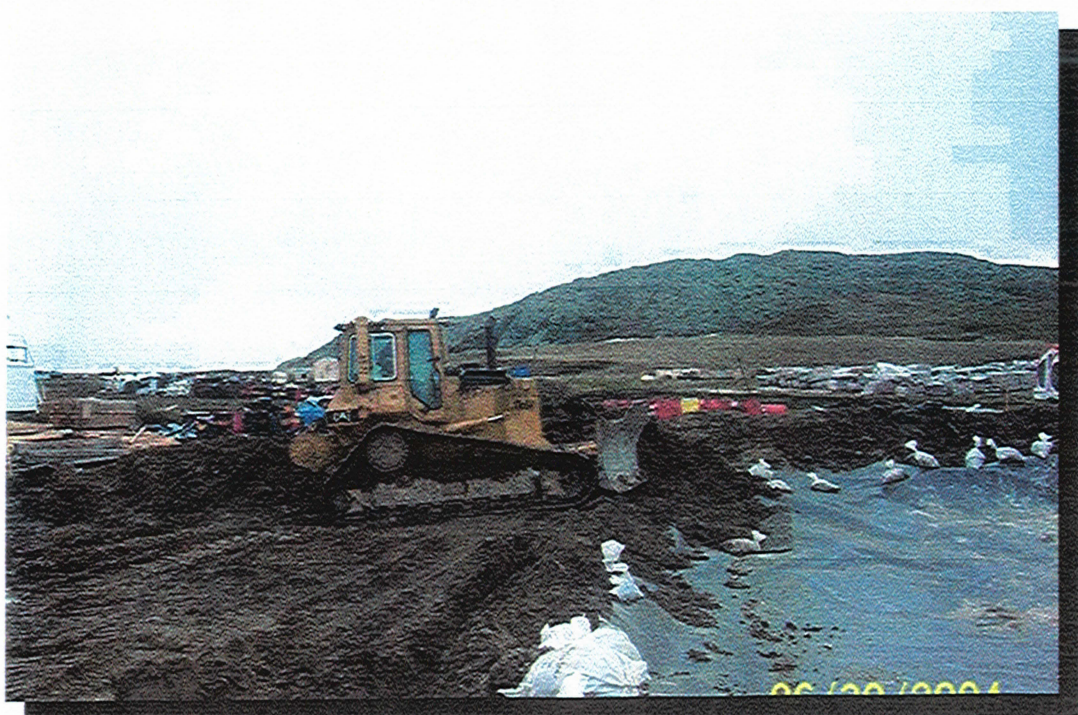
**Photo 16**  
Placement of impacted soil within land treatment area.

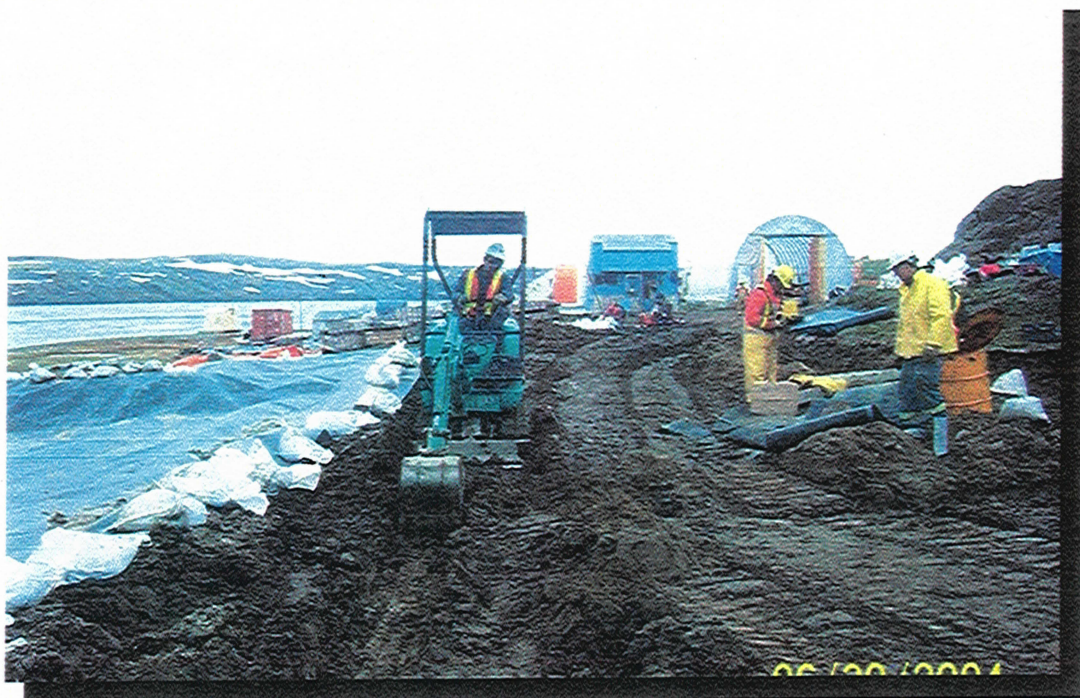
**Photo 17**  
Excavation of drainage trench around land treatment area.

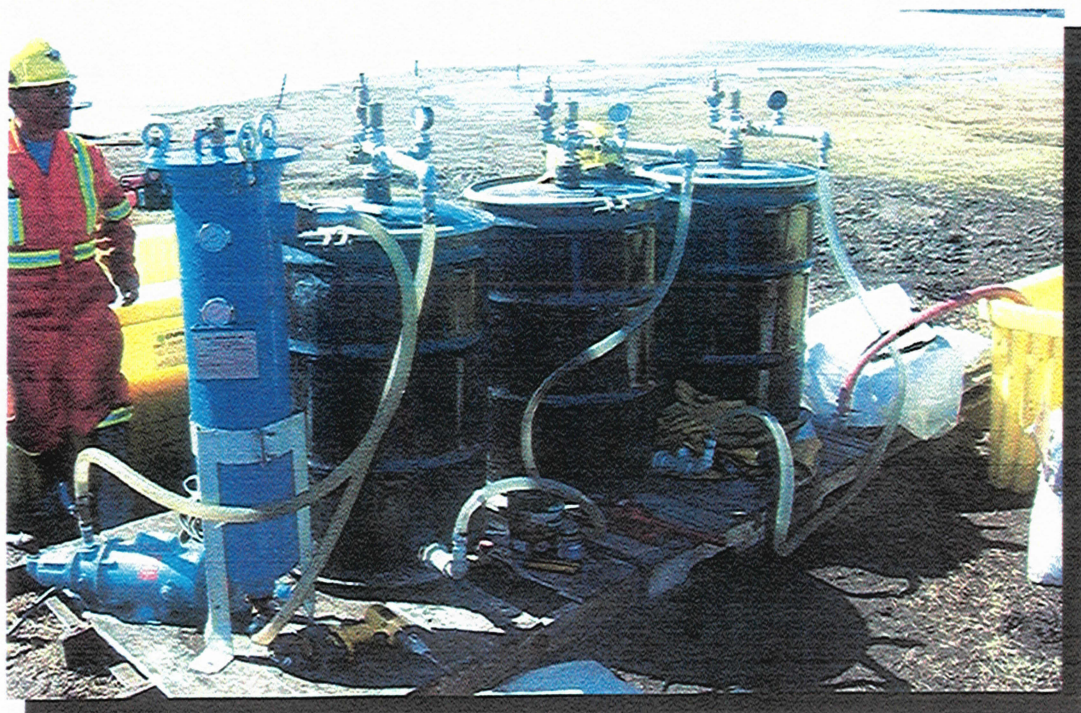
**Photo 18**  
Water treatment system.

All spent media from the water treatment unit was placed within the LTA as recommended by the supplier.
