**Table 1**  
**Contents of Barrels with Recovered Liquids**  
**Fuel Spill Remediation**  
**WindyCamp, Nunavut**

**Table 2**  
**Soil Analytical Results**  
**Fuel Spill Remediation**  
**WindyCamp, Nunavut**

Table 3  
Water Analytical Results  
Fuel Spill Remediation  
WindyCamp, Nunavut

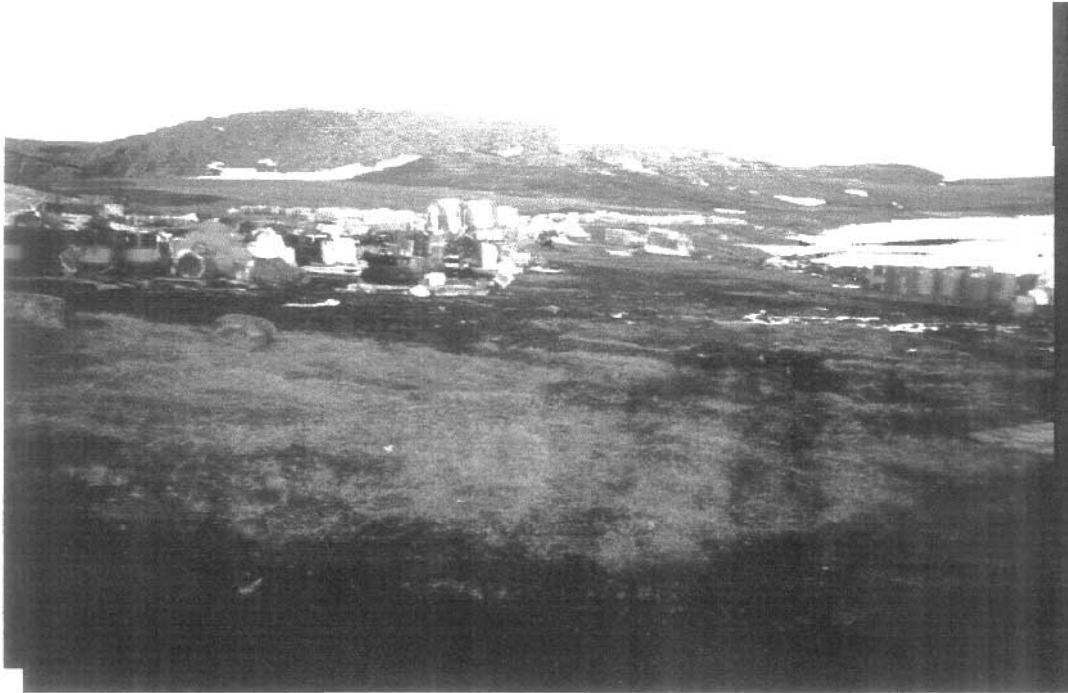
**Photo 1**  
Spill area at the time of EBA's arrival.

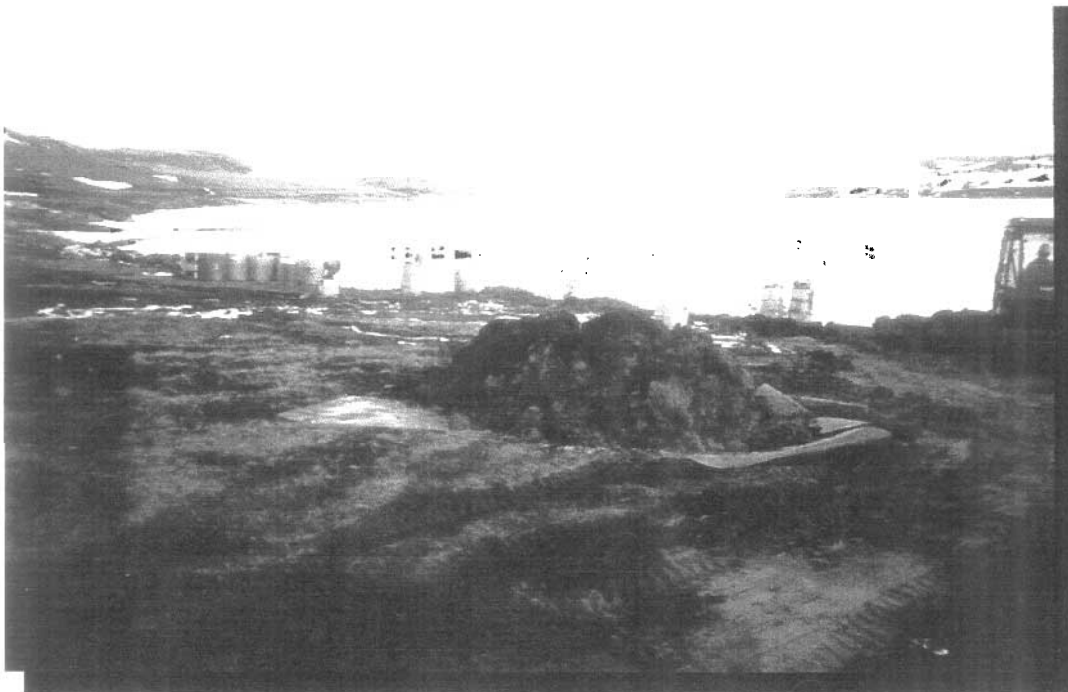
**Photo 2**  
Spill area hours after EBA's arrival.

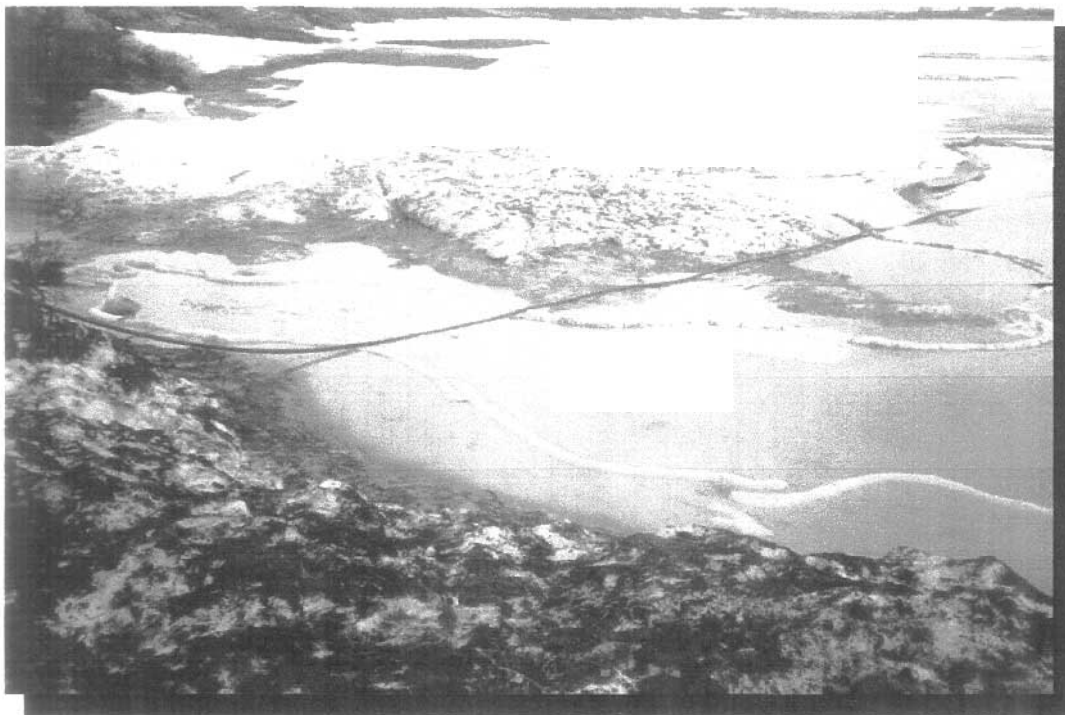
**Photo 3**  
Water surface prior to in situ incineration.

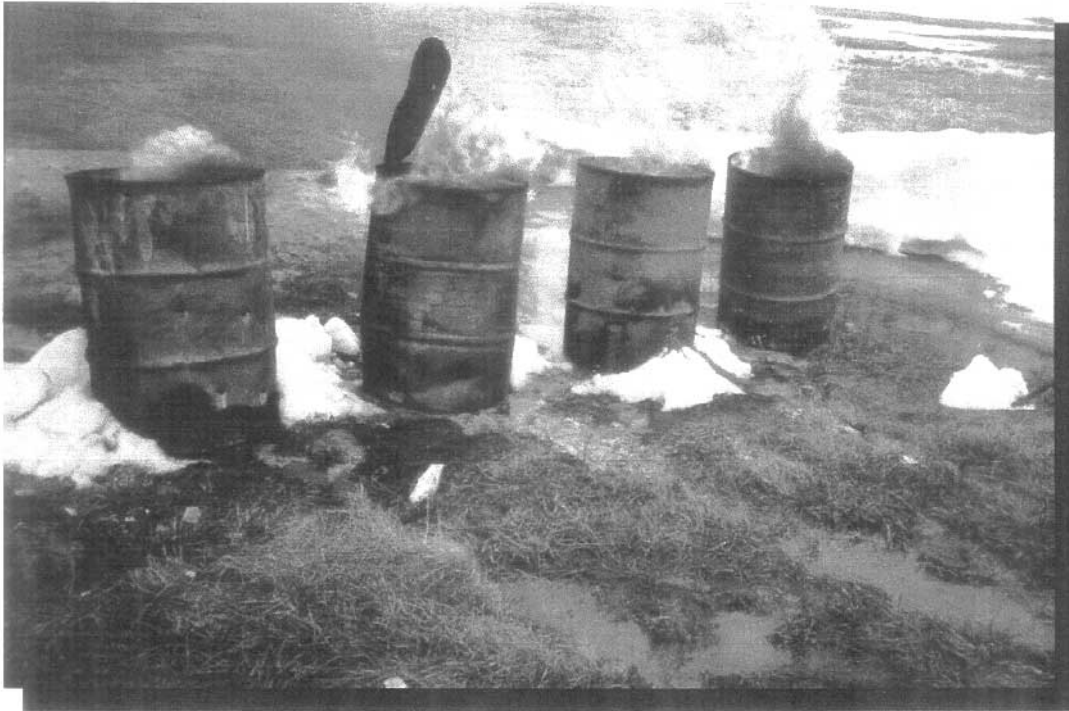
**Photo 5**  
Incineration of used hydrocarbon-absorbent material.

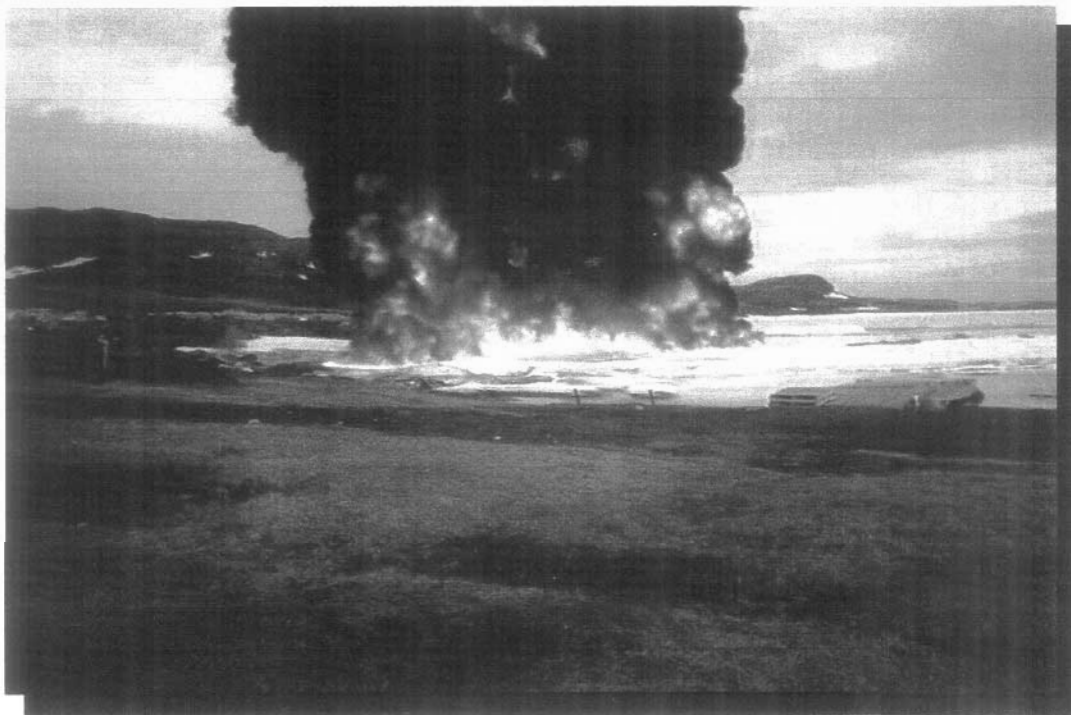
**Photo 7**  
In situ incineration of liquid hydrocarbons on surface of water.

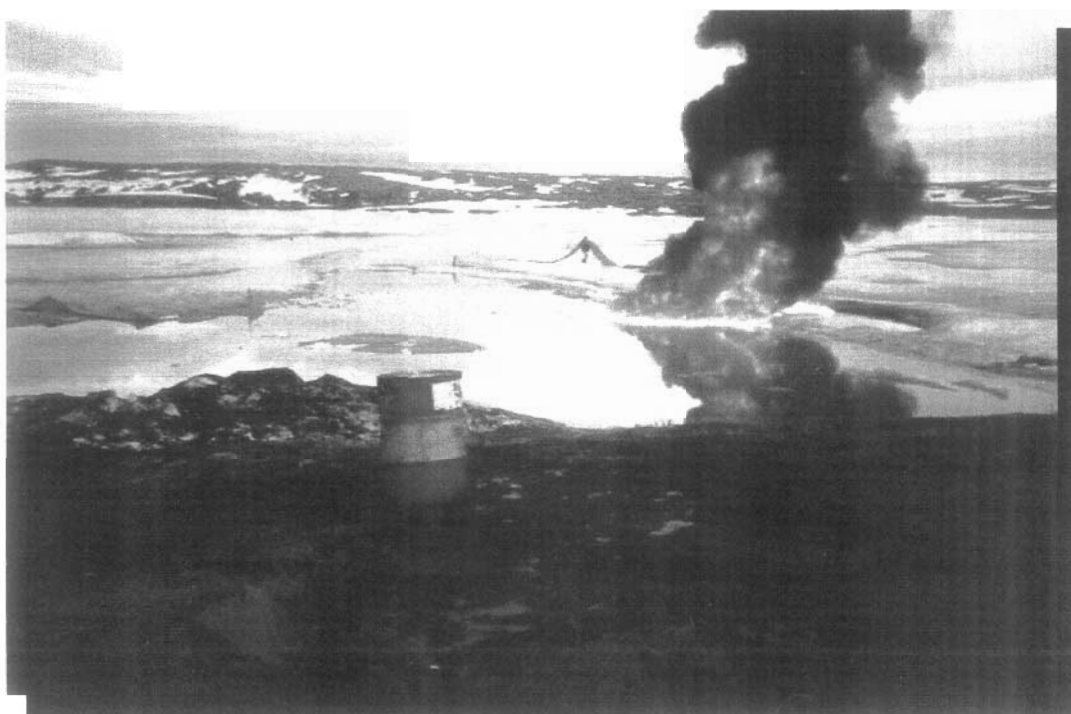
**Photo 8**  
In situ incineration of liquid hydrocarbons on surface of water.

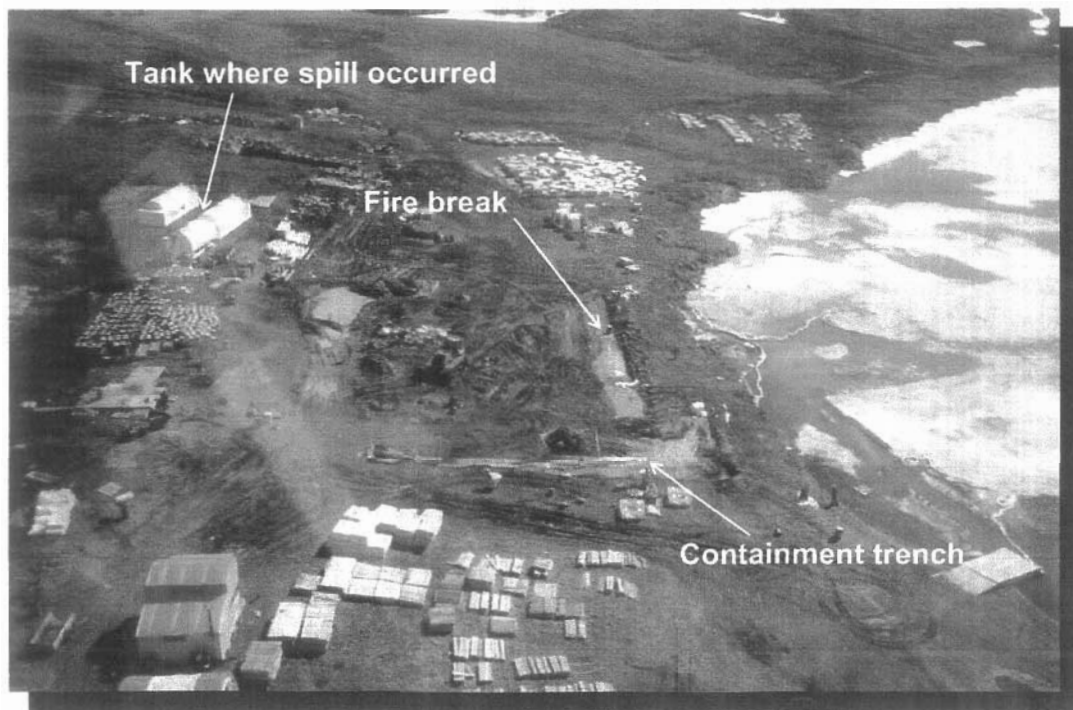
**Photo 10**  
Aerial photo of spill area.

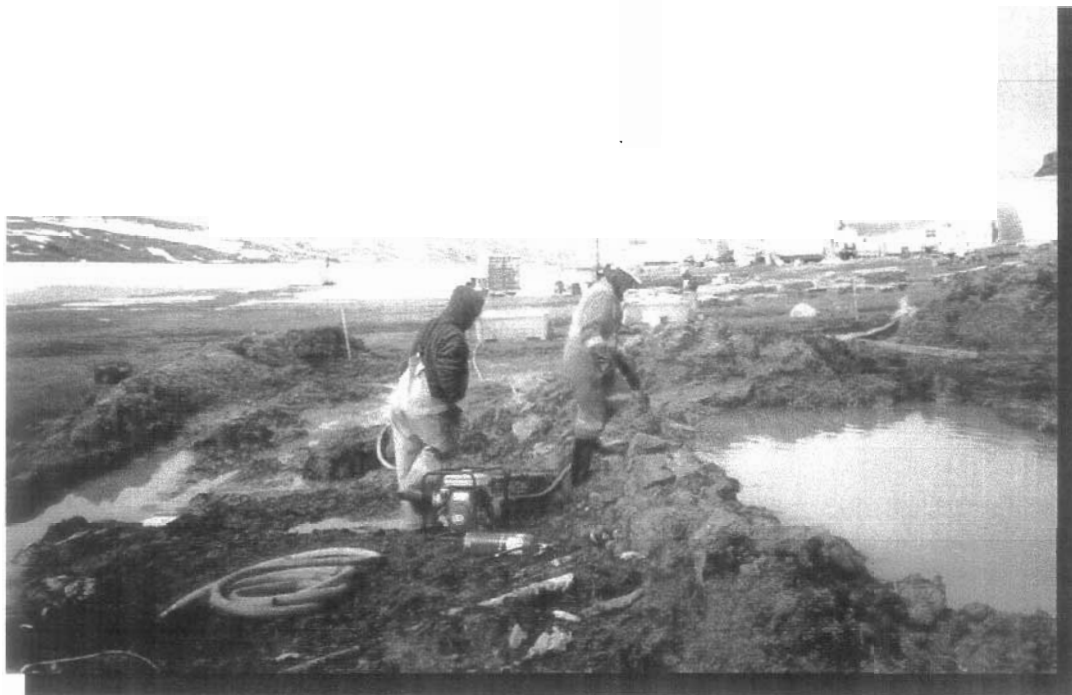
**Photo 11**  
Removal of water within firebreak for treatment and disposal.

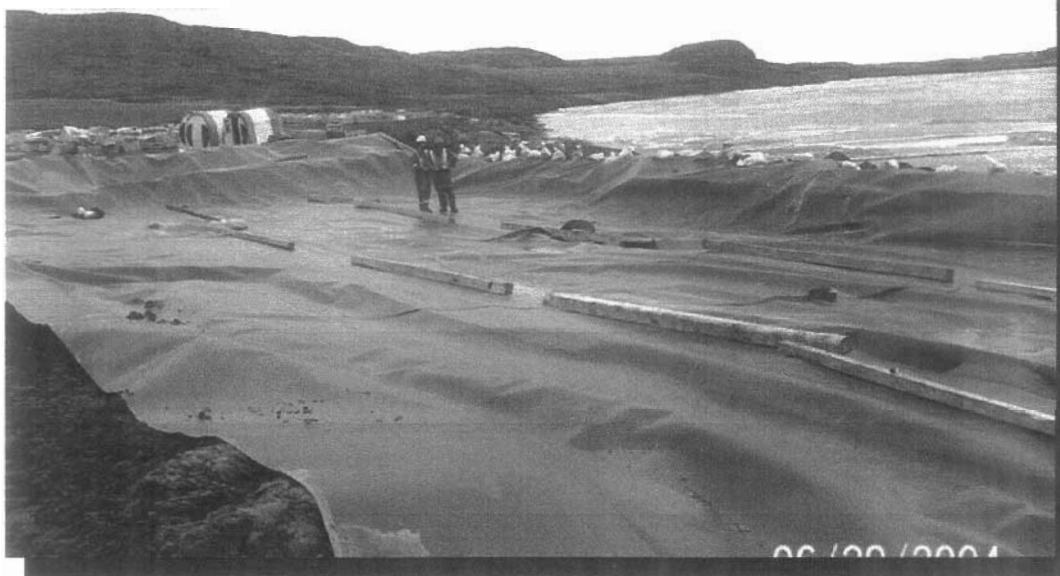
**Photo 15**  
Land treatment area.

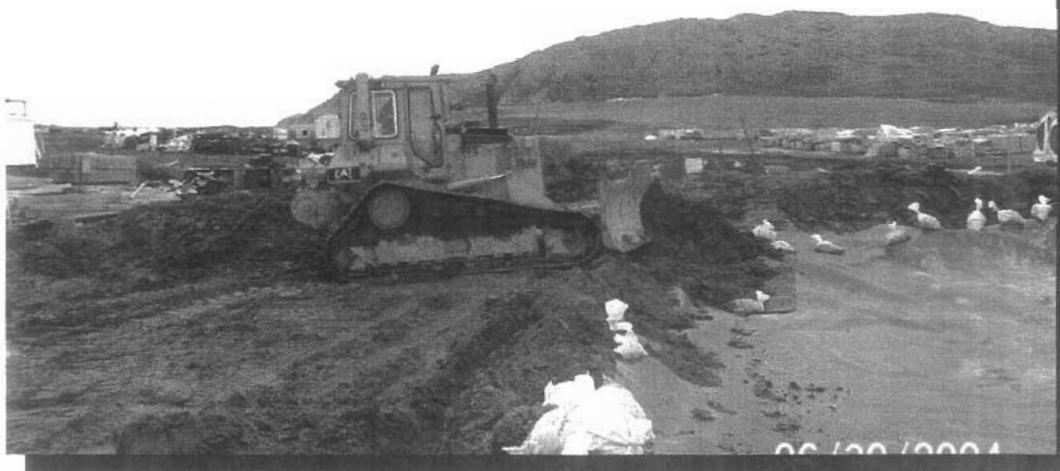
**Photo 16**  
Placement of impacted soil within land treatment area.

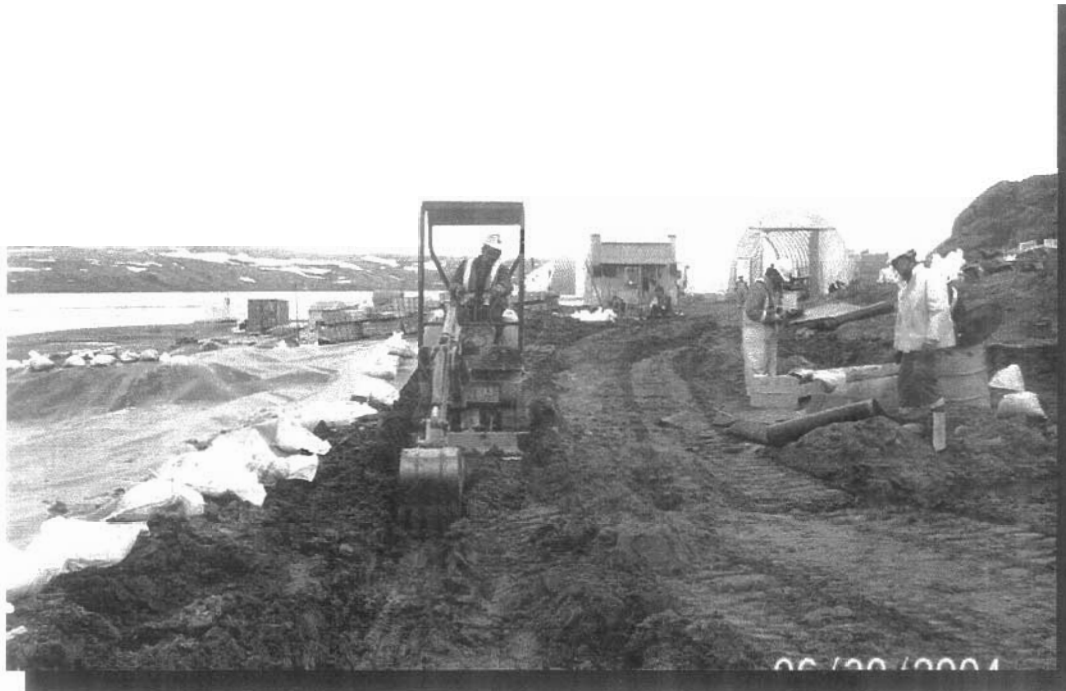
**Photo 17**  
Excavation of drainage trench around land treatment area.

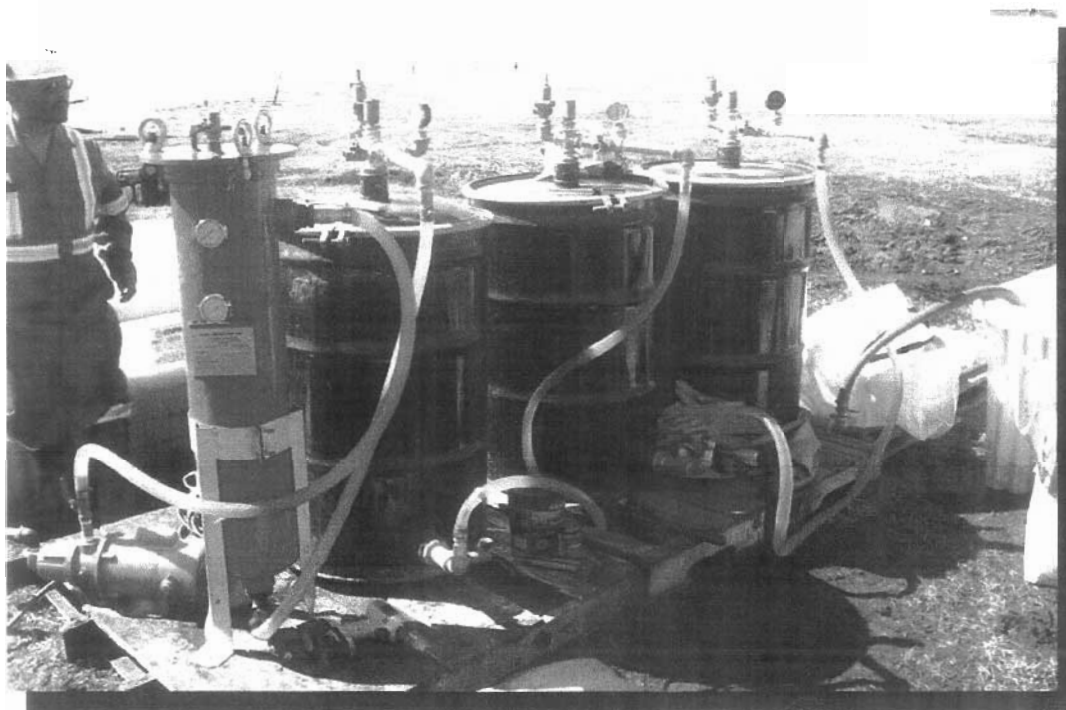
**Photo 18**  
Water treatment system.
