Hope Bay Project Patch Lake Facility Final Closure Plan

Hope Bay, Nunavut, Canada

Hope Bay Mining Ltd.

January 2011

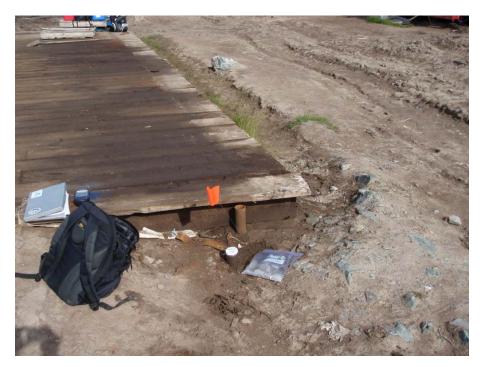
Photo 3: Southeast corner of the former mechanical shop foot print. Sample PLF09-SS-083 in the foreground. Significant PHC staining found throughout the foot print.

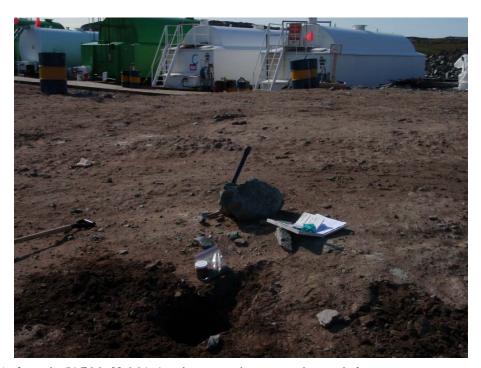
Photo 4: Sample PLF09-SS-001. Looking southwest at the tank farm

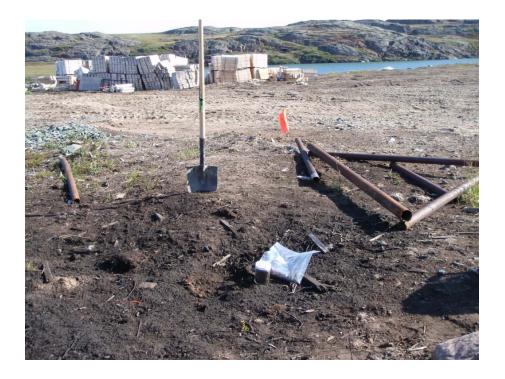
Photo 5: Sample PLF09-SS-077. There was a stain with oily odour present in the area.

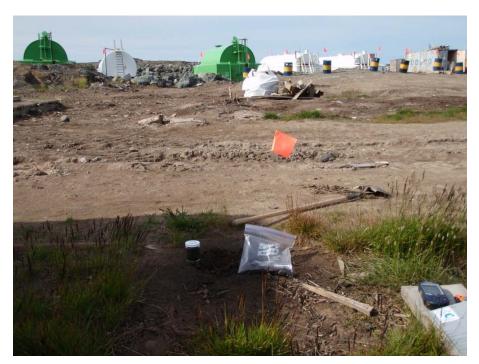
Photo 6: Sample PLF09-SS-082. Looking west with dark brown staining $(1.5 \, \text{m X } 1.5 \, \text{m})$ where the sample was collected in the foreground. Strong odour present.

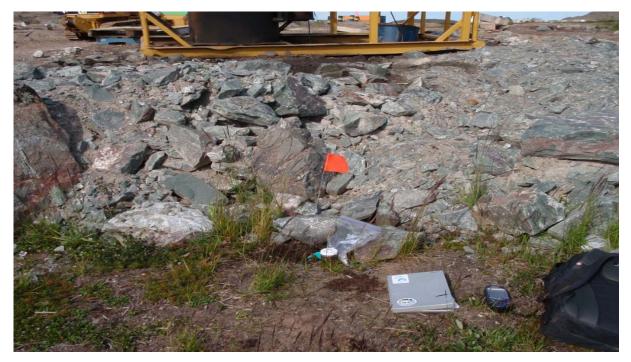
Photo 7: Sample PLF09-SS-084 collected south of the incinerator. There was hydrocarbon staining with sparse vegetation in the area.

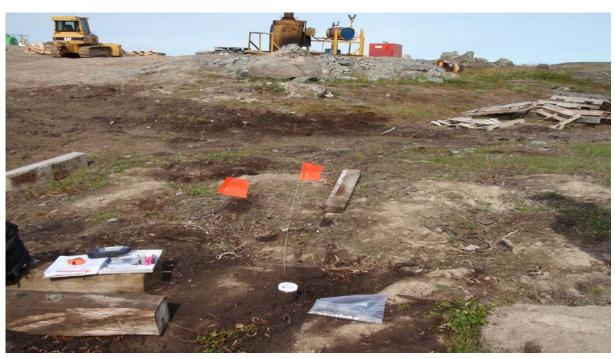
Photo 8: Sample PLF09-SS-085 collected in Area 4. There was a 2.5m by 2.5m stain observed in the area.

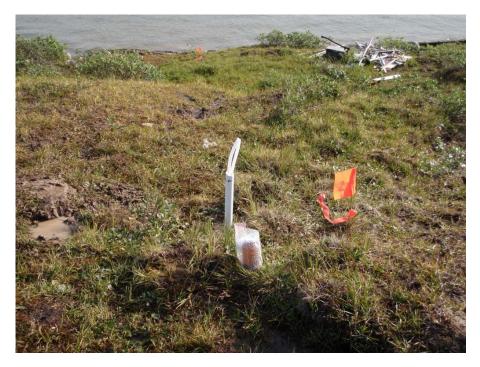
Photo 9: PMW -1 and Sample PLF 9-SS-038. PMW-2 installed in a drainage course downgradient of Areas 3 & 4.

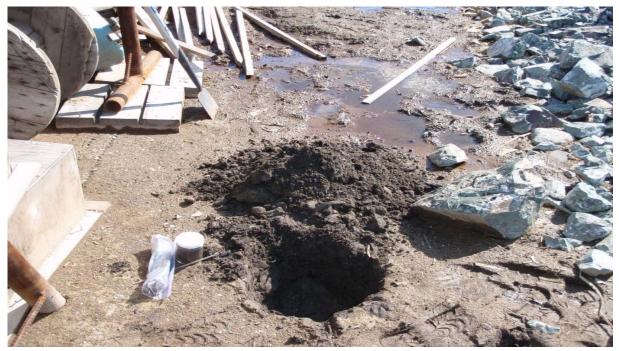
Photo 13: Sample WLF09-SS-026 at Area 1 Southwest of Former Tank Farm. There was hydrocarbon odour with anoxic conditions at the bottom of the test pit. Black stains visible around the area.

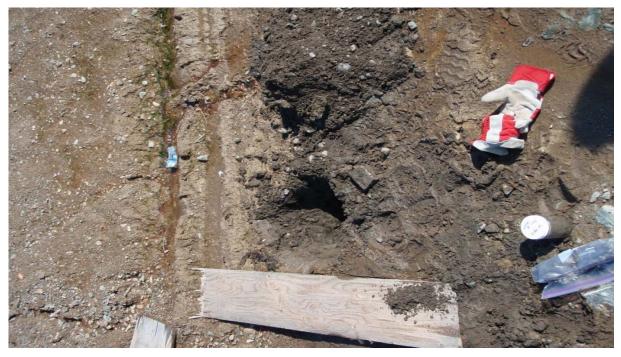
Photo 14: Sample WLF09-SS-024. West of the Former Tank Farm immediately down gradient.

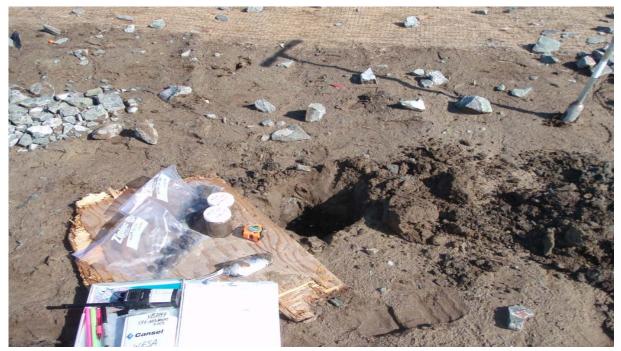
Photo 15: Sample WLF09-SS-20/21. No Staining, odour or sheen was observed in the area.

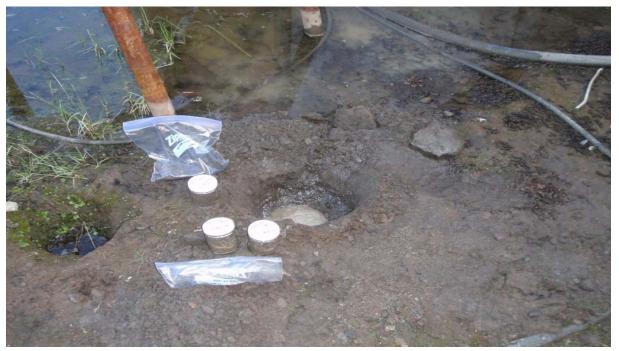
Photo 17: Samples WLF09-SS-29/30/31. Strong hydrocarbon odour observed in the area.

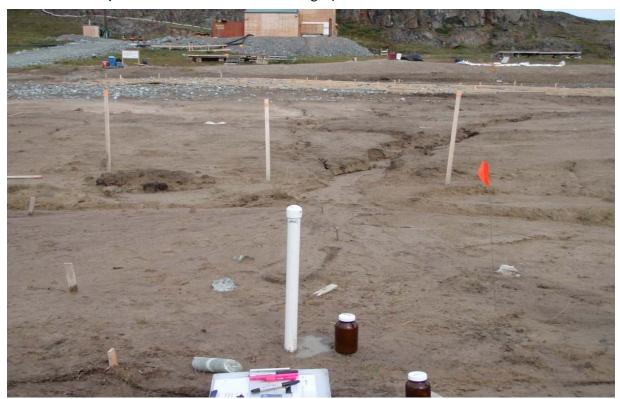
Photo 18: Groundwater Monitor WMW-1.
