**Windy Camp, Nunavut Diesel Fuel Spill Assessment and Remediation report,
EBA 2004**

Windy Camp, Nunavut

Diesel Fuel Spill Assessment and Remediation

SPILL ASSESSMENT AND REMEDIATION WINDY CAMP, NUNAVUT

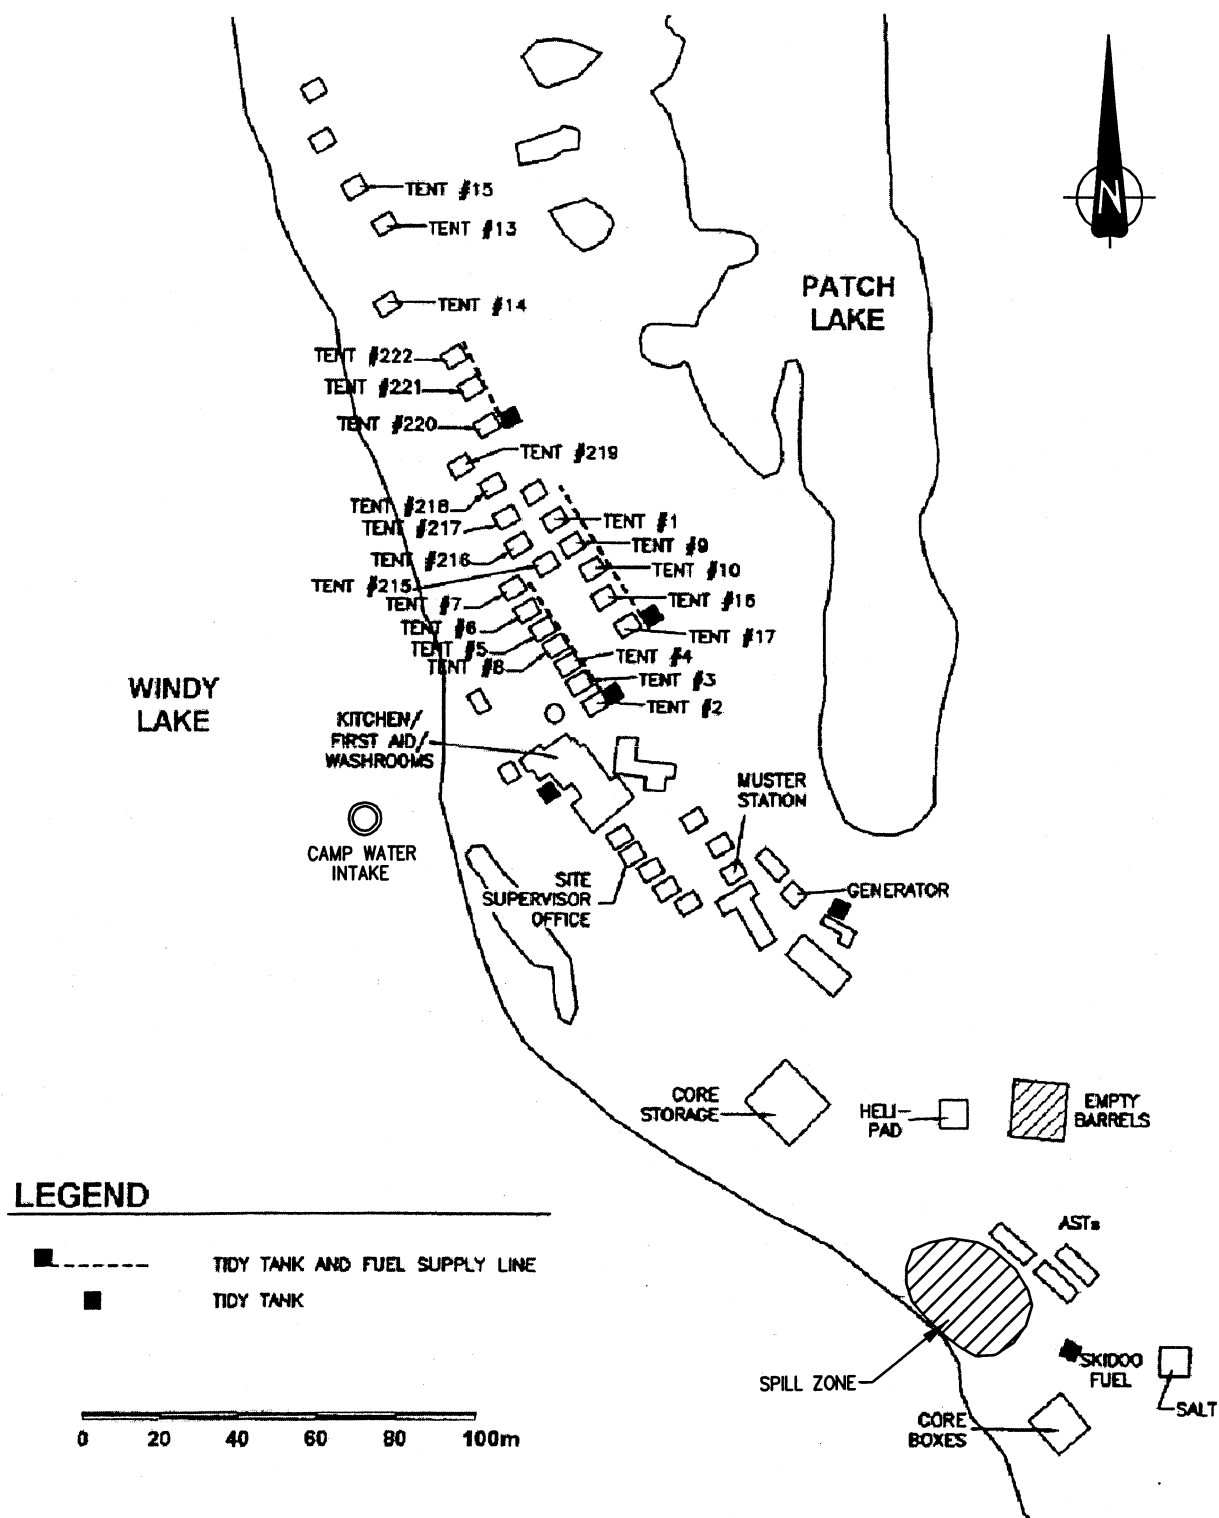
Figure 2
Site Plan
Windy Camp Site

A site plan depicting the layout of the camp is presented in Figure 2. The northern portion of the camp consists of a series of tents and wooden structures that comprise the sleeping and eating quarters. The camp has the capacity to accommodate approximately 100 personnel. Located immediately south of the sleeping quarters are a series of tents

and wooden structures used for offices and a core logging area. Three above-ground storage tanks (AST), containing diesel fuel, are located south of the offices and have a capacity of 50,000 and 70,000 litres. A barrel storage area (approximately 200 drums of Jet-B fuel) is located to the northeast (upslope) of the ASTs. A second area, southeast of the ASTs, is used for storage of approximately 80 barrels of gasoline.

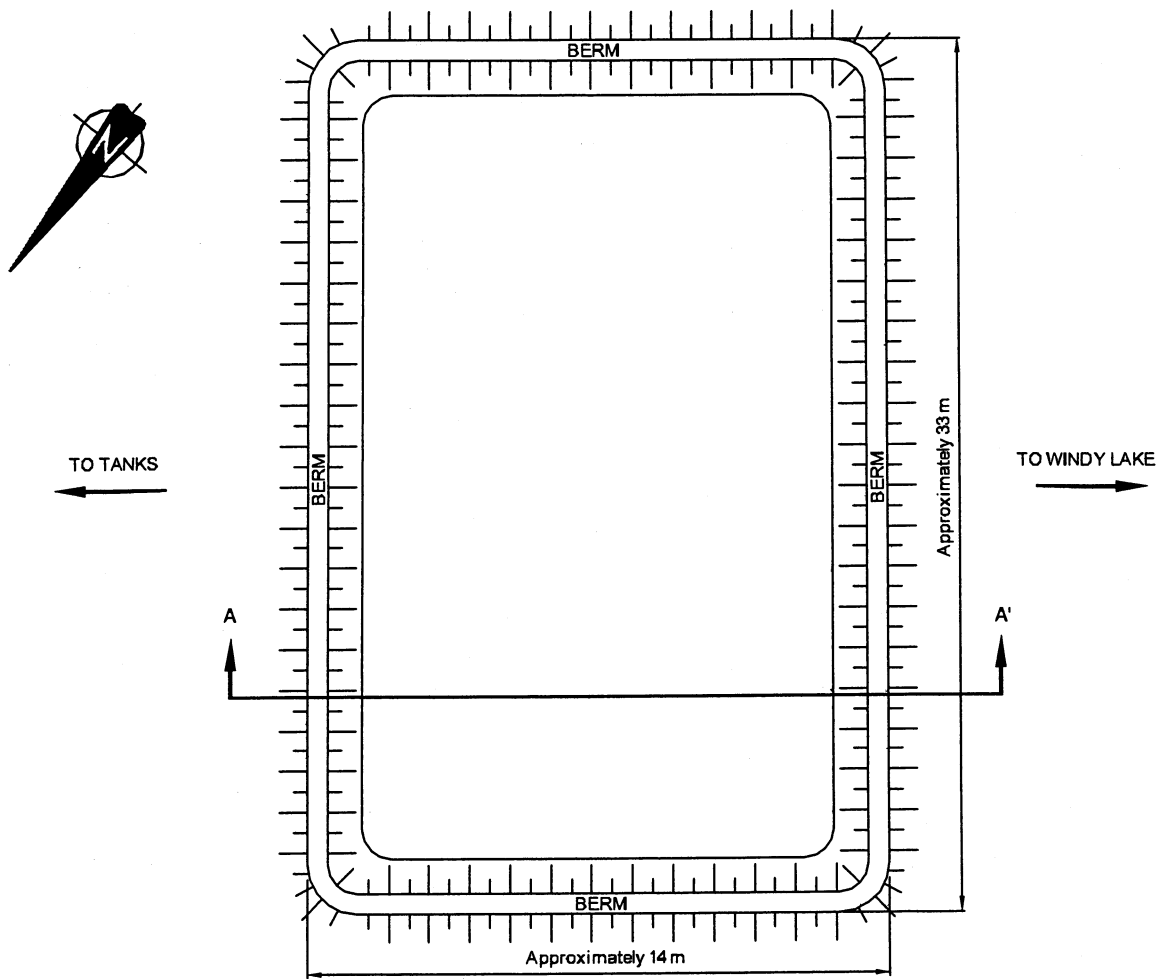
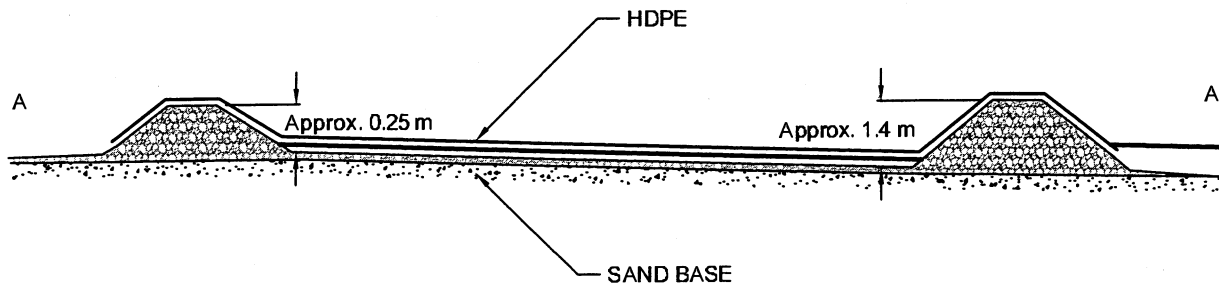
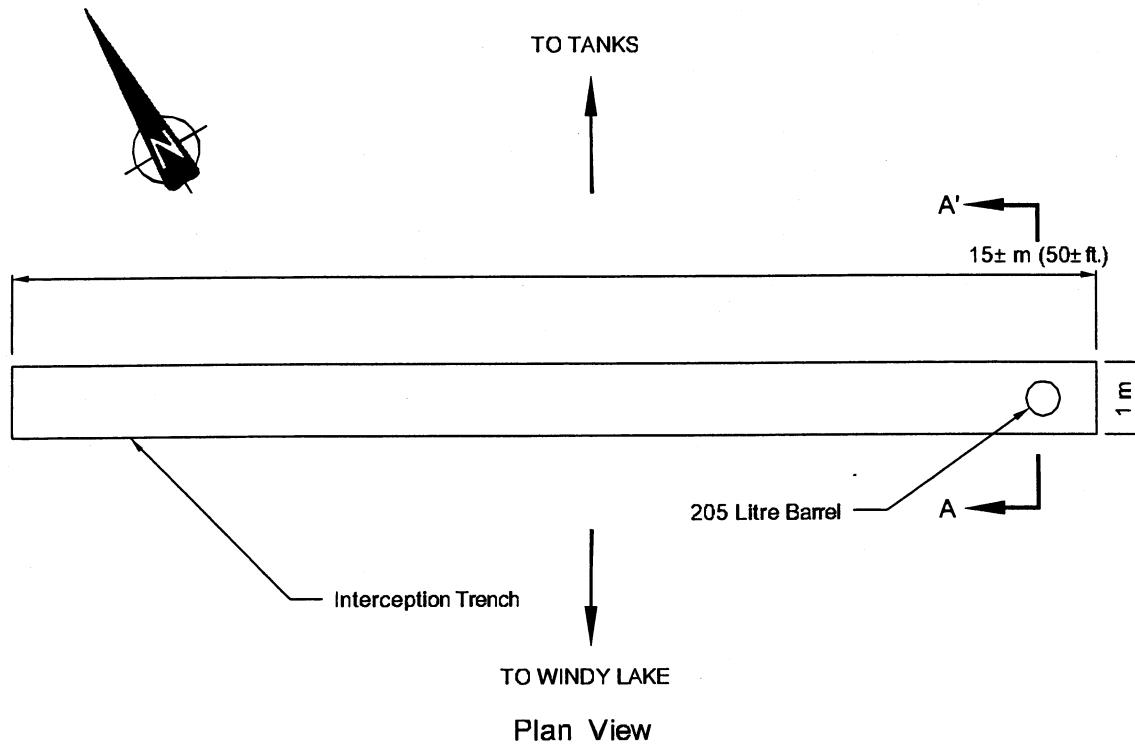
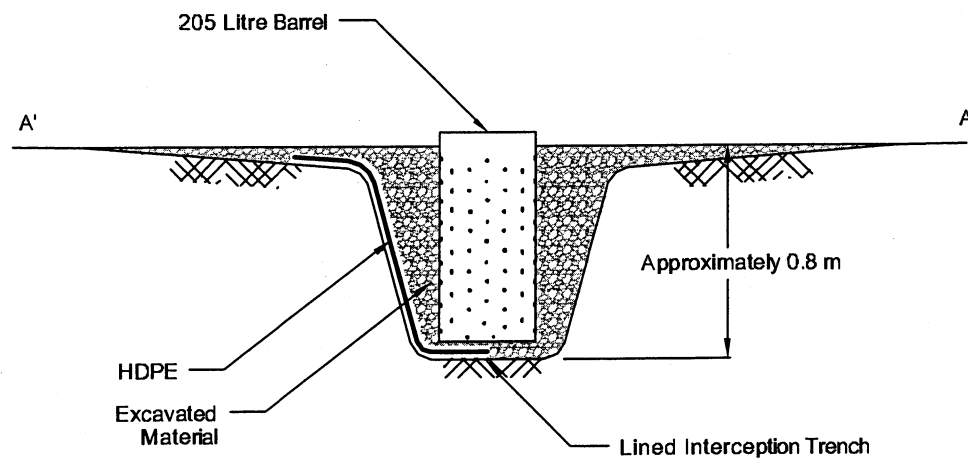
Figure 4
As Built of
Land Treatment Area

Plan View

Cross-Section A-A'

The land treatment area (LTA) was constructed by borrowing material within the footprint of the stripped area. The construction of the berms for the LTA required the removal of an additional 20 cm (approximate) of soil. The LTA was lined using 60 mil high density polyethylene (HDPE) liner underlain by native soil consisting of silty sand. The surficial area of the land treatment area (inside corners used for measurement) is 600 m². Approximately 100 m³ of hydrocarbon-impacted soil was placed into the LTA.

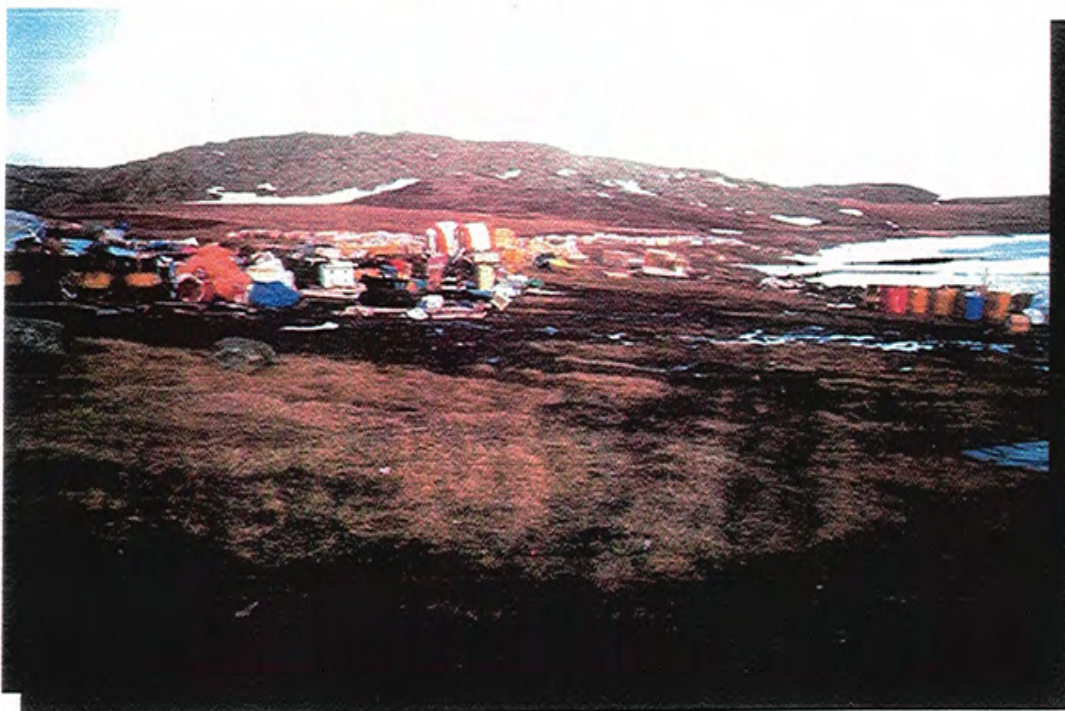
Photo 1
Spill area at the time of EBA's arrival.

EBA personnel (Messrs. Brent Murphy and Steven Taylor) arrived on-site at approximately 6:30 p.m. on Thursday June 17, 2004. Upon arrival, a site walkover was conducted to assess the spill incident. The following observations were made:

- Booms, containment barriers and absorbent pads had been installed on the frozen lake surface around melt-water pools.
- Approximately 0.25 cm to 6 cm of free diesel fuel was present on the nearshore ice surface and melt-water pools of Windy Lake, within the area of the containment booms.

- The thickest area of diesel fuel was located on the southwest side of the containment area (approximately 10% of the total area) as a result of wind blowing from the northeast.

- Solid lake ice was present around and below the melt-water pools containing free diesel fuel.
- Containment booms were installed at the edge of the ice, surrounding the diesel fuel.

- Barrels and plastic basins, full of diesel/water saturated absorbent pads, were located on the ice and shoreline surrounding the containment area.
- Several drainage interception trenches, approximately 10 cm deep, were excavated on the bank with absorbent booms installed within.

- Soil with diesel fuel odours was found to be present, extending from the 50,000 litre AST to the shoreline area located down-gradient.
- The spill pathway appeared to pass directly below a collection of stored debris and drums located on-site.

- Water with noticeable hydrocarbon sheen was observed draining (at a rate of less than one litre per minute) into the lake outside of the containment area.

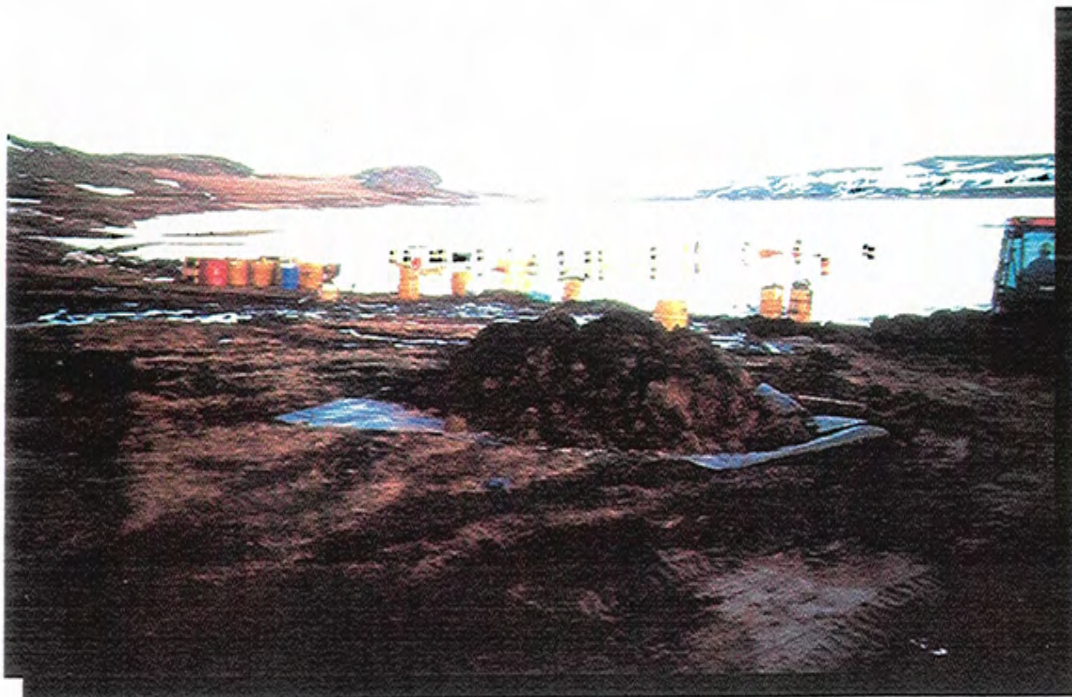
Photo 2
Spill area hours after EBA's arrival.

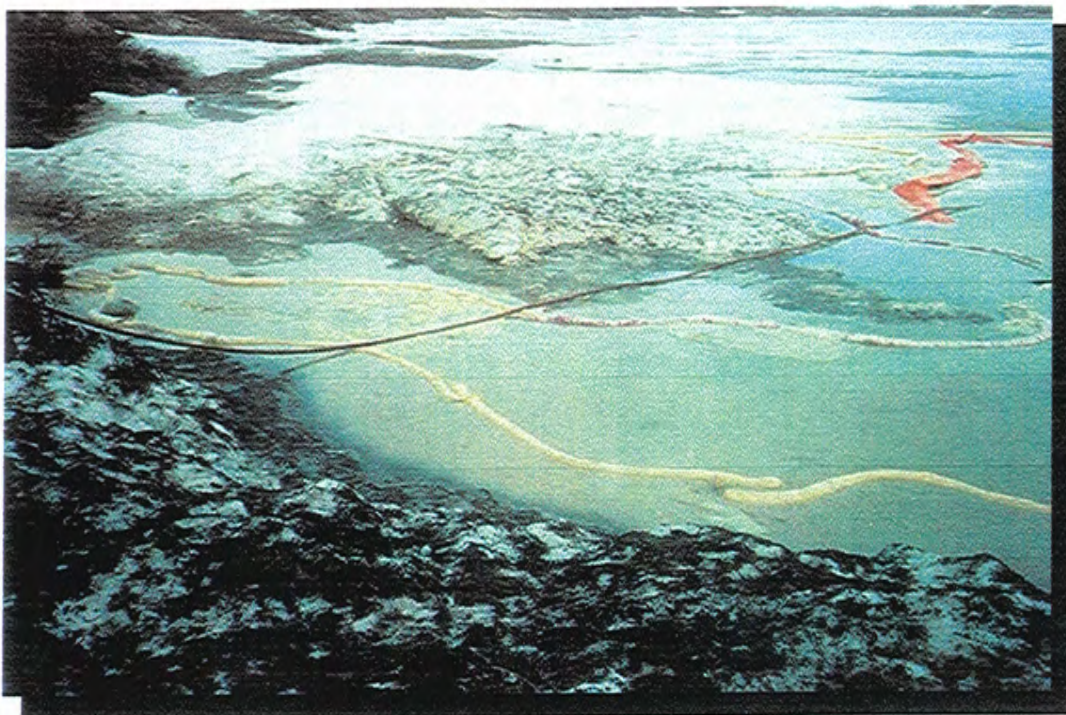
Photo 3
Water surface prior to in situ incineration.

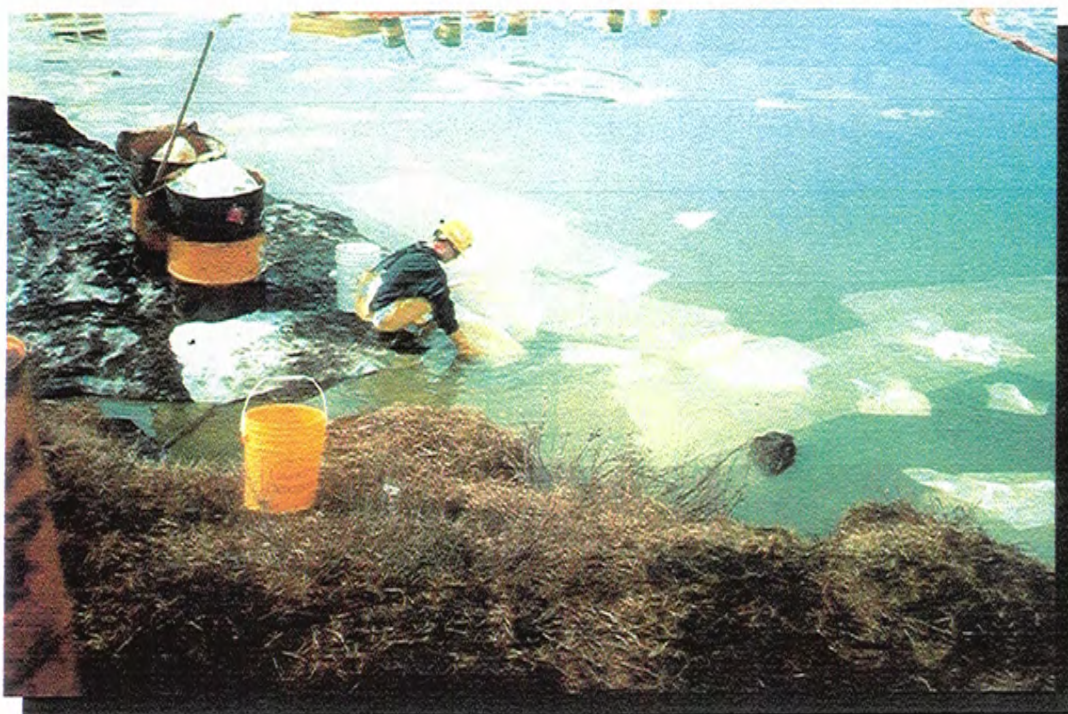
Photo 4
Removal of liquid hydrocarbon, using absorbent pads, prior to in situ incineration.

Free diesel fuel was manually recovered using absorbent pads placed on the surface of the melt-water pools. Coffee cans were also used to skim the diesel fuel from the surface of the melt-water pools and the recovered product was placed into 205 litre barrels for future treatment and

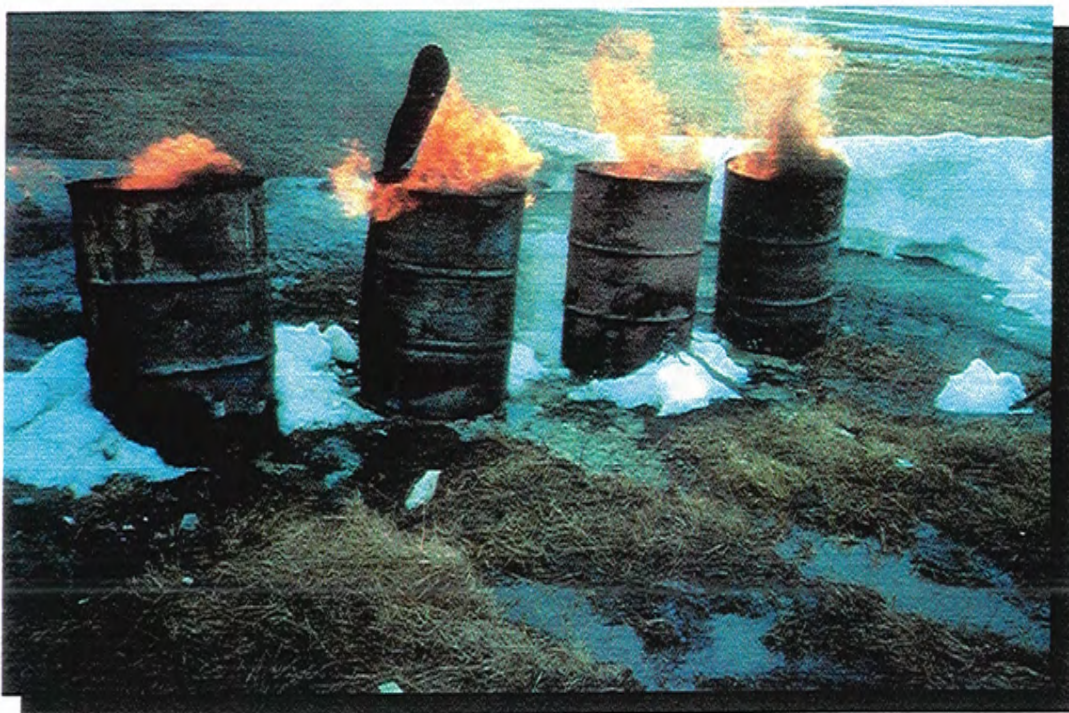
Photo 5
Incineration of used hydrocarbon-absorbent material.

In addition, approximately 1,000 absorbent pads and 25 absorbent booms were incinerated. Some free product was manually removed from the surface of the melt-water on the ice prior to incineration. Approximately 1,550 litres of diesel fuel was recovered in this manner and stored onsite in above ground tanks. Thus, in total, approximately 8,250 litres of free diesel fuel was recovered by physical means.

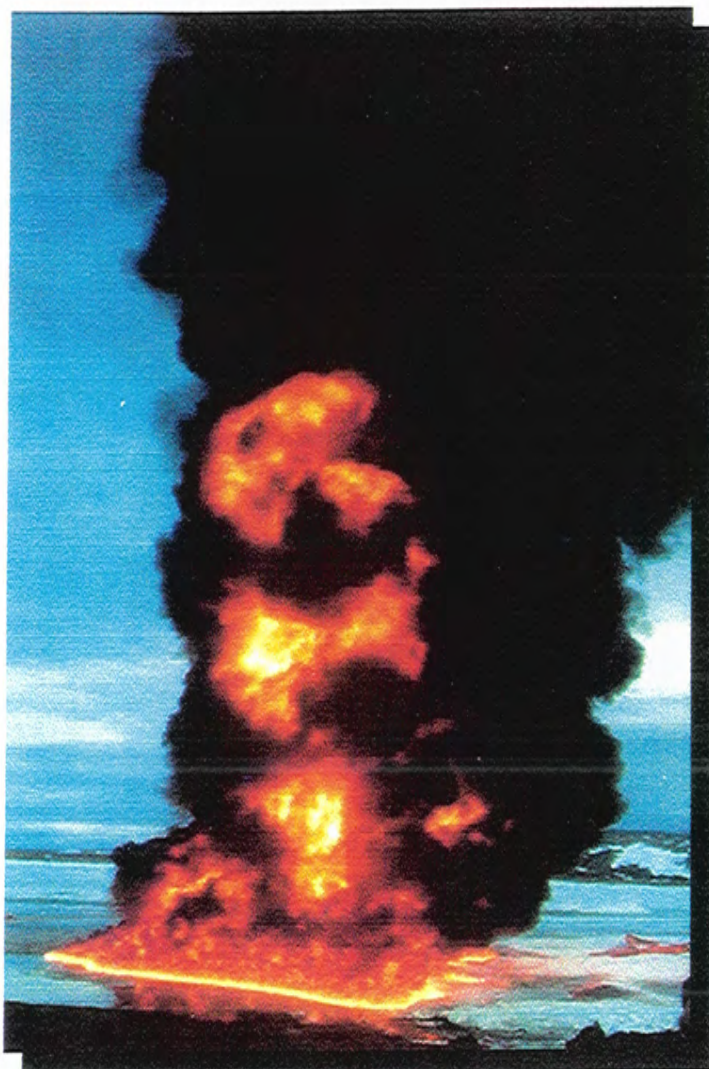
Photo 6

In situ incineration of liquid hydrocarbons on surface of water.

At 12:30 a.m. on June 20, 2004, after obtaining authorization from the on-site regulatory authorities, and when the environmental conditions were observed to be ideal, the free diesel fuel present in the contained melt-water pool area located on the frozen lake surface was ignited. The initial point of ignition was located along the northwest perimeter of the contained area. Following ignition, the flames swept over the entire containment area at a rate of approximately 125 cm per minute and terminated at the western corner, by the shoreline, at 1:30 a.m. on June 20, 2004. Based on the estimated surveyed area (1,100 m²) and the observed heating oil thickness (0.25 to 0.5 cm average) in the melt-water on the lake ice surface, the approximate volume of free diesel fuel product that was consumed during incineration was estimated at between 2,750 to 5,500 litres.

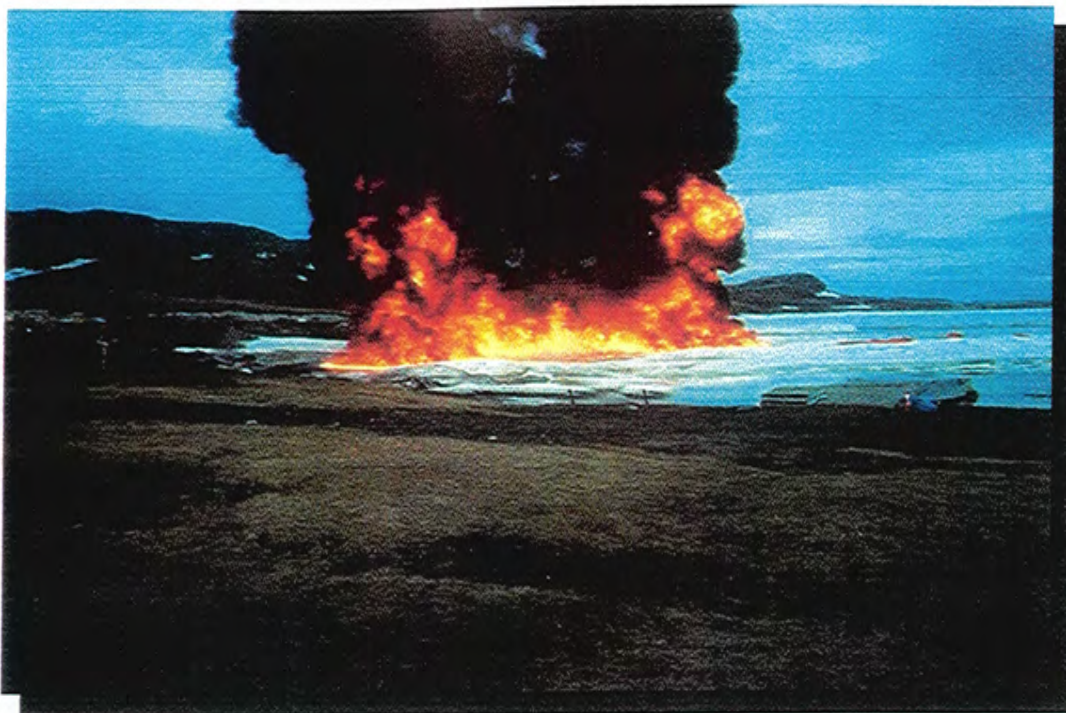
**Photo 7**

In situ incineration of liquid hydrocarbons on surface of water.

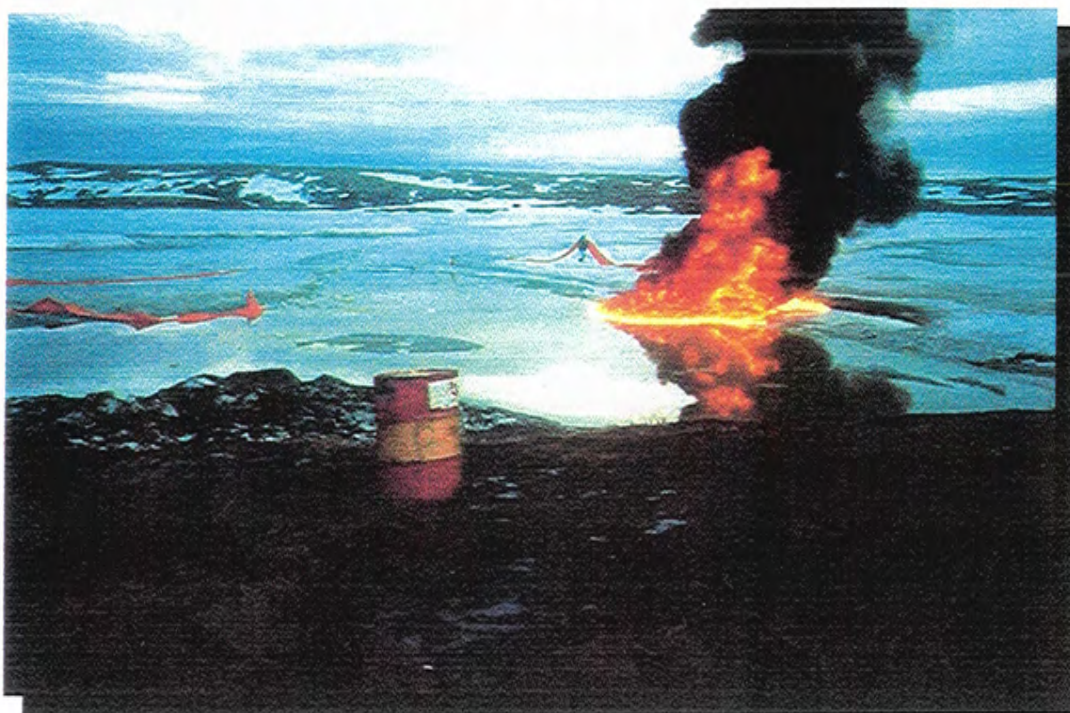
**Photo 8**

In situ incineration of liquid hydrocarbons on surface of water.

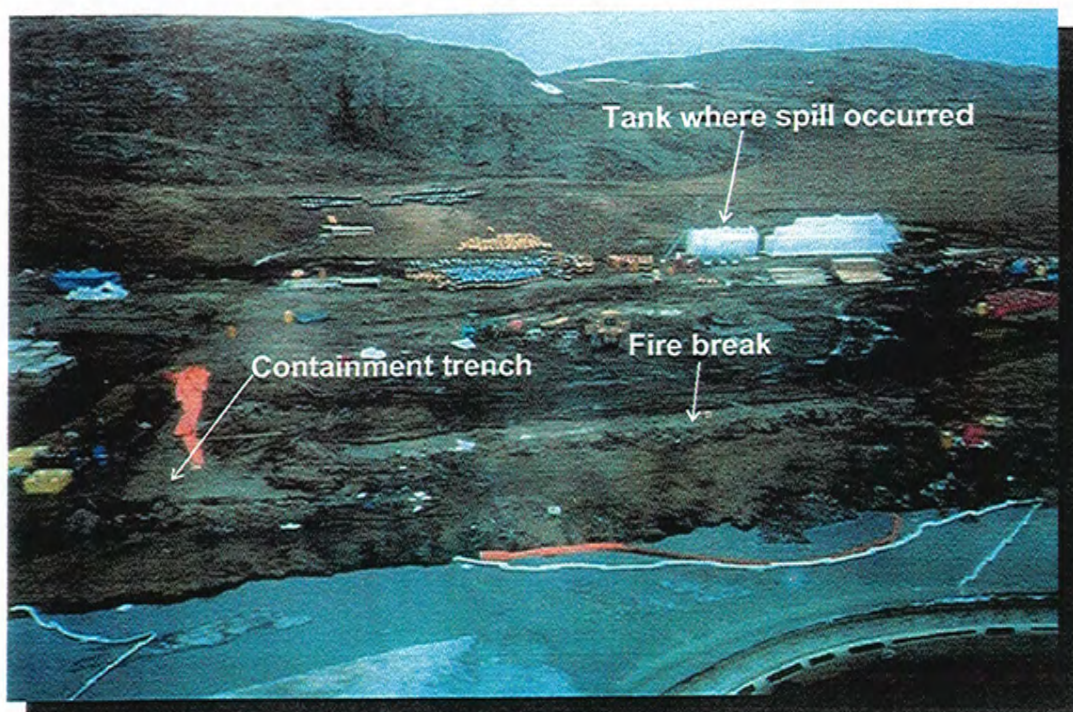
Photo 9
Aerial photo of spill area.

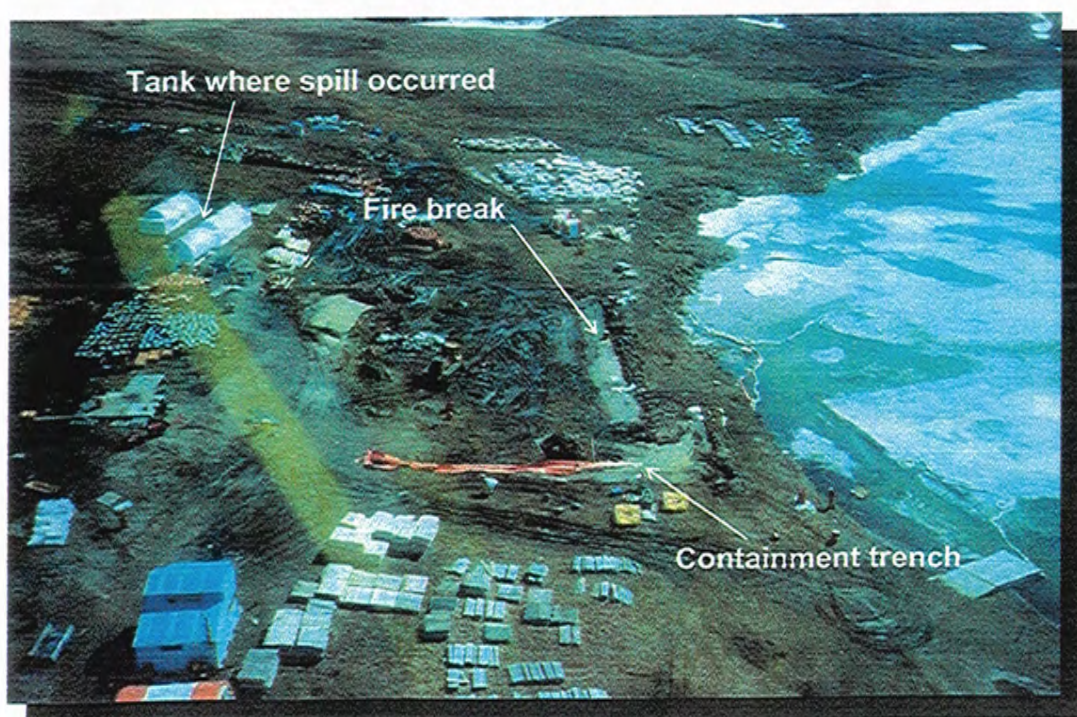
Photo 10
Aerial photo of spill area.

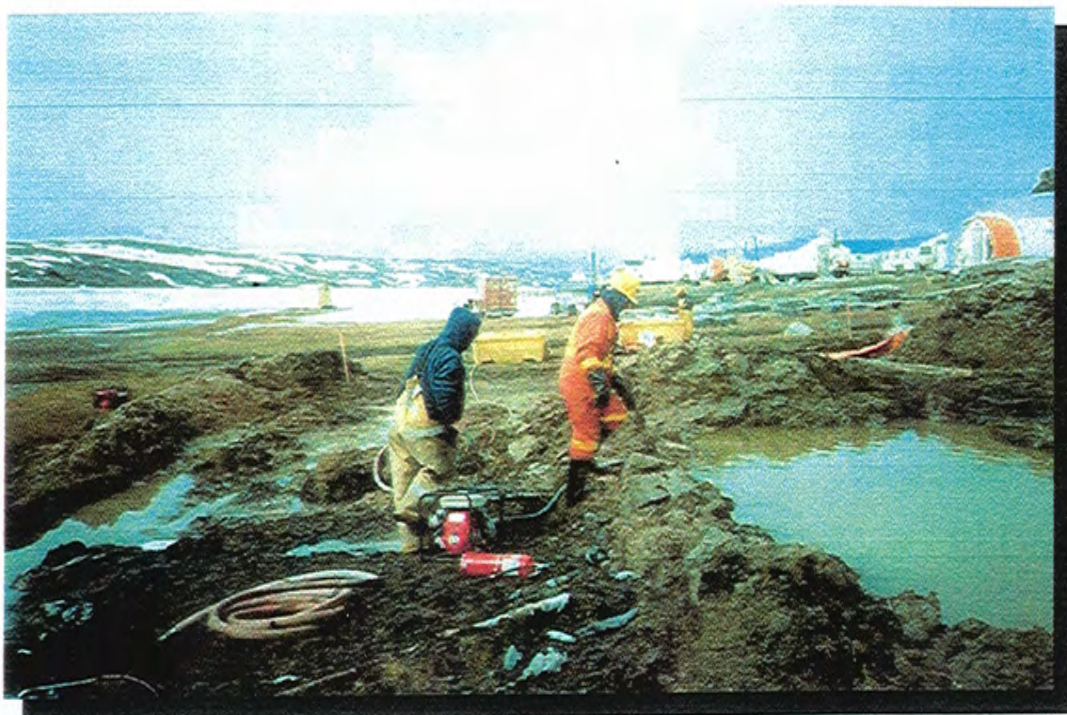
Photo 11
Removal of water within firebreak for treatment and disposal.

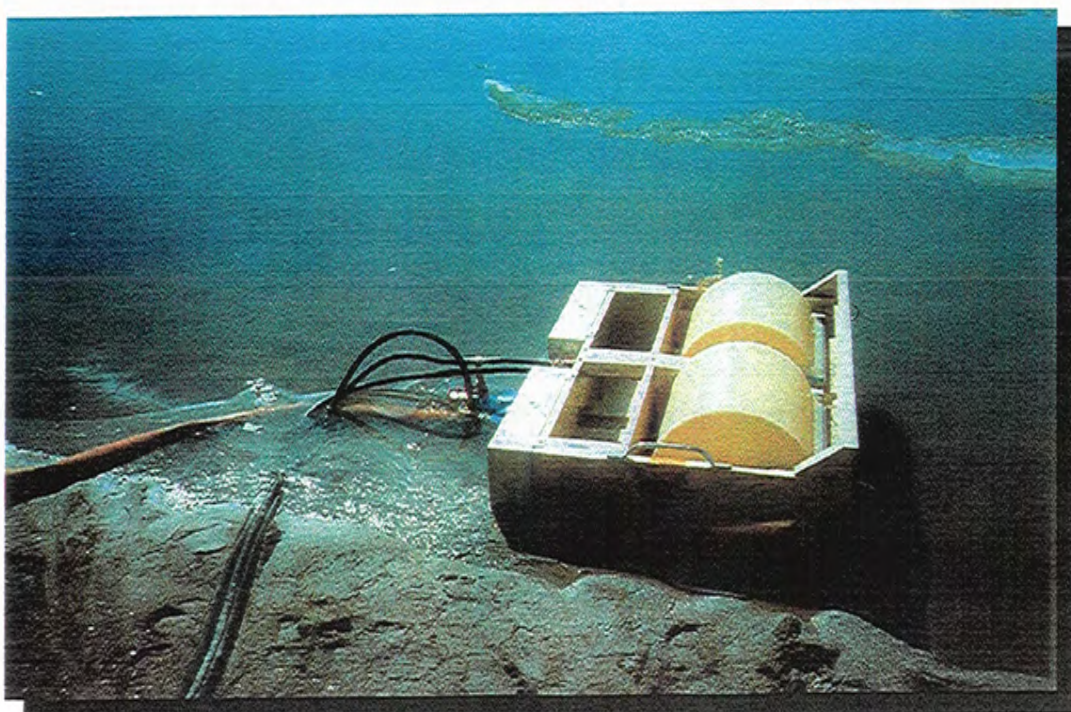
Photo 12
Skimmer used for attempted removal of liquid hydrocarbons on surface of water.

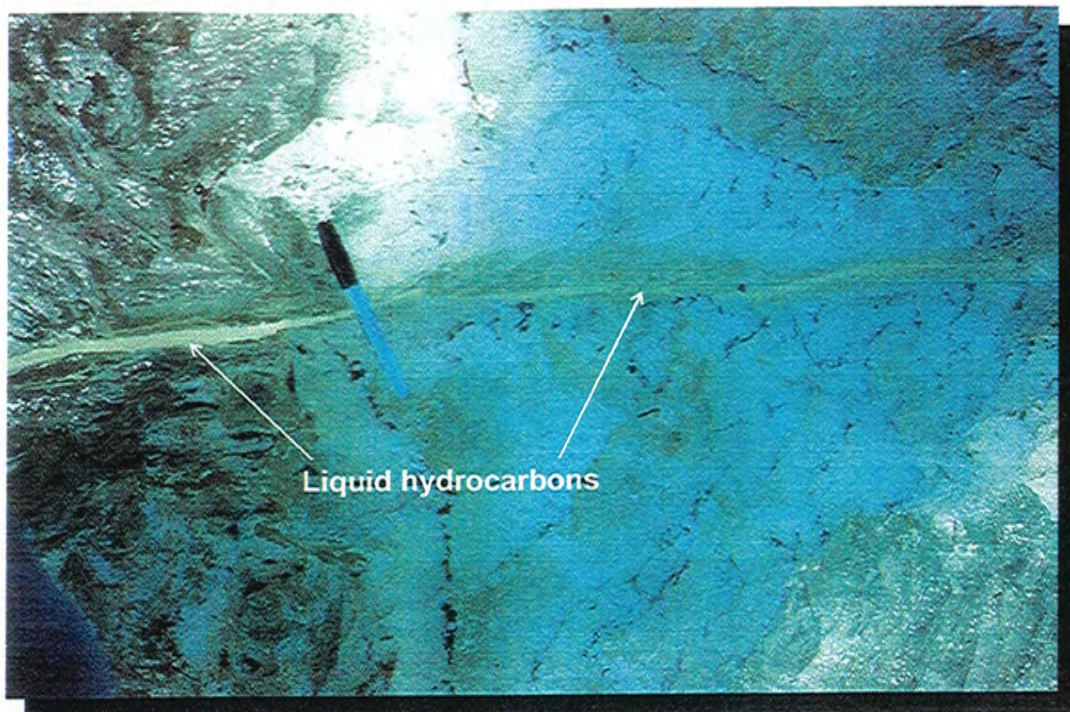
Photo 13
Liquid hydrocarbons within cracks of ice.

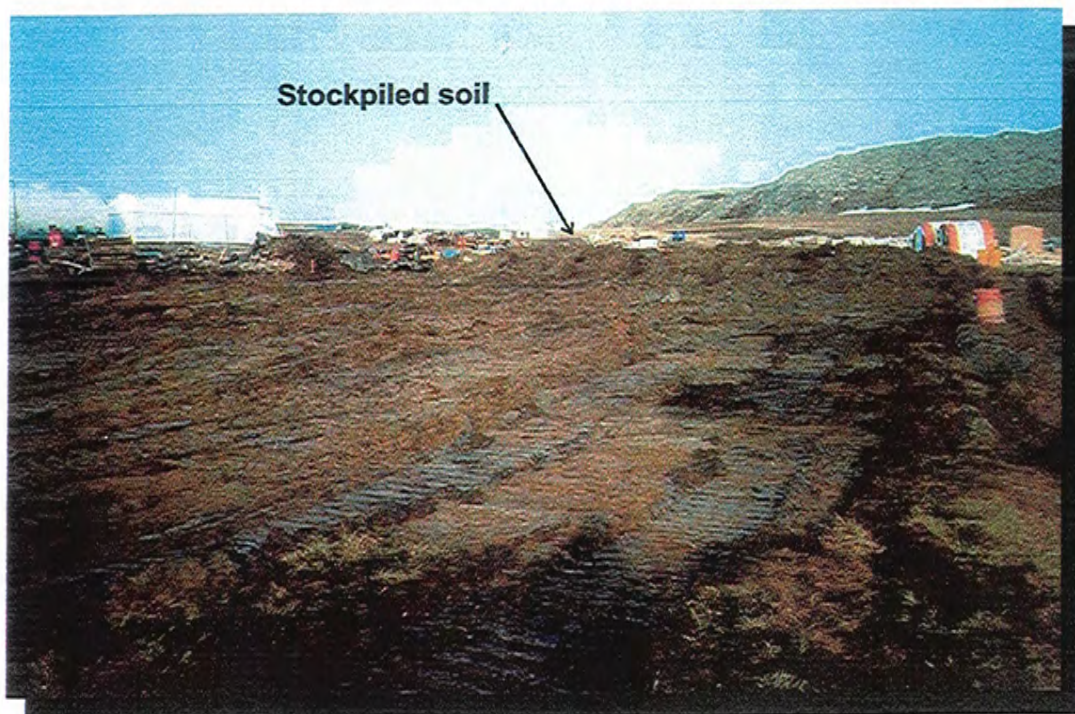
Photo 14
Spill area with impacted soil removed and stockpiled.

The hydrocarbon-impacted soil was stripped from the area where hydrocarbon odours and staining were detected. The soil was stripped using a D5 CAT Dozer to an approximate depth of 10 cm below surface grade where frozen ground was encountered.

Soil with noticeable hydrocarbon impacts surrounding the tanks was not excavated due to the proximity of the tanks and the concern that, by removing the material, the soil stability would be compromised and result in damage to the tank. A composite soil sample from the tank farm area was collected from four sub-sample locations, randomly chosen, to determine the amount of residual hydrocarbons in the vicinity of the tanks. A soil sample was also collected from a location where the diesel fuel on the soil appeared to be most concentrated (worst case2). The samples were submitted, as described in Section 3.3, for laboratory analysis of BTEX and PHC F1 to F4 concentrations.

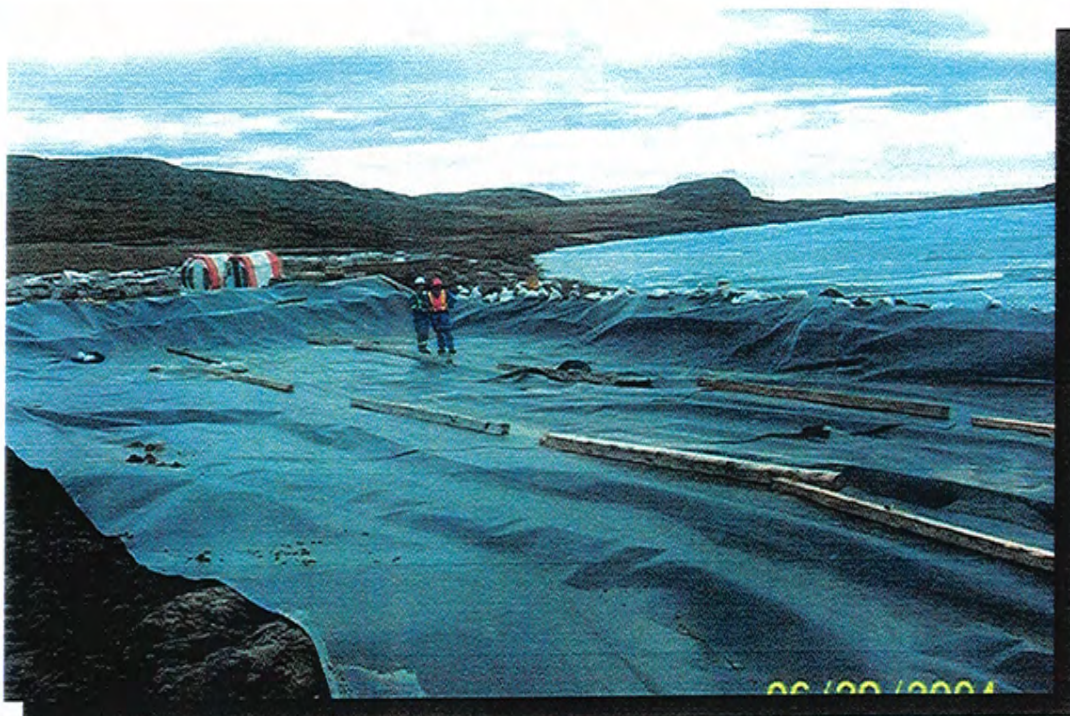
Photo 15
Land treatment area.

Soil within the LTA should be cleared of all large objects, segregated based on the date the material was placed in the LTA, and periodically aerated to promote remediation.

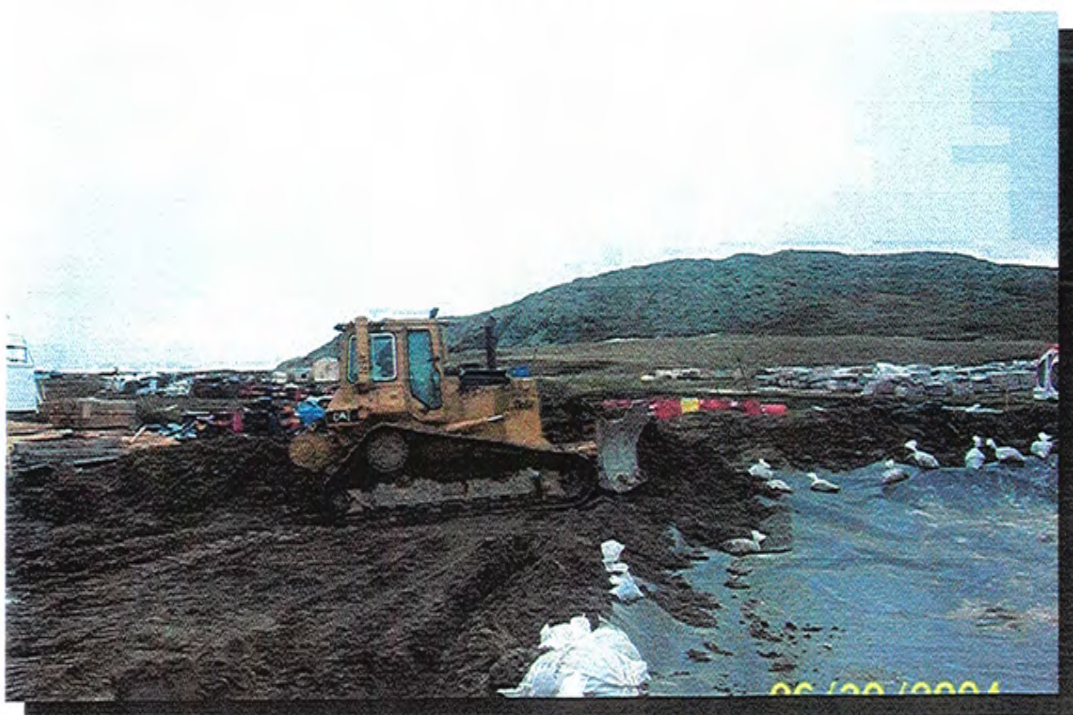
Photo 16
Placement of impacted soil within land treatment area.

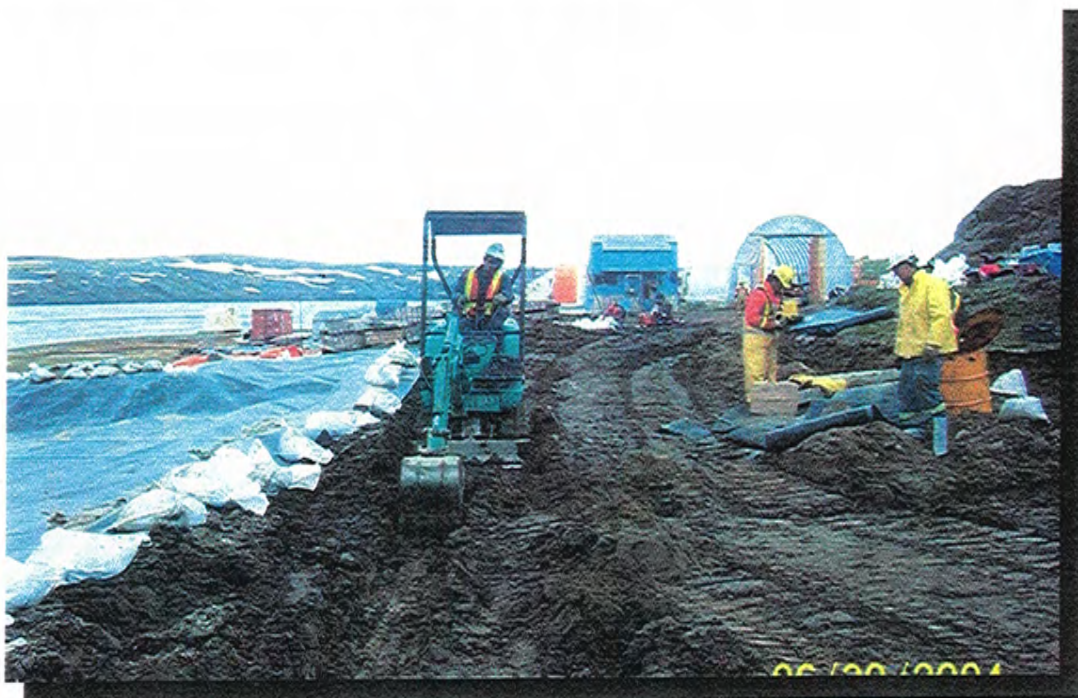
Photo 17
Excavation of drainage trench around land treatment area.

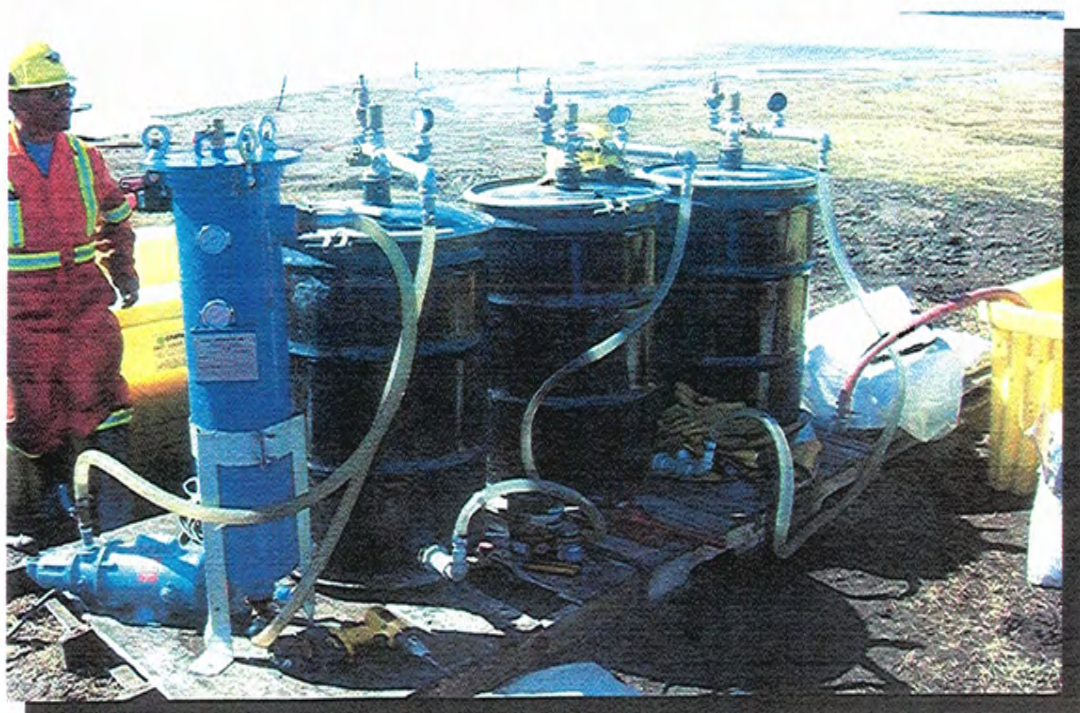
Photo 18
Water treatment system.

All spent media from the water treatment unit was placed within the LTA as recommended by the supplier.
