# MIRAMAR HOPE BAY LIMITED

**Subject: April 2006 Monthly Report for Water License: NWB2HOP0207**

Appendix B: Pictures of AST Tanks placed in Patch Lake lined secondary fuel containment area, April 2006

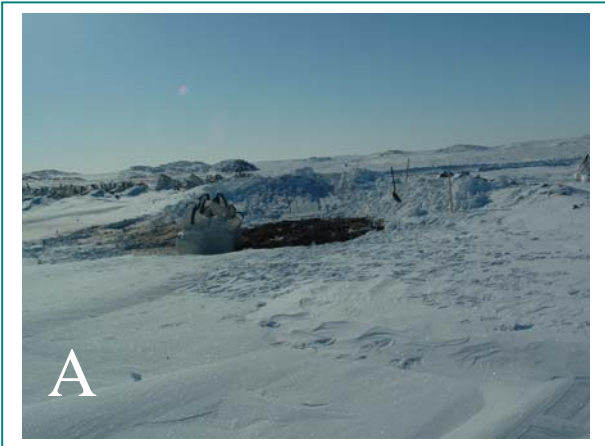
Photograph A: Preparing first sand pad. Photograph B: First AST tank (50,000 L) placed on the pad within the farm.

In the absence of sufficient materials in 2005 to cover the whole liner (300 m<sup>3</sup>), the option was to partially cover surveyed areas within the berm required for individual storage tank placement. The material required to complete this task was calculated to be 165 m<sup>3</sup>. Infilling between tanks will be done when suitable material becomes available overtime.

Work commenced on the Patch Lake secondary containment sand pads on April 12 and the project was completed on April 25 2006. Appendix B show photos taken at various stages of the project.

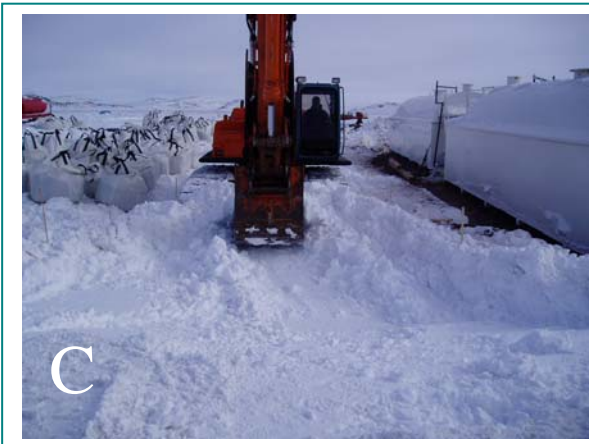
Photograph C: Removing snow with a backhoe. Photograph D: Spreading sand on the next pad before pulling a tank.

A backhoe fitted a specially designed mounting was used for snow removal. Care was taken at all times during this process by taking measurement using a wooden rod to measure snow depth as required. Final snow removal was by hand using shovels.

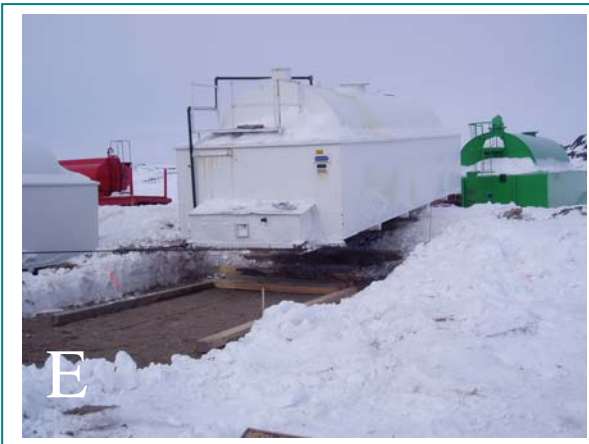
Photograph E: Pulling a 70,000 L AST tank onto the pad. Photograph F: All (8) AST tank placed onto the pads within the farm.

Snow ramps were built overnight over the berm to ensure it was compact and frozen to protect the liner from being damaged from the tracks of the heavy machineries and dragging of the tank.

A challenger was used to winch in the tanks while a backhoe was used as the anchor and to align the tanks. Once a tank was placed onto the pad, a hand jerk was used to lift the tank, which enabled leveling, and re-alignment of the timbers under the tank.
