Re: August 2022 – Monthly Monitoring Report for Water License 2BE-HOP2232

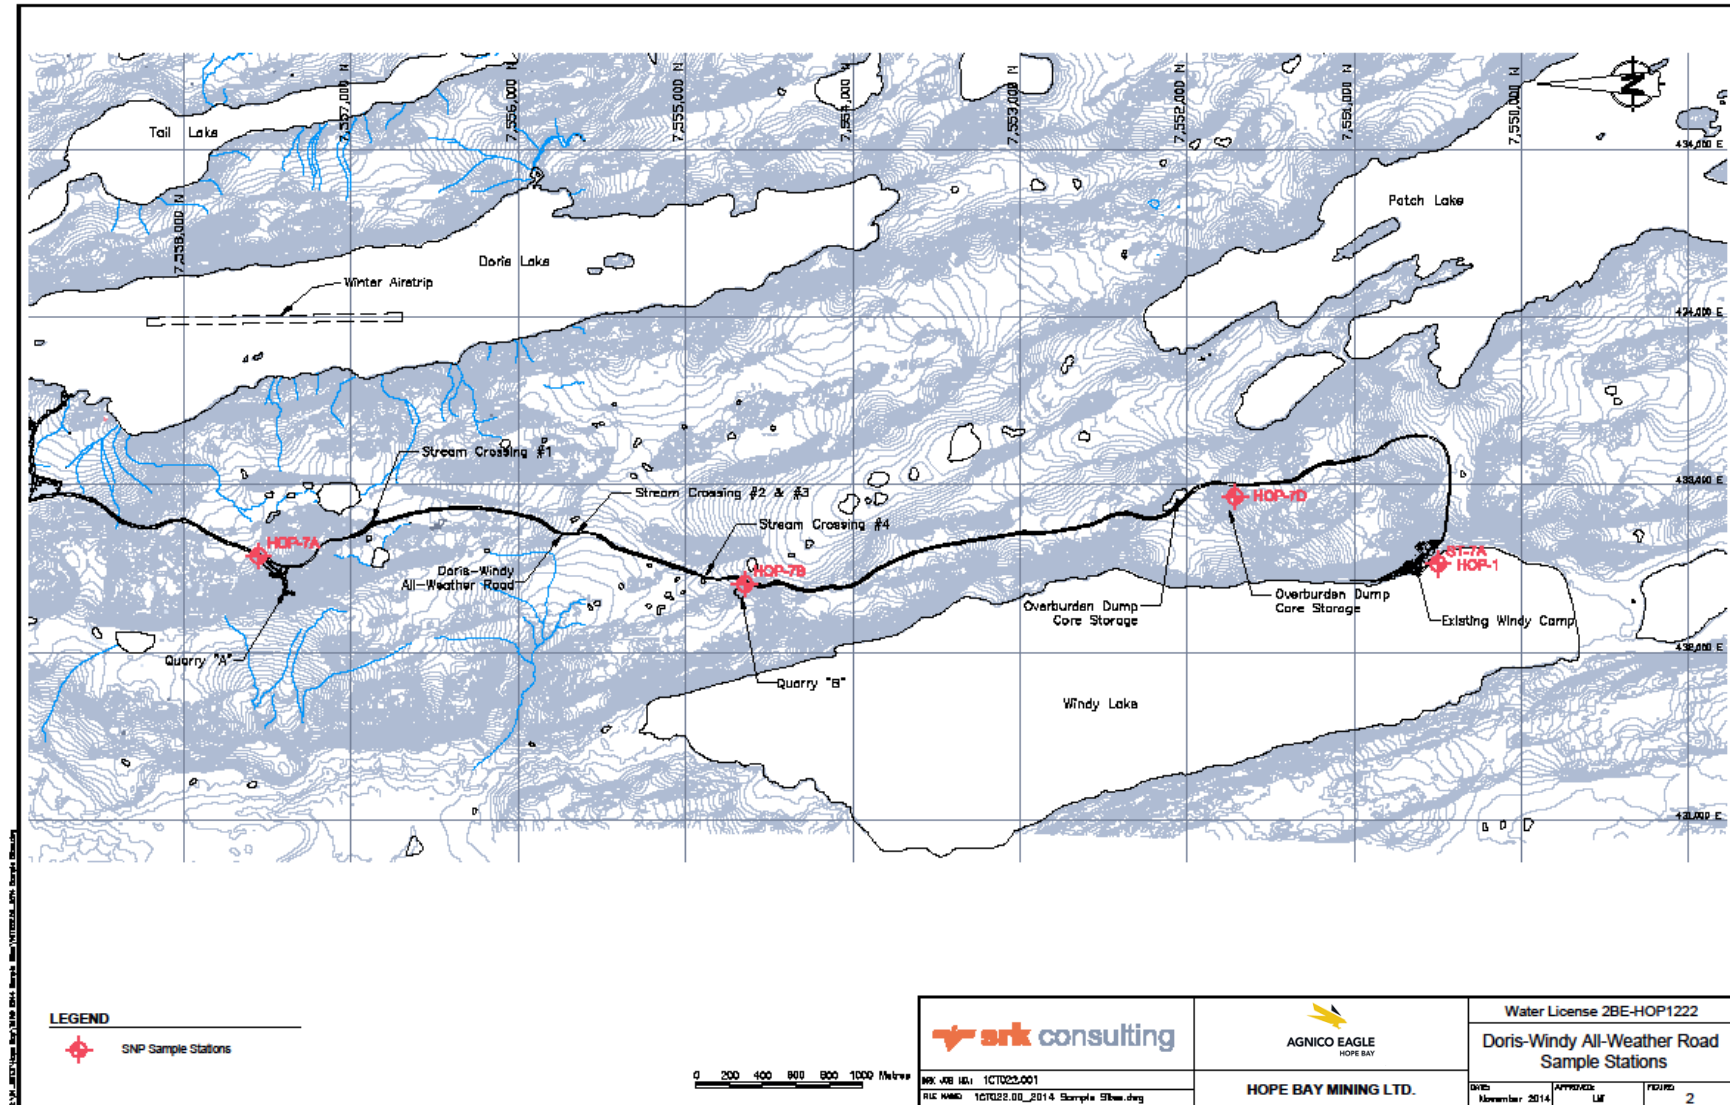
Figure 1. 2BE-HOP2232 SNP Monitoring Locations

This report is comprised of monitoring requirements as set out in Part J, Items 2 through 8, and 10 of water license 2BE-HOP2232. Some monitoring requirements stipulated in this Part refer to facilities that have not been constructed, facilities that no longer exist, or facilities where activity is seasonal. Water levels in Windy Lake will be monitored in accordance with Part J, Item 9 during open water season. Sampling locations monitored under this license (seasonally or when facilities are operational) are provided in Figure 1 at the end of this report.
