Re: April 2023 – Monthly Monitoring Report for Water License 2BE-HOP2232

During the period of this report, the focus of activities under the Windy Regional Exploration license was on-land surface exploration drilling, on-ice exploration drilling, water management and environmental compliance.

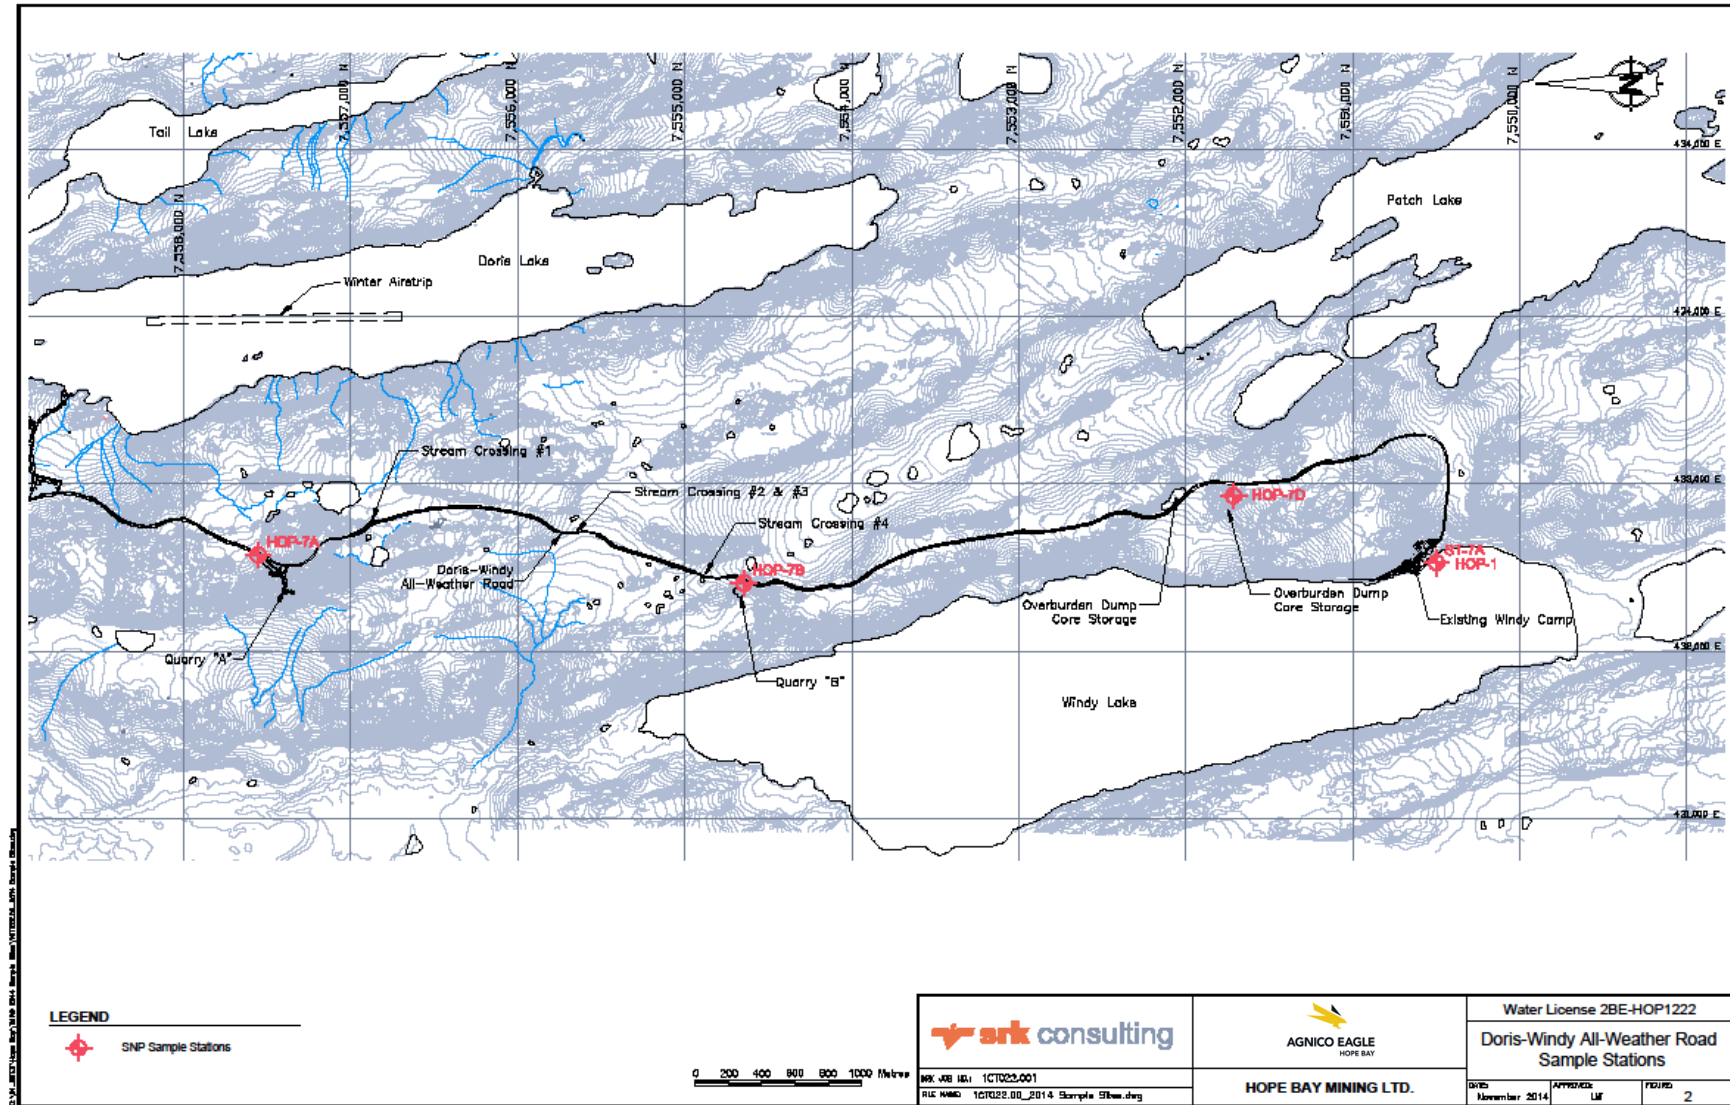
Figure 1. 2BE-HOP2232 SNP Monitoring Locations

This report is comprised of monitoring requirements as set out in Part J, Items 2 through 8, and 10 of water license 2BE-HOP2232. Some monitoring requirements stipulated in this Part refer to facilities that have not been constructed, facilities that no longer exist, or facilities where activity is seasonal. Water levels in Windy Lake will be monitored in accordance with Part J, Item 9 during open water season. Sampling locations monitored under this license (seasonally or when facilities are operational) are provided in Figure 1 at the end of this report.
