| | Aurora Energy Resources Inc<br>FINAL CLOSURE AND RECLAMATION PLAN<br>Baker Lake Basin Property, Nunavut | Final | Page: 20 of 25 |

### 2009 Status Report

# **BAKER LAKE BASIN PROPERTY STATUS REPORT**

**Kivilliq Region, Nunavut**

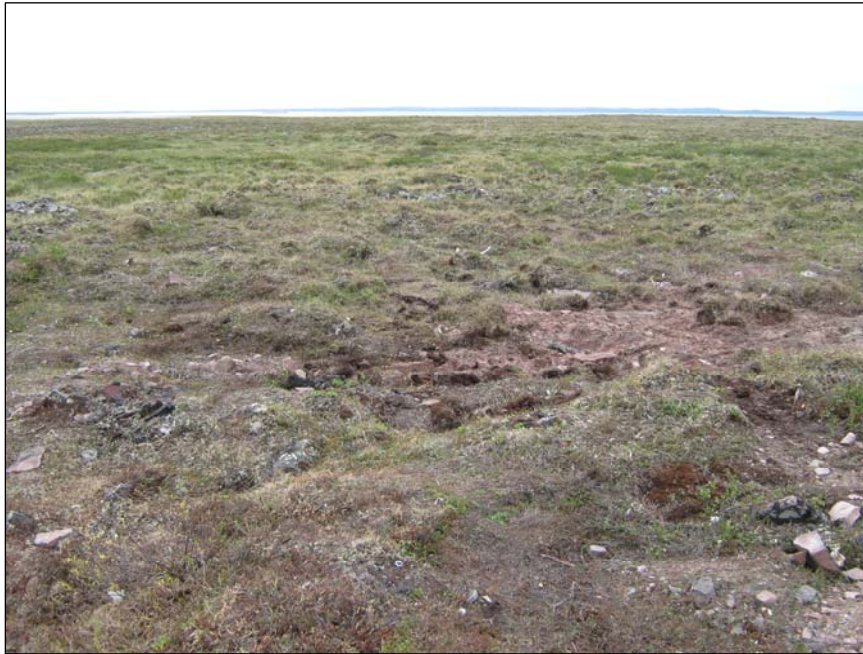
**Figure 2: DDH-07-08 after reclamation.**

The drill was removed from the Lucky 7 site between July 18-21<sup>st</sup> and flown to Baker Lake so it can be barged to Kamloops B.C. All materials were removed from the site including; garbage, excess drill grease, casing sticking above ground, all hose and equipment. The drill site was returned to as close to its natural state as possible. Both drill pads were built on top of wood blocks, drill pad contact with the ground was minimal. The reclamation of both drill sites removed almost all traces of drilling activity, figure 1.
