Aurora Energy Resources Inc FINAL CLOSURE AND RECLAMATION PLAN Baker Lake Basin Property, Nunavut	Final	Page: 20 of 25
Final Closure & Reclamation Plan	Date: June 28, 2010	Approved by: JSA

### 2009 Status Report

# **BAKER LAKE BASIN PROPERTY STATUS REPORT**

**Kivilliq Region, Nunavut**

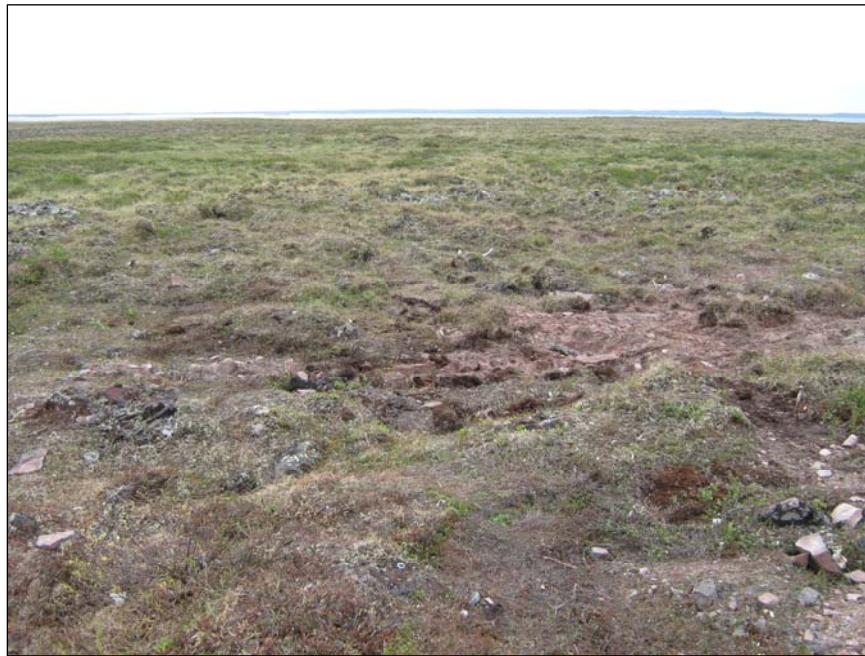
The drill was removed from the Lucky 7 site between July 18-21<sup>st</sup> and flown to Baker Lake so it can be barged to Kamloops B.C. All materials were removed from the site including; garbage, excess drill grease, casing sticking above ground, all hose and equipment. The drill site was returned to as close to its natural state as possible. Both drill pads were built on top of wood blocks, drill pad contact with the ground was minimal. The reclamation of both drill sites removed almost all traces of drilling activity, figure 1.

**Figure 2: DDH-07-08 after reclamation.**

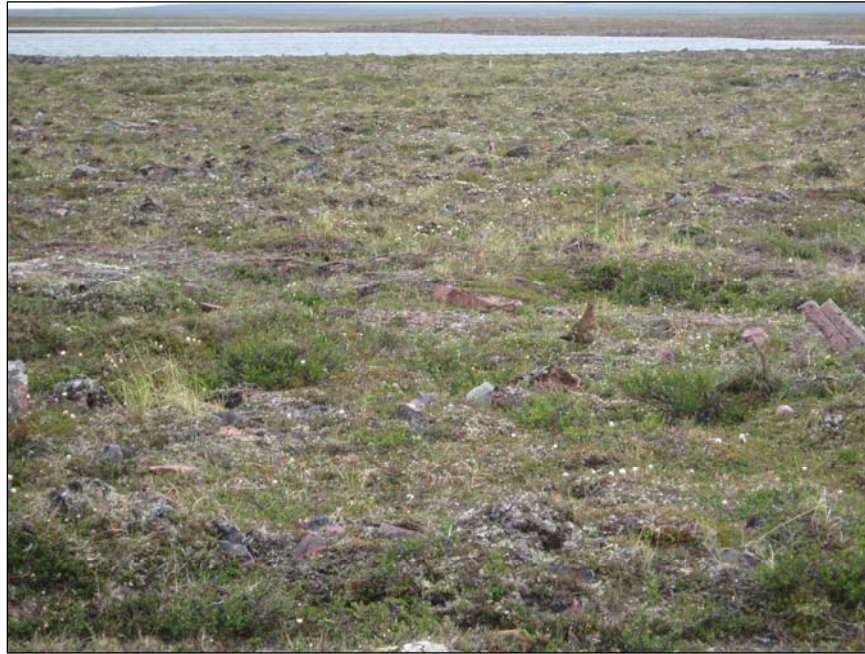
All drill holes were sealed with cement to prevent ground surface waters from mixing with ground water. Drill cuttings were pumped to low lying natural depressions where grey water drained away into overburden or fractured bedrock eliminating the need to dig sumps and re-contour the ground surface. The cuttings were collected and pumped back down the hole after it was completed. Very little drill cutting is observable at the sump site, figure 2.

**Figure 3: Sump site for drill cuttings.**

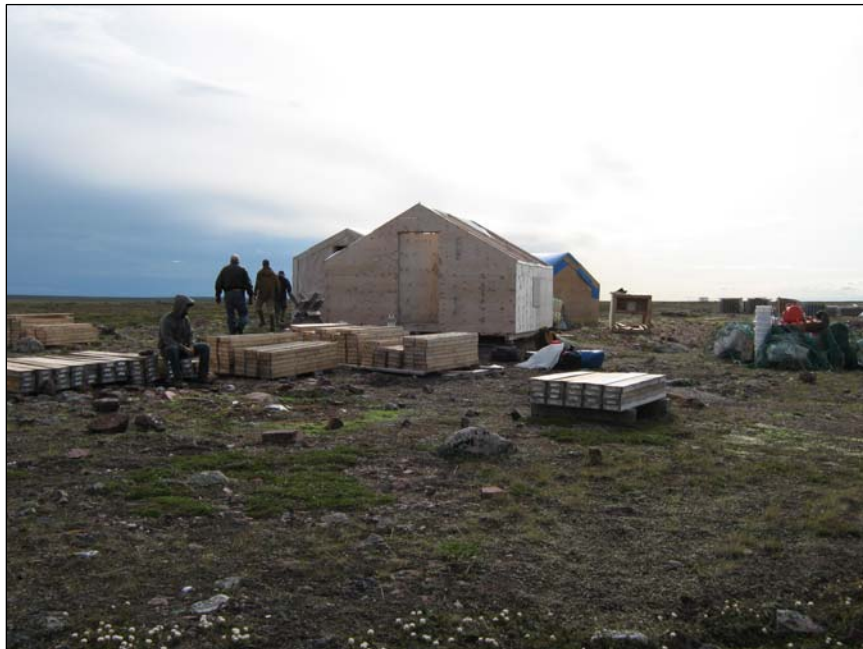
The camp located on northern shore of Bissett Lake was demobilized at the same time the drill was demobilized from the Lucky 7 site. All the equipment and supplies were removed from site and the site tied up, figure 3. Empty and full barrels were removed from the camp site and flown back to Bake Lake. Three Partial drums were sealed stored up right and left on site.

**Figure 4: Camp Clean-up and demob.**

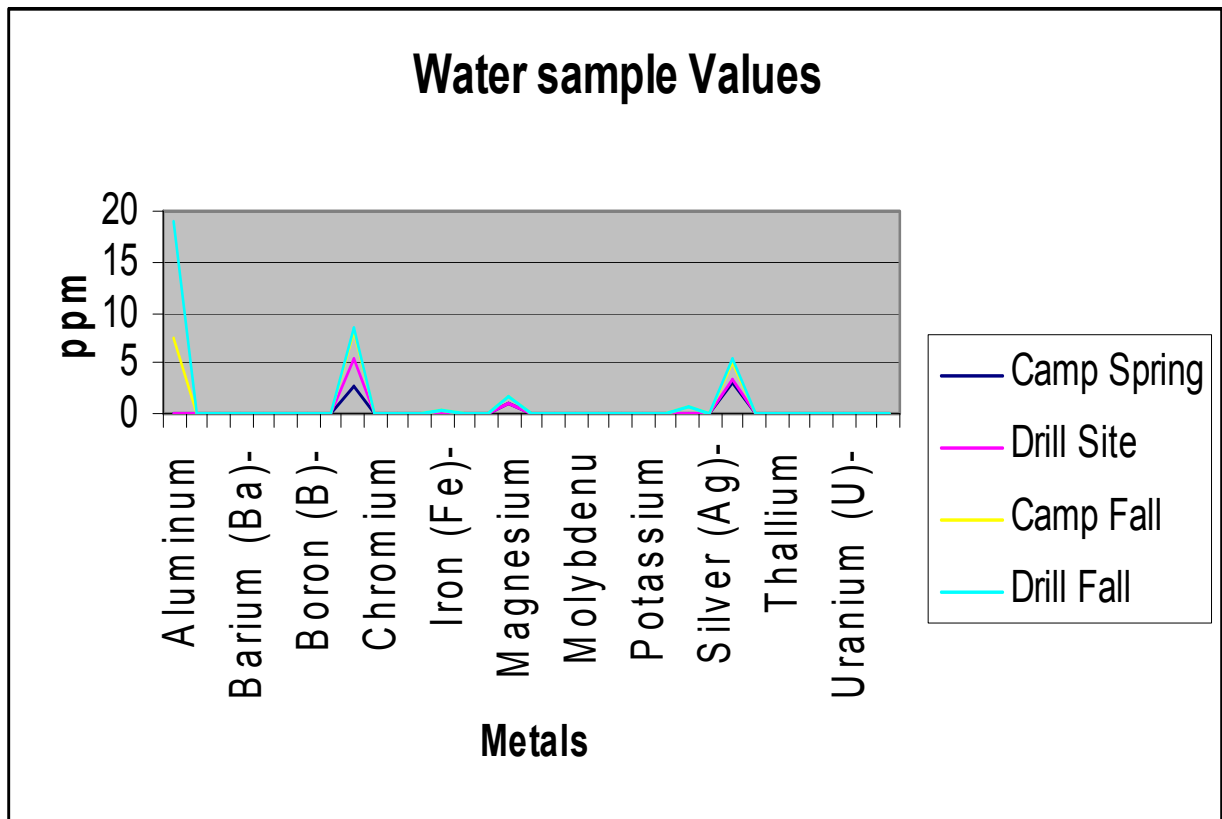
Graph 1: Comparison of water samples from the 2008 and 2009 work.

Results from the second water survey continue to show negligible changes in PH, suspended solids, alkalinity and dissolved metals graph 1 (metals only).

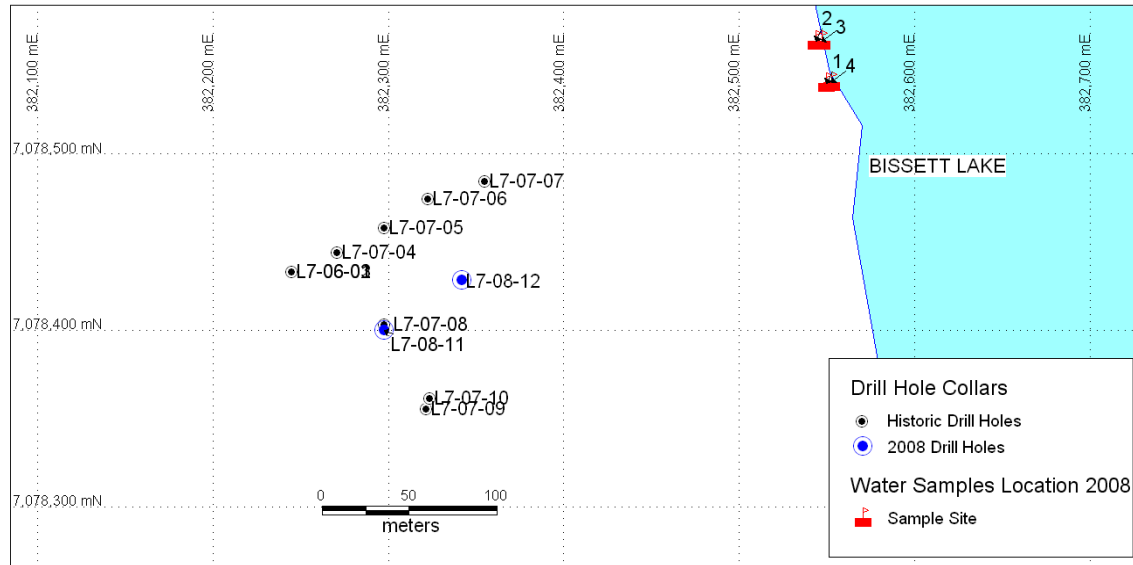
The water sample was taken at the conclusion of the drill demob from site. The sample was taken next to the water pump, UTM 677726E 7081033N NAD 83 Zone 15, Figure 5. The second sample was taken 65m east of the camp, at the closest shore of Bissett Lake, UTM 674666E 7078300N NAD 83 Zone 15.

**Figure 5: Drill site water sample location.**
