Kiggavik Project

Final Spill Report Sept. 20, 2011 Spill

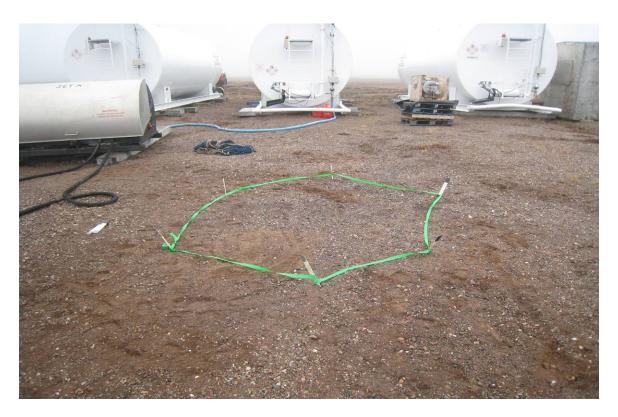
Photo 5-3 Spill Area Near Jet A EnviroTanks

At approximately 7:00 pm on September 20th a pilot with Forest Helicopters (under contract with Forum Uranium) was refuelling a helicopter at the Kiggavik fuel cache. After placing the nozzle in the helicopter's fuel tank the pilot walked around the opposite side to reprogram his GPS. After a couple of minutes he walked back to the nozzle and found that it had fallen out of the helicopter and was continuing to dispense fuel onto the ground. He immediately shut off the pump to prevent any further spillage. The quantity of Jet A fuel estimated to have spilled is 100 - 150 L. Forum personnel notified the Kiggavik Project's Facility Supervisor of the spill who then contacted the 24 hr spill report line.
