KIYUK BIOPHYSICAL PROGRAM SUMMARY 2012

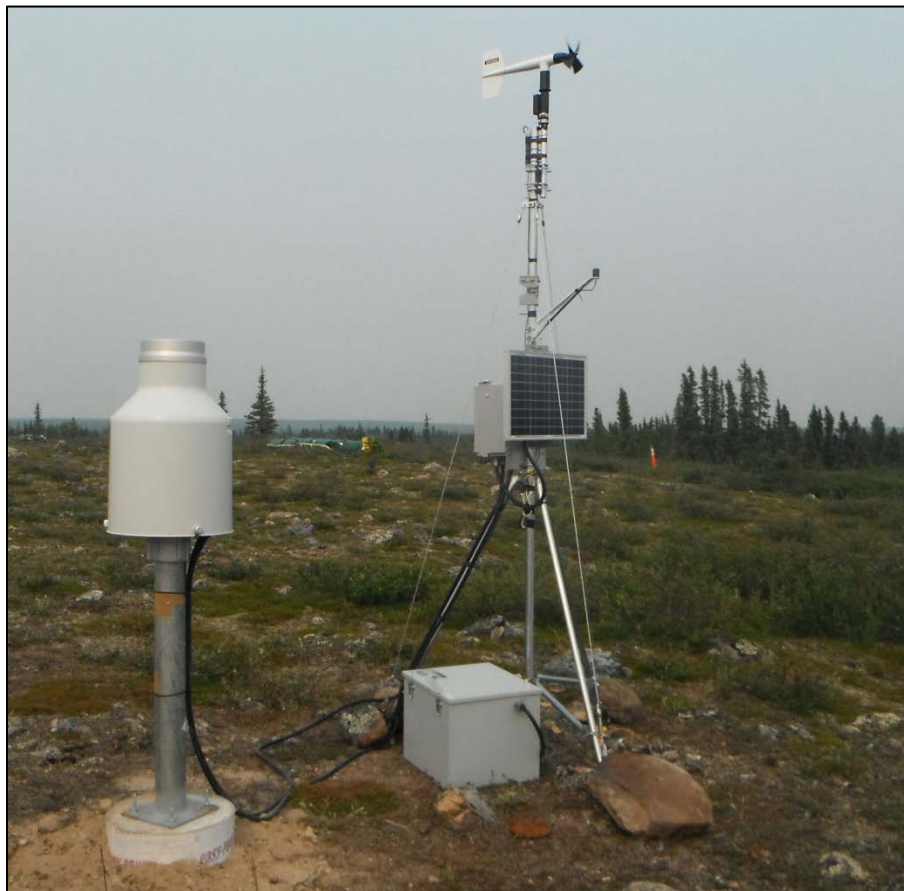
Figure 1 Kiyuk Camp Climate Station

- Install fully operating climate station during July 2012 Site visit
- Connect to Data Garrison via satellite uplink
- Brief Prosperity staff on the climate station including physical equipment and remote data access

- Broken wind sensor arrived at camp
- Incorrect cable glands provided by the supplier
- Wrongly sized Altershield collar provided by the supplier

- New wind sensor part sent to camp. Has been fitted by Prosperity staff. Dominique was briefed on how to do this.
- Correctly sized cable glands were sent to camp, in the meantime replacements were found on-site and fitted. The new cable glands were absorbed into the camp supplies.

- Another Altershield collar has been manufactured and will be sent to site. This is to be fitted by Prosperity staff. Dominique was briefed on how to do this but has since left camp. Further instruction has been provided in the form of an instruction manual.

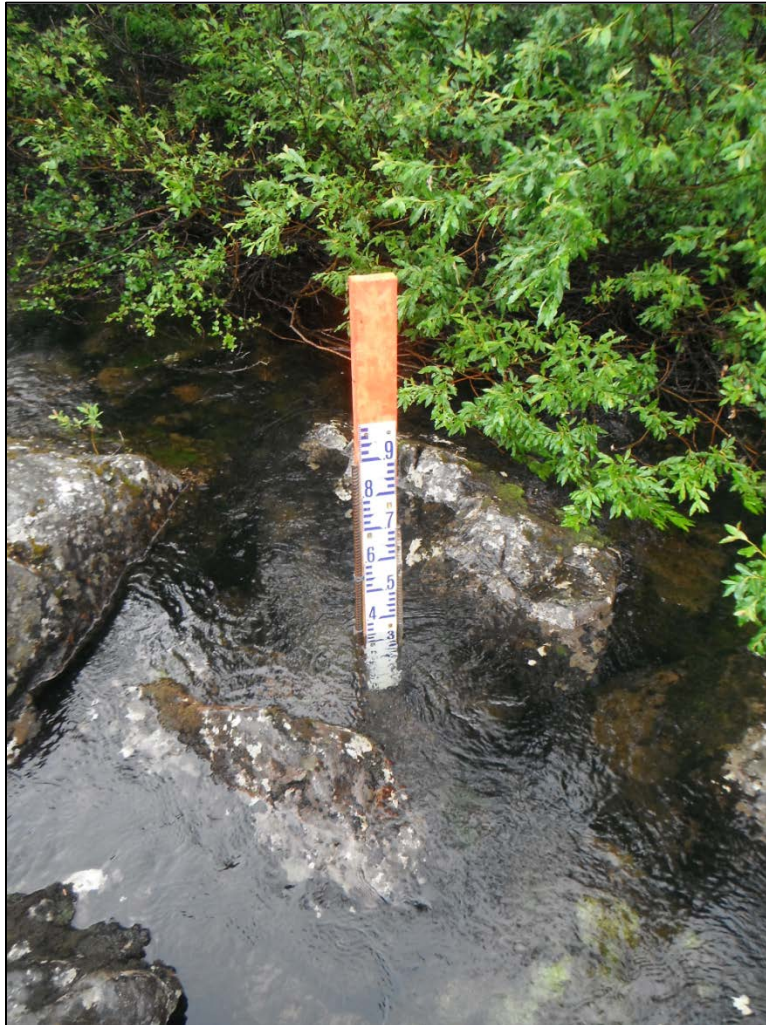
Figure 2 Staff Gauge

- Install a staff gauge to measure changes in water level (see Figure 2 and project overview map above).
- Assign one person in camp to collect the data.

- Prosperity staff to oversee that data is collected (data received from Prosperity is included in Table 1).
- It would be desirable if photographs could be taken from the helicopter of the channel at the same time that the data is collected.
- The gauge plate may need to be moved for next year, and it is preferable to remove it before freeze up.
- Please contact Ben if you have any questions.
