APPENDIX E.8
DECOMMISSIONING REPORTS

APPENDIX E.8.1
MILNE PORT NUNA SHOP

Technical Memorandum

To: Jim Millard
From: Lea Willemse
cc:
Date: March 19, 2016
Re: 2015 Nuna Shop Decommissioning Work

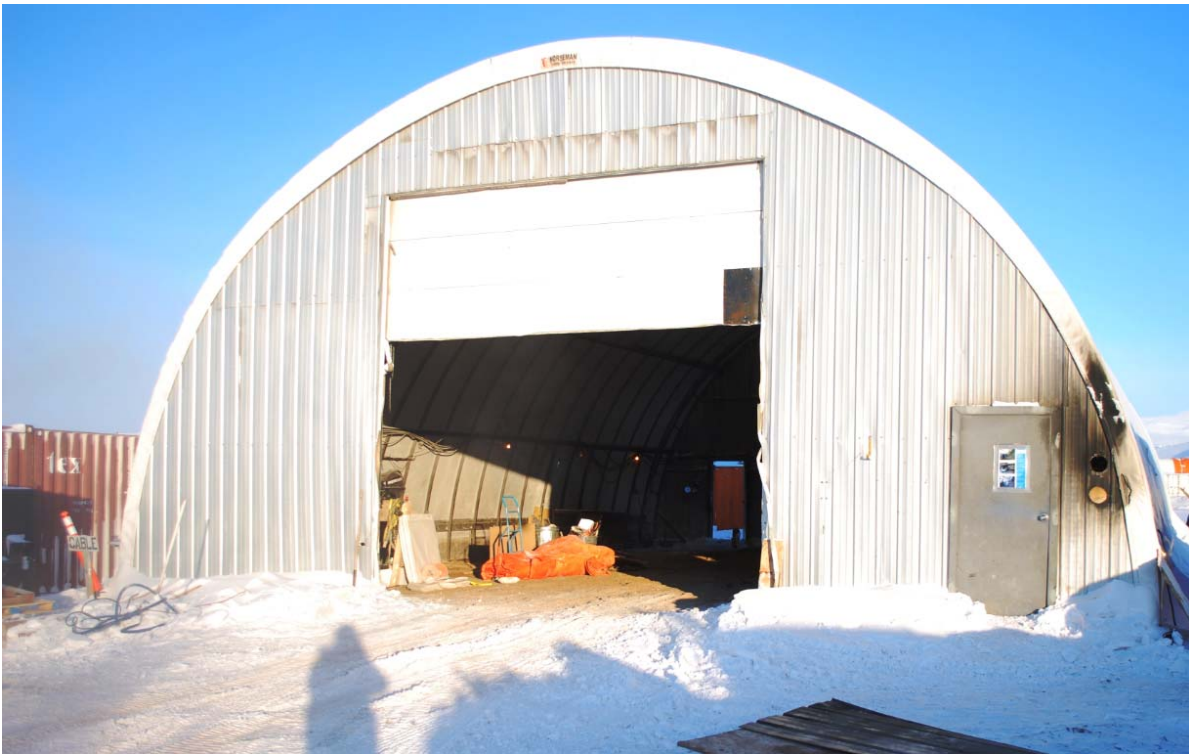
Photo B.1: Former Nuna Shop Quonset Structure Constructed in the winter of 2007 - 2008

The former Nuna shop was a 19 m x 13 m Quonset structure (refer to Photo B.1) constructed during the winter of 2007-2008 to serve as a workshop for contractor personnel completing maintenance activities on project equipment. The footprint of the structure was lined with a geosynthetic liner at an approximate depth of 0.25 m to contain hazardous materials routinely used in the shop (fuels, lubricating oils, greases, etc.). Ancillary to the former Nuna shop, were two diesel generator seacans (east and west) used to supply electricity to the shop and adjacent Shanco Camp (also removed).

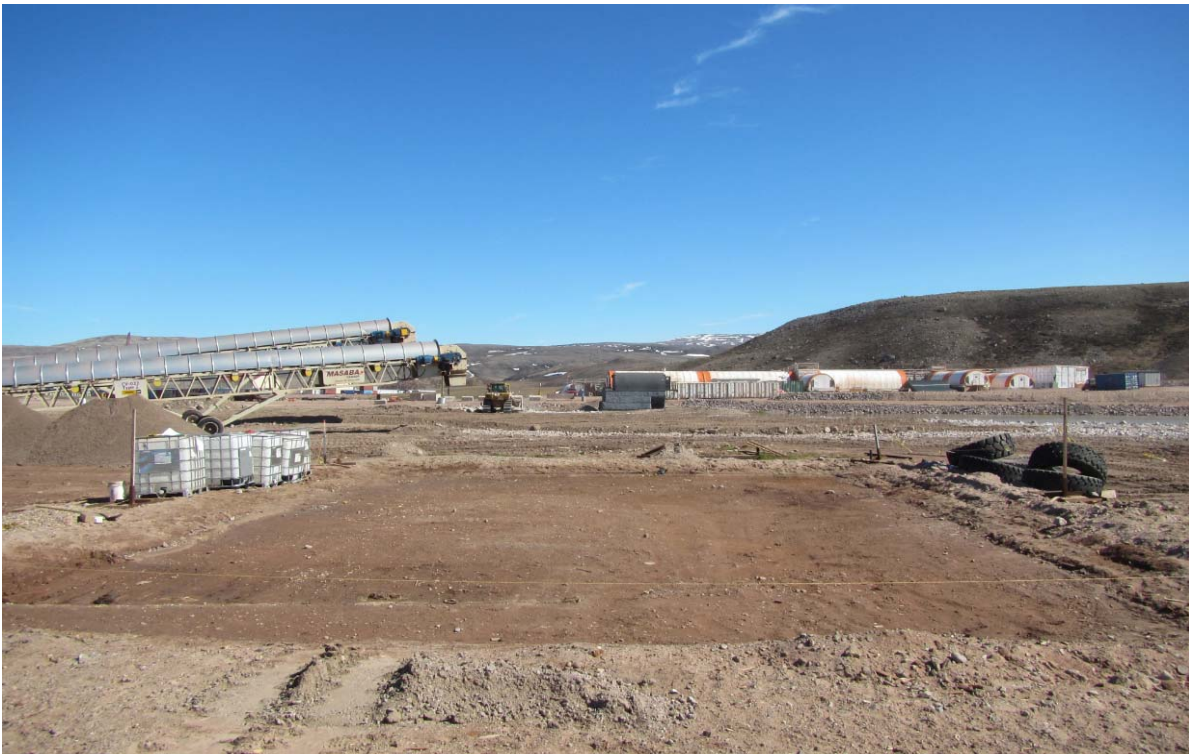
Photo B.3: Former Nuna Shop Footprint Staked-off for Assessment and Excavation

thaw conditions permitted further assessment and excavation of the area (refer to Photos B.2 and B.3 in Attachment B). Subsequent to removing the Nuna Shop liner, the generators were also removed from the area. The generator footprints were also staked-off for further assessment upon ground thaw conditions.

In June 2015, decommissioning of the areas staked-off in March recommenced with the excavation of 126 m³ of underlying soil to a depth of 0.5 m at the Nuna shop footprint (refer to Photo B.3 in Attachment B).

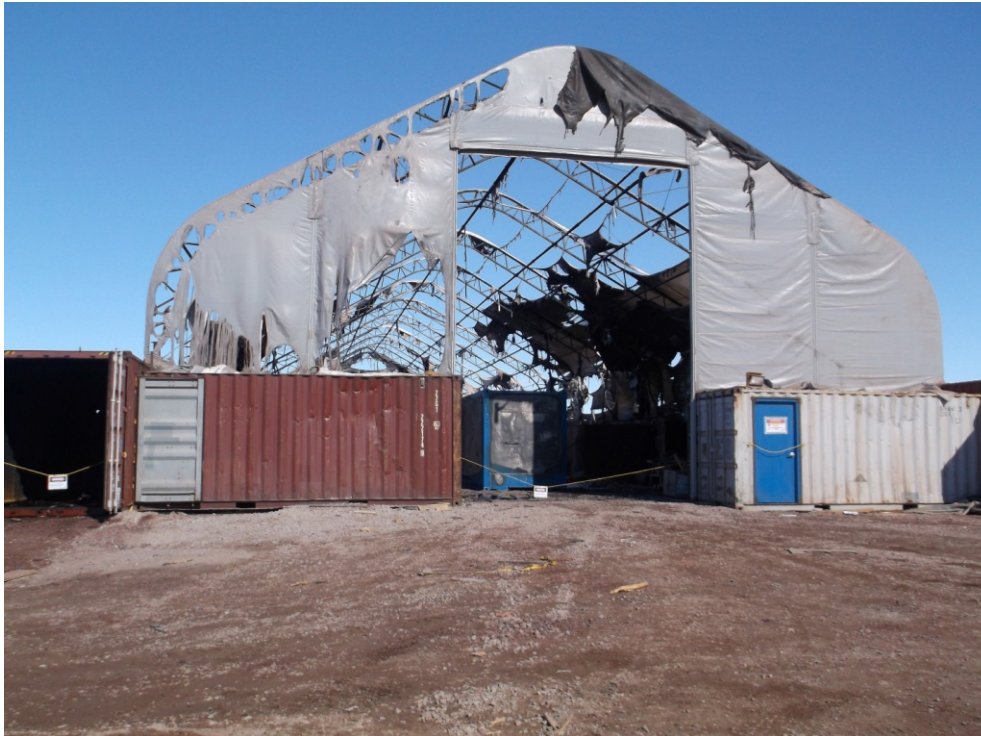
Photo 1

Overview of the
burned Anmar
Maintenance Shop
that burned.

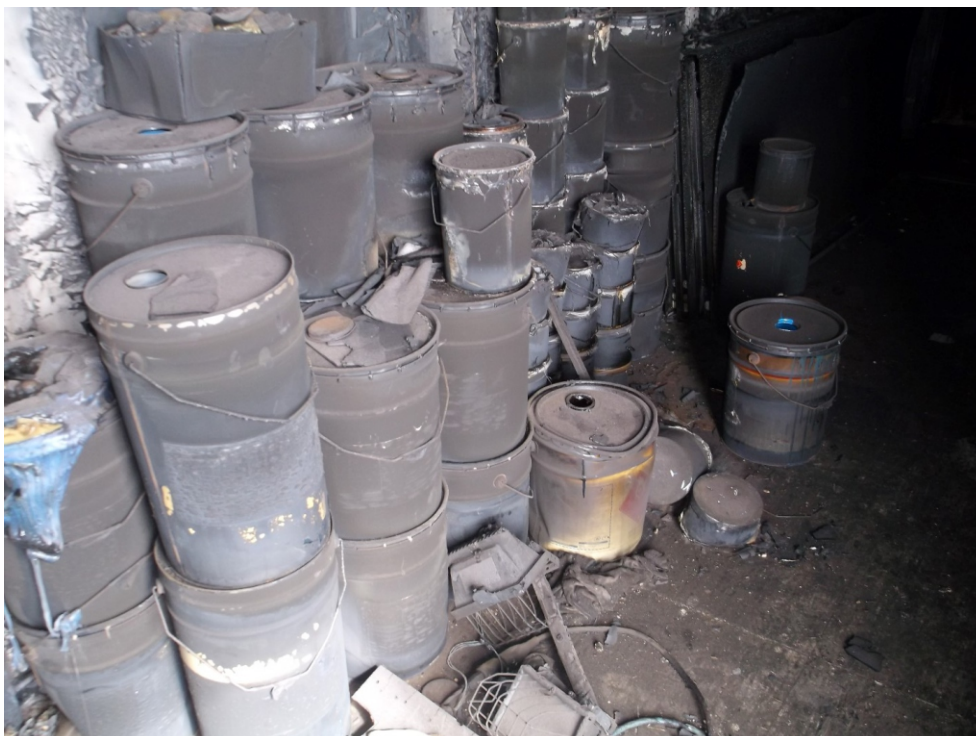
Photo 2

View of paint and
solvent containers in
Seacan #222174.

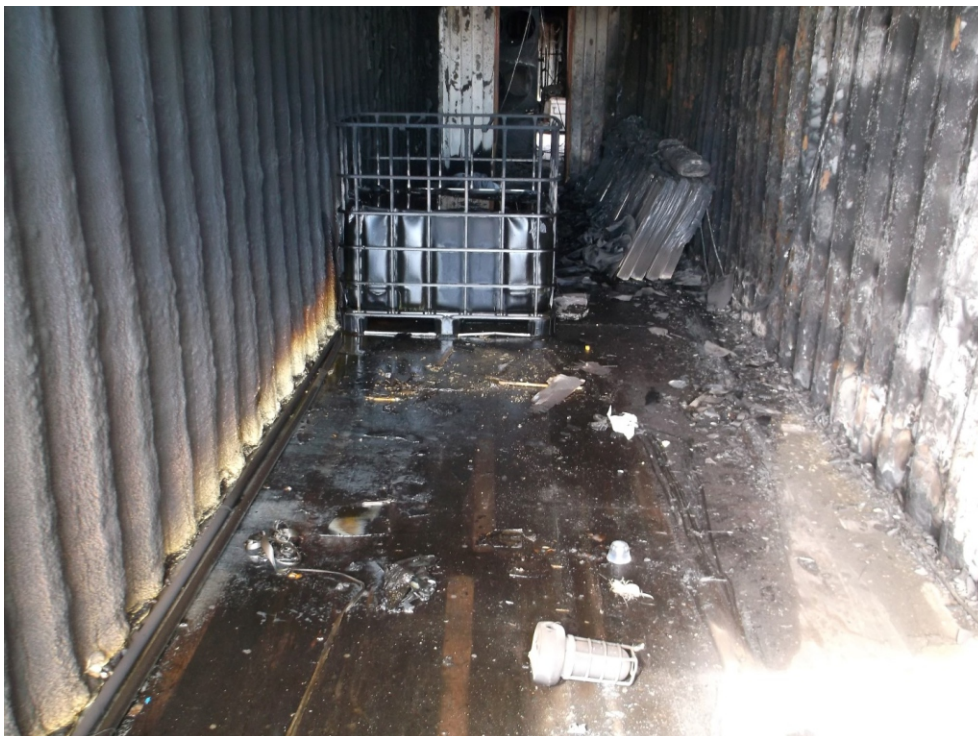
Photo 3

View of a partially burned tote tank containing oil in Seacan #901030. Oil is covering the wooden floor.

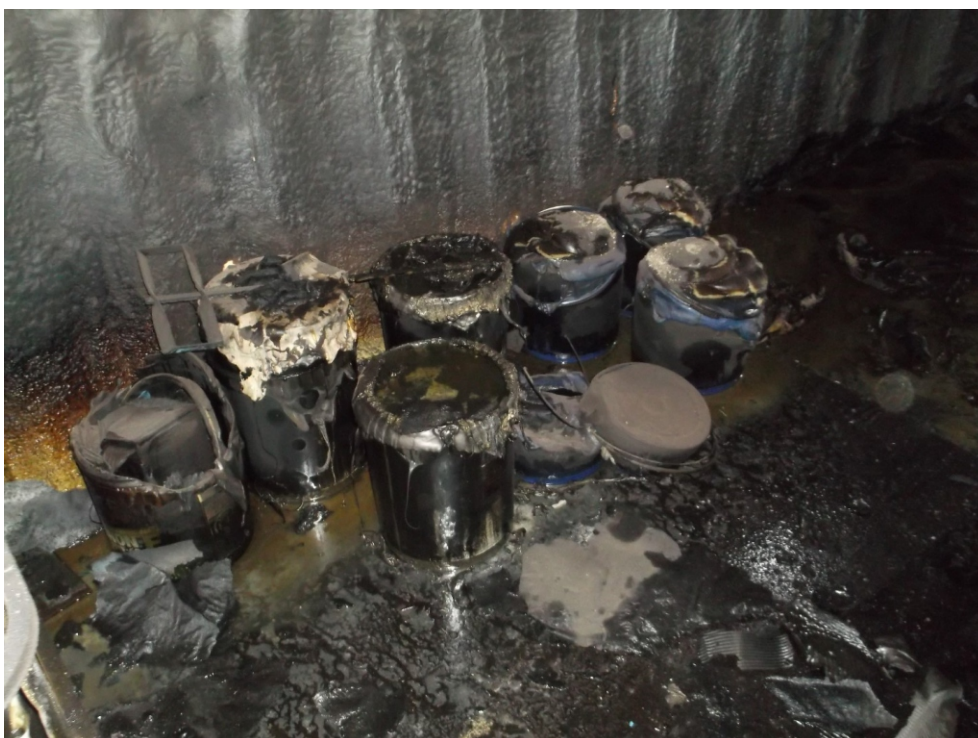
Photo 4

View of partially burnt 5-gallon containers filled with oil and grease in Seacan #901030.

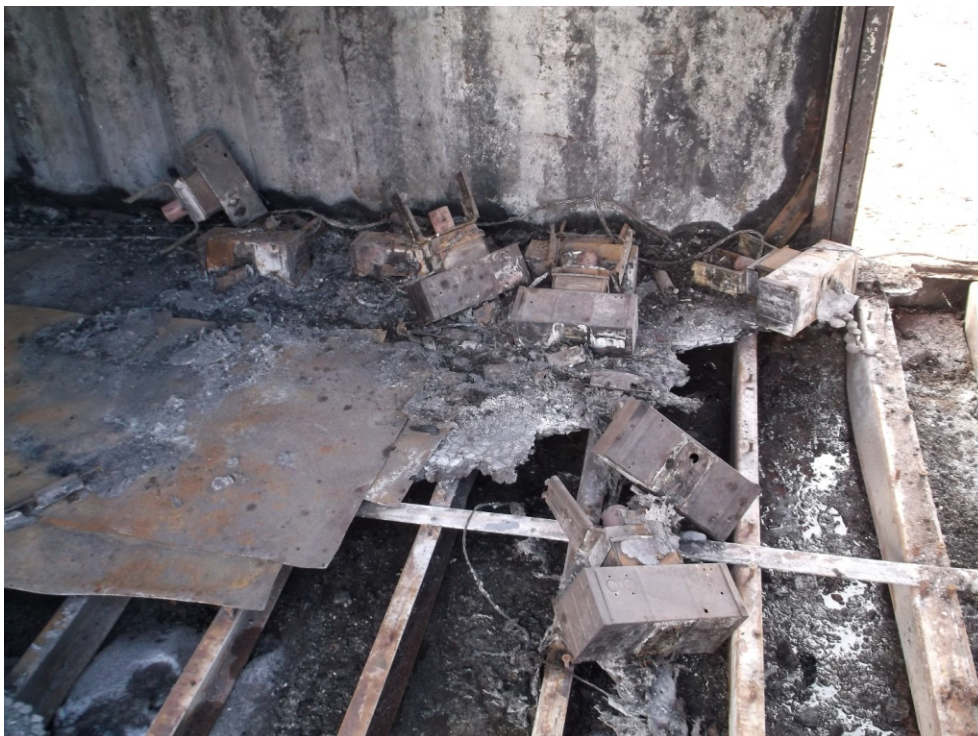
Photo 5

View of burnt light
ballasts in Seacan #
BSC-2.

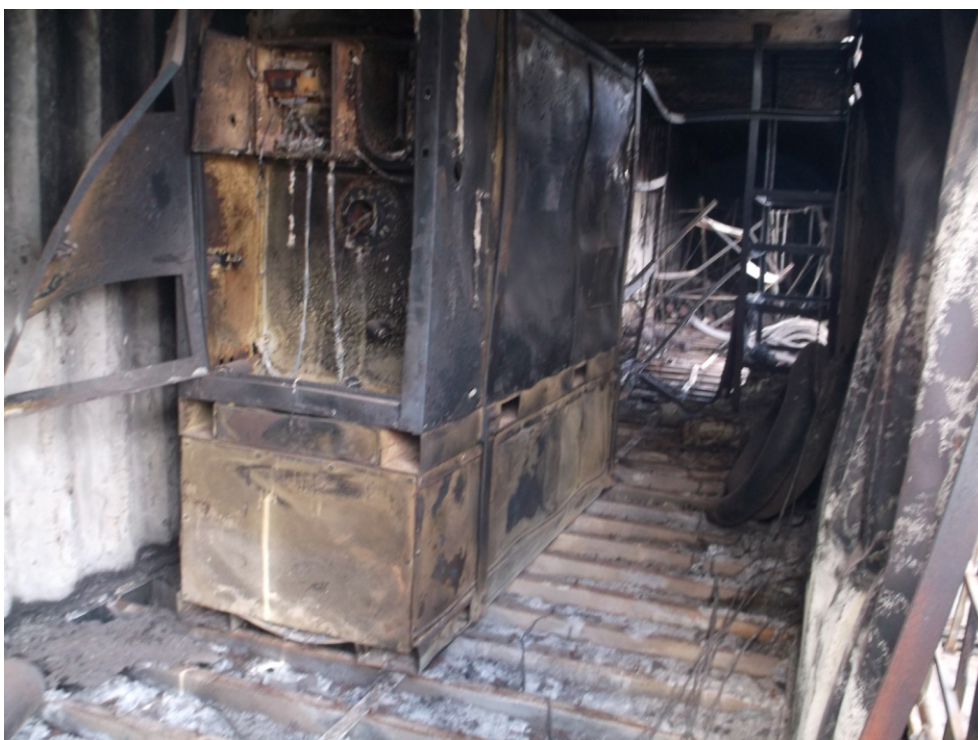
Photo 6

View of the burnt hot
air blower (heater) in
Seacan # BSC-2.

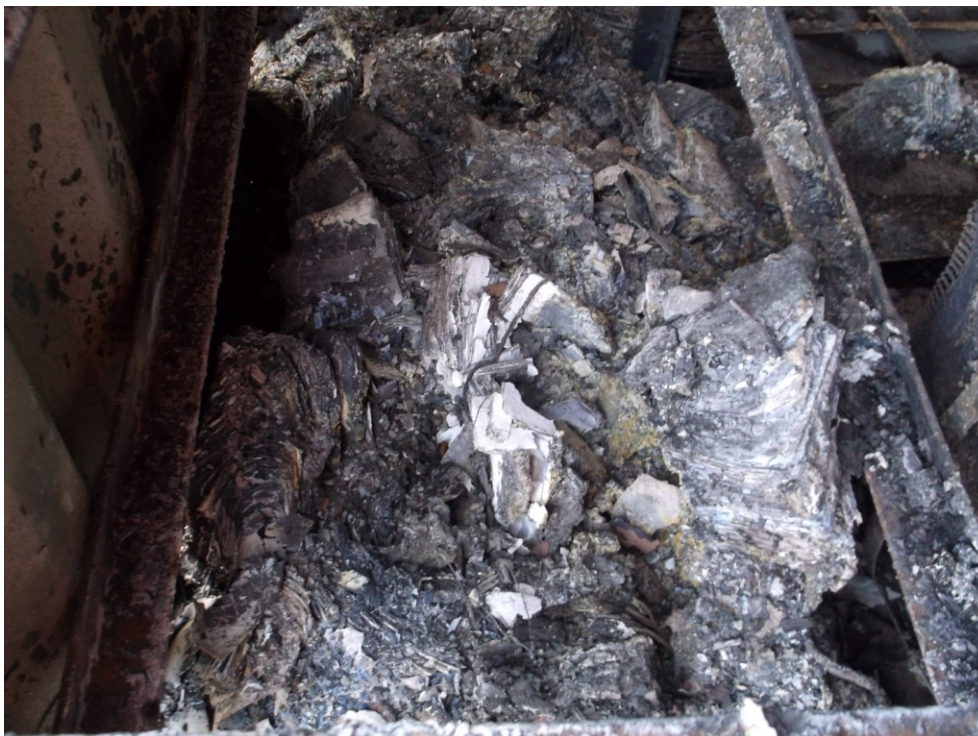
Photo 7

View of burnt battery ash in Seacan # BSC-3.

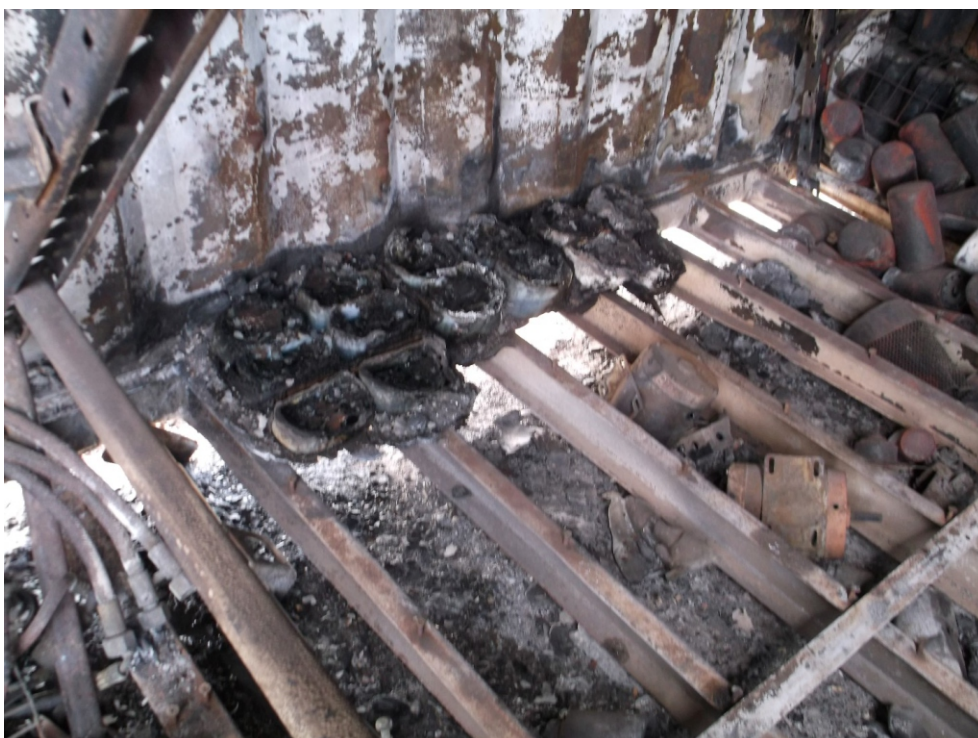
Photo 8

View of burnt 1-gallon containers in Seacan # BSC-3 which presumably contained lubricant, grease or solvent.

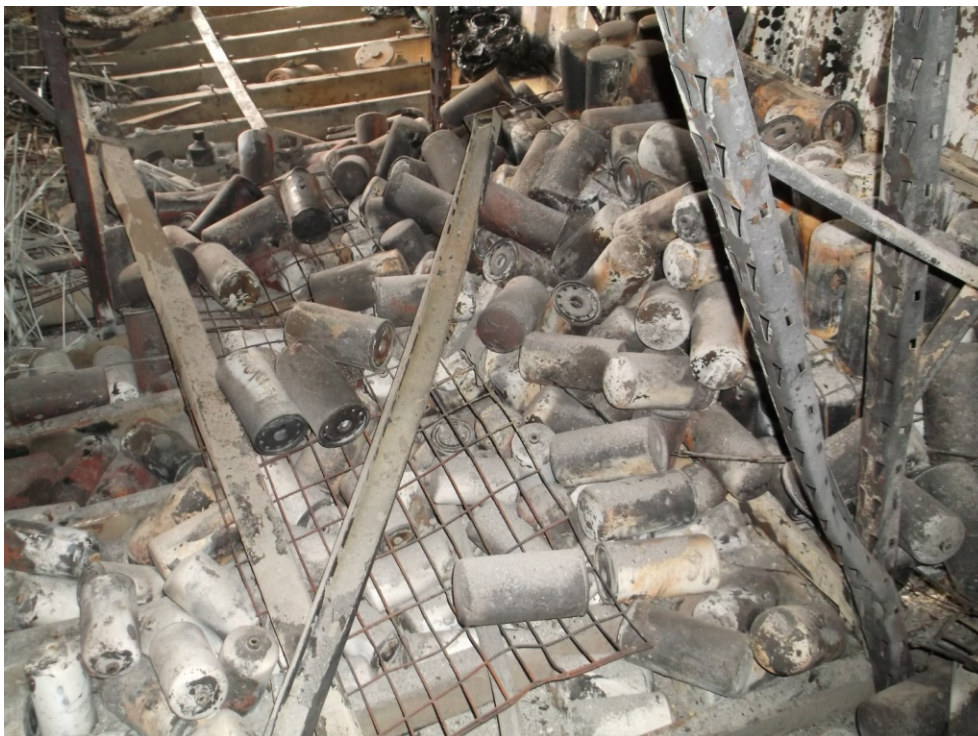
Photo 9

View of new oil filters
that were burned in
Seacan # BSC-3.

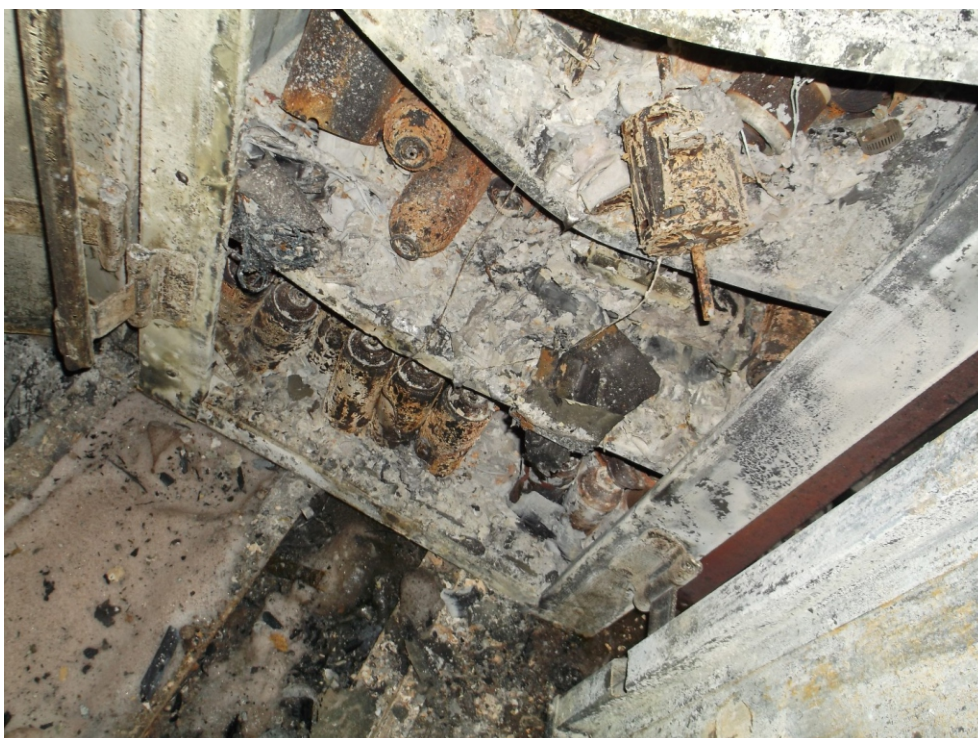
Photo 10

View of burnt aerosol
cans in Seacan
BSC-4.

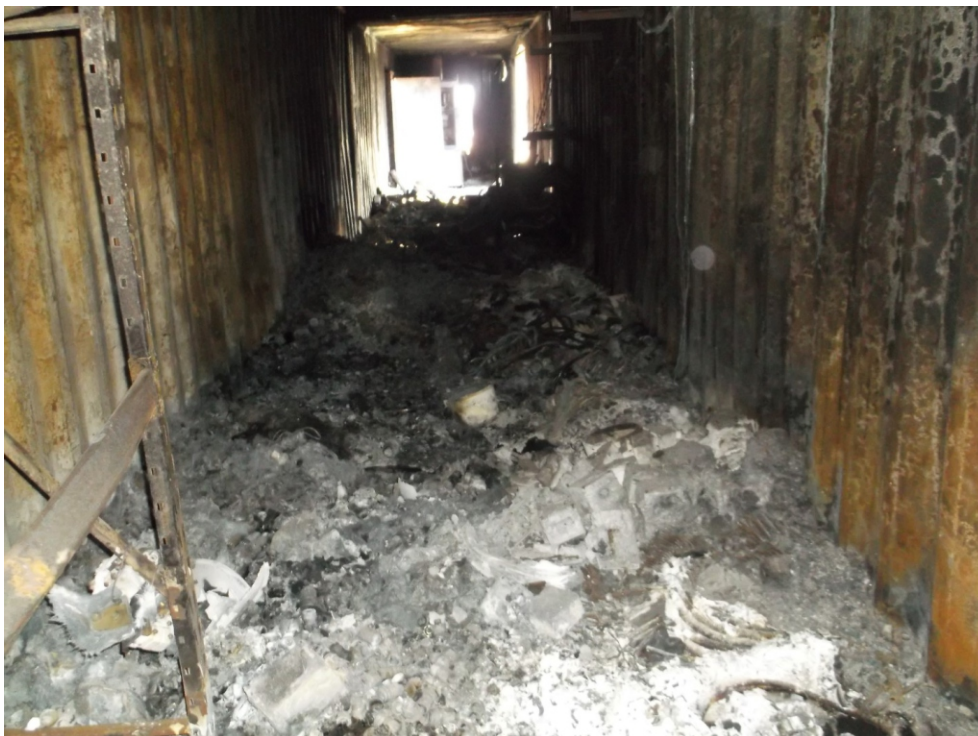
Photo 11

View of mixed materials (wood ash, small metal parts and electrical components) inside Seacan # 679514. Thickness of mixed materials is between 0.25 and 0.5 m.

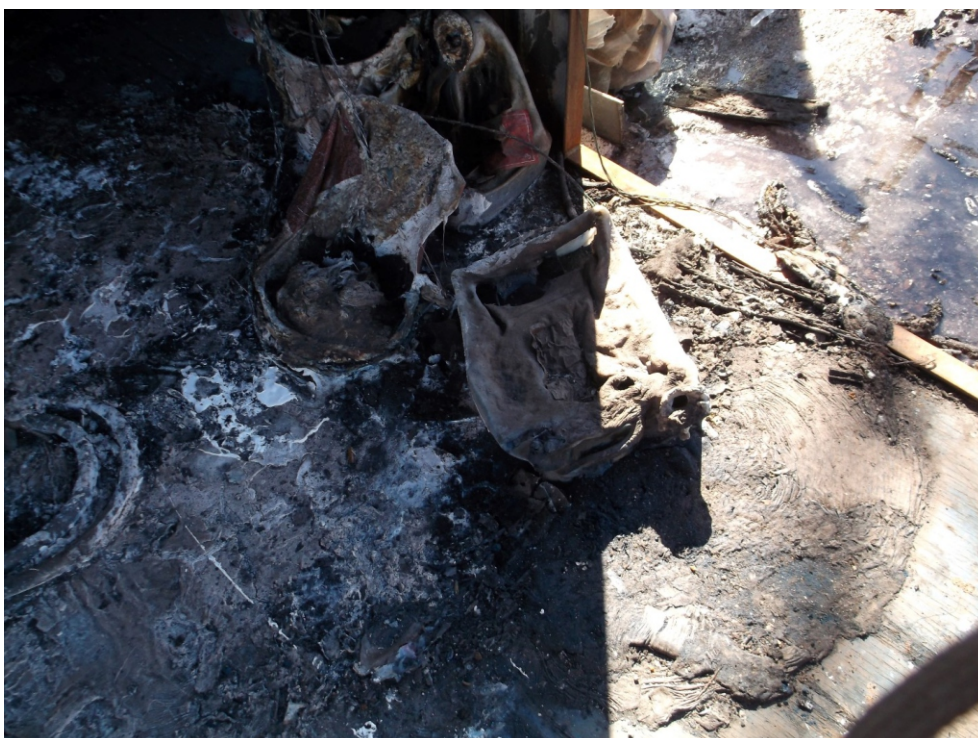
Photo 12

View of partially burned 5-gallon containers of blue paint in Seacan #110709. Blue paint leaked out of both sides of the Seacan.

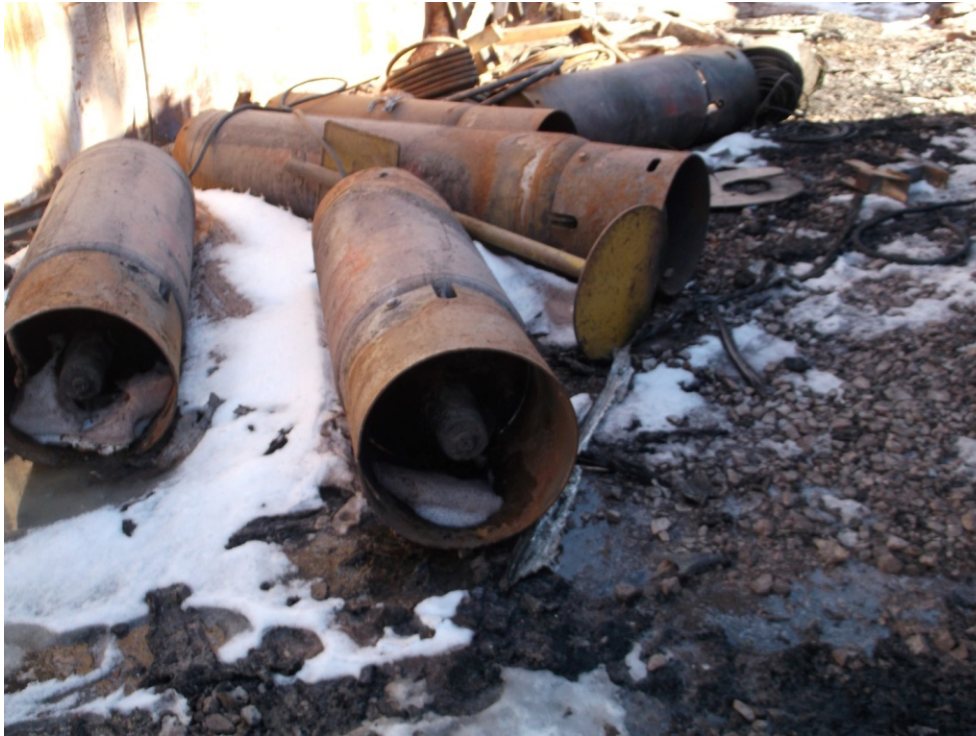
Photo 15

View of burnt 100-lbs propane cylinders in the materials storage area.

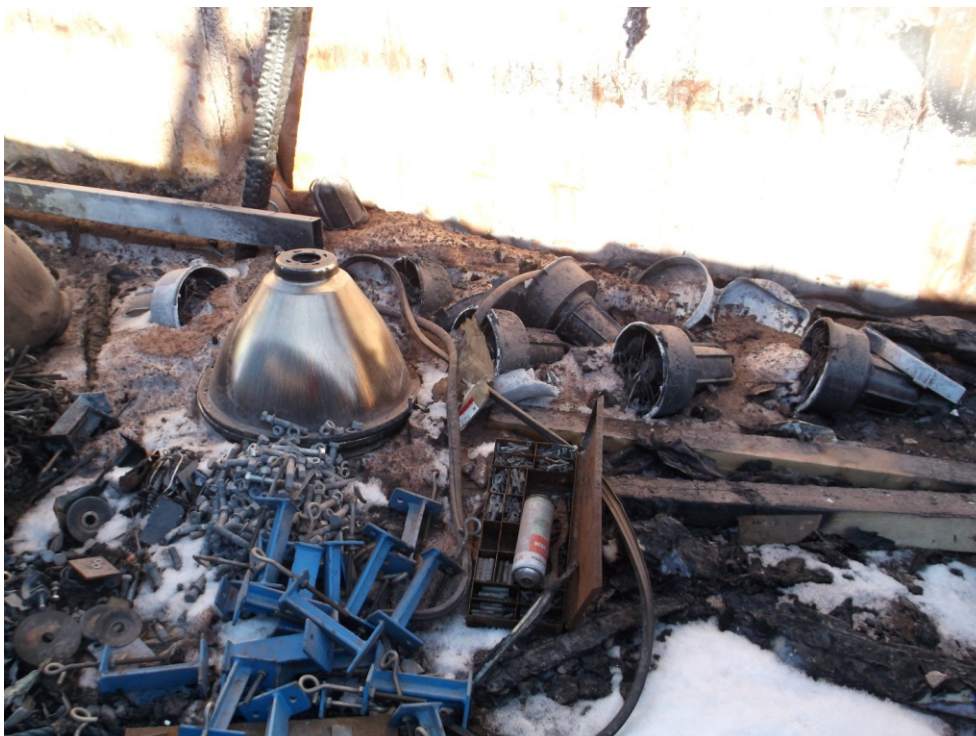
Photo 16

View of partially burned mixed materials in the materials storage area (explosion-proof lights, metal parts, aerosol cans, etc.).

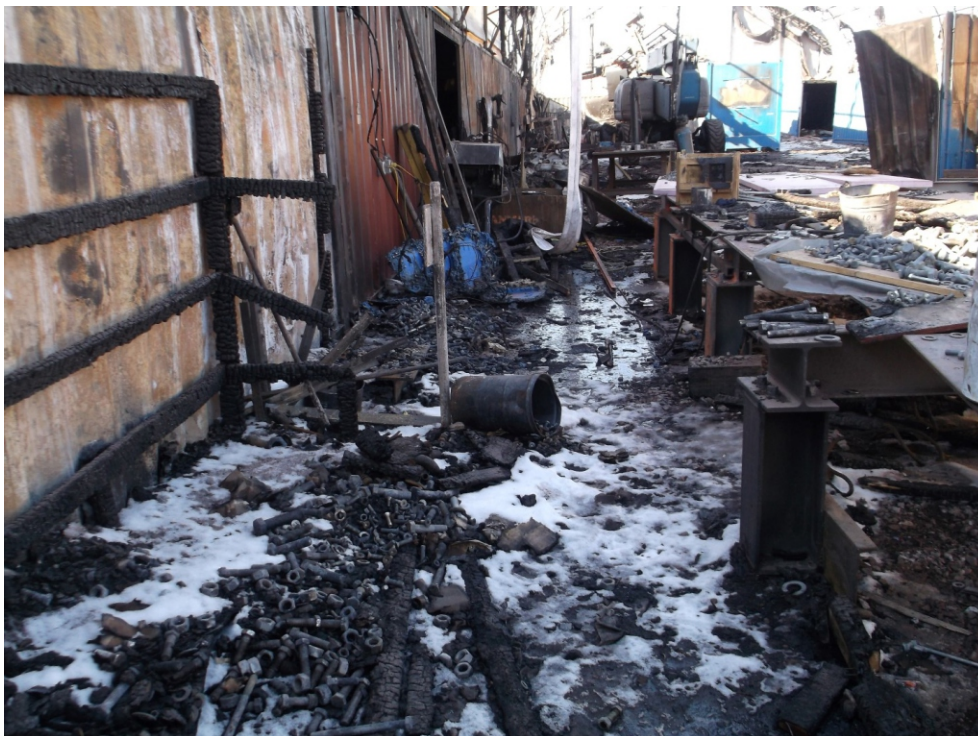
Photo 17

View of mixed materials (ash, metal parts, tools, etc) in the machining area near the southwest corner of the shop.

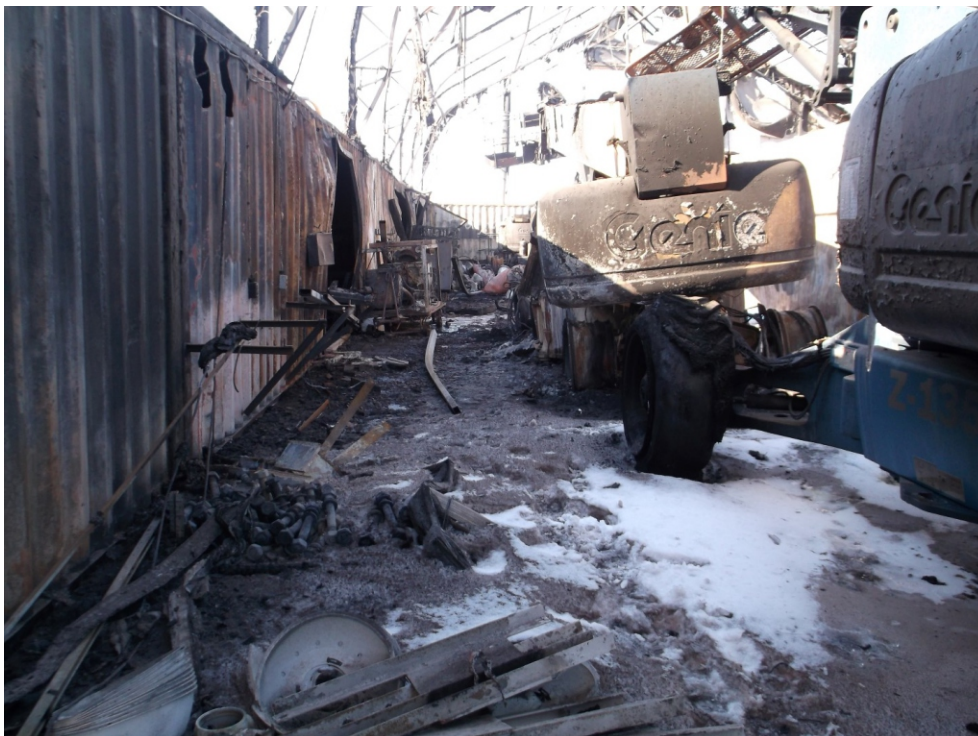
Photo 19

View of partially to completely burnt lifting machinery in the western area of the shop, near the Genie-Lift area.

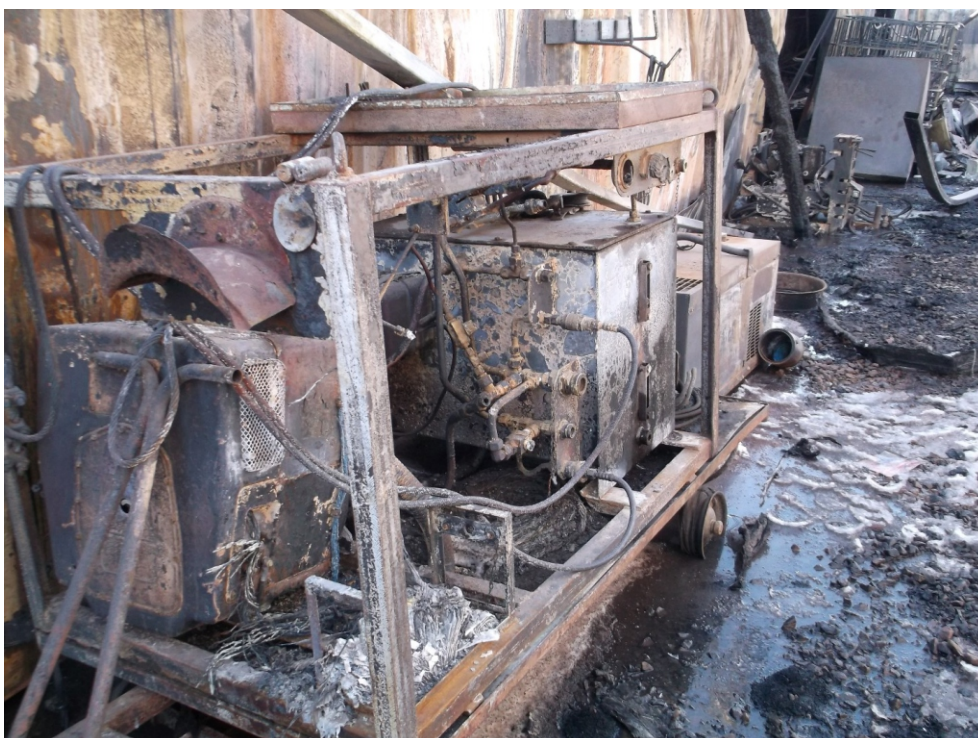
Photo 20

View of the burnt hydraulic unit in the western area of the shop, near the Genie-Lift area.

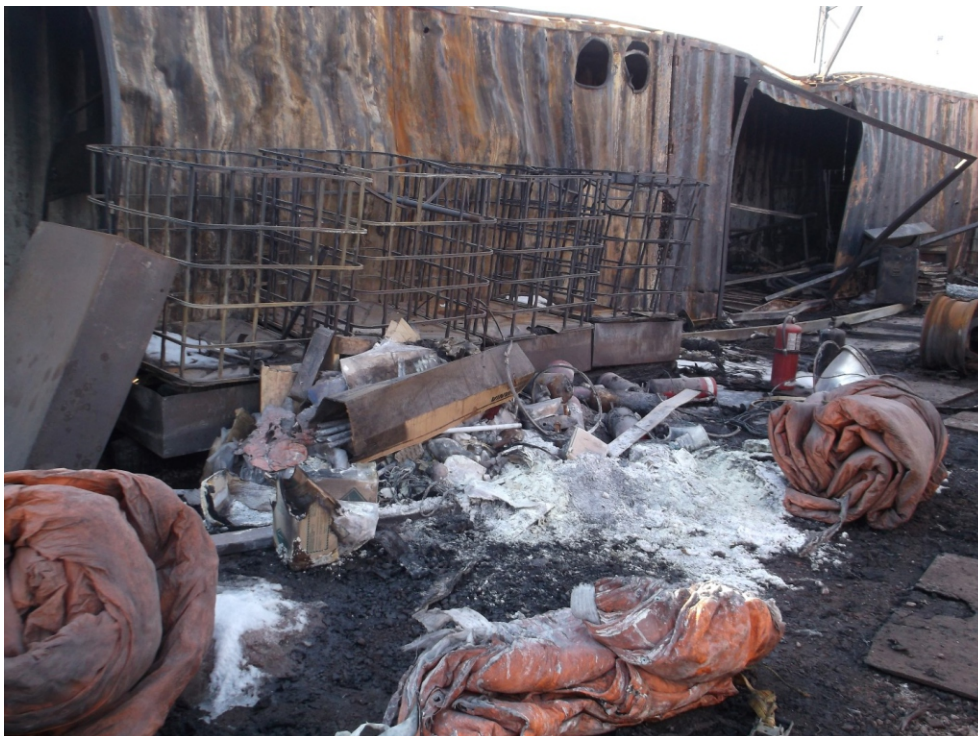
Photo 21

View of partially to completely burnt materials (oil tote tanks, fire extinguishers, tarps, light bulbs and tubs) and of ash and ABC powder on the ground in the used oil area near the northwest corner of the shop.

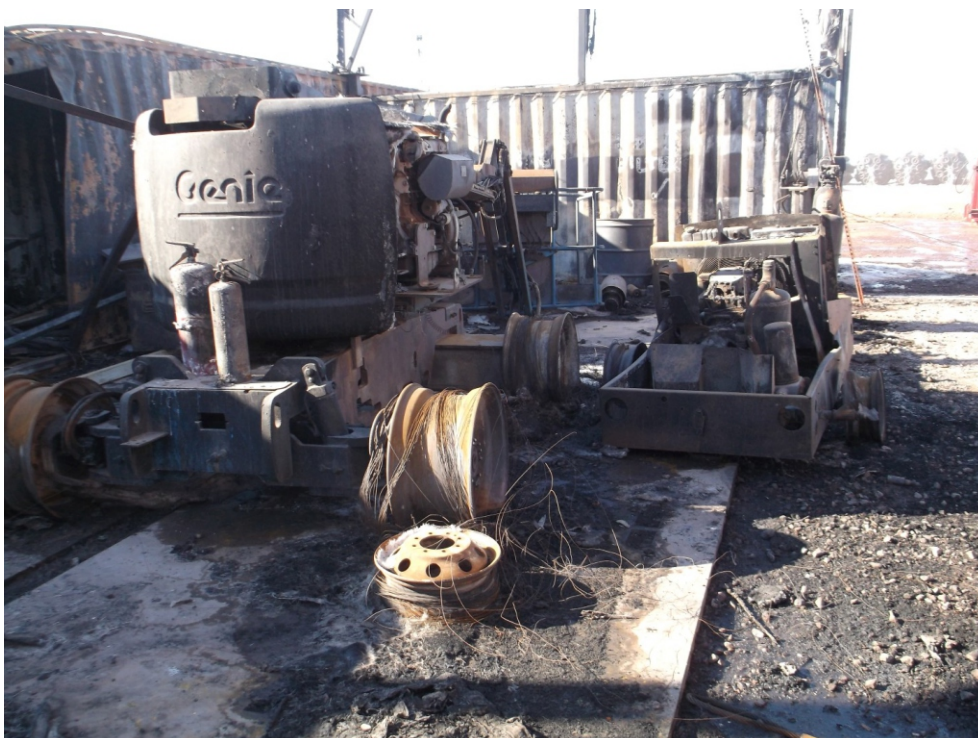
Photo 22

View of burnt equipment in the used oil area near the northwest corner of the shop.

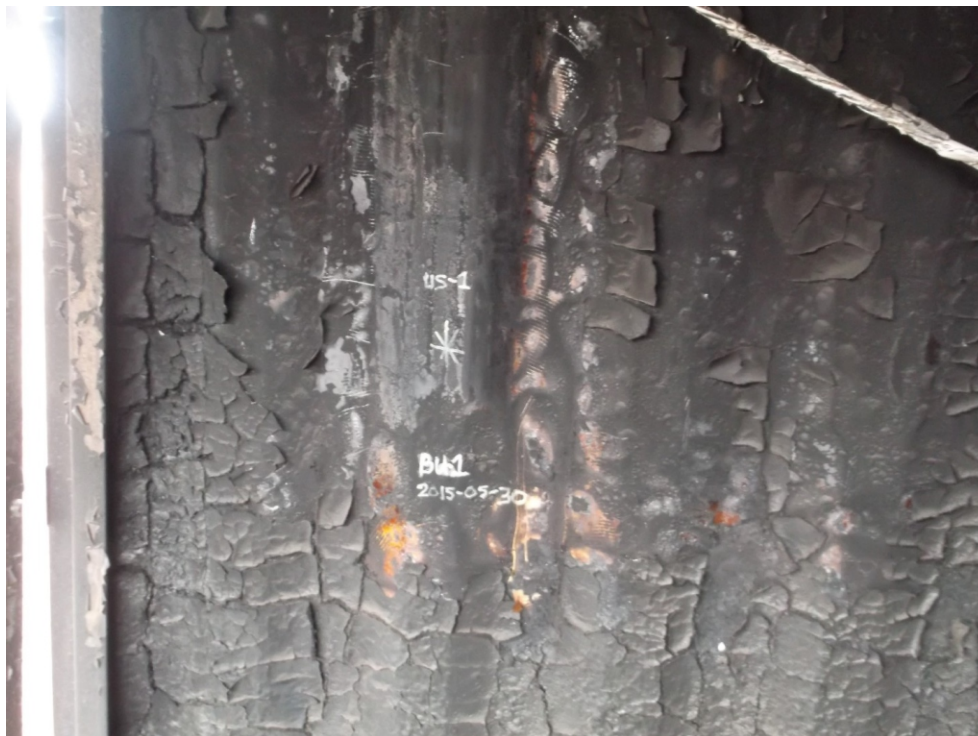
Photo 23

View of burnt urethane (Sample BU-1) and urethane soot (Sample US-1) sampling location in Seacan #694267.

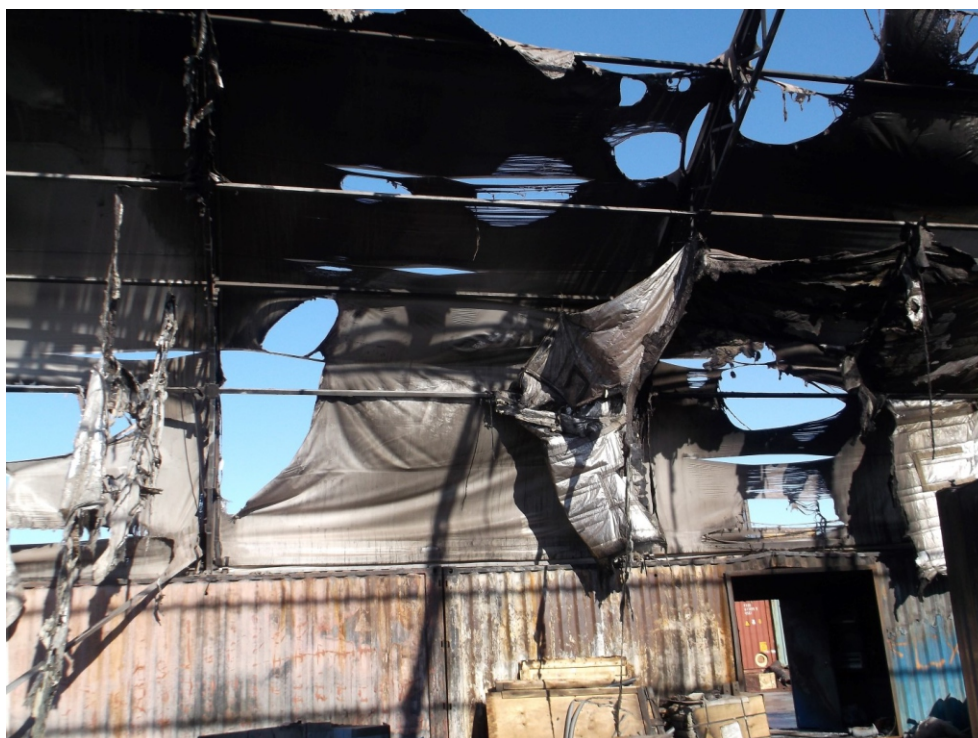
Photo 24

View of the partially burnt PVC tarp composing the former roof near the intact area in the southeast of the shop.

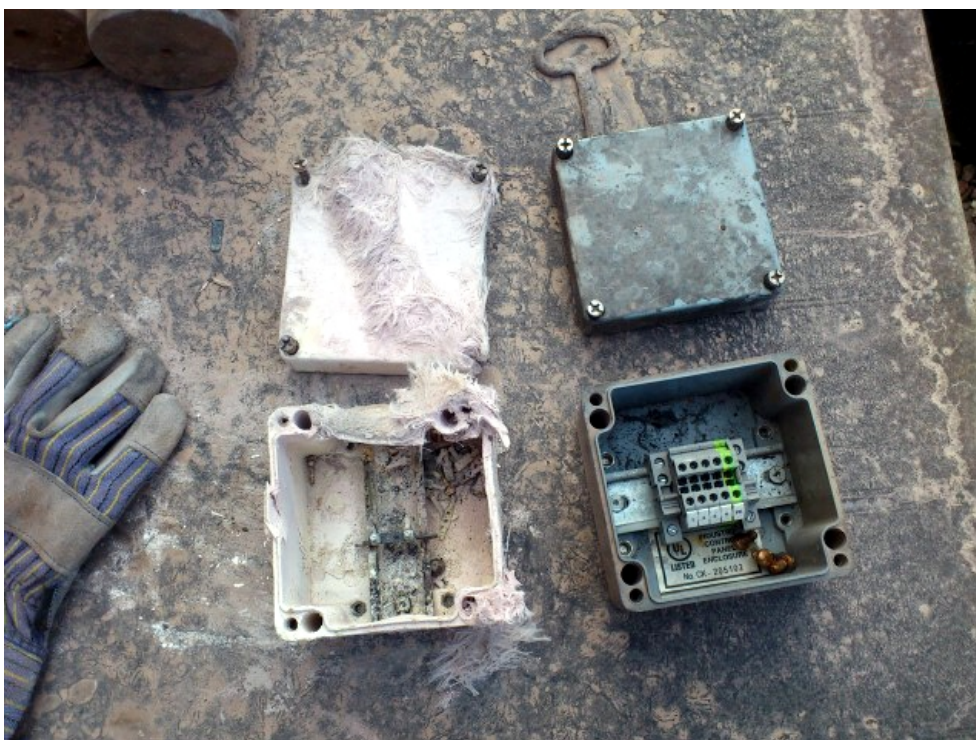
Photo 2

View of fibrous burned
electrical component
found on August 23,
2015.

In an effort to confirm the suspected presence of asbestos in a material found on the project site (photograph 2 of Appendix B), a laboratory analysis was requested. The material may possibly have served as an insulator for the lights that were hung on the roof structure. The analyses (2 in all) revealed that the samples contained less than 0.1% asbestos. The corresponding certificate of analysis is presented in Appendix I of this report.

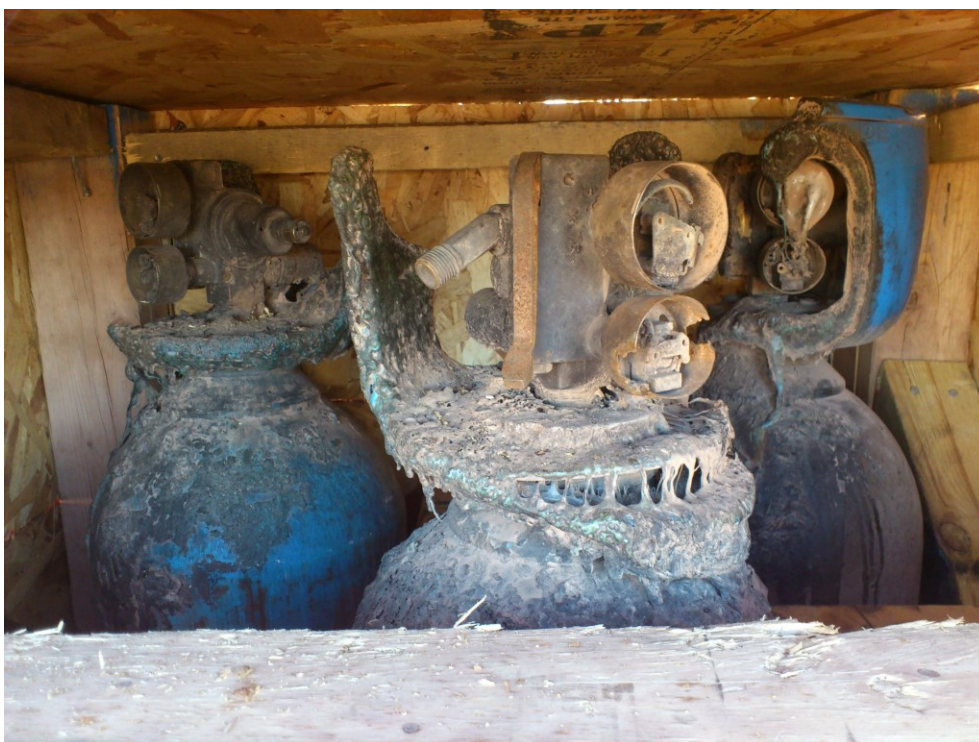
Photo 10

View of burned valves from oxygen cylinders in adequate wooden crate relative to IMDG requirements.

On the project site, some cylinders were found with their valves completely burned. It was impossible to tighten the security cap. As compressed cylinders are regulated for maritime transport, Transport Canada was contacted to provide a technical instructions. It was decided that the cylinders could be transported without the valves under the condition that they be packaged in such a way that the valve not be disturbed during the maritime transport. Transport Canada's email is presented in Appendix J of this report.

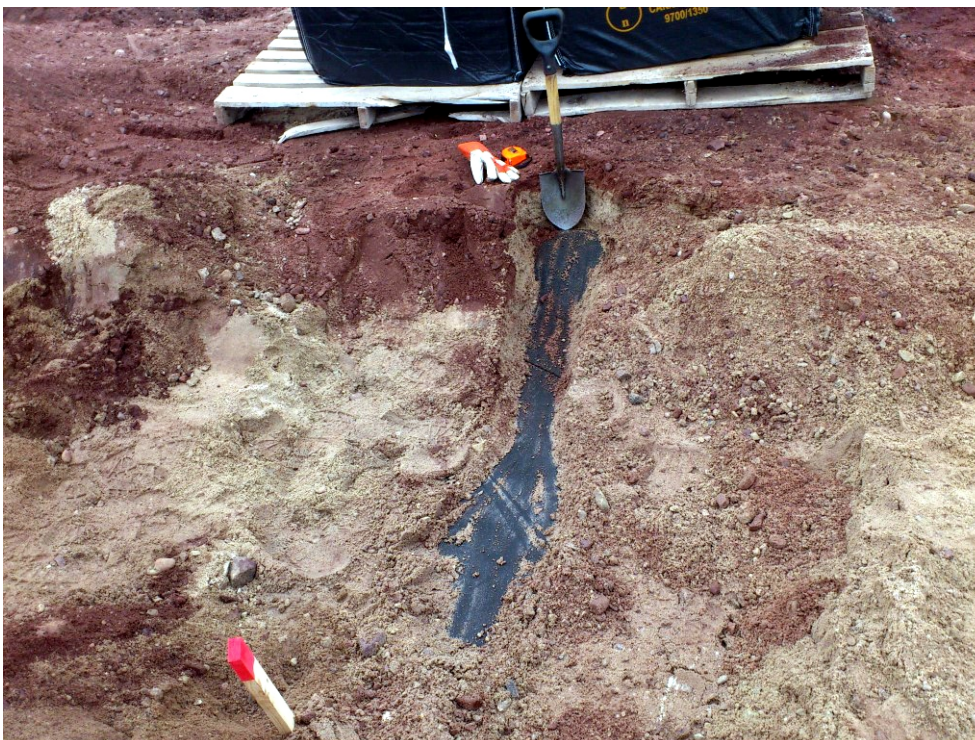
Photo 14

View of the liner observed at an approximate depth of 1.5 foot below ground surface.

- Contaminated soils on the east side of BSC-2 and BSC-3 were also excavated over an 11" thickness, but olfactory evidence of contamination (associated with diesel fuel, probably stemming from burned Genie lifts, or a previous spill) were observed in a wider area than what appears to be associated with the fire. Natural soils in this area are covered by a liner, located at a depth of approximately 1.5 ft;

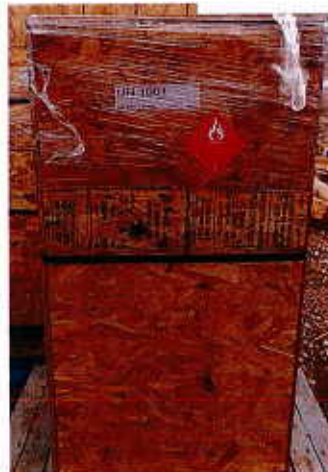
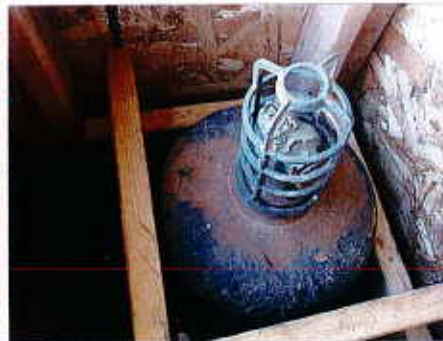
Packaging details: 1 acetylene cylinder with no original protective cap, specially prepared in a wood crate to protect the valve. Strapped, labelled and wrapped.

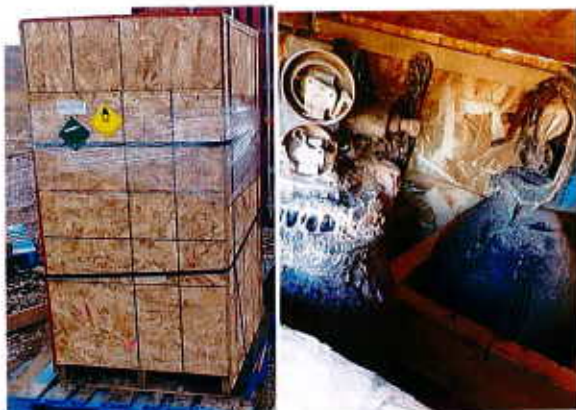
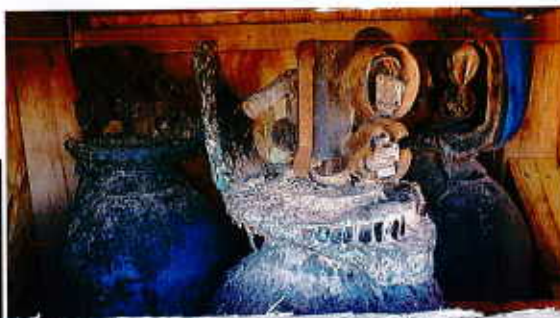
Packaging details: 3 oxygen cylinders with burned protective cap, specially prepared and separated in a wood crate to protect the valves. Strapped, labelled and wrapped.

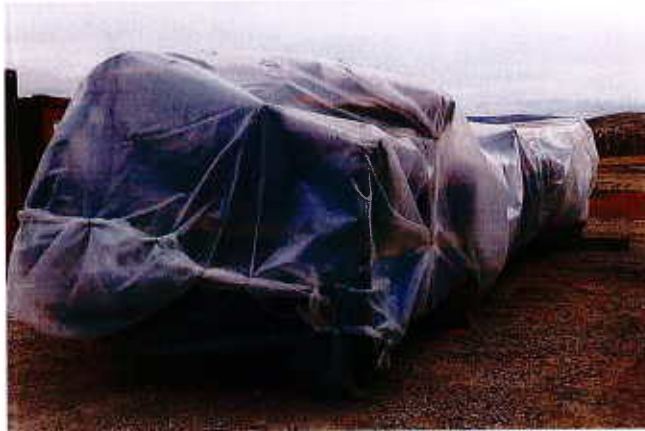
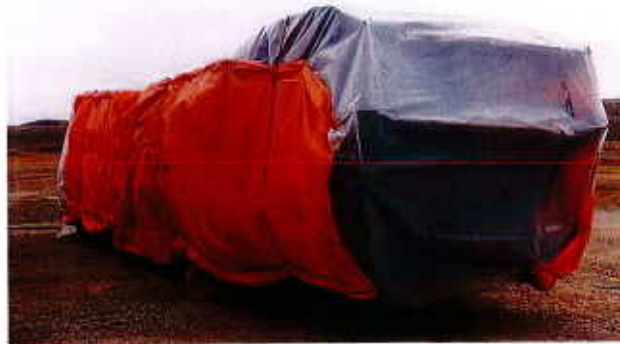
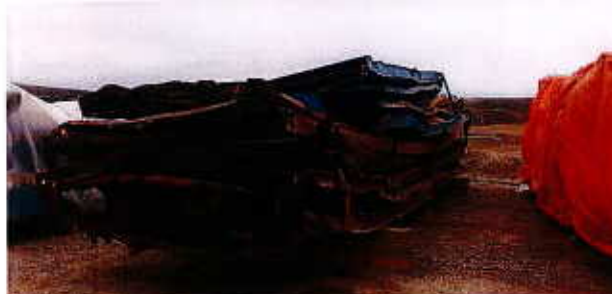
Packaging details: 3 packs consist of each 4x stacked crushed containers, welded at the 4 corners. 2 of them are wrapped as a precaution against soot staining.

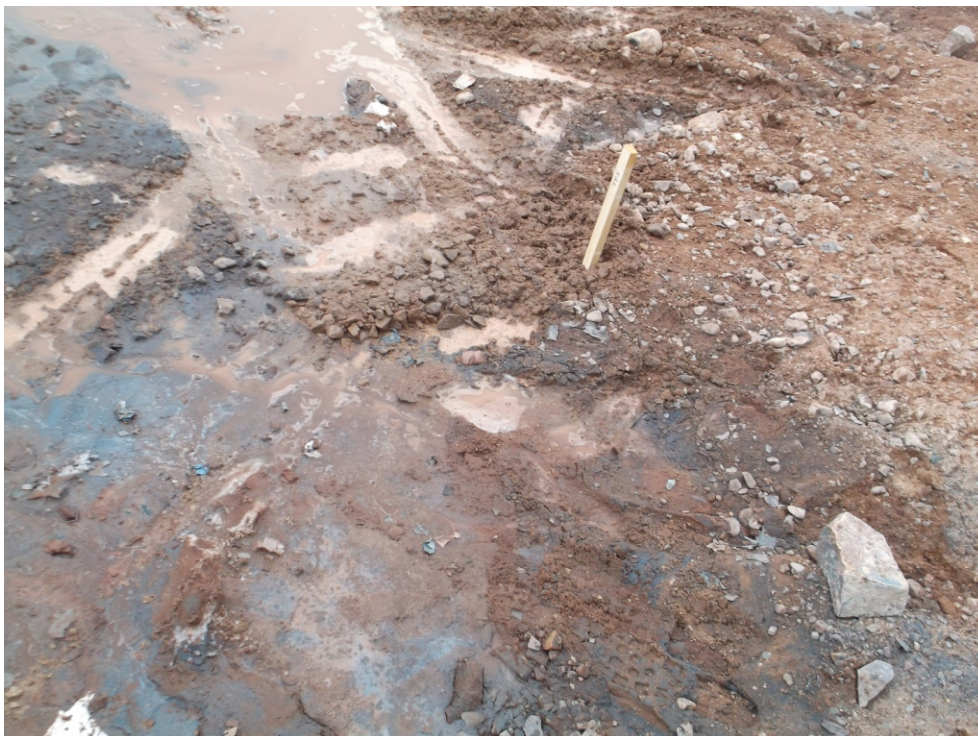
Photo 1

View of test pit TP5 where blue paint stains were visible on soil surface east of Seacan #110709.
