APPENDIX E.8
DECOMMISSIONING REPORTS

APPENDIX E.8.1
MILNE PORT NUNA SHOP

Technical Memorandum

To: Jim Millard
From: Lea Willemse
cc:
Date: March 19, 2016
Re: 2015 Nuna Shop Decommissioning Work

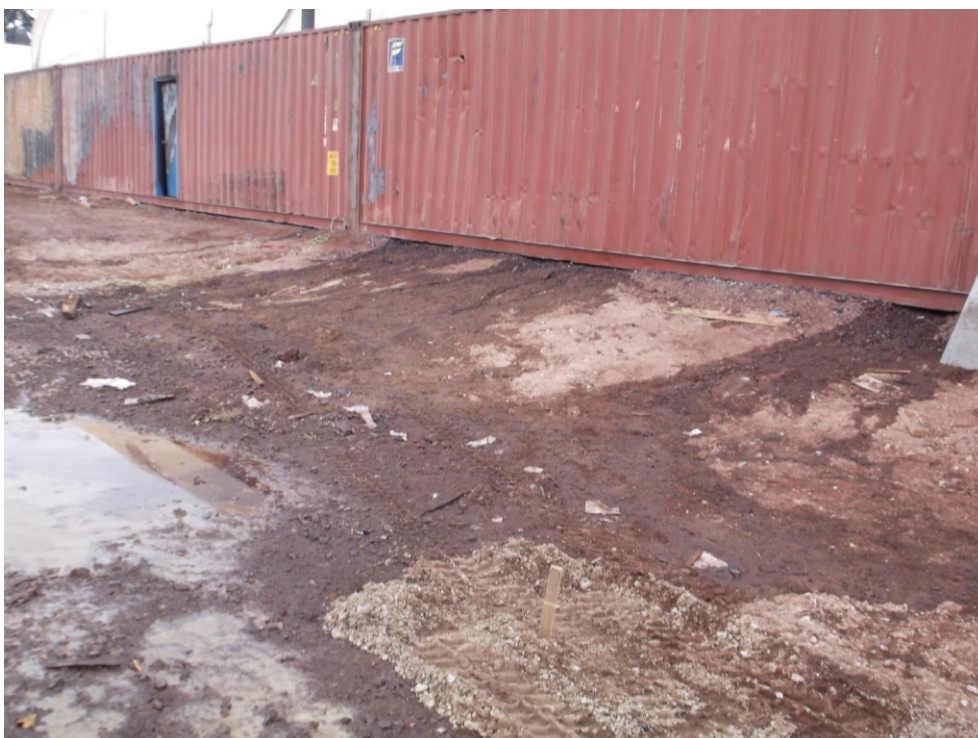
Photo 2

View of test pit TP7 where oil stains and LNAPL were visible on soil surface west of Seacan #901030.

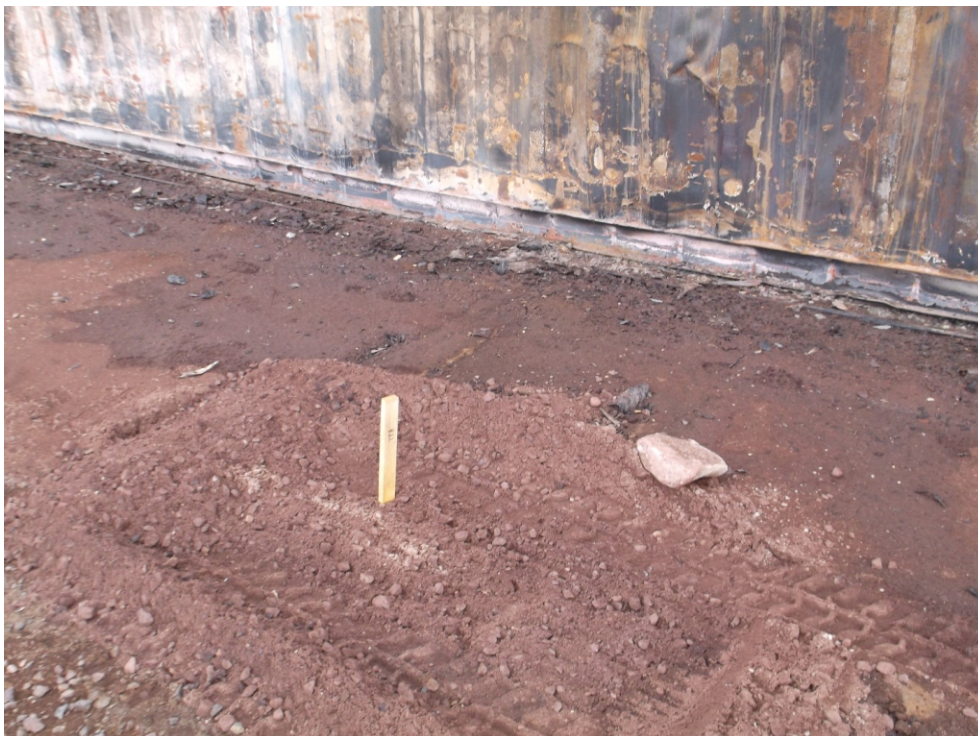
Photo 3

View of test pit TP8 where oil stains were visible on soil surface west of Seacan #BSC-1.

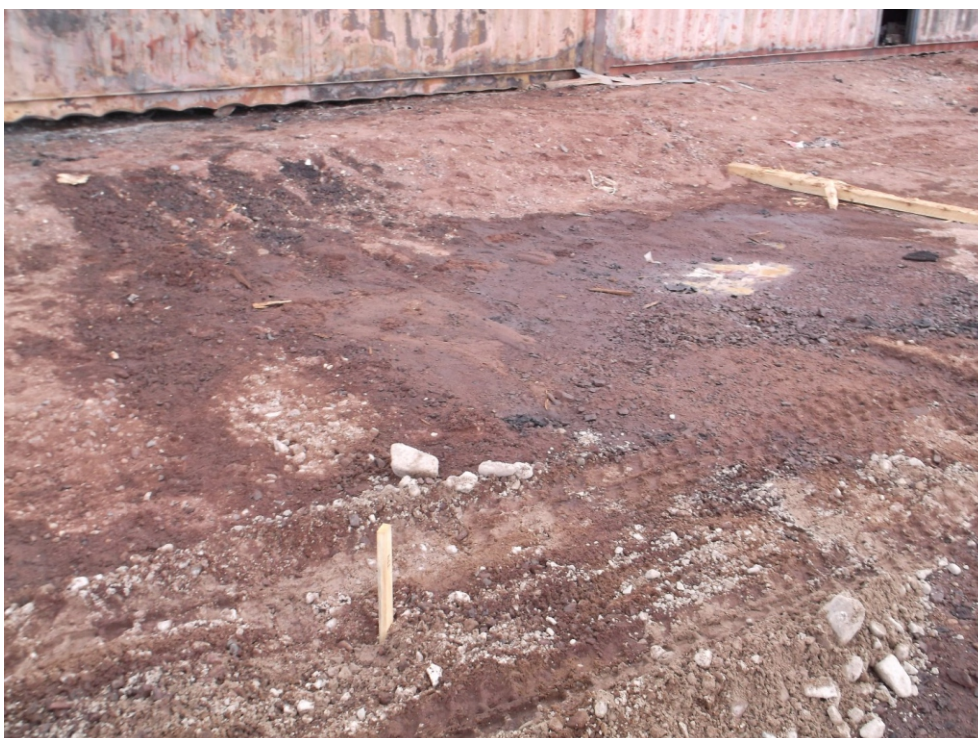
Photo 4

View of test pit TP9 where oil stains and LNAPL were visible on soil surface west of Seacan #BSC-3.

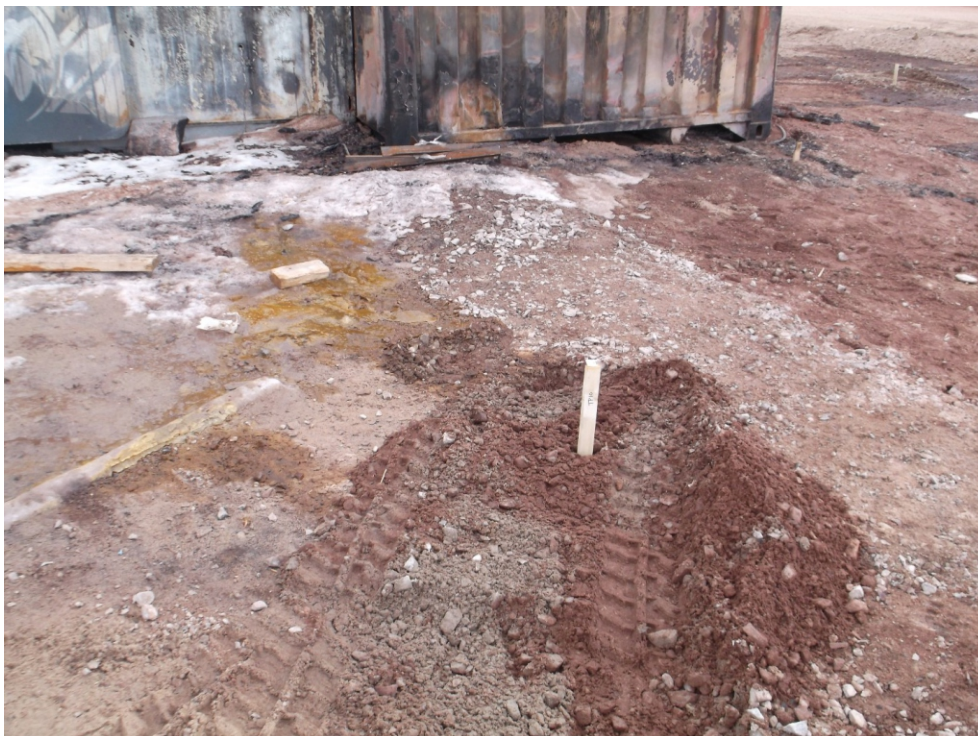
Photo 5

View of test pit TP10 where oil stains and LNAPL were visible on soil surface north of Seacan #BSC-4.

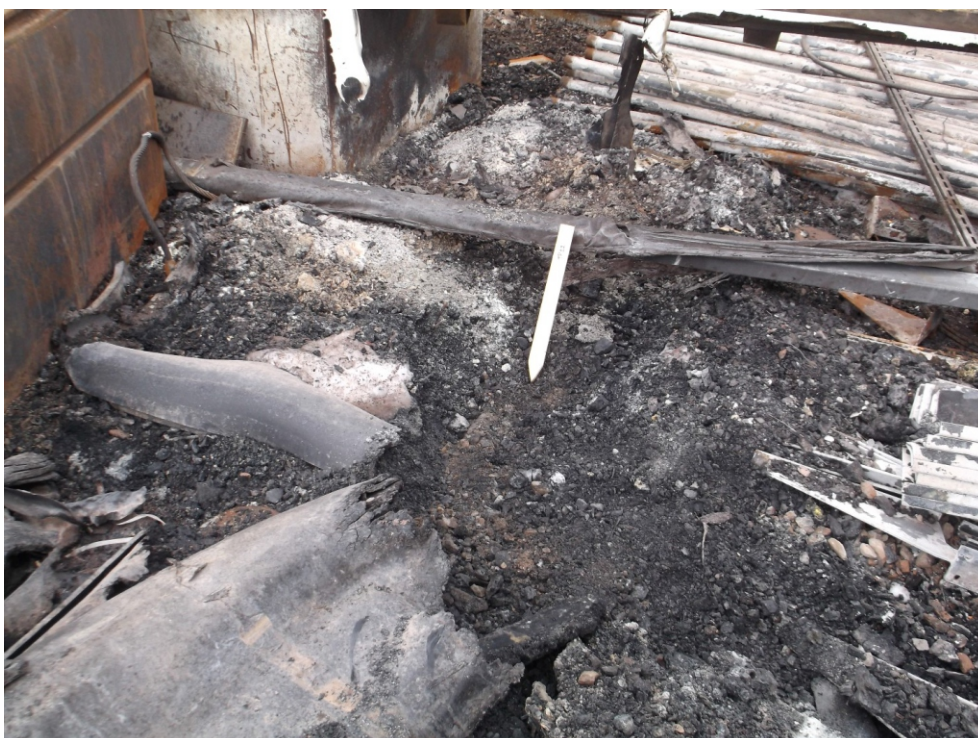
Photo 6

View of test pit TP11 where residual materials (ash) were visible on soil in the materials storage area.

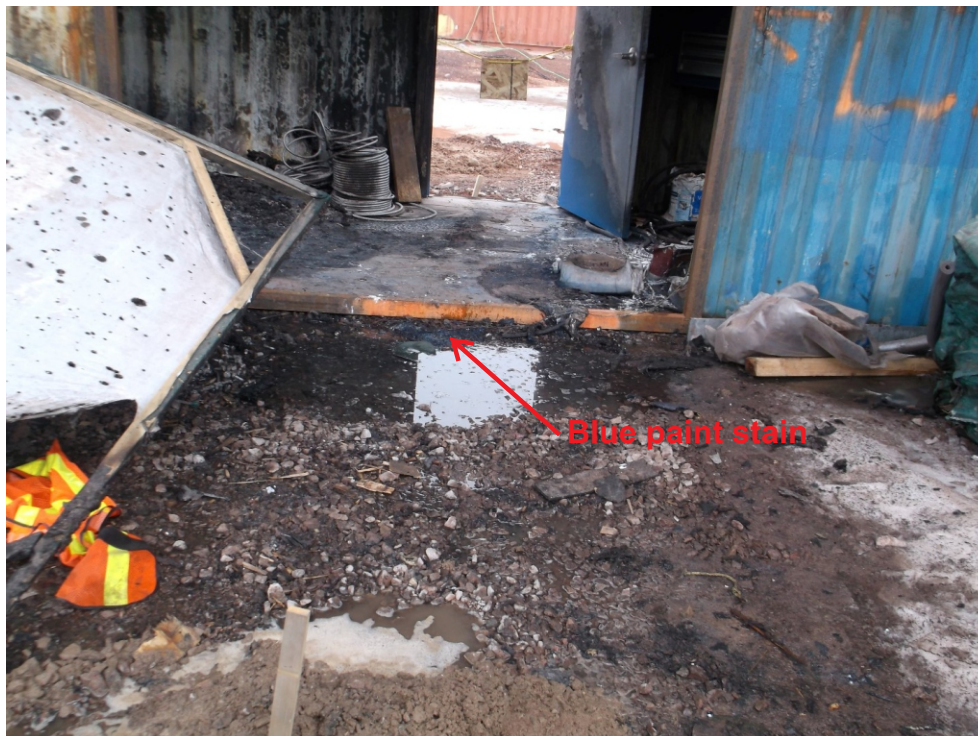
Photo 9

View of test pit TP14 where blue paint stains and ash were visible on soil surface in the materials storage area.

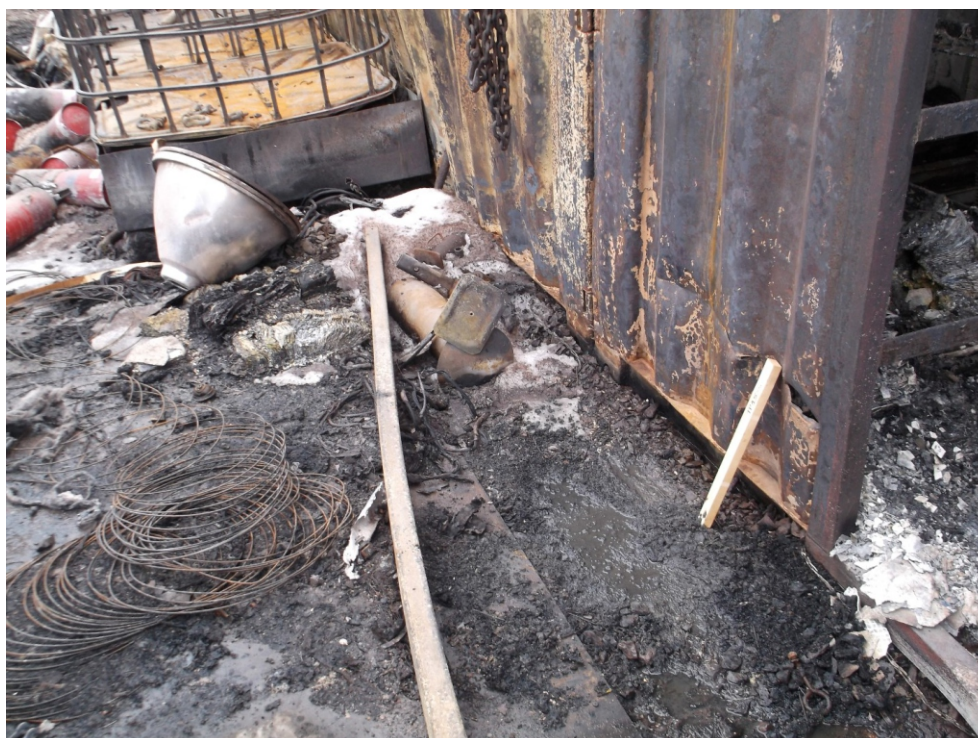
Photo 10

View of test pit TP15 where oil stains were visible on soil surface near oil storage tote tanks.
