Re: 2011 Flyover Inspection of 2BE-MSX0712 (Silvermet Inc.)

Water Licence: 2BE-MSX0712 Silvermet Inc. Land Use Permit: 2007J0012 (Valley Lake)

> Inspection photographs –July 10, 2011 (taken by WRO A. Keim; notations by WRO M. Joy)

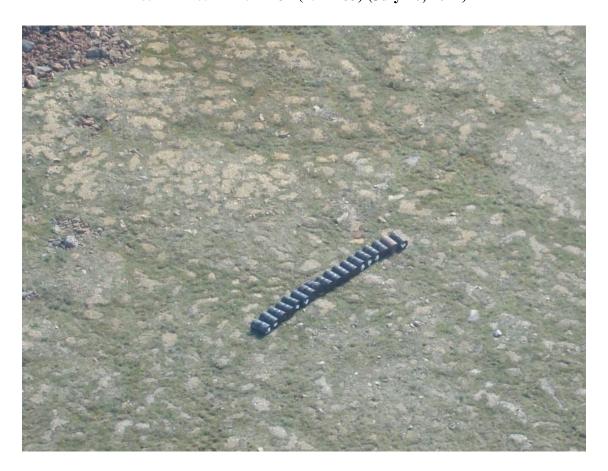
In addition to the state of the camp site, another fuel cache was identified approximately a half mile away from the camp at coordinates N66° 59' 17" W114° 54' 13" (NAD 83). It contained approximately 18 barrels of fuel.

Photograph 1: Aerial view of fuel cache near Silvermet camp at coordinates N66° 59' 17" W114° 54' 13" (NAD 83) (July 10, 2011)

Silvermet is to address these issues in their Compliance Plan, as requested with the distribution of the 2010 Inspection Report, emailed and sent via registered mail on March 13, 2012.

This Plan is to provide a current record of progressive reclamation activities and is to include the development of a more comprehensive Plan with firm dates for implementation. Coordinates of all drill sites and fuel caches are to be included, as well as proof of reclamation at these sites. Any work the company has already undertaken to correct deficiencies is to be documented and provided to the Inspector and the Nunavut Water Board.

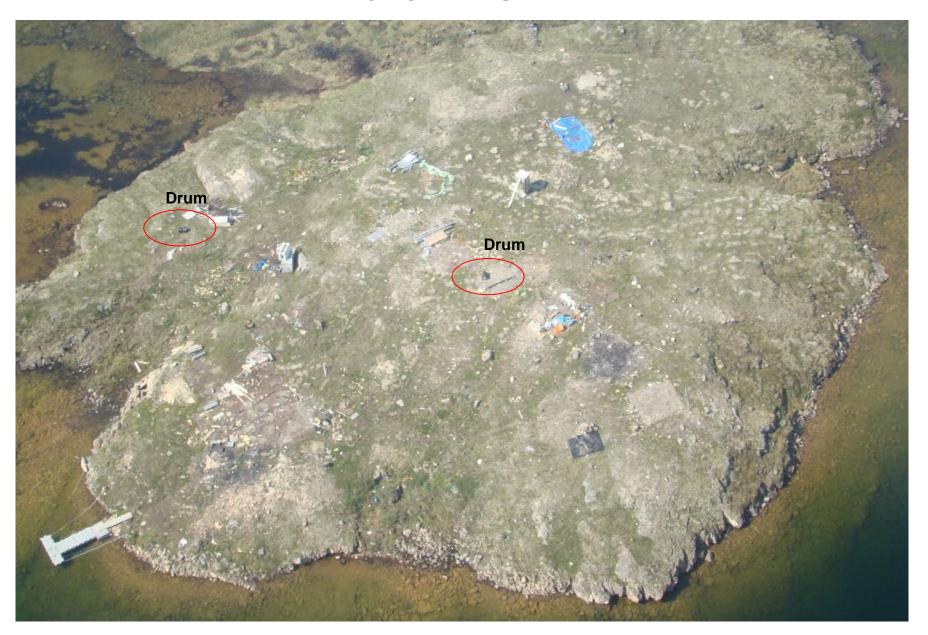
On July 11, 2011, Water Resource Officer Andrew Keim conducted a flyover inspection of the Silvermet/Muskox camp. As per our photographs (enclosed for your reference) site structures appear to have been dismantled; however several drums were still visible, along with extensive garbage and debris.

Photograph 2: Aerial view of 2BE-MSX0712, Silvermet camp (July 10, 2011) –Main structures and most drums removed; garbage and debris prevalent
