WATER USE INSPECTION FORM

☒ Original  
☐ Follow-Up Report

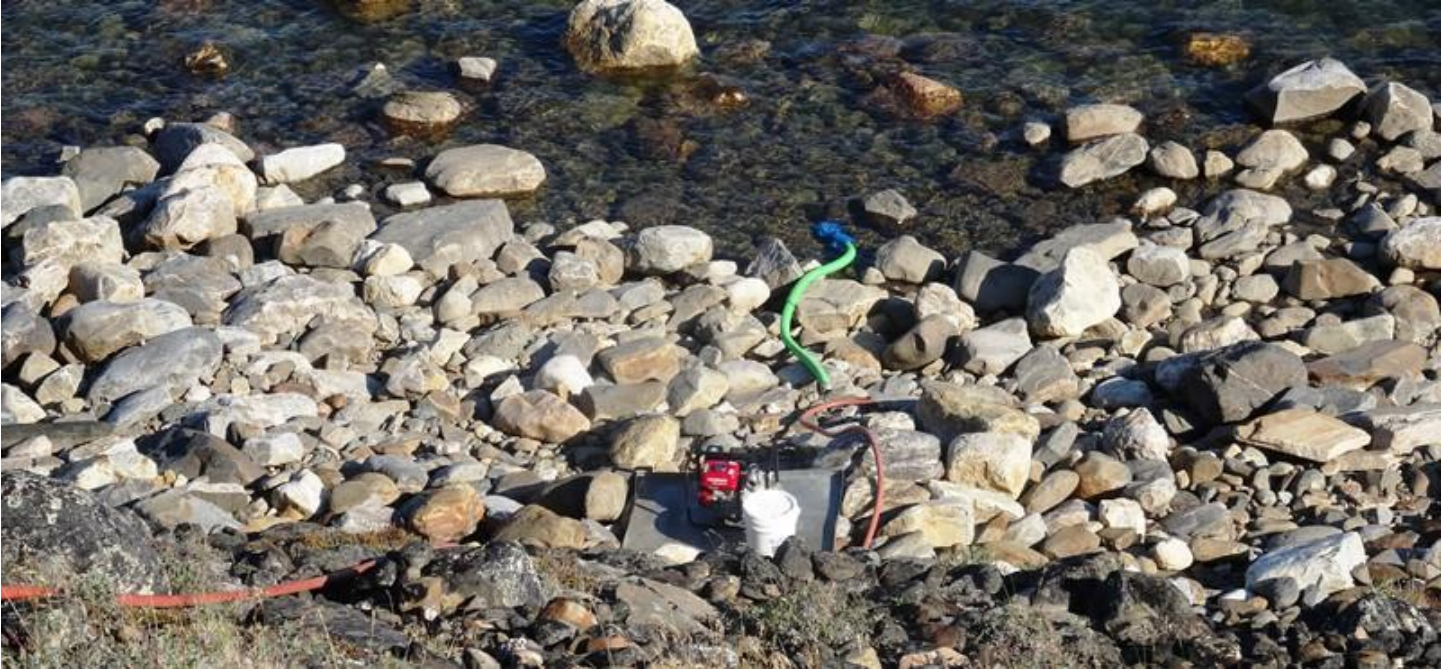
Photo 2: Water pump with intake screen in blue.

3. No erosion to banks or sedimentation was occurring as observed related to this use of water.			
4. There was a screen attached to the pump hose (see <i>Photo 2</i> ).			
Waste Disposal

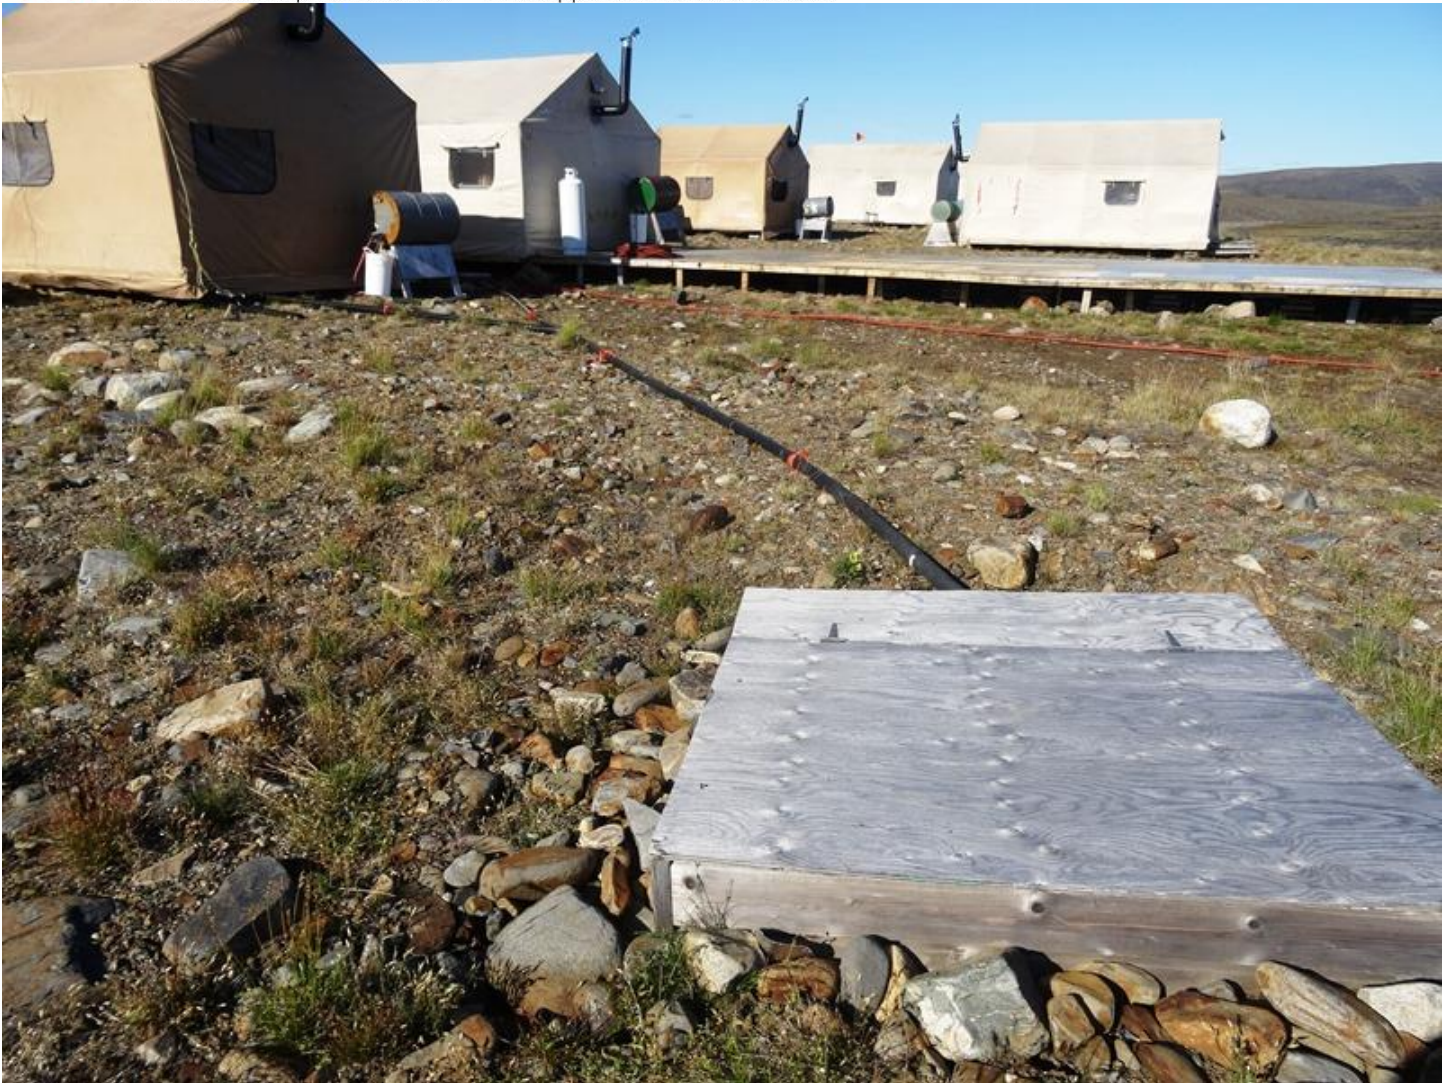
Photo 3: Sump where greywater is discharged.

5. Greywater was being directed to a sump located greater than 31m from the stream (see <i>Photo 3</i> ).			
6. Solid waste was not being stored in a way in which it would likely effect inland waters.
