NWB Annual Report

Year being reported: 2009 ▼

Project Name: Nanuq Project

Licensee: Peregrine Diamonds Ltd.

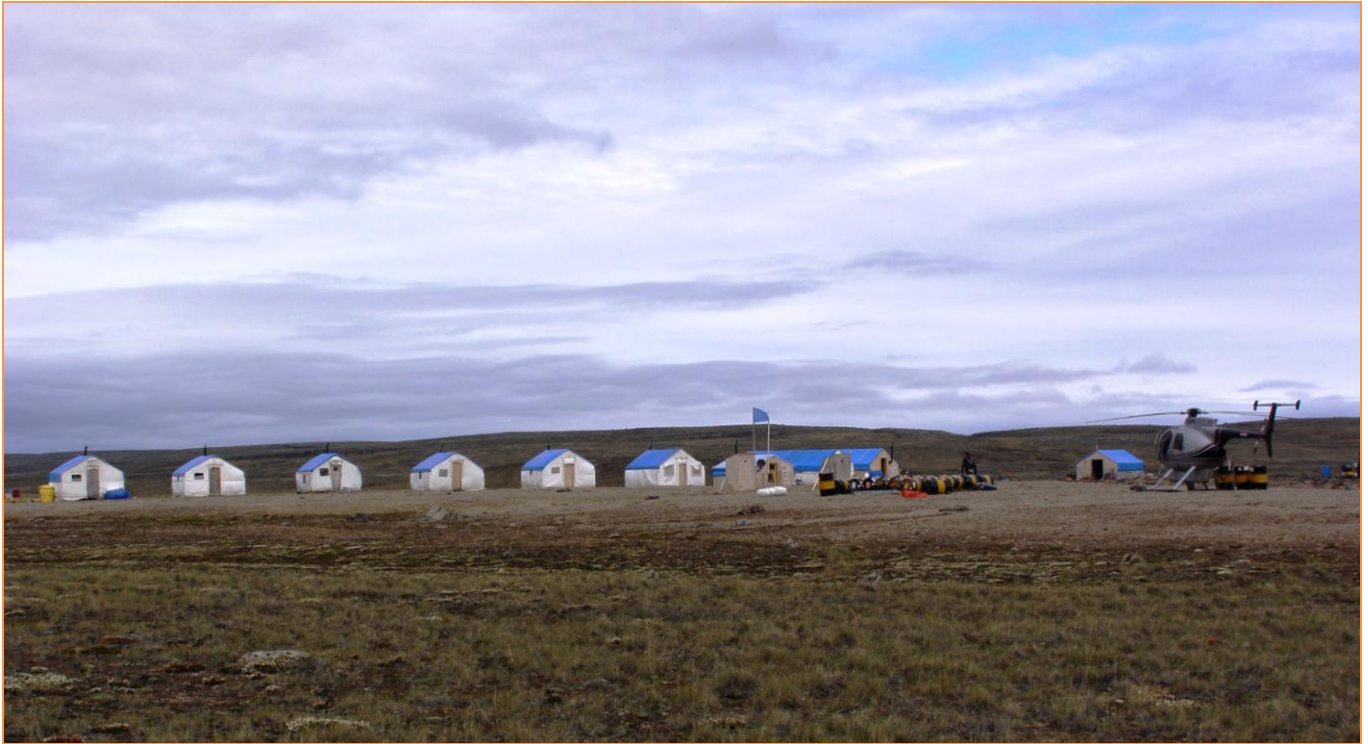
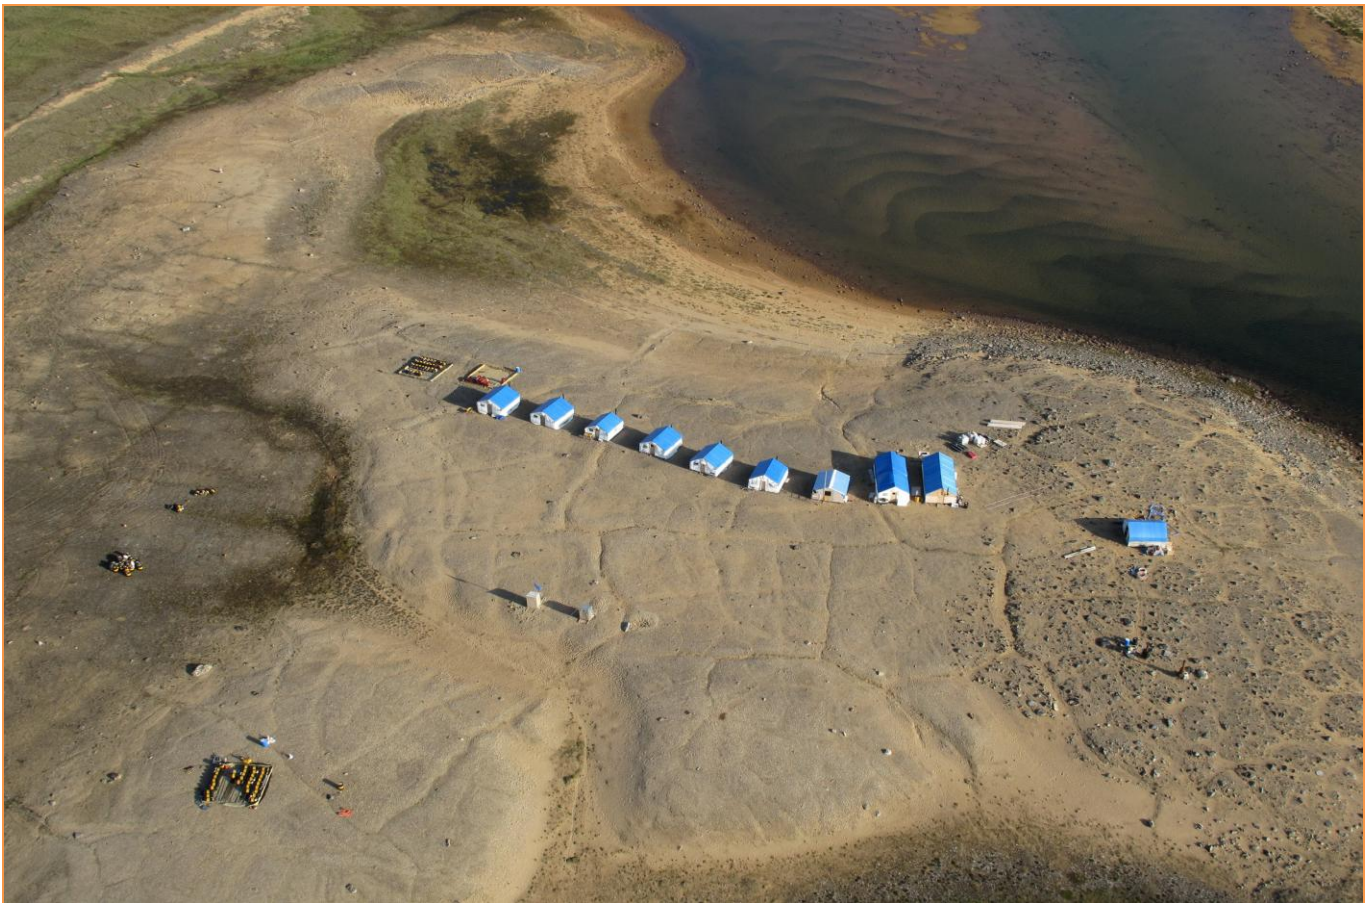
TOP: Nanuq Camp looking north – July 2009. ABOVE: Aerial view of north end of sandy outwash plain where Nanuq Camp is located – August 2009; Lorillard River at top of photo.

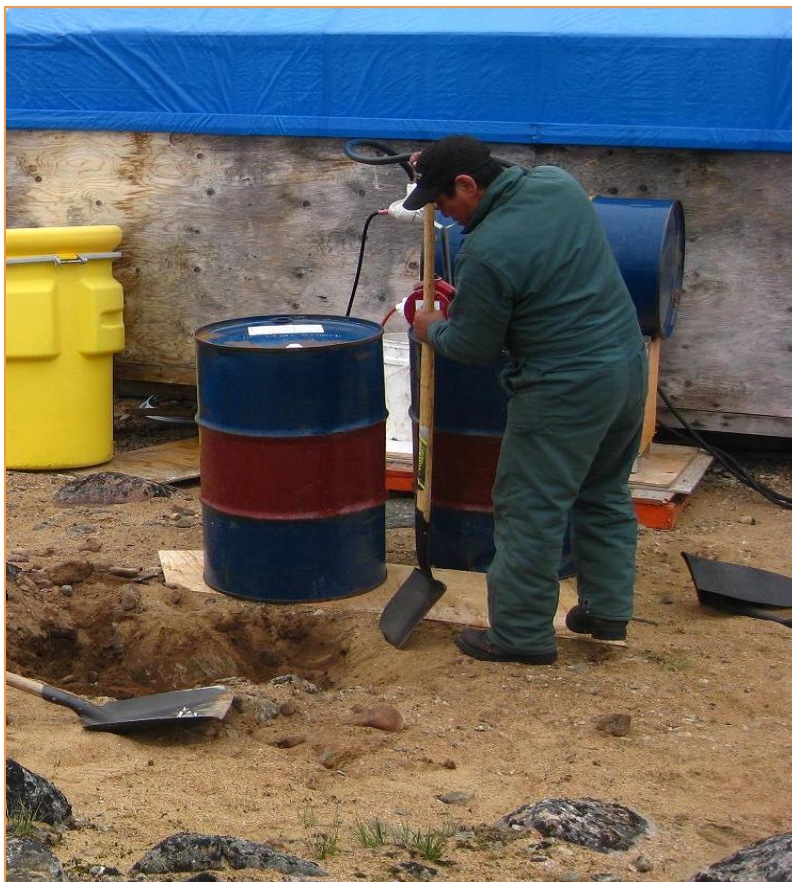
TOP: Camp attendant Hugh Haqpi of Repulse Bay excavates small hydrocarbon spill on 07 July 2009. Refilled petrol drum had leaked over winter from small rupture on its side. ABOVE: Material excavated from diesel spill (when leakage occurred from a faulty bung over winter) was aerating successfully in a wooden box behind camp in late July 2009.

Discovered leak from 2 drums (80L diesel, 15L petrol) when camp reoccupied 07 July 2009; reported to Spill Line, 08 July; formal rpt. to inspectors, 10 July. No impacts to water. Contaminated sand dug + aerated on tarps. Petrol dissipated. Diesel had begun to dissipate with aeration + was bagged in heavy plastic + rice bags, stored in diesel berm over winter. A land farm will be part of new Rankin landfill, and could become destination of dug material if not aerated on site. Alternatively, if arrangements are made with a Registered Waste Receiver in Winnipeg, material could be containerised and shipped out to Receiver.

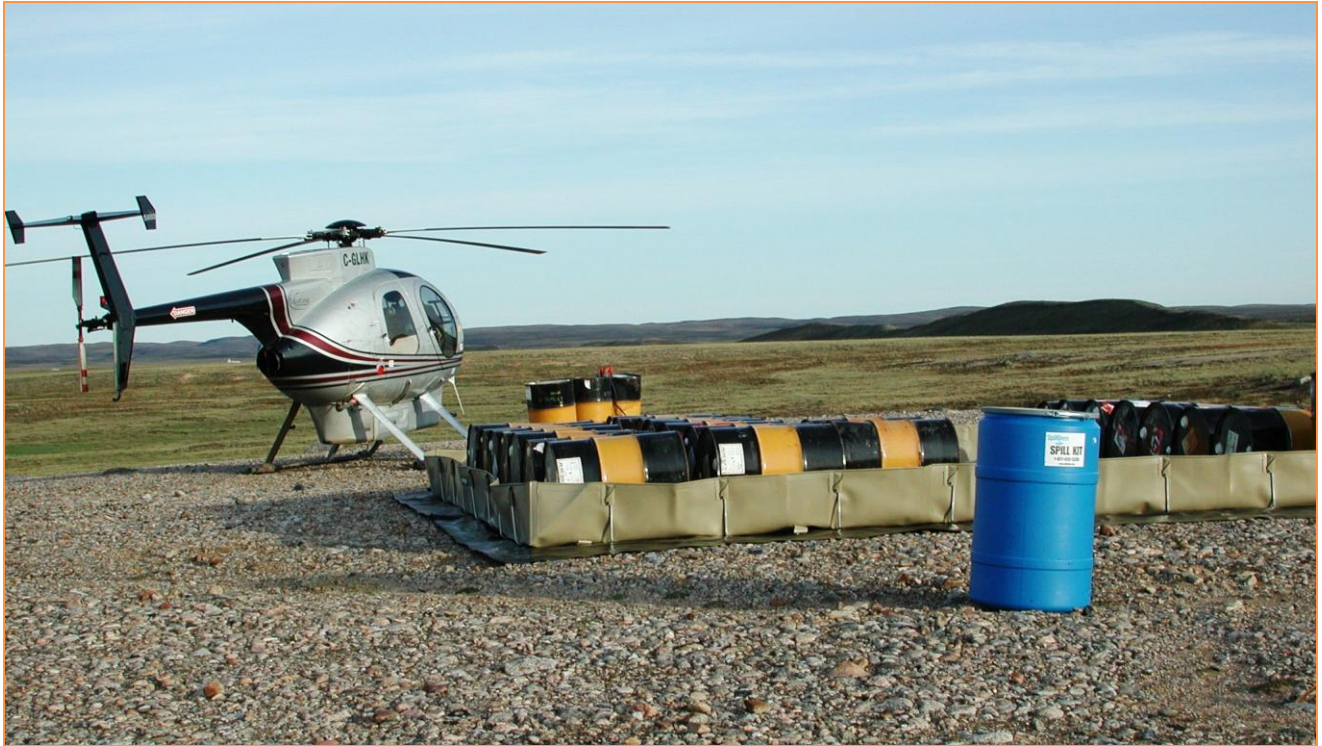
TOP: Looking south to Jet-B Insta-Berm and spill kit – July 2009. ABOVE: Field supervisor and Rankin Inlet technician collect and sieve a till sample on Nanuq claimblock – July 2009.
