Advanced Explorations Inc.

ROCHE BAY MAGNETITE PROJECT ENVIRONMENTAL BASELINE STUDIES 2006 MARINE AND AQUATIC RESOURCES

1740183.005

September 2007

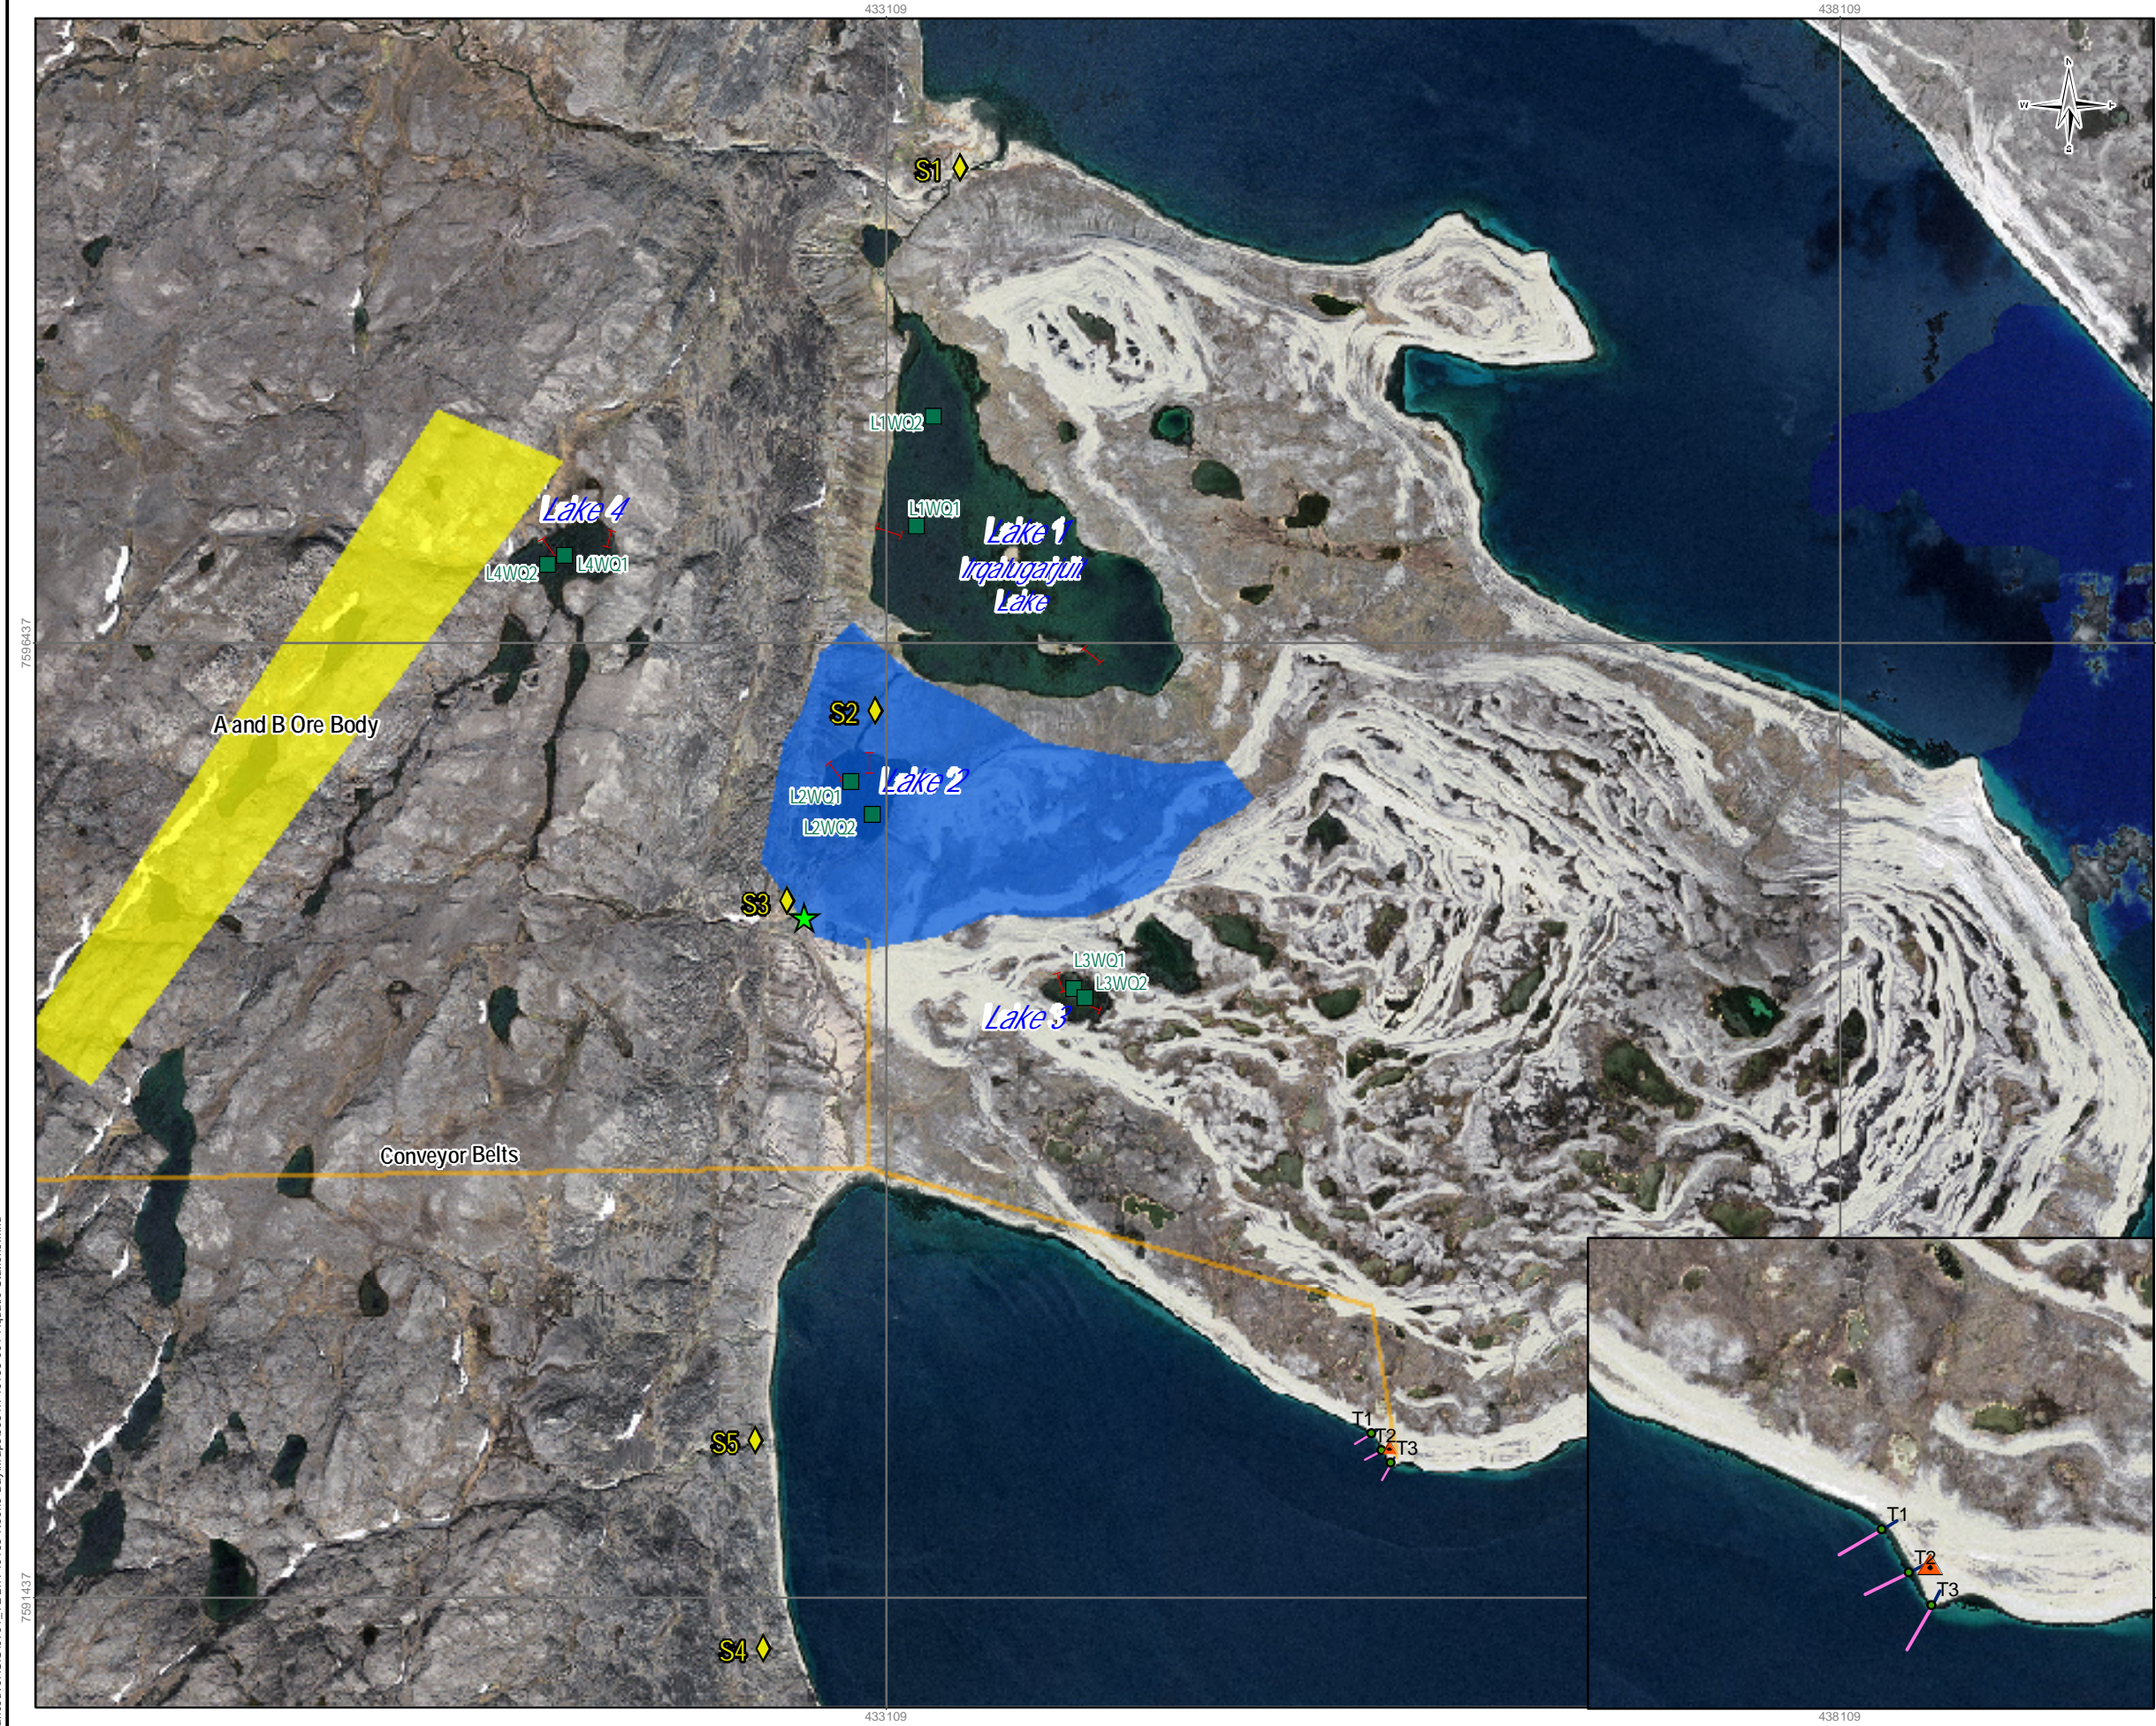
1 Scale: 1:35,000 0.5 Kilometers			
FILE No: 1740183-005-Aquatic-Stations		DATE: June 27, 2007	
JOB NO: 1740183-005	REVISION NO: 0		Figure 2
OFFICE: EBA-VAN	DRAWN: MEZ	CHECK: TA

- Water Quality Sampling Locations
- Camp
- Transect Locations
- Proposed Dock Location
- Stream Sampling Locations

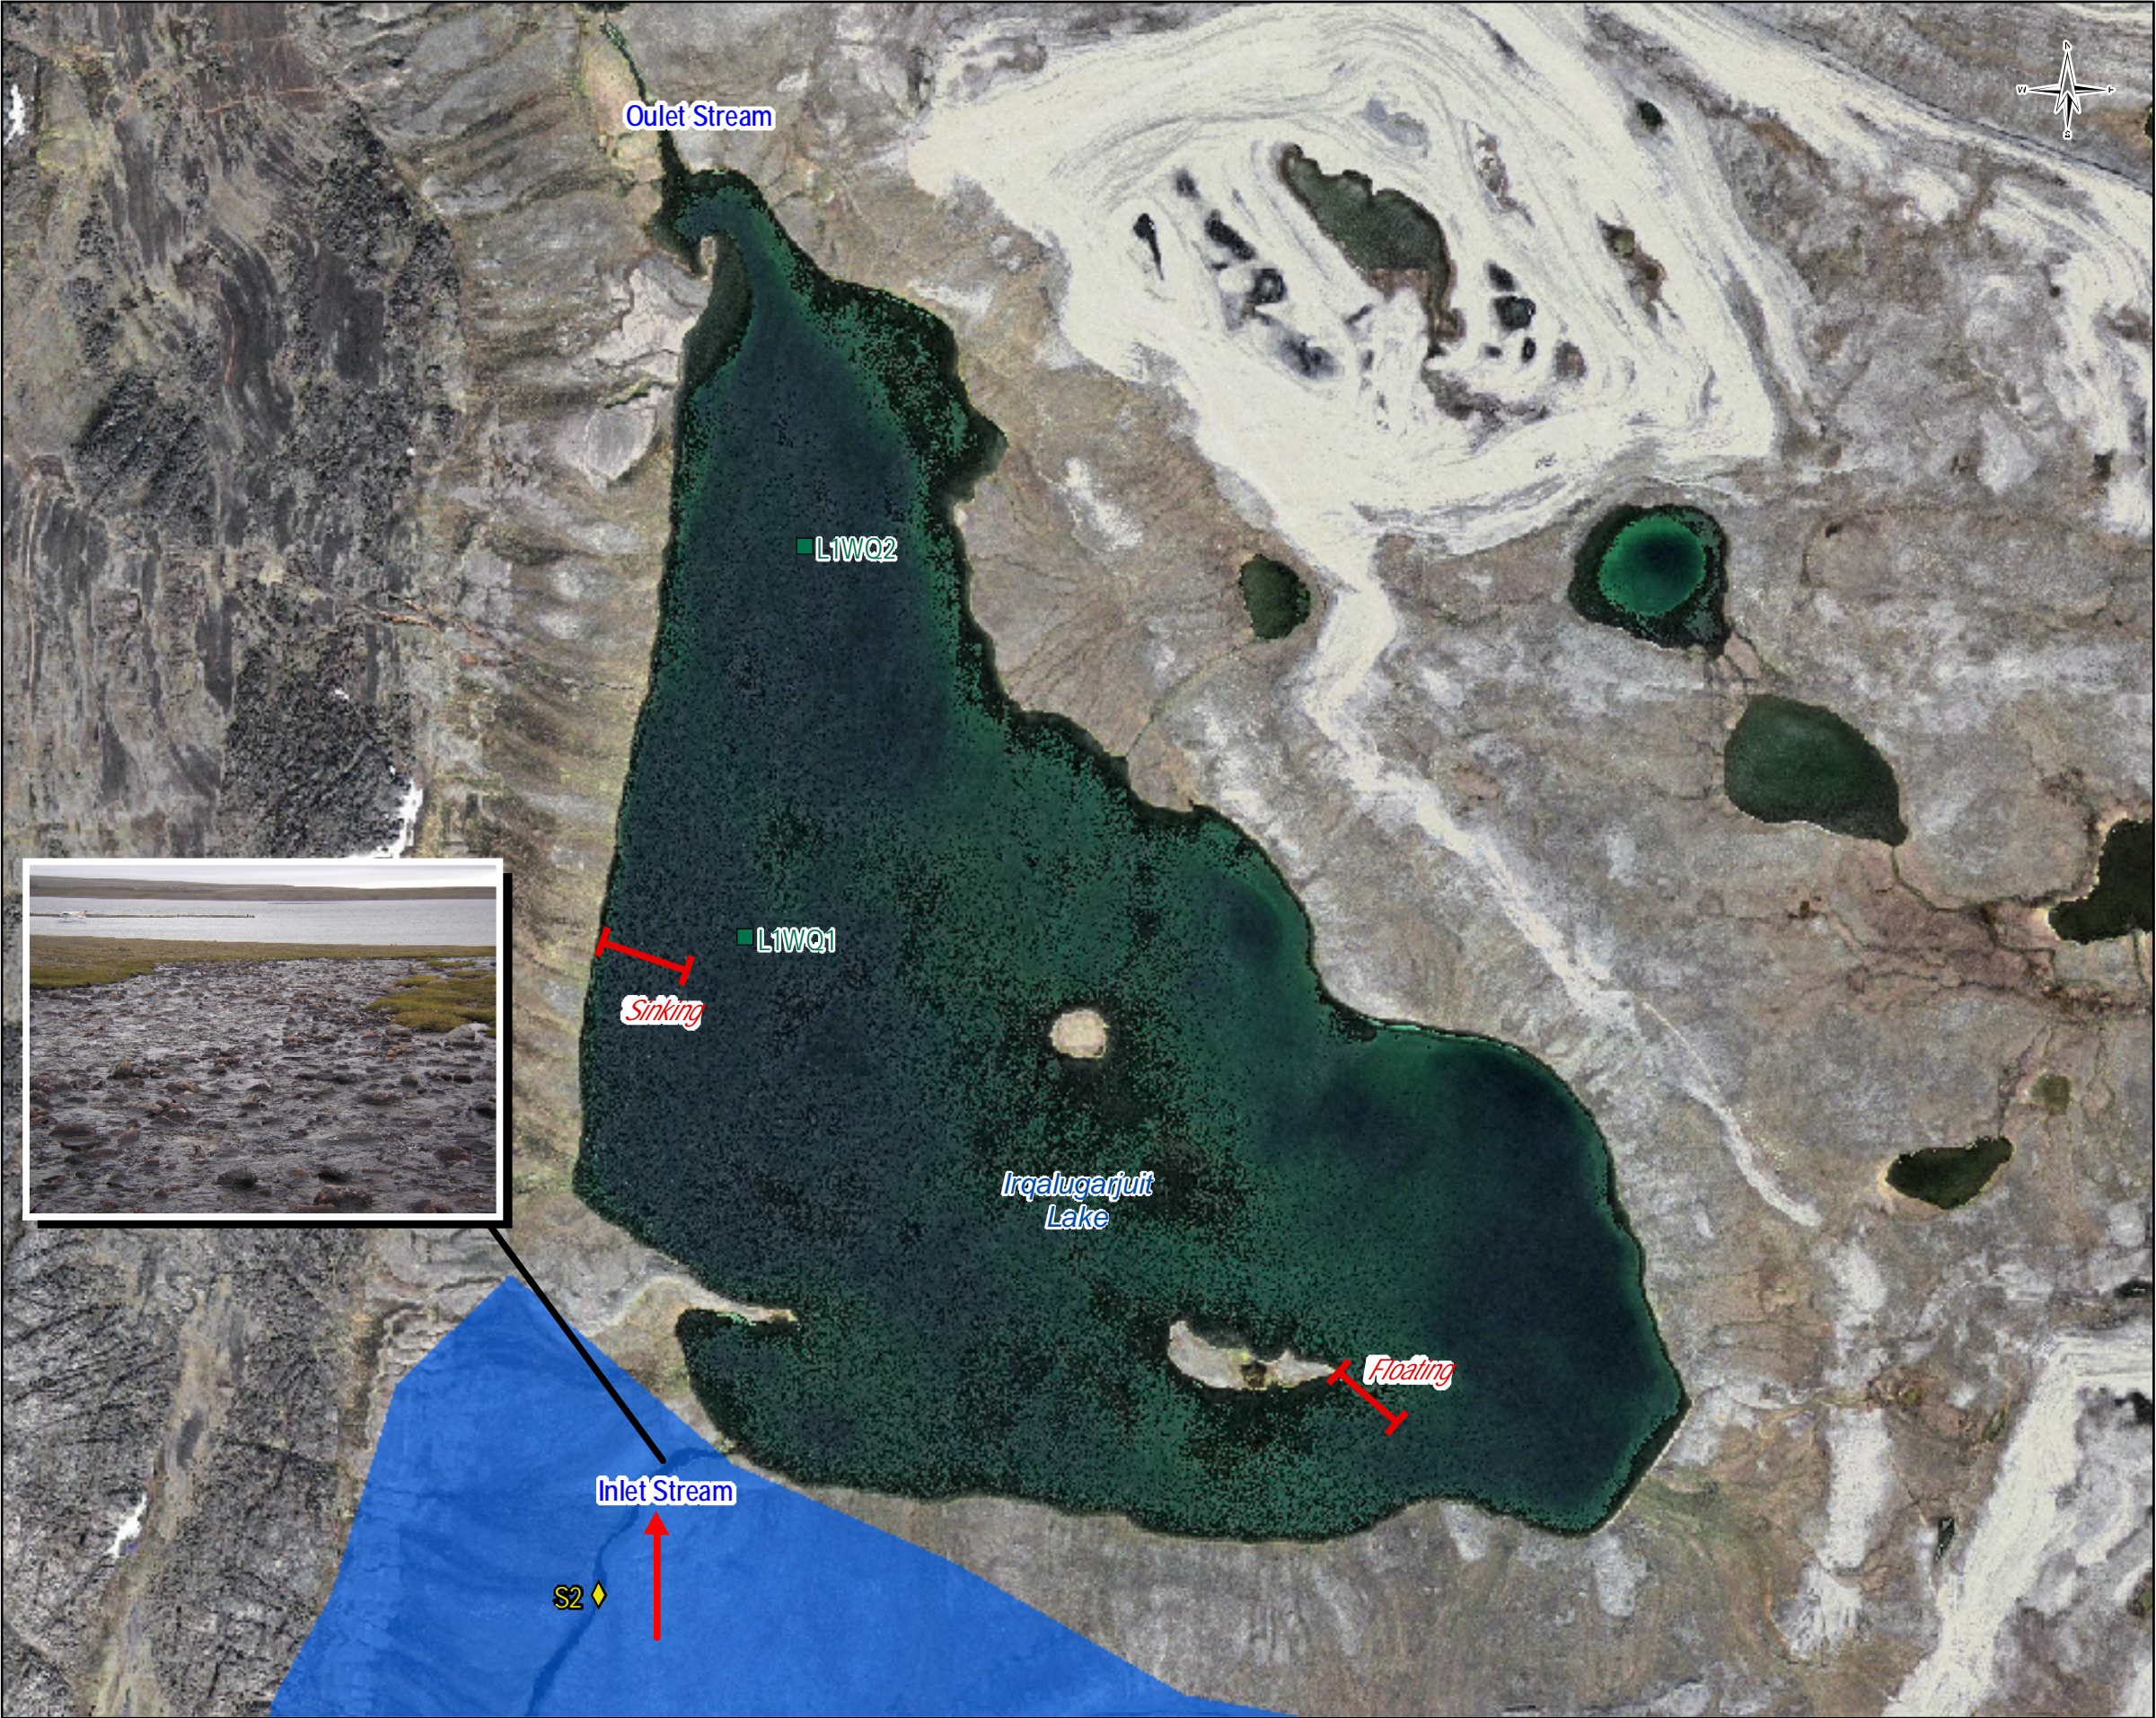
Figure 3

- Water Quality Sampling Locations
- Stream Sampling Locations
- Gill Net Locations
- Proposed Tailings Pond Area

Field physical water quality sampling data from two locations in each of the lakes are described below and presented in Table 3. Water quality sampling locations in the lakes sampled are shown in Figures 3-6. Due to their relatively shallow and exposed condition, the water column of all of the lakes sampled were well mixed and oxygenated with no discernable thermoclines.

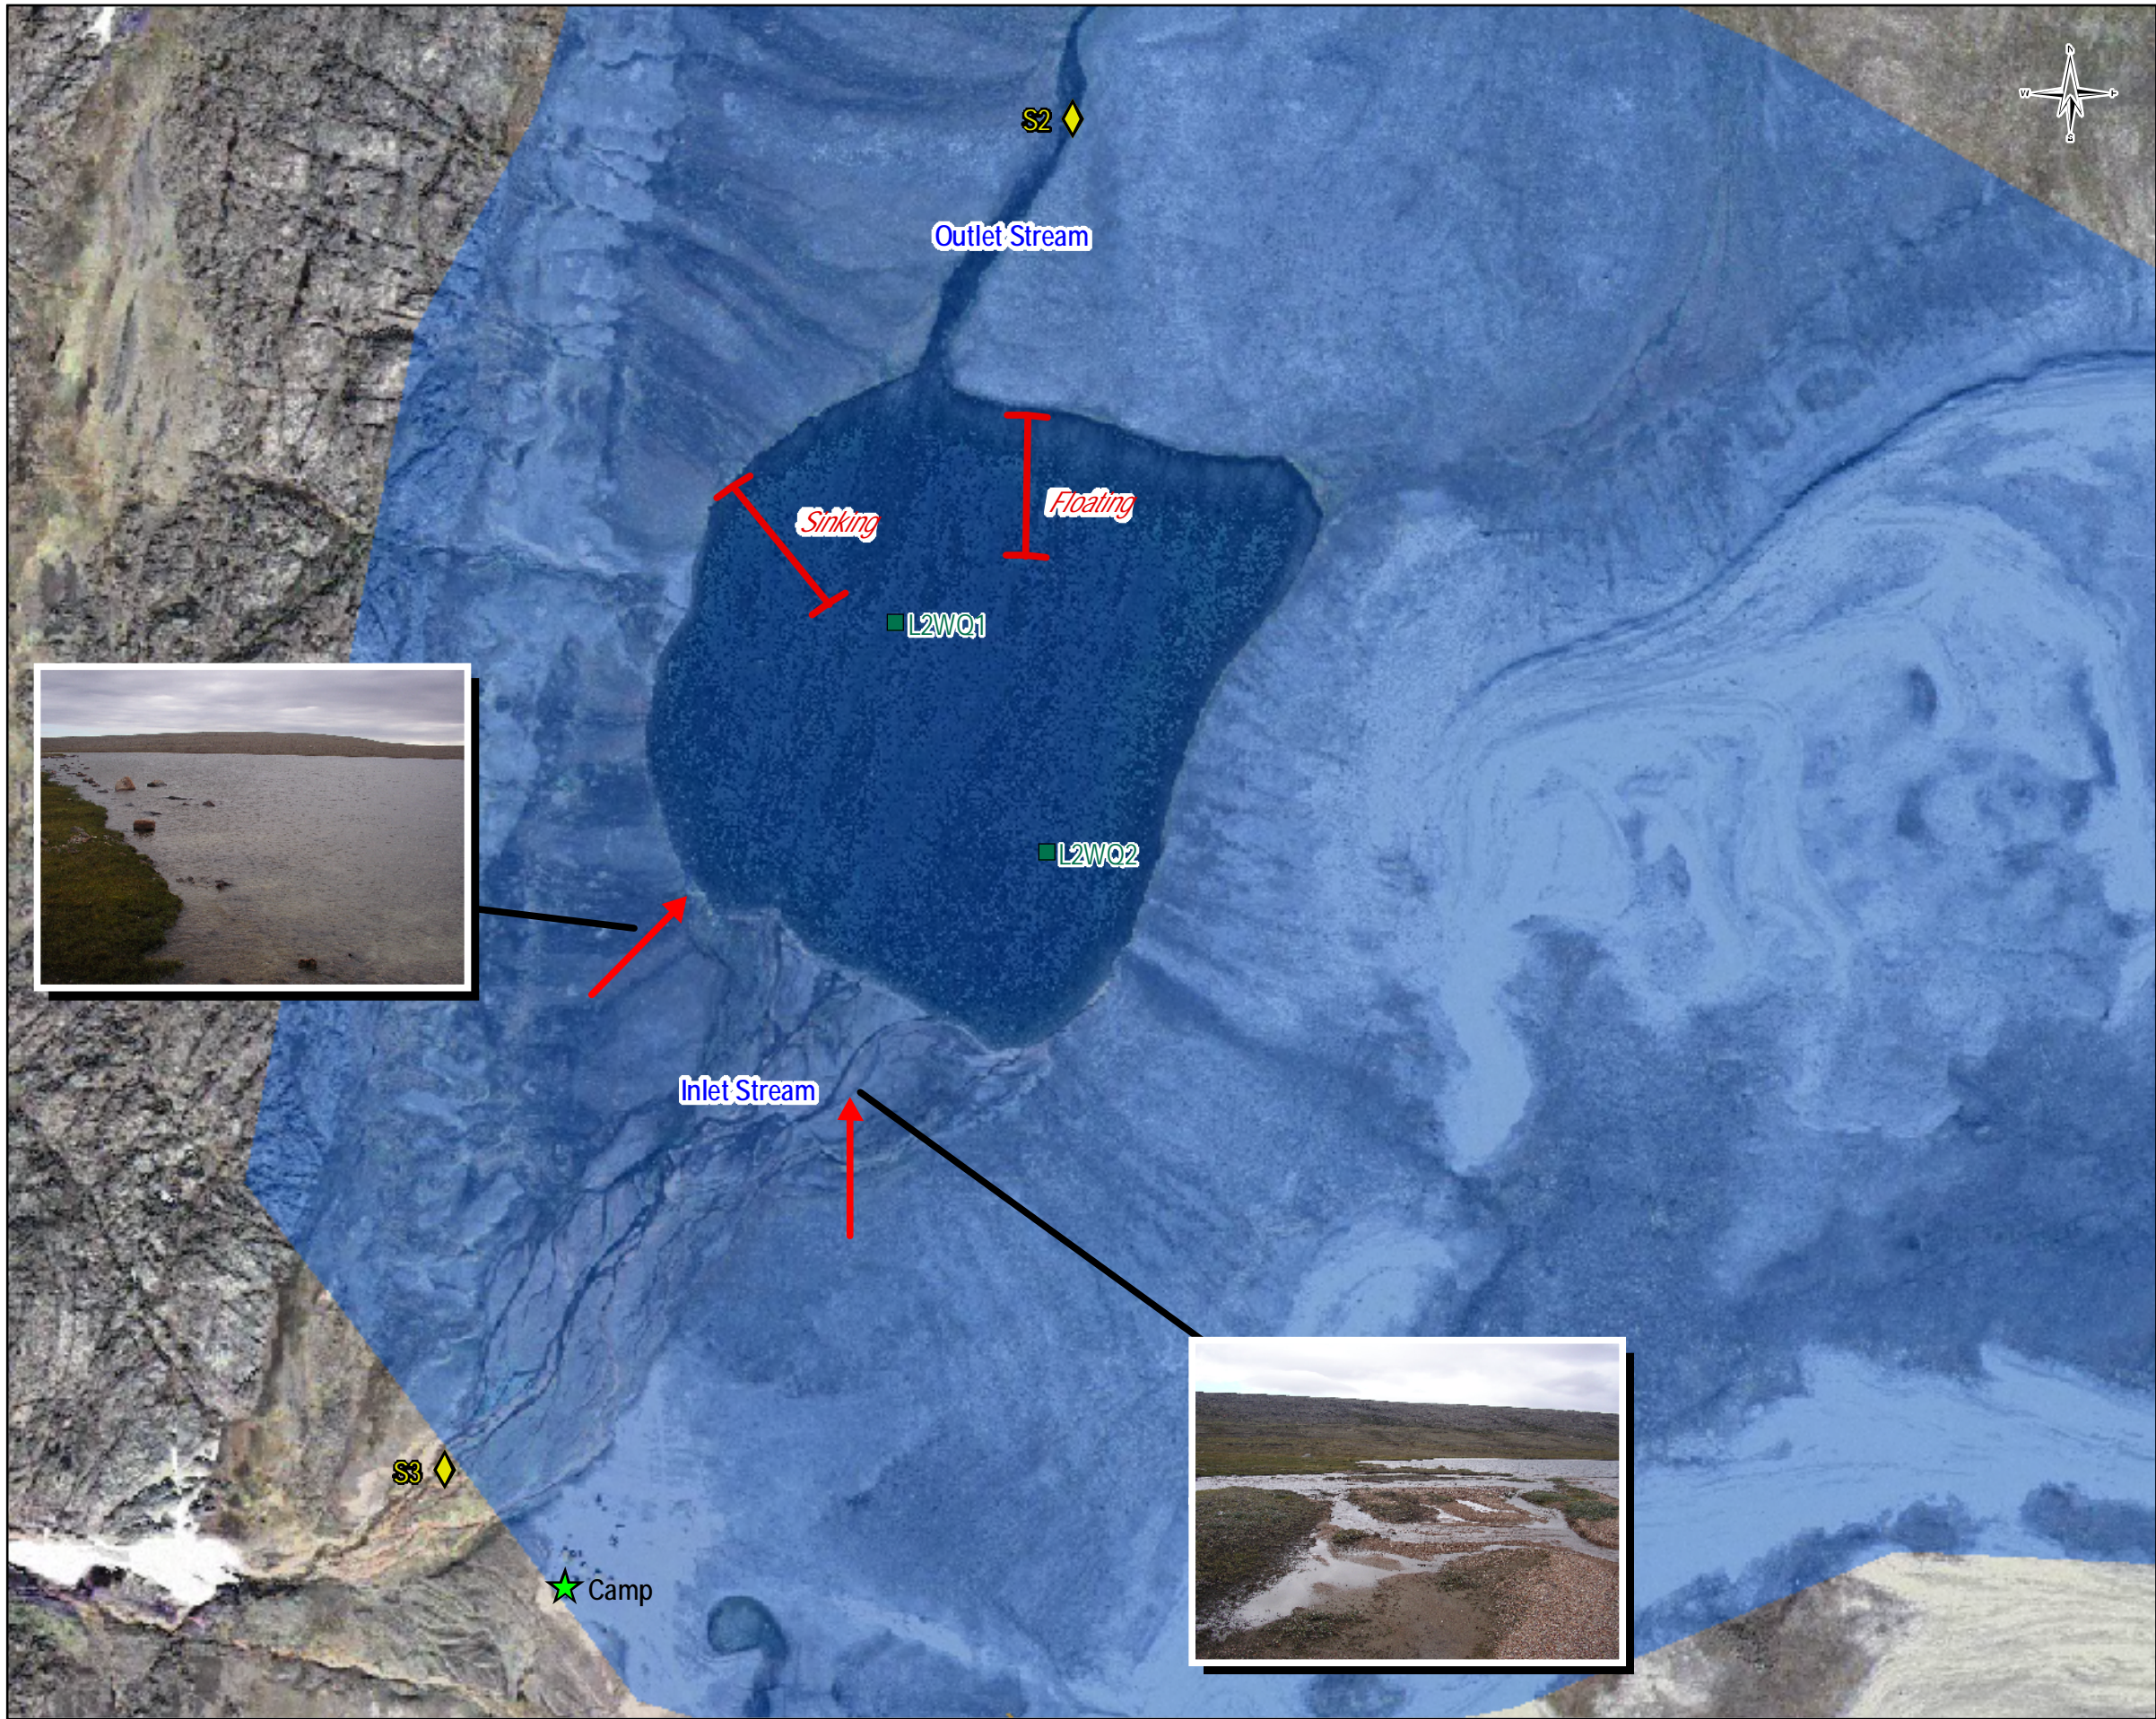
</div> <div>Meters</div>			
FILE NO: 1740183-005-Aquatic-Stations-Lake2			DATE: June 29, 2007
JOB NO: 1740183-005		REVISION NO: 0	Figure 4
OFFICE: EBA-VAN	DRAWN: MEZ	CHECK: TA

- Water Quality Sampling Locations
- Stream Sampling Locations
- Camp
- Gill Net Locations
- Proposed Tailings Pond Area

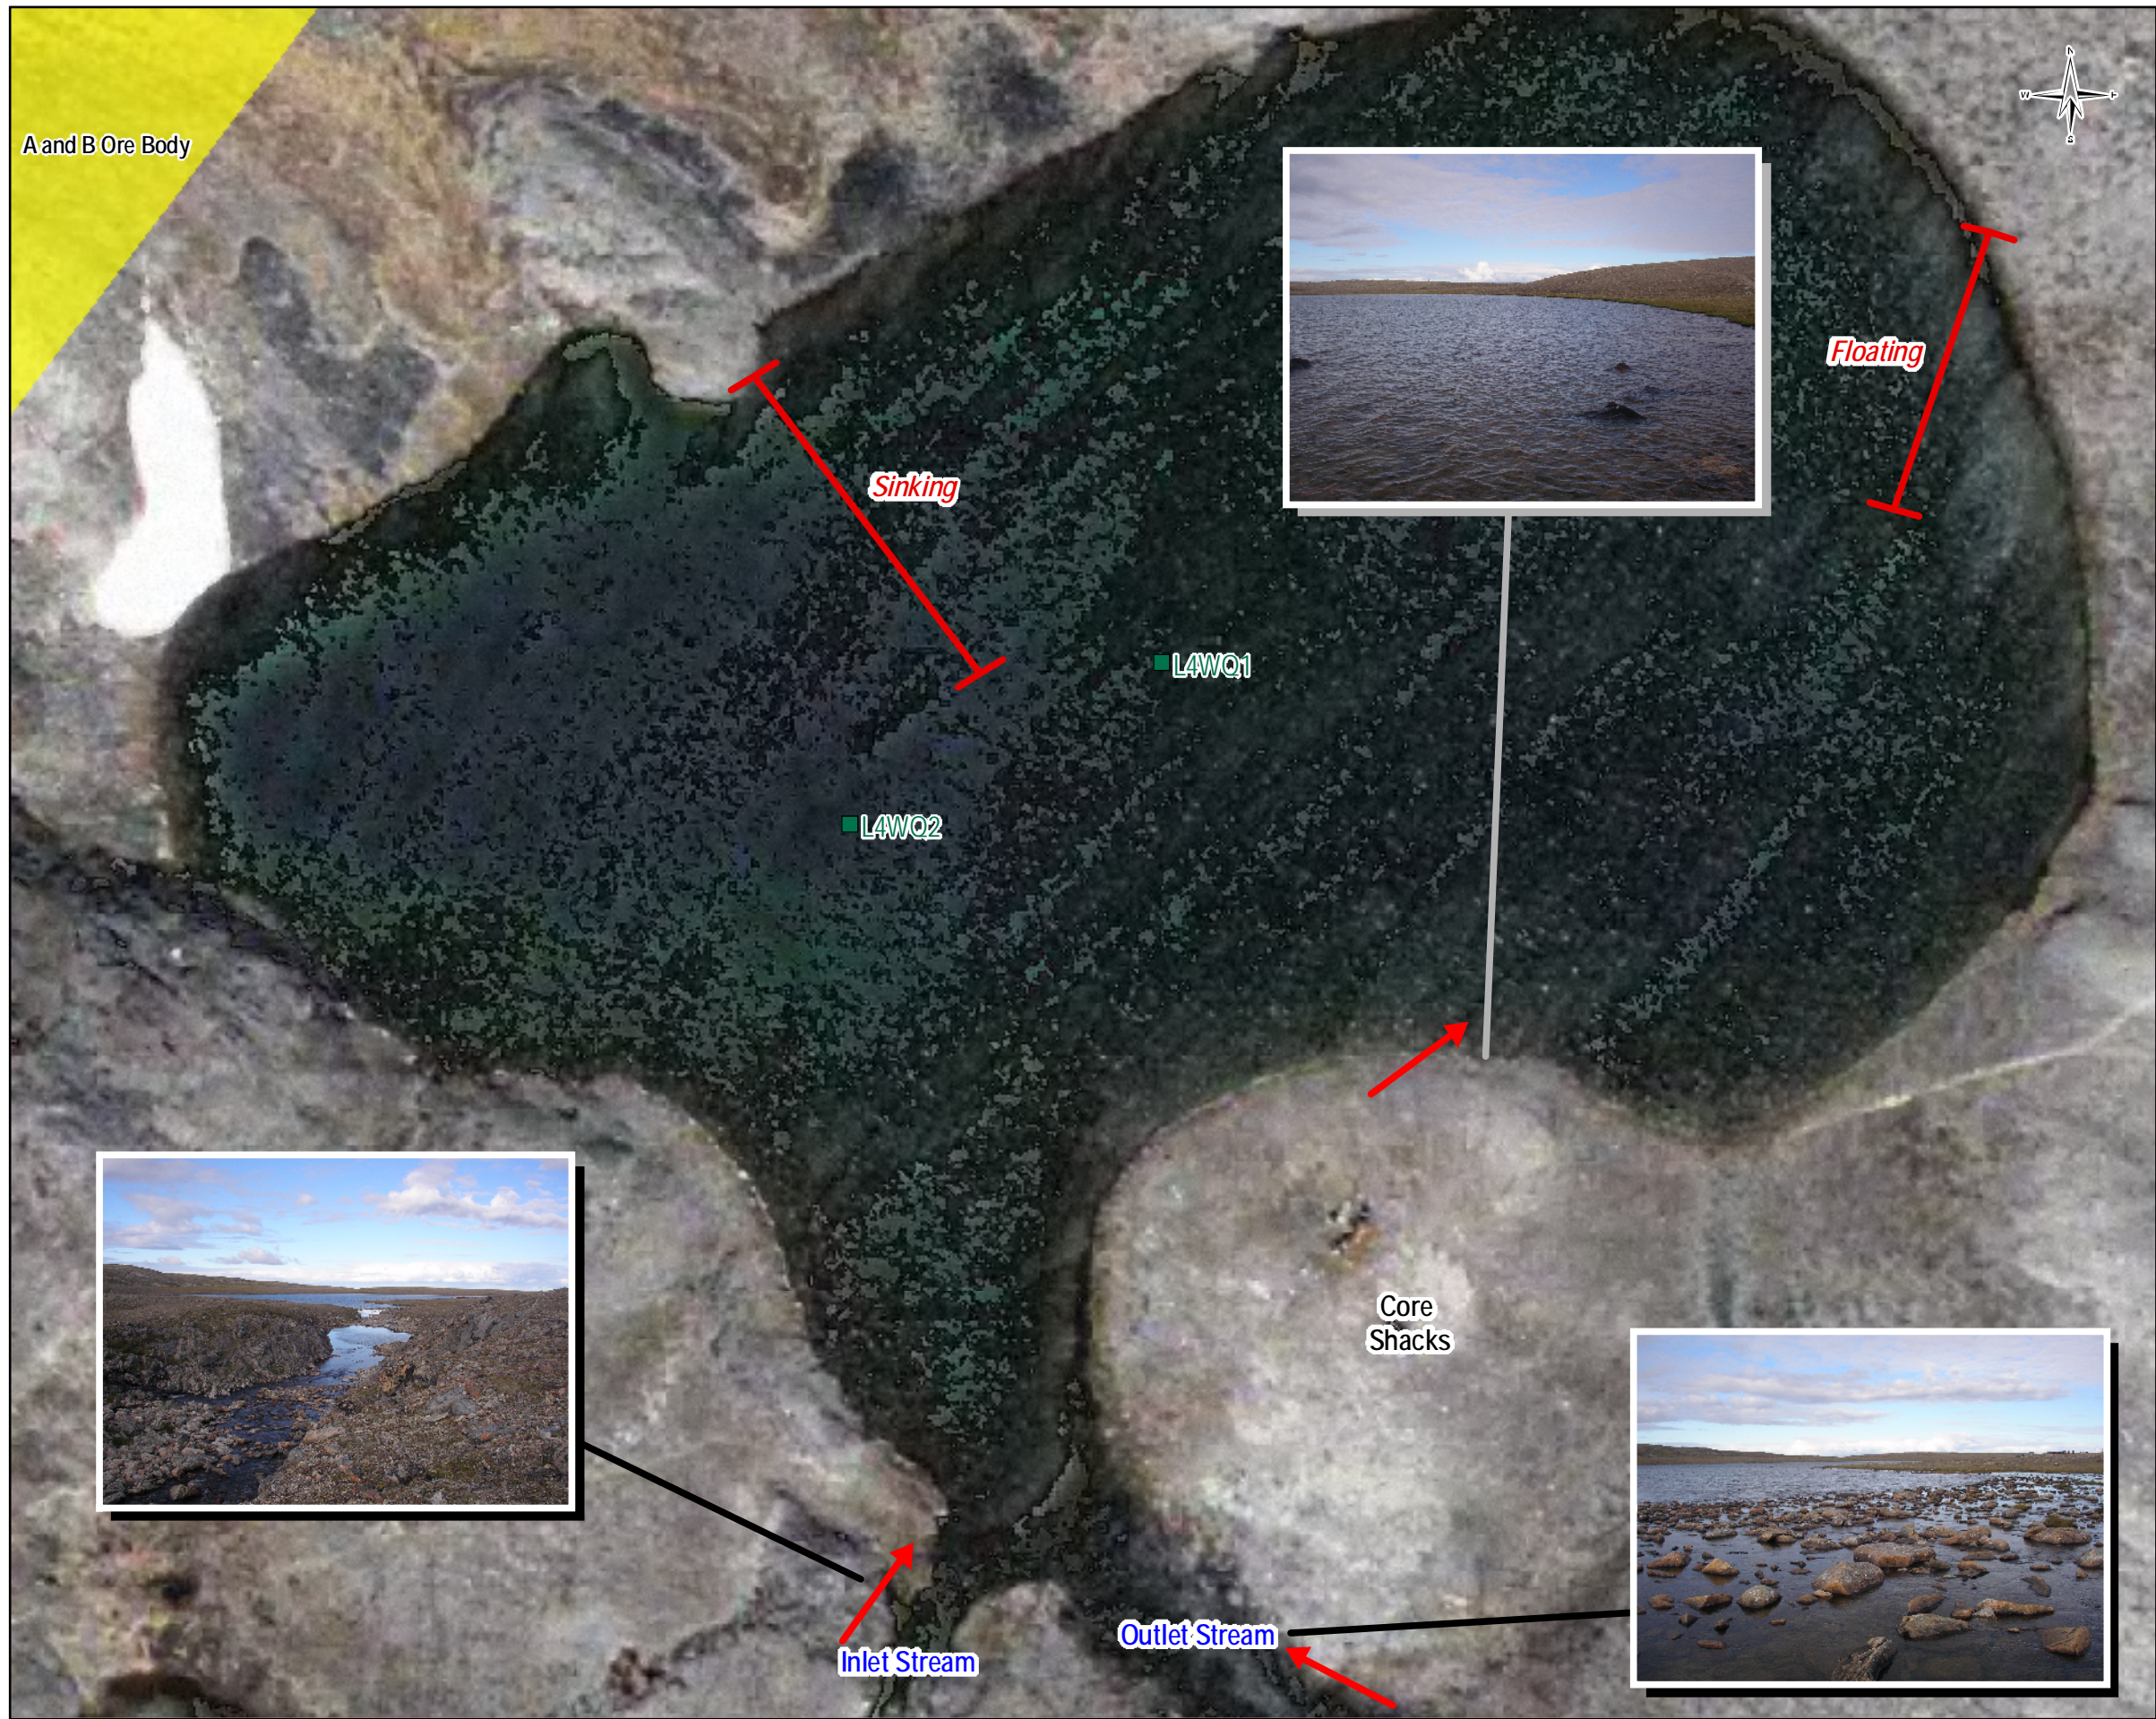
</div> <div>Meters</div>			
FILE NO: 1740183-005-Aquatic-Stations-Lake 4			DATE: June 29, 2007
JOB NO: 1740183-005	REVISION NO: 0		Figure 6
OFFICE: EBA-VAN	DRAWN: MEZ	CHECK: TA

- Water Quality Sampling Locations
- Gill Net Locations
- Ore-Body

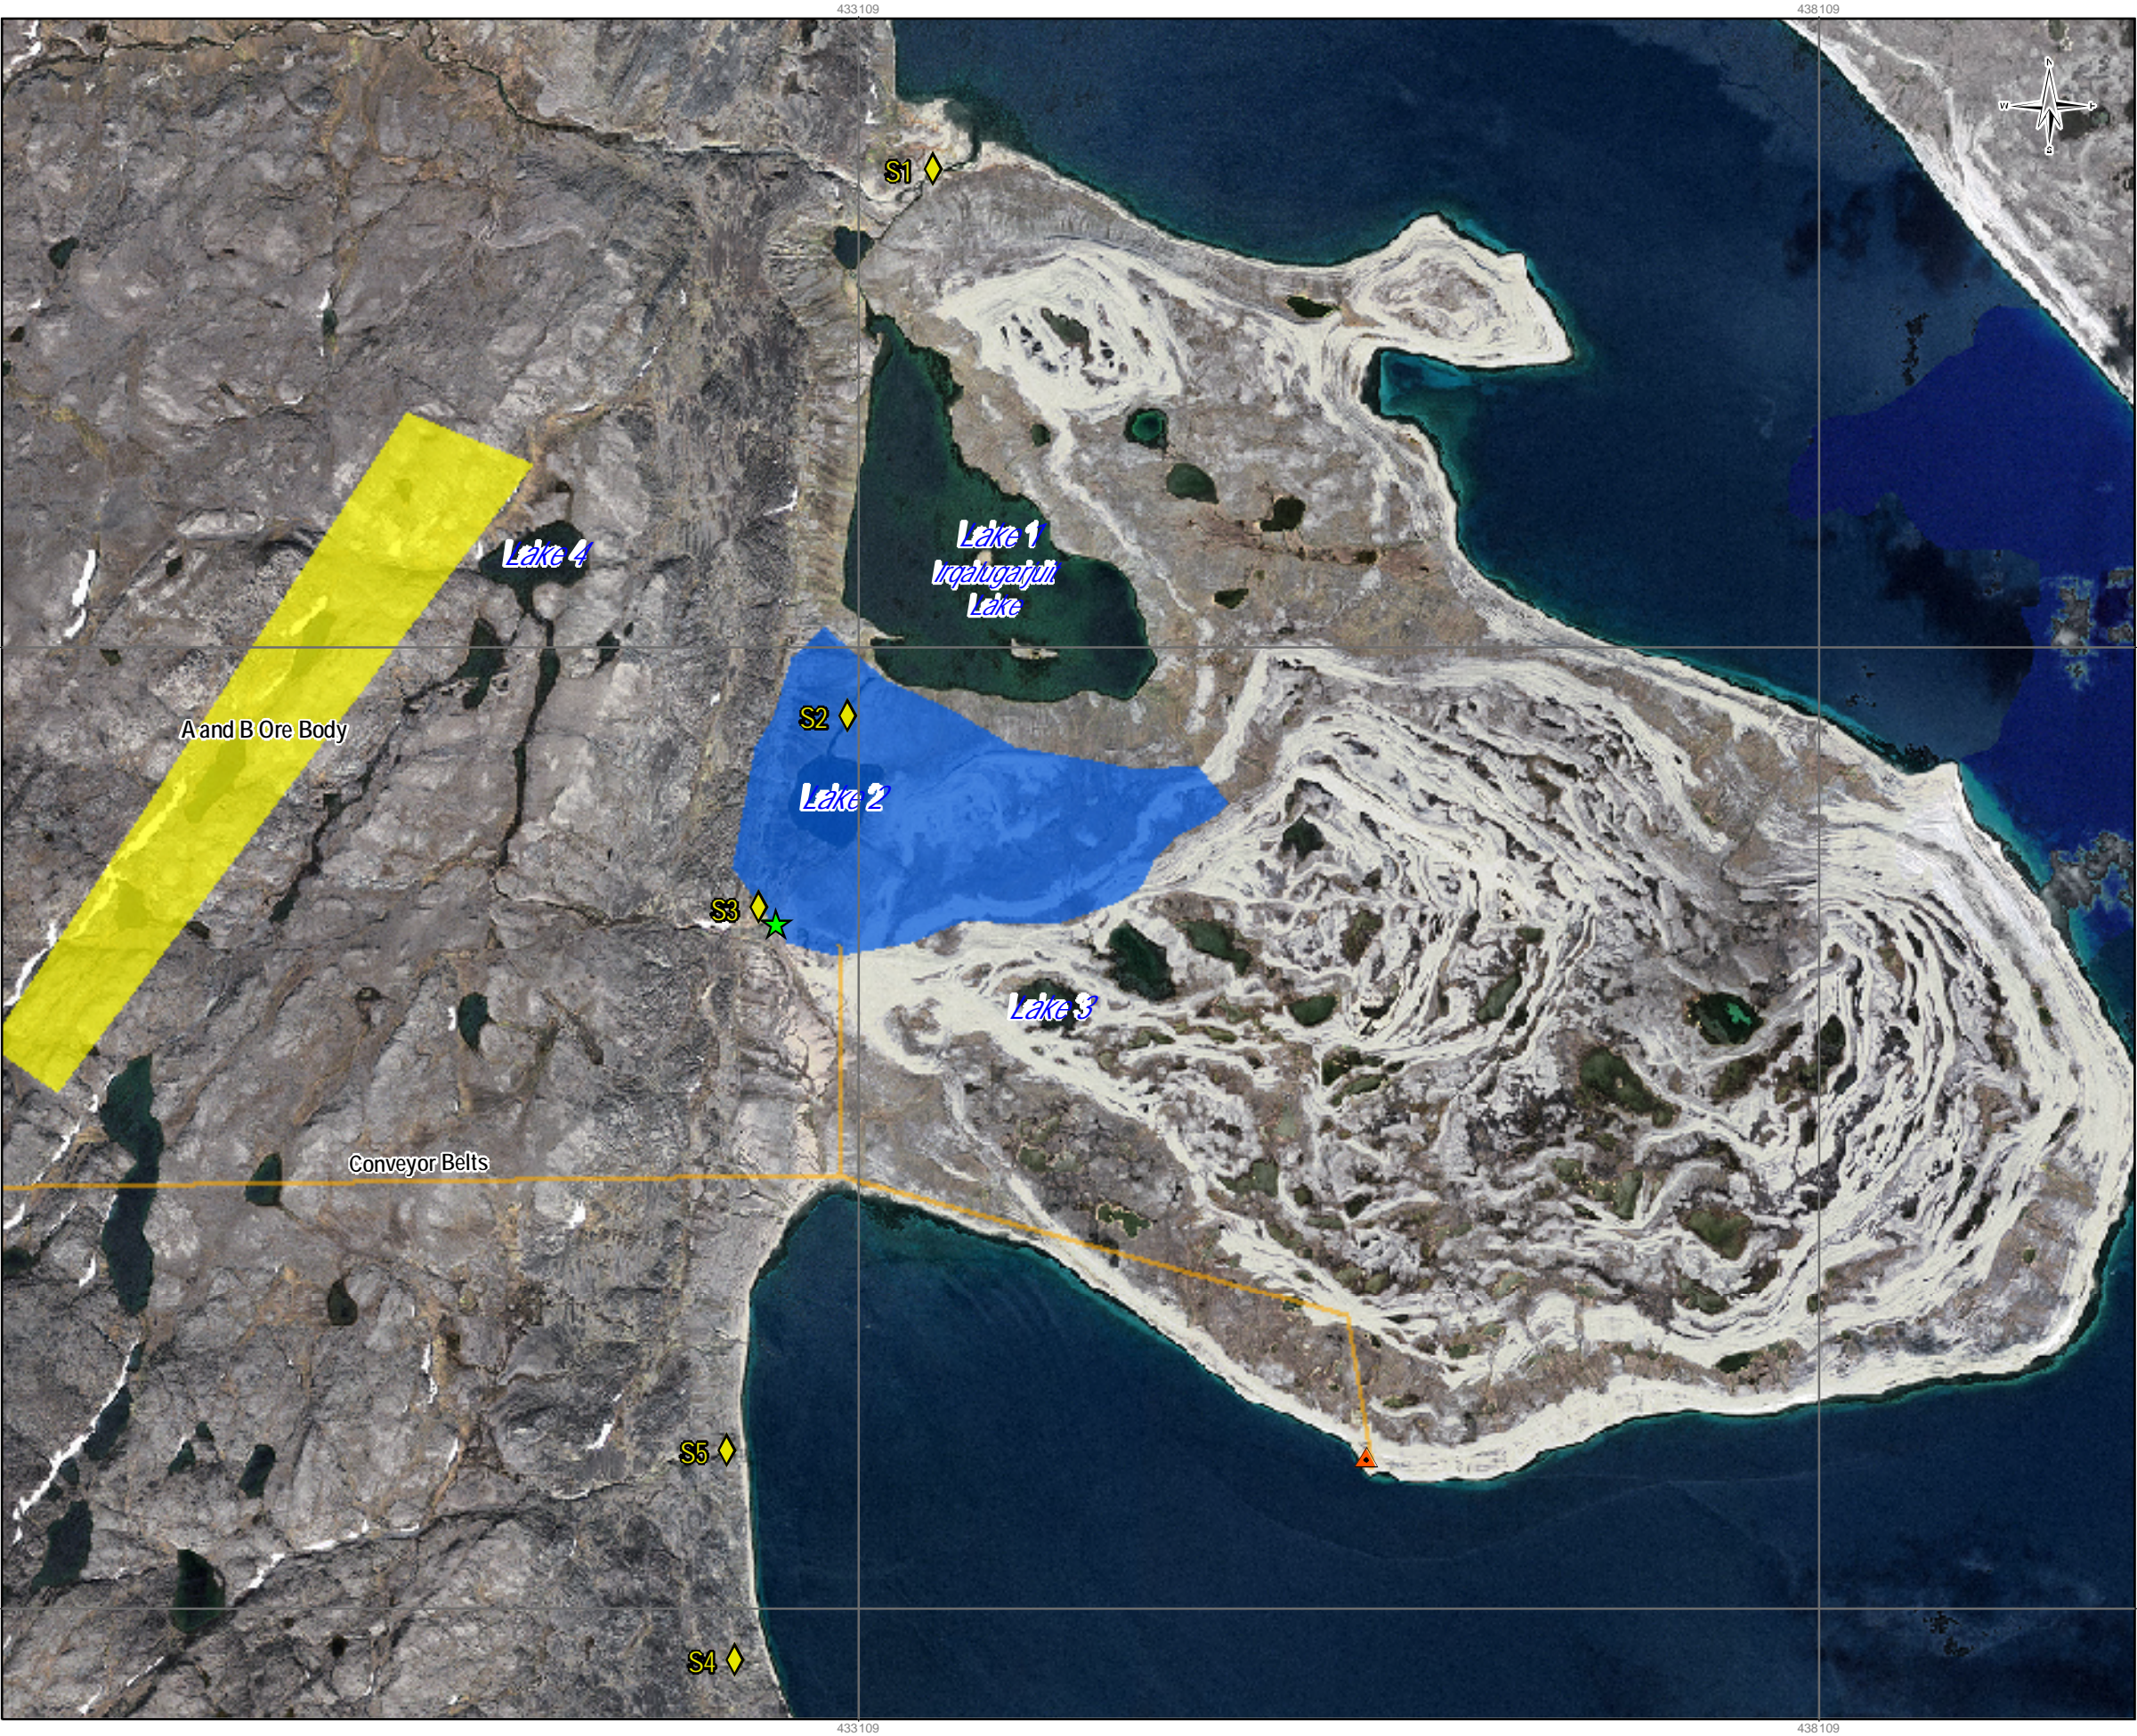
Scale: 1:35,000 1 0.5 Kilometers			
FILE No: 1740183-005-Stream-Sampling		DATE: July 3, 2007	
JOB NO: 1740183-005	REVISION NO: 0		Figure 7
OFFICE: EBA-VAN	DRAWN: MEZ	CHECK: TA

- ★ Camp
- ▲ Proposed Dock Location
- ◆ Stream Sampling Locations
- Conveyor Belts
- Proposed Tailings Pond Area
- Ore-Body

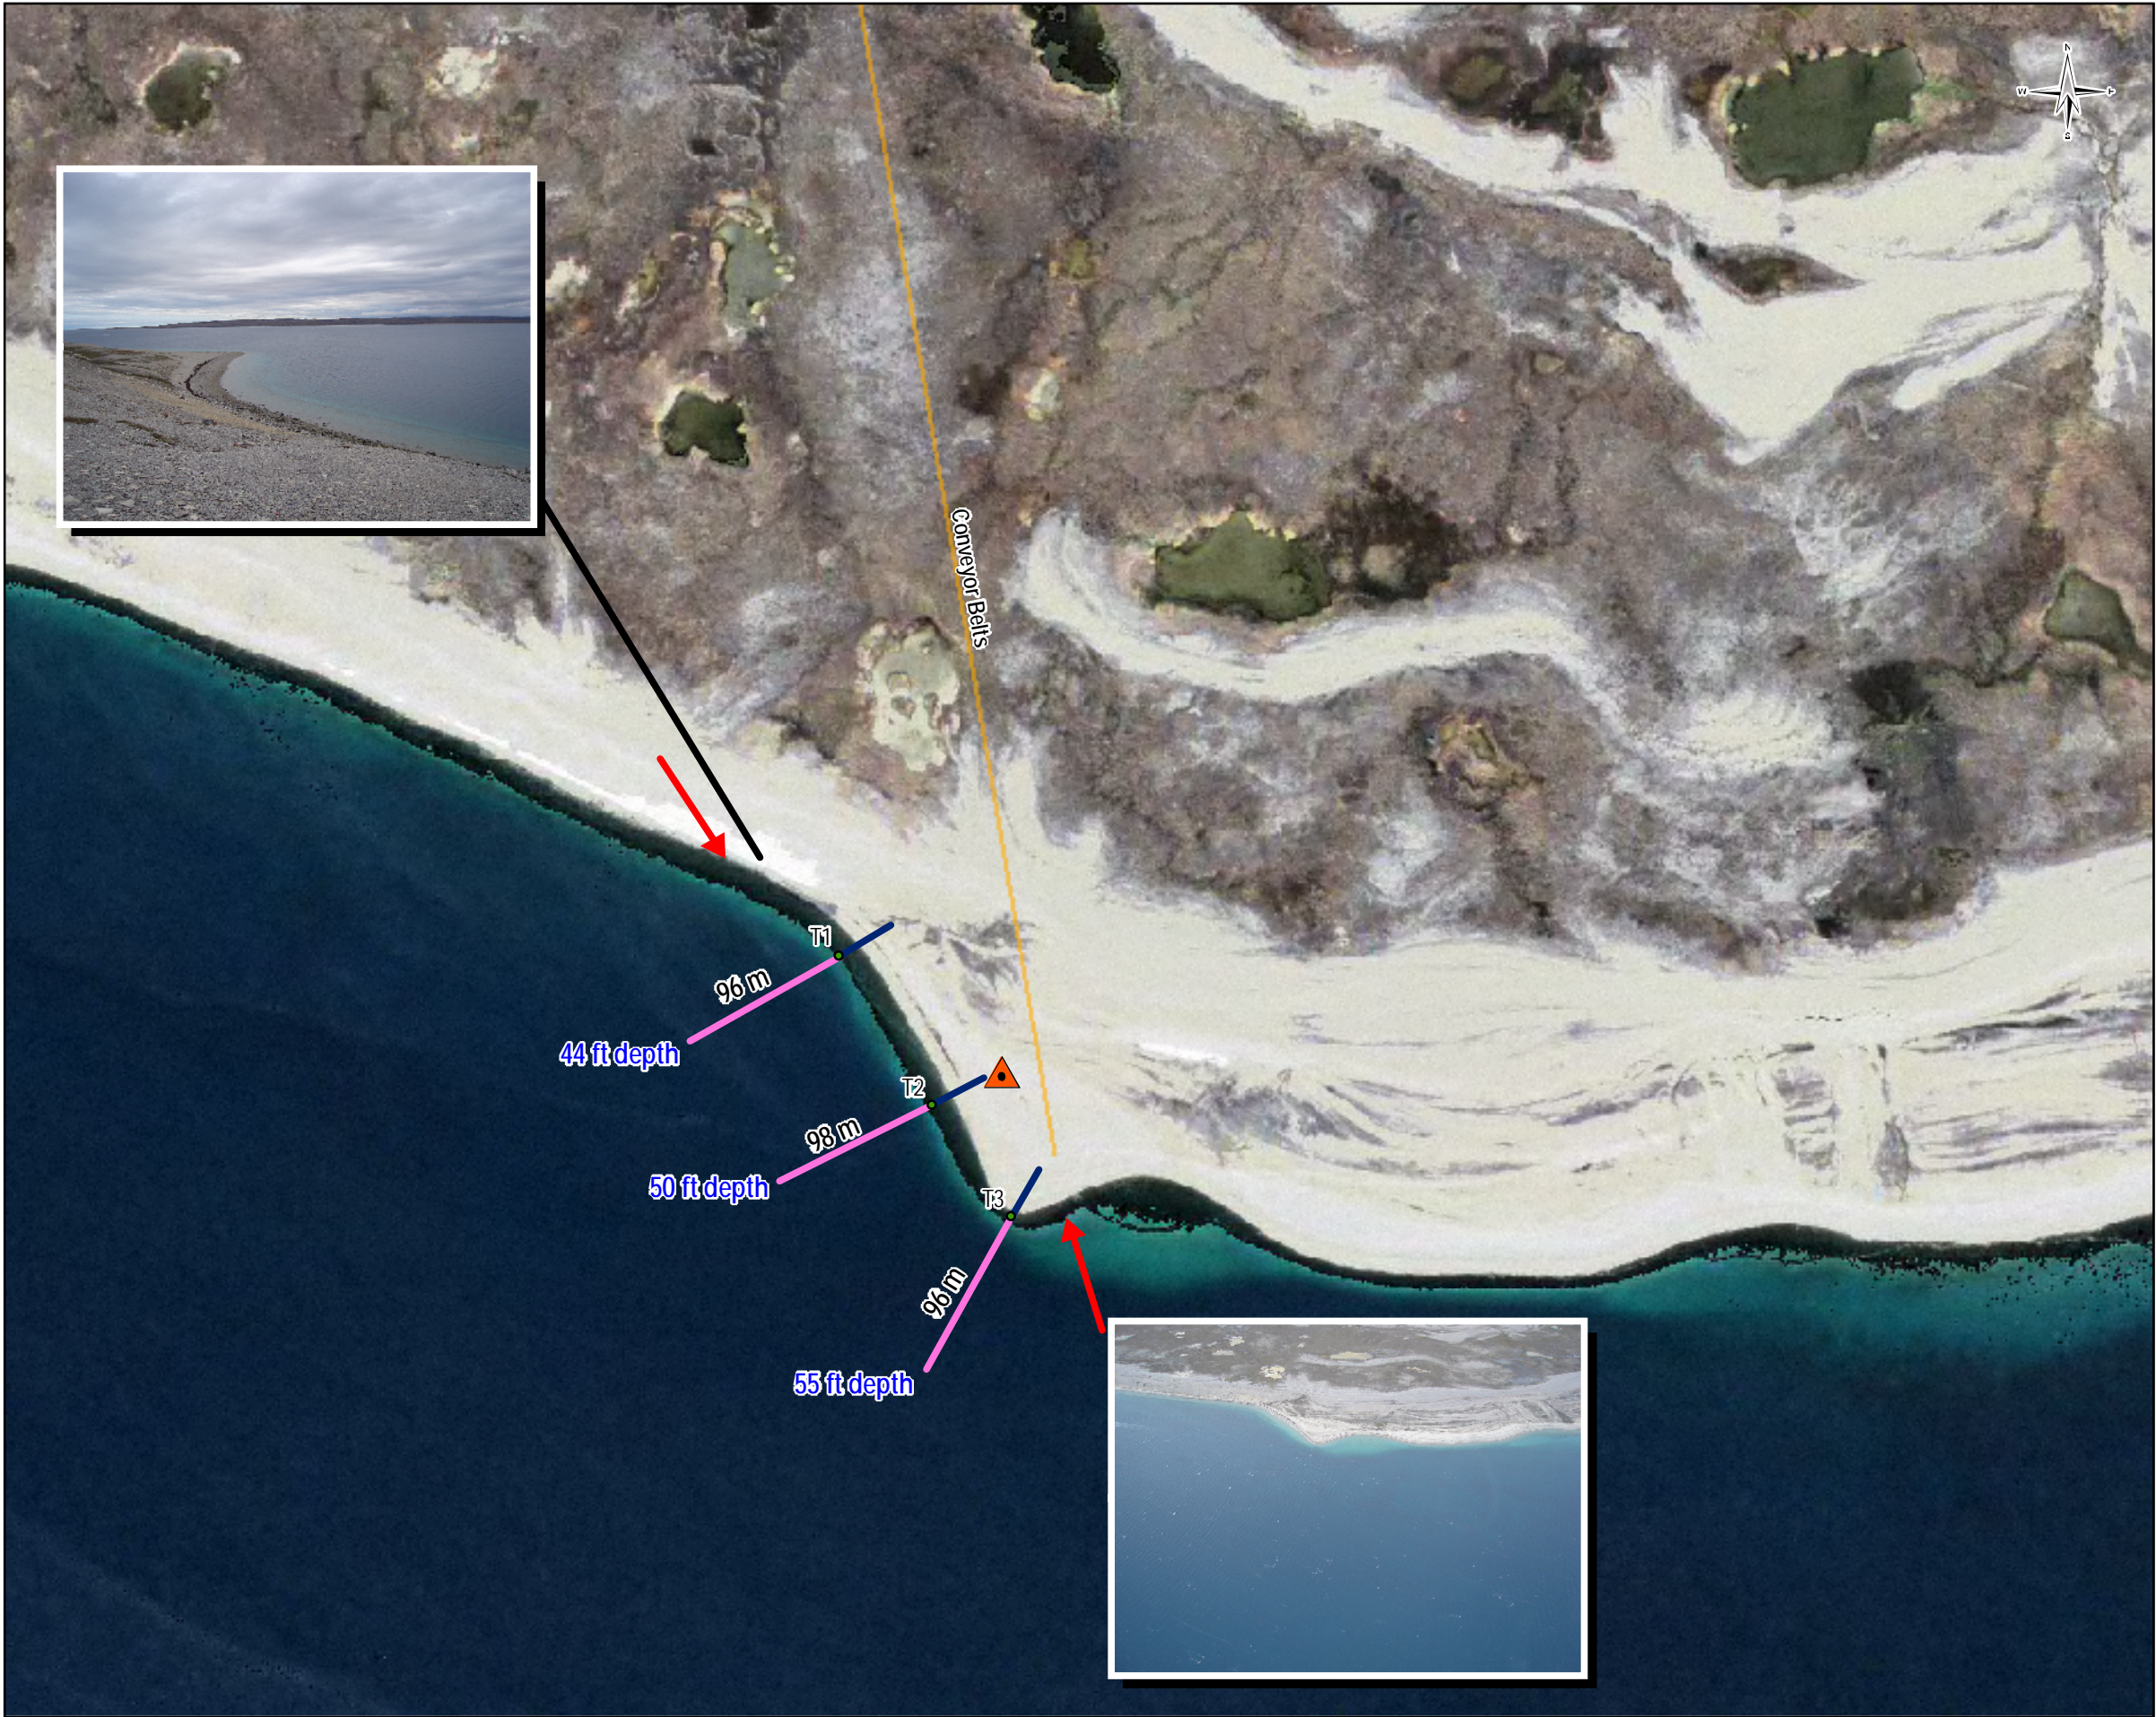
- Transect Locations
- Proposed Dock Location
- Conveyor Belts
- Transects
 - Intertidal
 - Subtidal

A key component of the proposed Roche Bay development project is a floating dock potentially anchored with piles. The current proposed location of marine development is off the most southerly point of the peninsula where there is sufficient water depth for moorage of large vessels. Baseline marine habitat conditions within the marine footprint and zone of influence of the project were assessed during the 2006 field program. The marine survey location is presented in Figure 8. Table 4 presents the Roche Bay marine inter-tidal and sub-tidal survey data.
