Advanced Explorations Inc.

ROCHE BAY MAGNETITE PROJECT ENVIRONMENTAL BASELINE STUDIES 2006 MARINE AND AQUATIC RESOURCES

1740183.005

September 2007

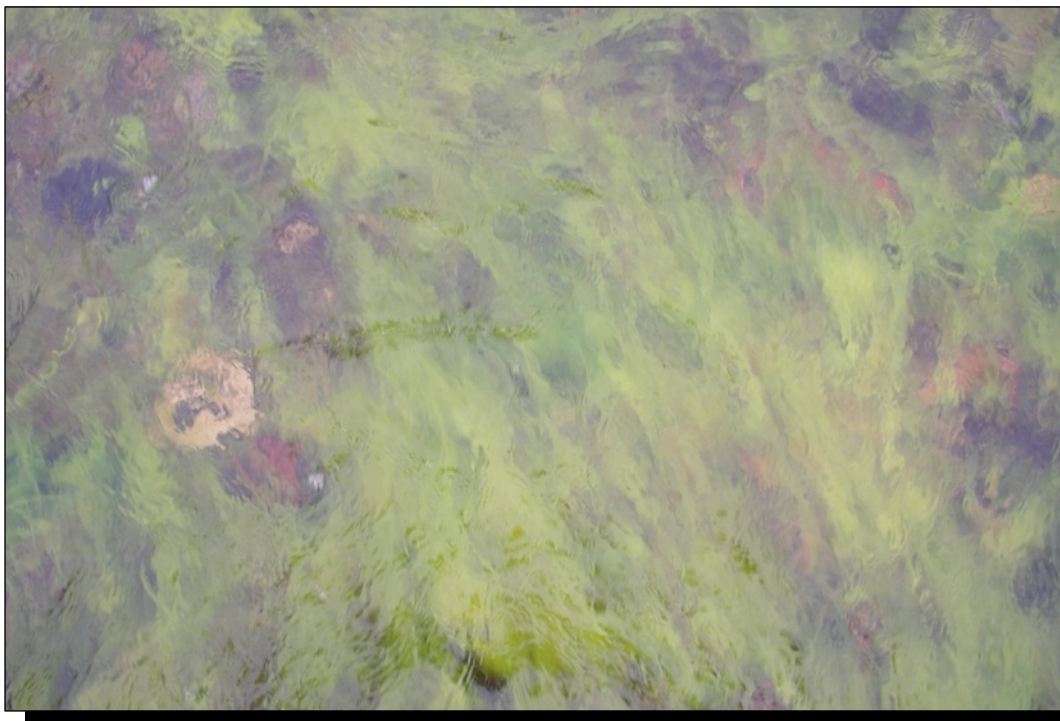
Photo 3
Filamentous algae cover in Lake 1 inlet stream.

The inlet to Lake 1 is from Lake 2, to which it is connected by a stream at the south end of the lake. Where the stream enters Lake 1 it has two separate channels. The stream is fairly steep (3-4 m between lakes) but there are no significant falls or barriers. The inlet stream is approximately 7-12 m wetted width. The inlet stream is 100% boulders with 50% cover of green algae. Flow was considered average consisting of 90% riffle and 10% small pools. Riffle depth was 10-15 cm and pool depth was 15-20 cm. Numerous juvenile trout were observed in the inlet stream.

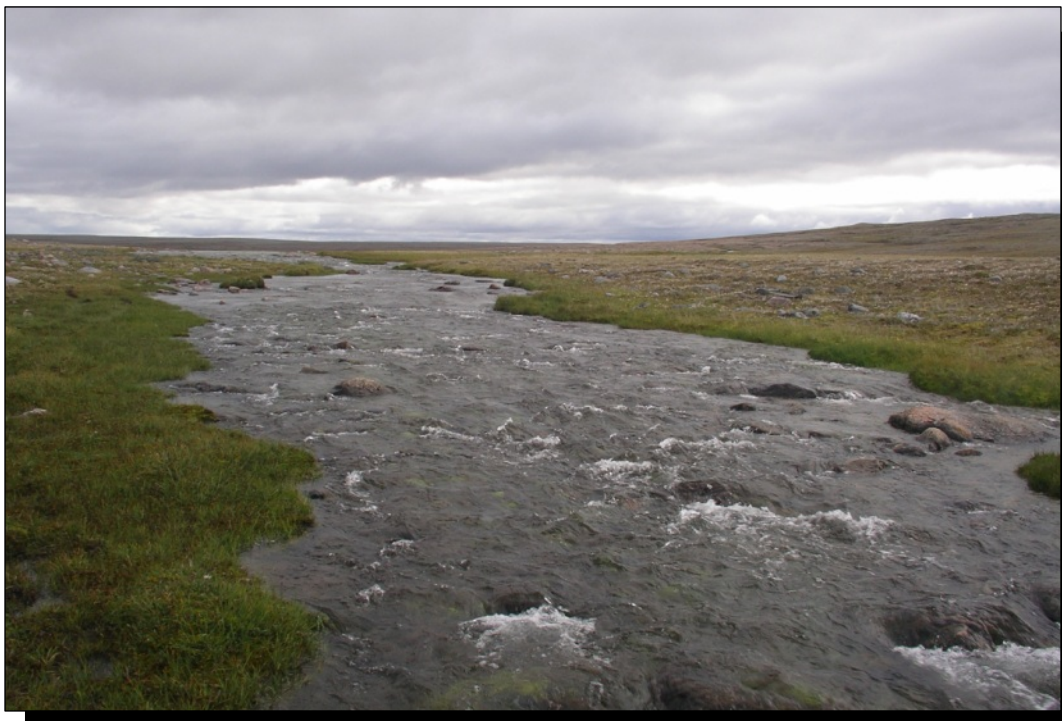
Photo 7
Lake 1 outlet stream looking upstream.

The outlet of Lake 1 drains into a small pond at the north end of the lake before flowing into the sea. The outlet stream has considerable gradient and is primarily riffle habitat through boulders and large cobbles. Filamentous green algae covers a considerable portion of the boulders. Where the stream enters the small pond the stream becomes deeper with pools, and small cobbles and gravel substrate. Downstream of the pond toward stream site 1 numerous adult Arctic char in spawning condition and juvenile trout were observed in pools and calm water area.

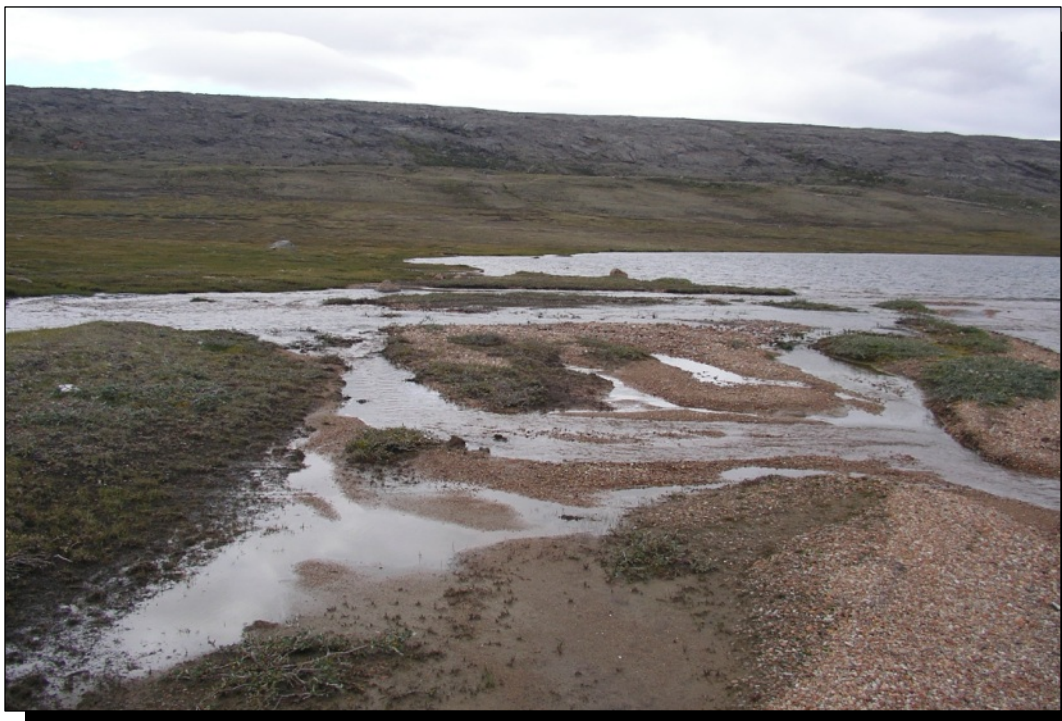
Photo 13
Principal inlet stream to Lake 2.

The principle inlet to the lake is located at the south end of the lake near the Roche Bay project exploration camp. The inlet stream flows down from the escarpment towards Lake 2. The inlet is braided with two main channels at the inlet to the lake. Both channels had a wetted width of 2-3 m, 70% pools with depths of 40-50 cm and 30% riffles with 15-20 cm depth. Substrate is 80% small cobbles and gravel and 20% boulders. In slower moving water boulders have green algae growth. Large schools of juvenile trout were observed. An additional smaller inlet with a single defined channel flows down from the escarpment into the west side of the lake. Some juvenile trout (2-6 cm in length) were also observed in this inlet stream. Further upstream the stream is crossed by an ATV trail. A common loon was observed on the lake during the survey.

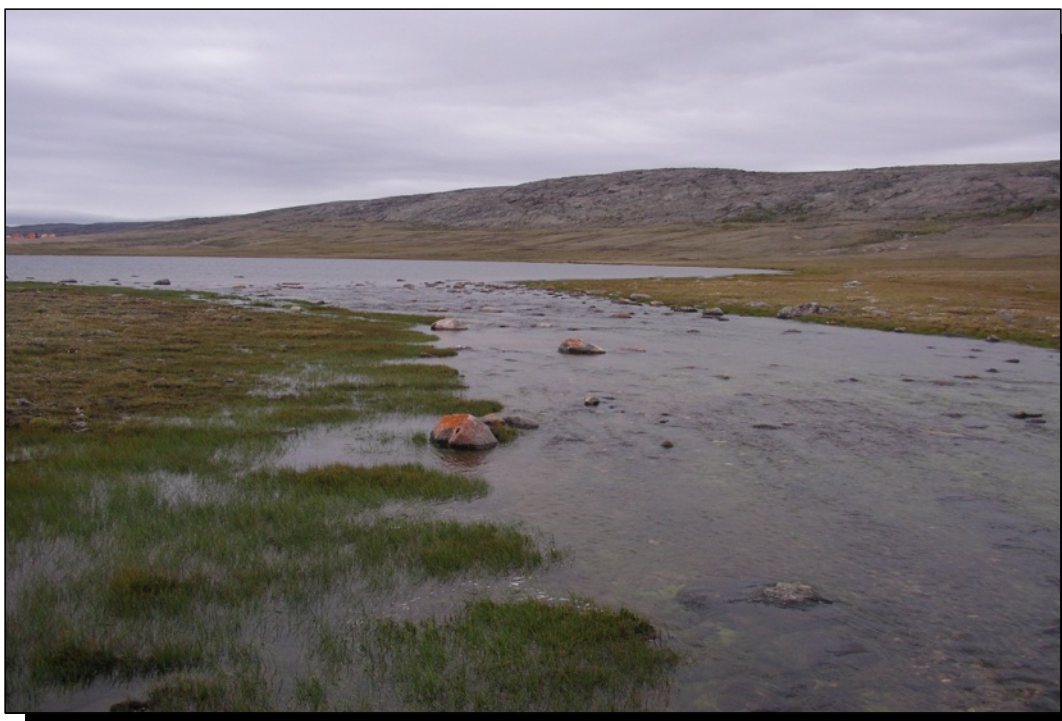
Photo 14
Principal outlet stream from Lake 2.

The outlet stream from Lake 2 is at the north end of lake. The outlet is also the inlet stream to Lake 1. At the outlet the stream is 15- 20 m of wetted width, pool-like with 80% small and large cobble and 20% boulders. Immediately downstream the gradient increases, depth decreases to 10-15 cm, with 100% riffles. Further downstream there are more boulders. Approximately 10% of boulders were covered with filamentous green algae. Juvenile trout were observed in the outlet stream during the survey period.

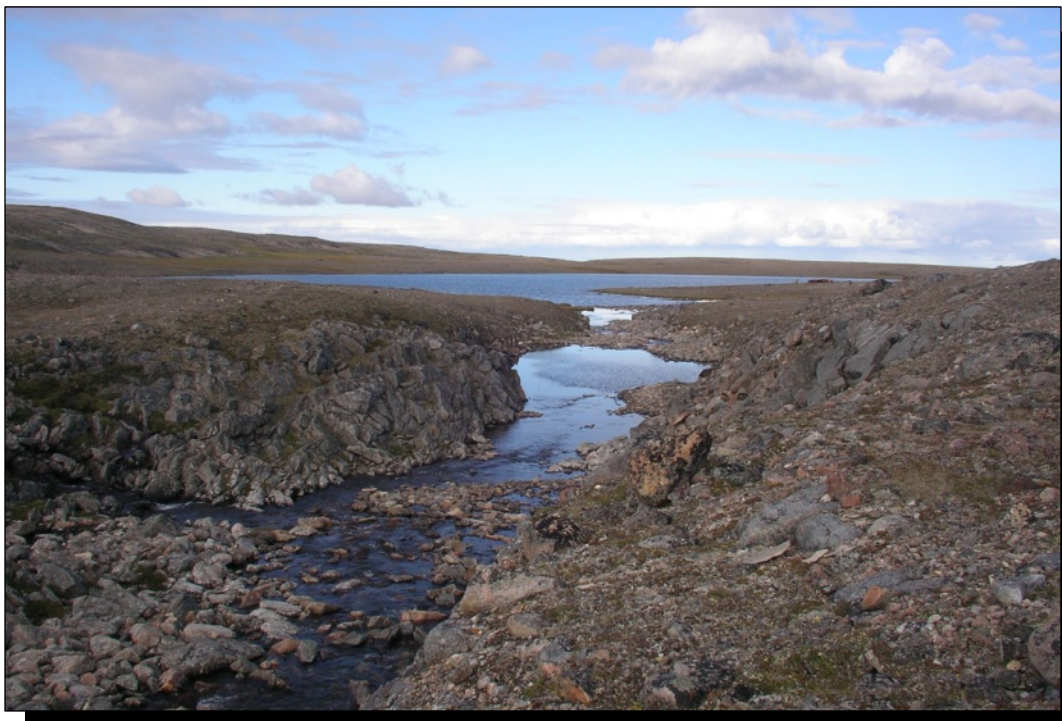
Photo 23
Lake 4 inlet stream and pools.

The inlet stream to Lake 4 lies immediately east of the outlet to the lake. Substrates in the outlet are 90% boulders and 10% cobbles. Immediately upstream of the inlet several deep pools (80 cm) were observed to be used by juvenile trout (4-8 cm). Approximately 10% of boulders were covered with green algae. Upstream a series of pools are separated by small falls which eventually meet the outlet of another small lake. An additional small inlet stream was observed draining down from the escarpment on the west side of the lake.

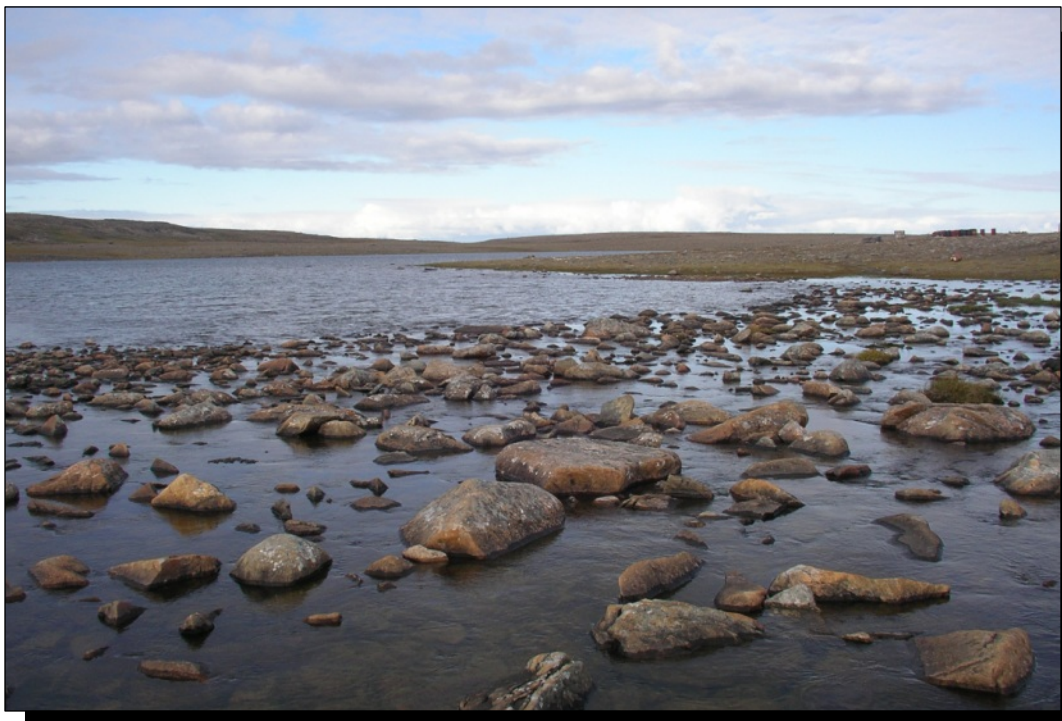
Photo 25
Lake 4 outlet stream looking north.

The Lake 4 inlet and outlet stream are close in proximity at the south end of the lake. The outlet stream is 80% boulders and 20% cobbles. It is wide (30-40 m) and shallow (5-20 cm). Water is slow moving (still) with a few small riffles. One small patch of water sedge and small amounts of submerged moss and sedge were observed to be present in this area. Approximately 10% of boulders are covered in filamentous green algae. No fish were observed in the Lake 4 outlet stream. Approximately 200-300 m downstream from the outlet, two small lakes/ponds are separated by a wide slow flowing stream.

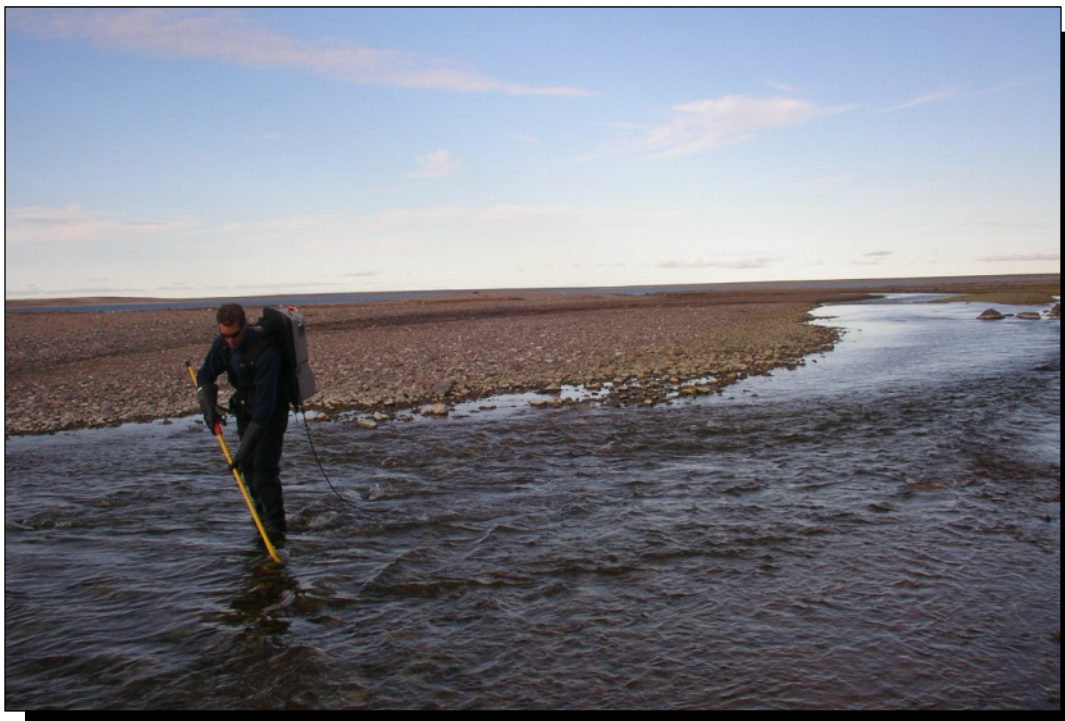
Photo 29
Electroshocking at Stream site S1.

At Site S1, 86 fish were captured during an electrofishing effort of 697 seconds over approximately 100 m of stream. Approximately 10% of fish captured were removed from the stream and were identified as juvenile lake trout. The remaining 90% were observed to react to the electrofishing but were not removed from the stream. All fish were captured in deeper pools and slower flowing side channels. The lake trout measured ranged from 2-20 cm in length.

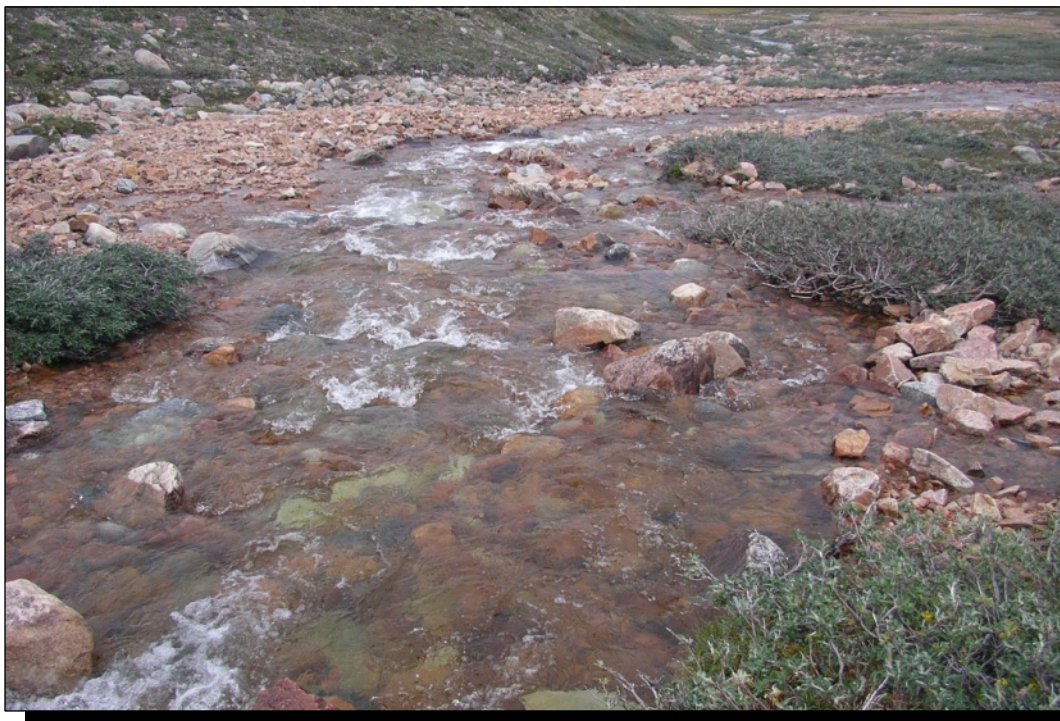
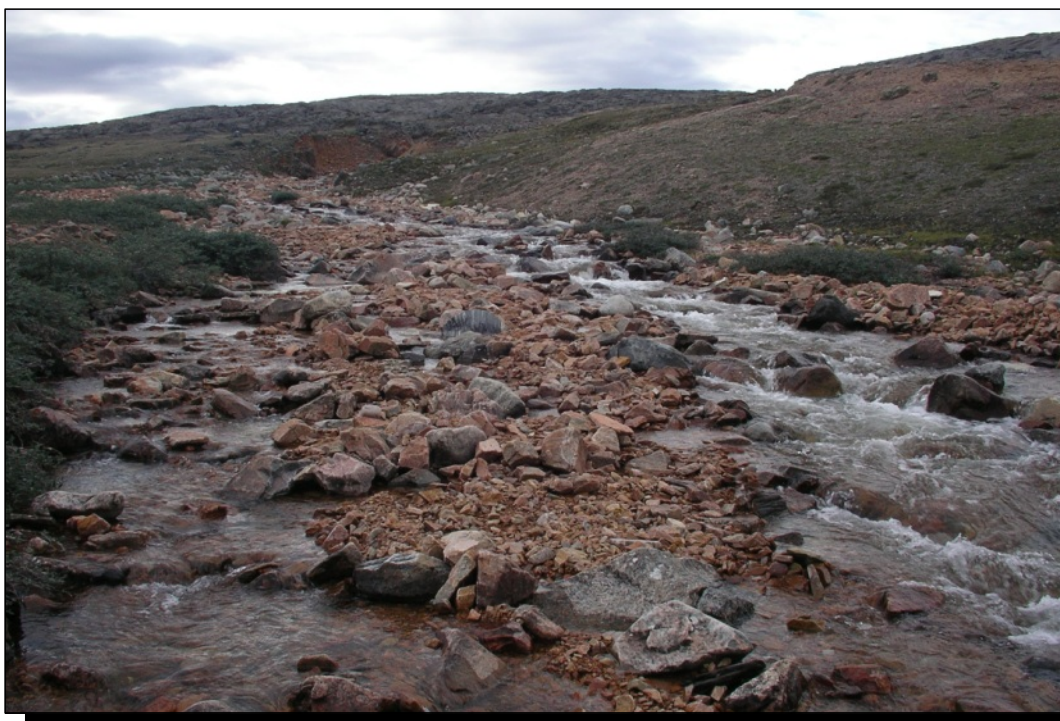
Photo 33
Stream site S3 looking downstream.

Photo 34
Stream site S3 looking upstream toward escarpment.

Site S3 is located at the base of the escarpment and flows into Lake 2. There are several channels and a wide rocky channel with cutbanks which indicate that site S3 experiences high water flows during freshet and storm conditions. Water flow consisted of 70% riffles and 30% small pools. The substrate consisted of 15% small gravel, 20% large gravel, 30% small cobbles, 20% large cobbles and 15% boulders. The average wetted width of this reach was 9.1 m with an average riffle depth of 10-20 cm and an average pool depth of 30-40 cm. Cover amounted to approximately 30%, which consisted of 50% pools and 40% boulders and 10% instream vegetation (green algae). Riparian vegetation was tundra consisting predominantly of sedge (*Carex* sp.), moss with willows (*Salix* sp.) Upstream of site S3 a waterfall appears to present a barrier to upstream fish movement. However, during the survey juvenile lake trout were observed downstream from S3. Photos 33-34 show stream site S3.

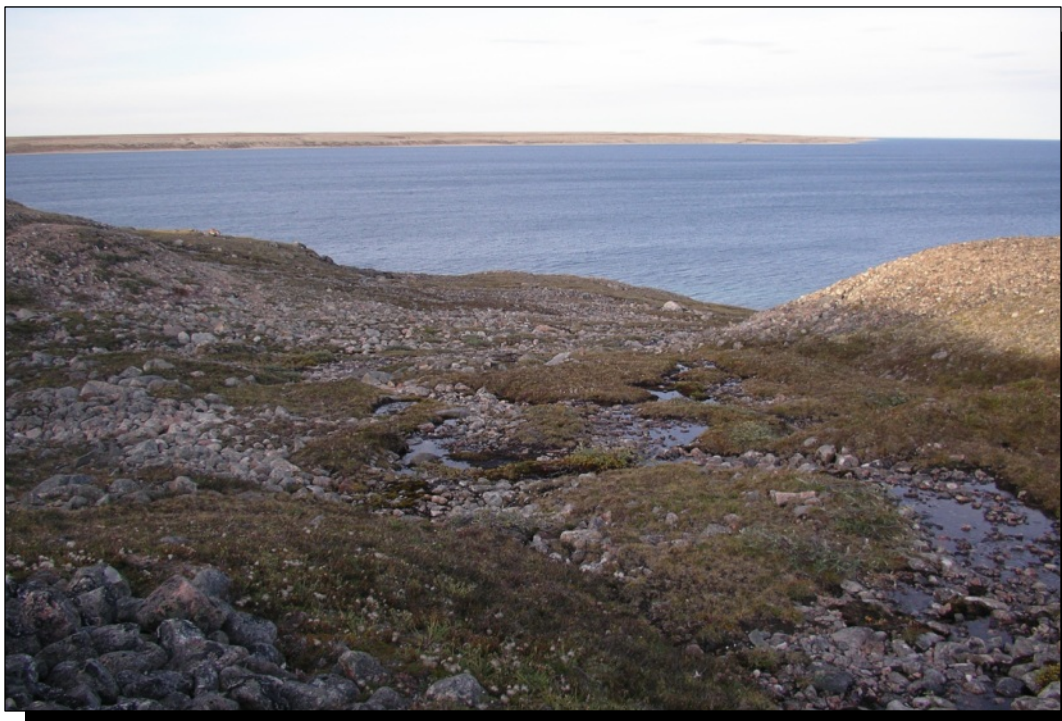
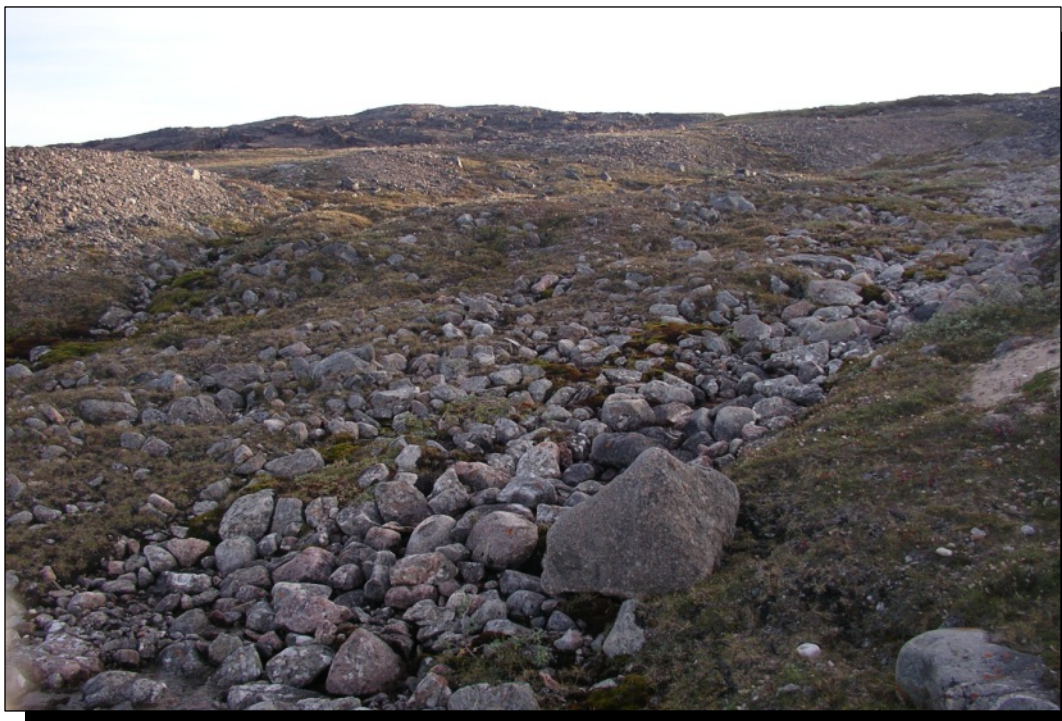
Photo 35
Stream site S4 looking downstream toward ocean.

Photo 37
Stream site S4 looking upstream up escarpment.

Site S4 is the furthest south of the stream sites surveyed. S4 lies on a steep gradient flowing down the escarpment into the sea. There are several channels and a wide rocky channel with cutbanks indicating that site S4 experiences high water flows during freshet and storm conditions. Water levels were low during the survey. Water flow consisted of 40% riffles and 60% small pools. The substrate consisted of 10% large gravel, 10% small cobbles, 20% large cobbles and 60% boulders. The average wetted width of this reach was 9.1 m with an average riffle depth of 4 cm and an average pool depth of 12 cm. No cover was provided. Riparian vegetation consisted predominantly of sedge (*Carex* sp.), mosses with willows (*Salix* sp.) The considerable gradient and low flow at the time of survey indicates that S3 is likely an ephemeral drainage stream and is not represent good fish habitat. Photos 35-36 show stream site S4.

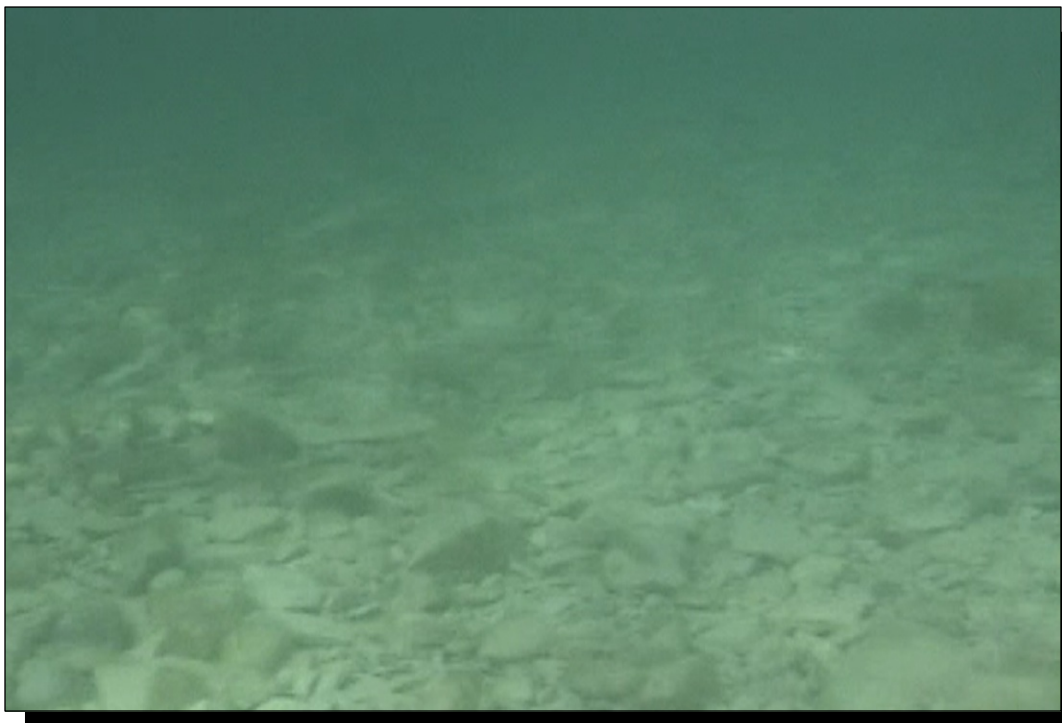
Photo 52
Cobble substrates near shore along T1.

The sub-tidal component of Transect 1 was surveyed on August 22, 2006. The transect length was 96 m offshore from the high tide mark to a depth of 44 ft (13.4 m). The largest portion of the transect (96 m to 35 m) occurred on a gently sloping sub-tidal sand flat. The seafloor sediment in this area of the transect consisted of soft silty sand, with a widespread mat of green algae. Marine life observed included various sea stars (*Solaster endeca*; *Crossaster papposus*) and brittle stars (*Ophiosten sericeum*), macro algae washed in from other areas, large isopods (*Munnopsurus giganteus*), and mysids (pelagic krill). Snails and nudibranchs (sea slugs) as well as jelly fish (*Phacellophora camschatica*) were also common. Various sculpin species (likely Great sculpin (*Myoxocephalus polyacanthocephalus*) or buffalo sculpin (*Enophrys bison*) as well as several smaller species including northern sculpin (*Icelinus borealis*) were observed. At 35 m along the transect, the seafloor sloped steeply upward to a depth of 10 ft (3 m). Marine life on this bank consisted of small benthic organisms and algae over a sandy, silty substrate. Above the top of the bank the substrate changed to flat angular cobbles on gravel with no visible epifauna (marine life living on the surface) being observed.

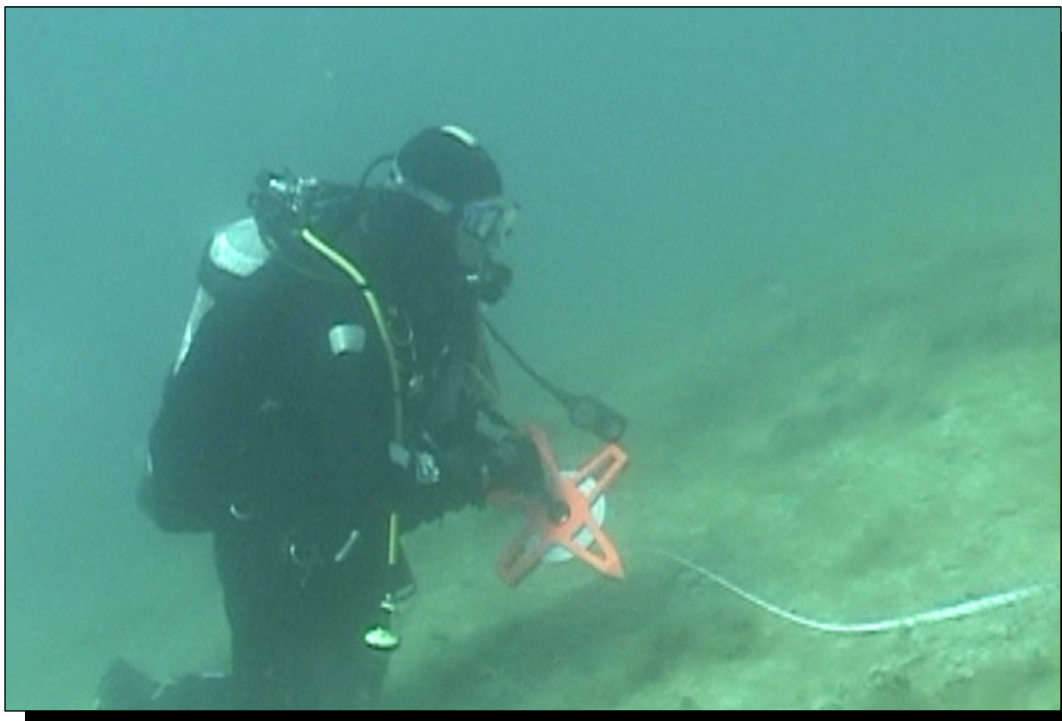
Photo 61
Slope along T3.

The sub-tidal component of Transect 3 was surveyed on August 23, 2006. The transect length was 96 m offshore from the high tide mark at a depth of 55ft (16.8 m). As observed at Transects 1 and 2, the largest portion of Transect (98 m to 56 m) was located on a gently sloping sub-tidal sand flat. The seafloor sediment in this area of Transect 3 consisted of soft silty sand, with a widespread algal mat layer. Marine life included the same sea stars and brittle stars, macro algae washed in from other areas, large isopods and mysids (large pelagic krill) observed at Transect 1. Snails and nudibranchs (sea slugs) as well as jelly fish were also common. Various sculpin species (likely Great sculpin or buffalo sculpin as well as several smaller species including northern sculpin were observed. At 56 m along the transect, the seafloor sloped steeply upward to a depth of 25ft (7.6 m). The bank at this depth harboured various small benthic organisms and large macro algae over a sandy, silty substrate. Above the top of the bank the substrate changed to flat angular cobbles on gravel with no visible epifaunal marine life being observed.
