**CAMECO CORPORATION
2013 TURQAVIK - ABERDEEN PROJECTS
EXPLORATION
ACTIVITIES AND CAMP MAINTENANCE
NUNAVUT WATER BOARD LICENSE: 2BE-QAM1217**

March 2014

**CAMECO CORPORATION
2013 TURQAVIK - ABERDEEN PROJECTS
EXPLORATION
ACTIVITIES AND CAMP MAINTENANCE**

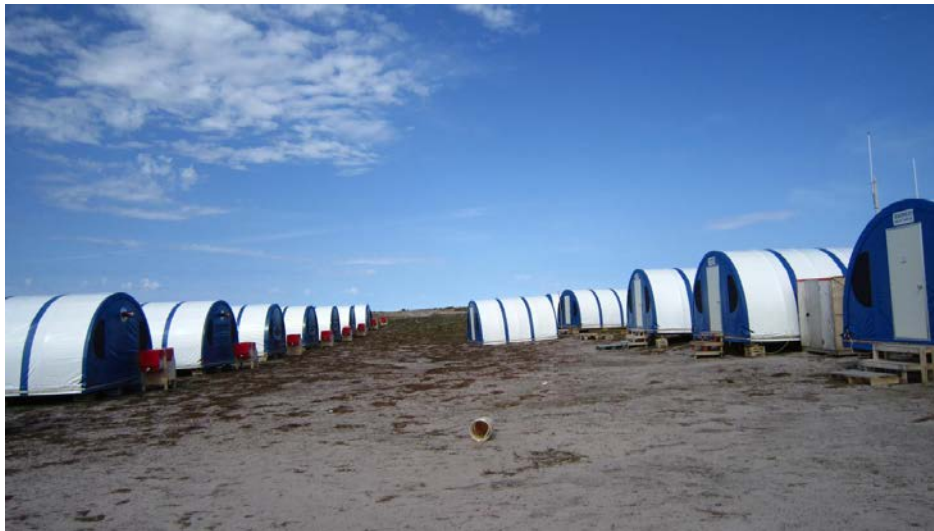
The Aberdeen Lake camp sustained some wind damage from the winter 2012 - 2013. Many structures had shifted and one as far as 20 ft. (Figure 1). Much time was spent putting these structures back in place (Figure 2). Structures in camp were then anchored in place in hopes of alleviating future shifting. A total of 8 sleeper tents, 3 core shack tents, and 1 driller dry building were manually shifted back in place. The anchoring method involved digging 3 ft. deep holes and burying 2 ft. long, 2" x 6" piece of lumber, which were fastened to two of the tent corners (north side due to the prevailing wind) via aircraft cable and a turnbuckle (Figures 3 and 4).

Figure 1: View of Aberdeen Lake camp looking west showing the huge amount of displacement one of the sleeper tents underwent during the winter months.

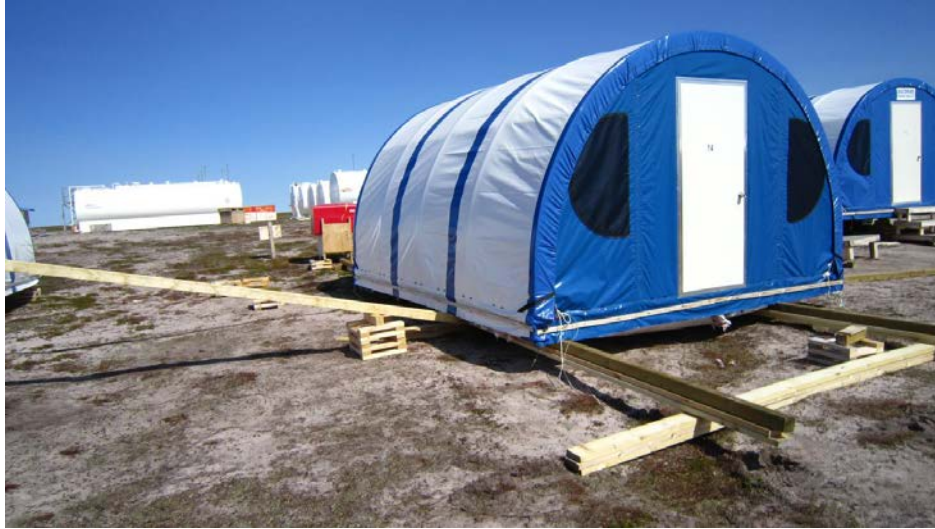
Figure 2: Displaced sleeper tent being slowly moved back into place.

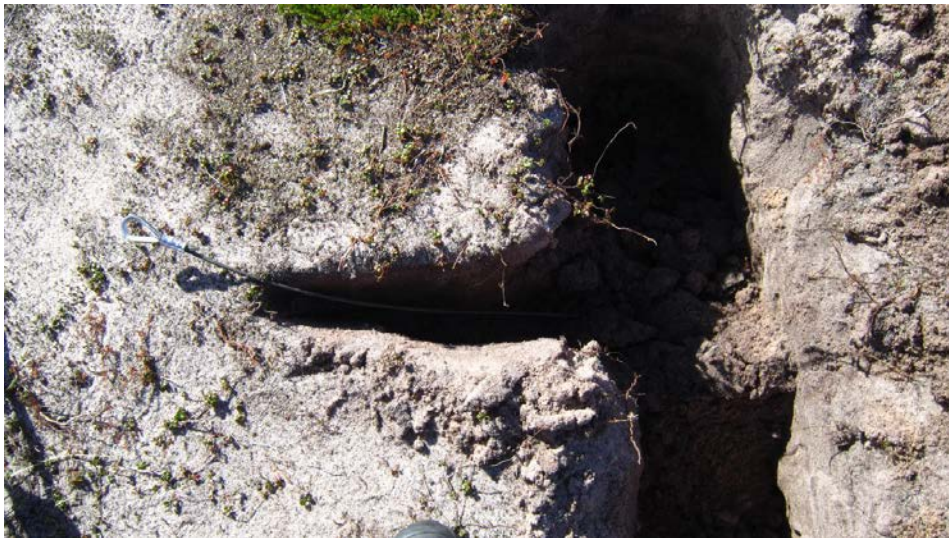
Figure 3: Photograph showing the 3 ft. deep holes where the 2 ft. long 2 x 6 were placed with the cable attached for fastening onto the tent structures.

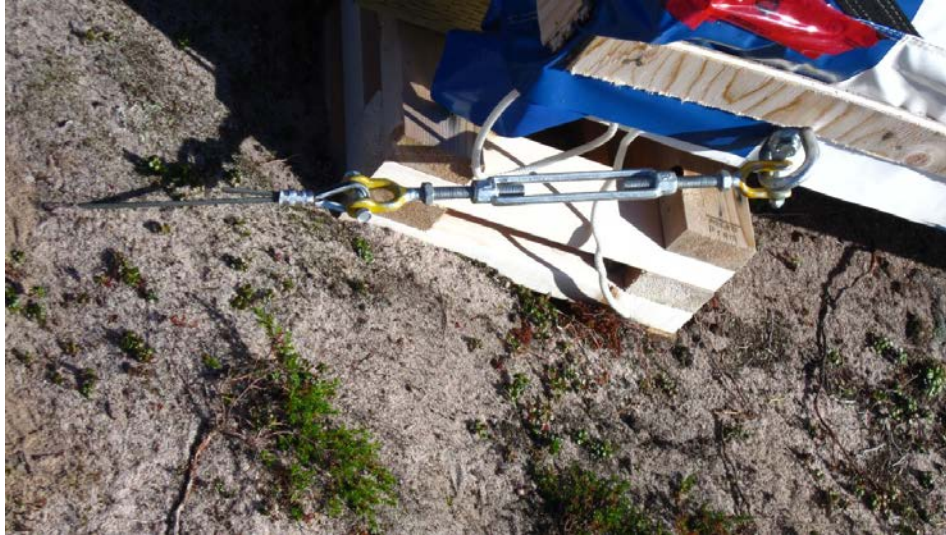
Figure 4: Photograph showing the anchoring method used to deter any further shifting of the structures during high wind events.

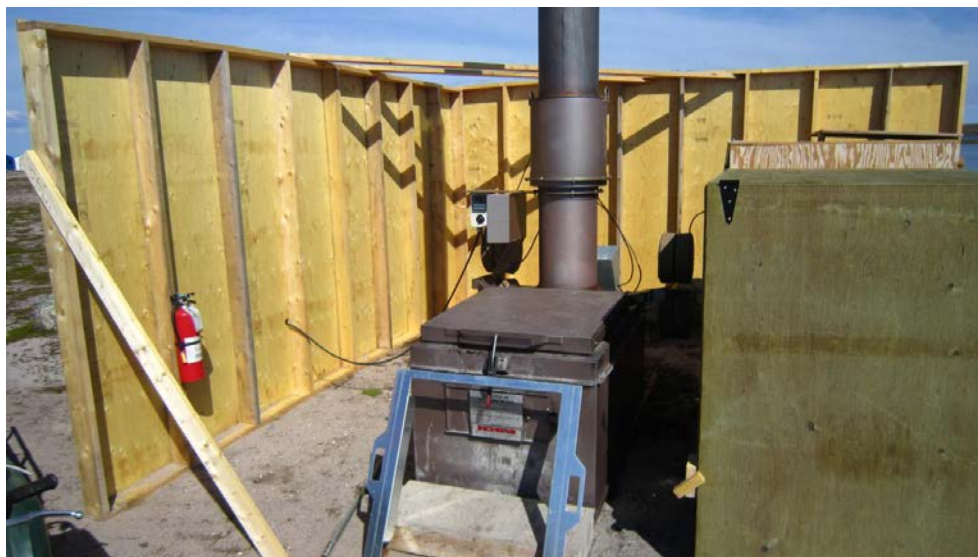
Figure 5: Photograph showing the L-shaped structure that was built around the incinerator.

Our dual chambered incinerator is currently being run on left over fuel from years past. An 8' x 16' L-shaped wind break constructed around the incinerator to allow for ease of loading even during windy days (Figure 5). Solid covers for fuel containment, as well as solid covers for ash containment were constructed to keep wind, snow, and rain out.

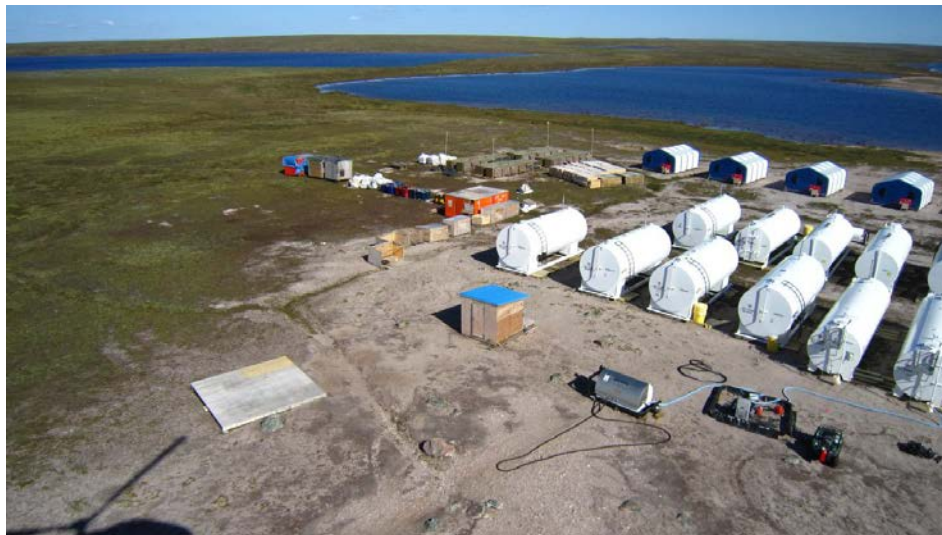
Our bulk 50,000 litre dual-walled fuel containment continues to be the primary source of fuel for the camp (Figure 6). The 2 cabinets (1 for jet fuel, 1 for diesel fuel) are metered and contained for ease of dispensing fuel. The cabinets are fed by 2 Gormann Rupp spark proof pumps that are individually contained within a 10' x 10' Insta-Berm should there ever be a leak while pumping. Yearly fuel is hauled to site via overland sleds during the pre-season (March – May). During

Figure 6: Aerial photography showing the bulk fuel farm, helipad and 4 coreshacks in the background.

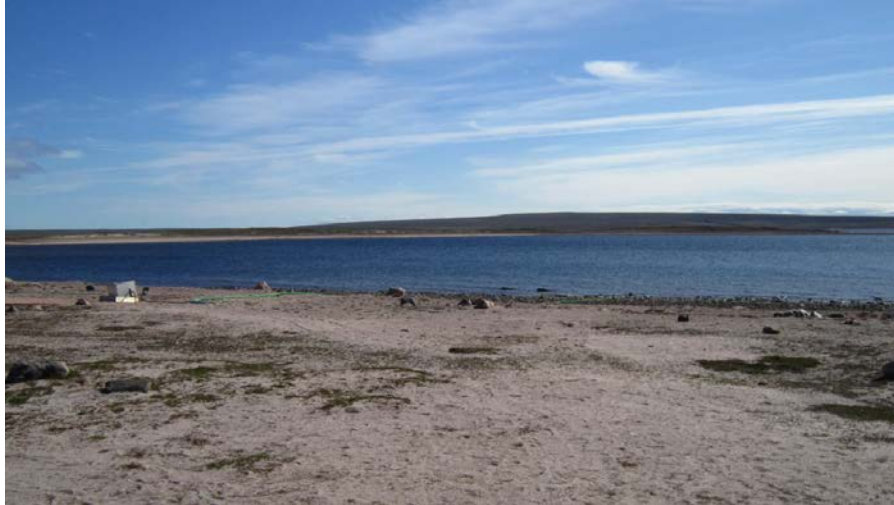
Water is drawn from Aberdeen Lake with a gas pump (Figure 7). There is roughly 40 m of 2" water suction hose to comply with separation distance from the water's edge. This season saw the improvement of a longer suction line, as well as an anchored suction box that houses the intake mesh. There are plans to convert the existing system to an electric pump to eliminate having water pump-related fuel along the Aberdeen Lake shoreline.

Figure 7: South facing photograph of Aberdeen Lake showing the water pump and green hose for water extraction.

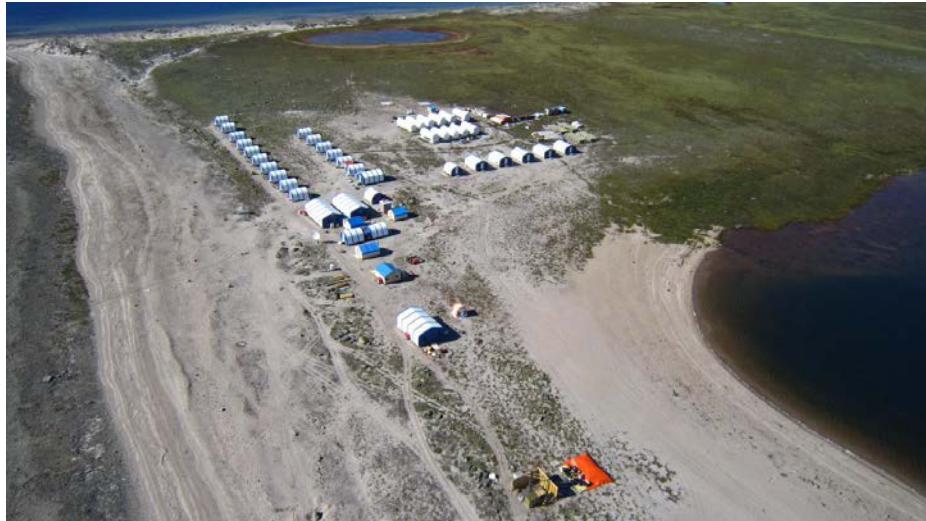
Figure 7: Aerial photo of Aberdeen Lake camp looking west.

During the 2013 season time was spent cleaning up construction-related material, as well as emptying and putting away a few fuel berms on site. Existing berms were covered to keep rain and snow out. Several drums of old fuel were burnt in the incinerator and the empty drums were flown off site to Baker Lake. Lastly, our helicopter landing pads were repaired from winter damage. Figure 8 shows the state of the camp in early August 2013.
