ENVIRONMENTAL INSPECTION FORM

Licensee	Licensee Representative
Stornoway Diamond Corporation	Nicole Westcott
Licence No. / Expiry	Representative's Title
2BE-SNN0813	Land Administrator
Land / Other Authorizations	Land / Other Authorizations
N2007C0003	
Date of Inspection	Inspector
15/07/2014	Atuat Shouldice
Activities Inspected	
<input checked="" type="checkbox"/> Camp <input type="checkbox"/> Roads/Hauling	<input checked="" type="checkbox"/> Drilling <input checked="" type="checkbox"/> Other: Water Discharge
<input type="checkbox"/> Mining	<input type="checkbox"/> Construction <input type="checkbox"/> Other:
<input checked="" type="checkbox"/> Reclamation	<input checked="" type="checkbox"/> Fuel Storage

N2007C0003

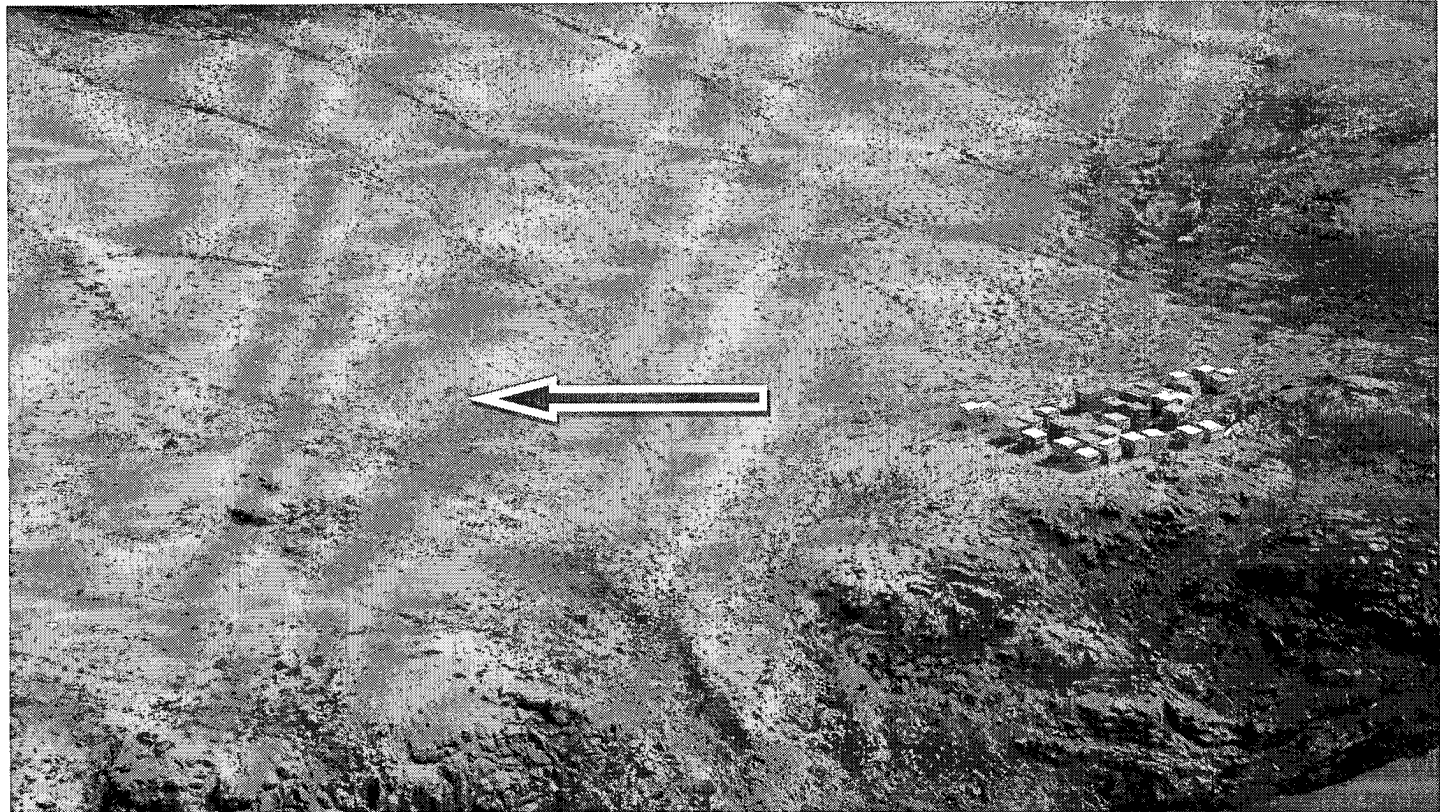
- Core boxes were stacked neat and tidy.
- Camp site/ tent frames look to have been burnt down during site remediation. Coal and lumber still visible around some tent rings and discoloration of earth where tent frames sat.
- No equipment, drums or debris were found on site as required in the Permit.
- The two drill sites noted above were left in a clean and close to natural state as possible. Cuttings were in a natural depression as required. No equipment or debris noted.

Photo 1: Camp site , arrow indicating tent rings

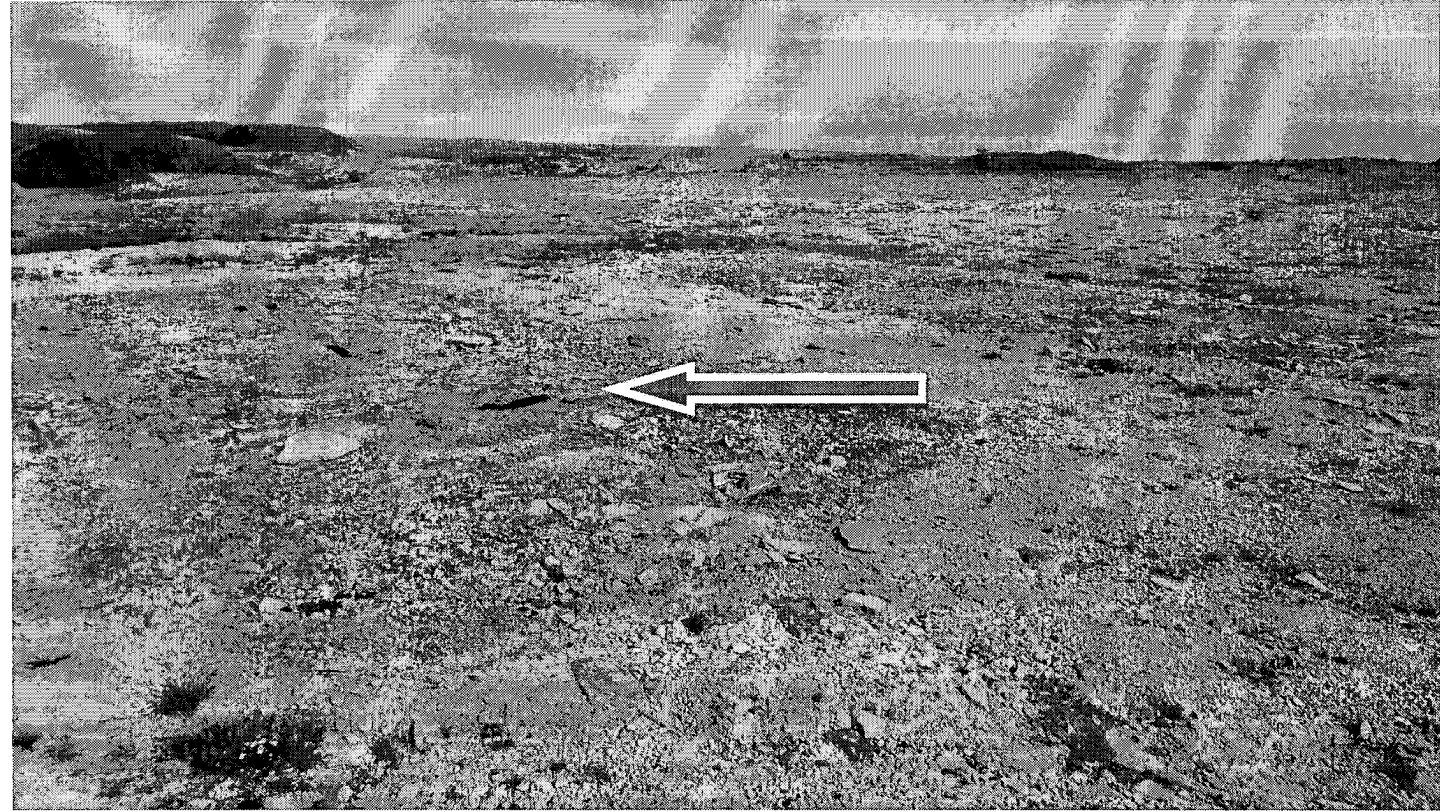
Although open burning is not permitted, small pieces burnt lumber are still visible and in the Inspectors opinion will have little to effect on the environment.

Photo 2: Tent rings, arrow indication burnt lumber and coal.

Land Use Permit N2007C0003 is recommended for closure.
