# **2013 Annual Report**

**Final Abandonment and Reclamation**

**Itza Lake Camp**

**Mega Uranium Ltd.**

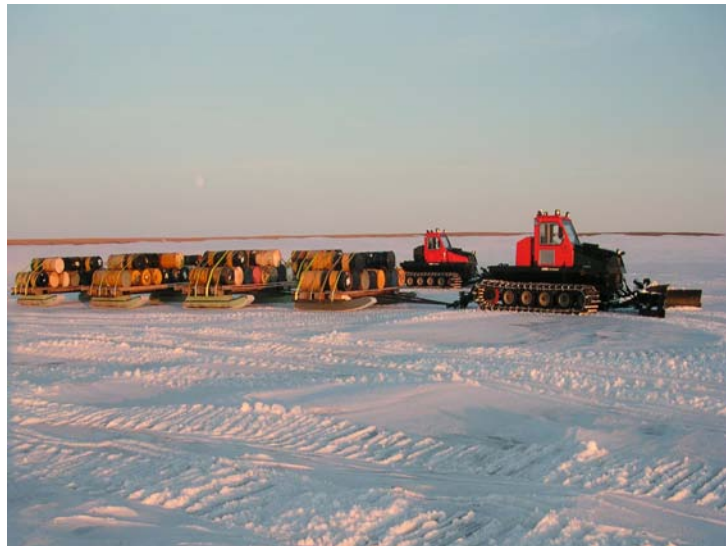
Figure 3. Sno-Cats loaded with drums of fuel at Itza Lake Camp. May 2013.

At the time of the start of the A&R Plan there were nearly 200 drums (45 gallon) of fuel (Diesel and Jet B) cached onsite in approved fuel berms. The majority (180 drums) of the fuel was removed during phase 1 of the A&R schedule using Sno-Cats overland from Baker Lake, NU. (Figure 3)

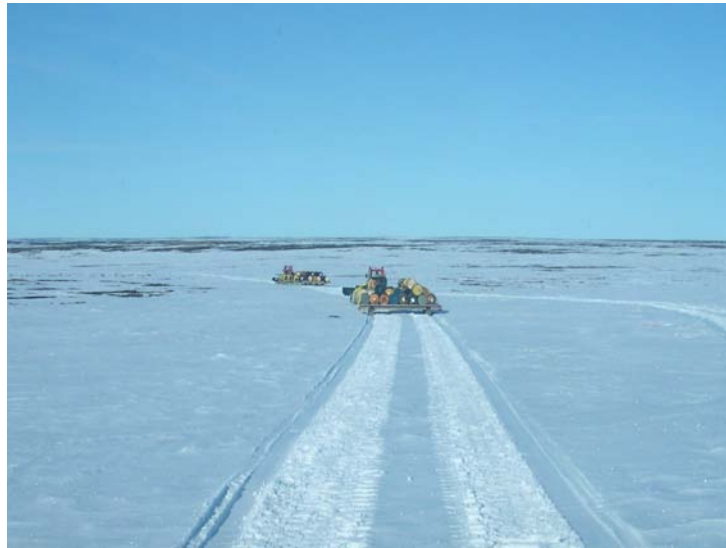
Figure 4. Demonstrating low environmental impact of the Sno-Cats on the ground while hauling the fuel overland. May 2013.

Sno-Cats were utilized during this phase as a low environmental impact, cost effective (Figure 4) option to remove the fuel while getting the work completed over a short duration. The overland route that was used from Baker Lake to Itza Lake Camp can be found in appendix D.

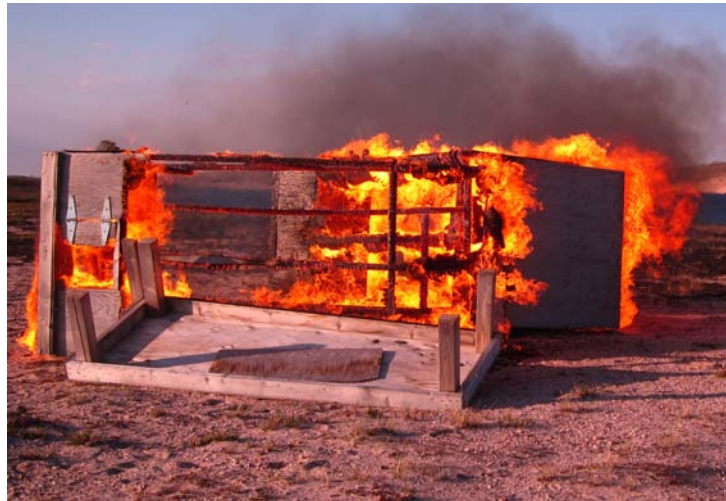
Figure 5. Wood being burned at Itza Lake Camp during Phase 2 cleanup work at Itza Lake Camp. July 2013.

As outlined in the introduction section of this report Titan Uranium had removed all equipment from the site in 2009 leaving only a skeleton camp (wooden platforms, wooden structures and a steel grain bin), meaning, the majority of materials left at Itza Lake Camp were combustible. As outlined in the approved A&R plan all wooden structures were burned. Burning took place under favorable conditions and was monitored at all times by workers on the ground. No large ash or unburned material was left on site after burning was completed. Figure 5 shows materials being burned at Itza Lake.

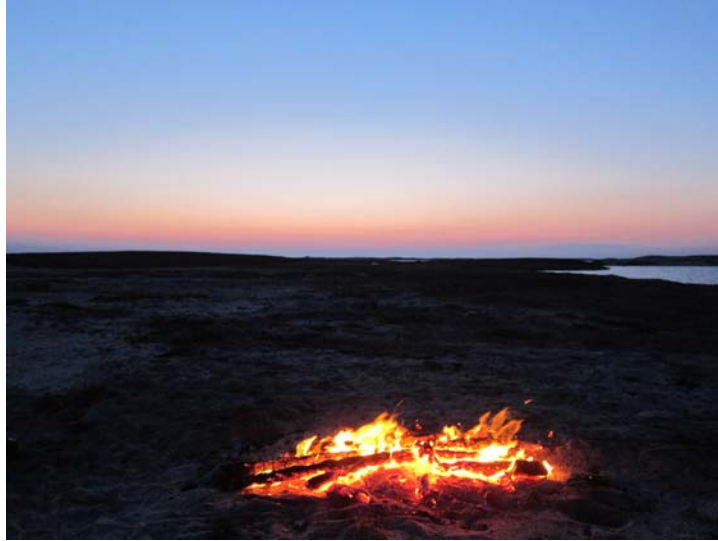
Figure 6. Controlled burning of materials at Itza Lake Camp. July 2013.

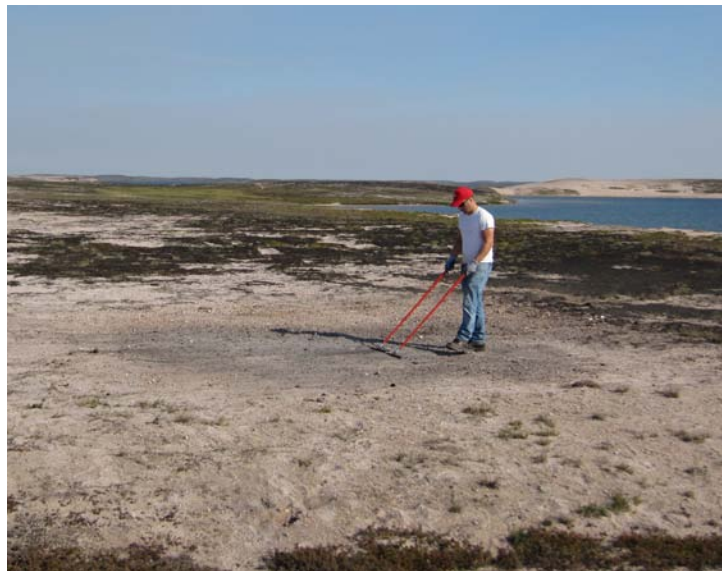
Figure 7. Demonstrating magnetic sweeping after burning to remove nails, screws, and other metals from the ground after burning was completed. July 2013.

In addition to burning materials Mega swept the area for nails, screws and other metals using magnetic sweepers (Figure 7).

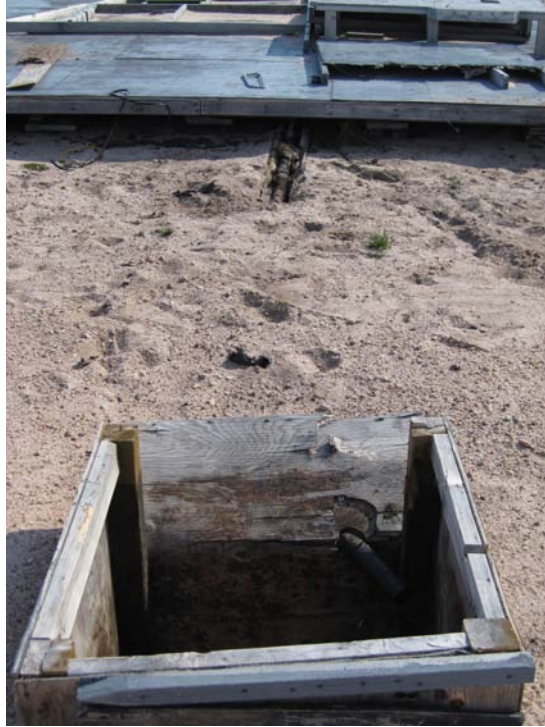
At the time of start of the A&R Plan there was only one sump remaining at the campsite that needed remediation work. This sump was located near the kitchen (Figure 9) and was not used since 2008 when Titan Uranium used the site last. This sump was removed and backfilled. Then the area was contoured to the original site grade (Figure 10). All other sumps located at this site were remediated over the past number of years by Titan Uranium (previous operator).

Figure 9. Sump located on the west side of the kitchen platform. This was the only remaining sump on site to removed. July 2013.

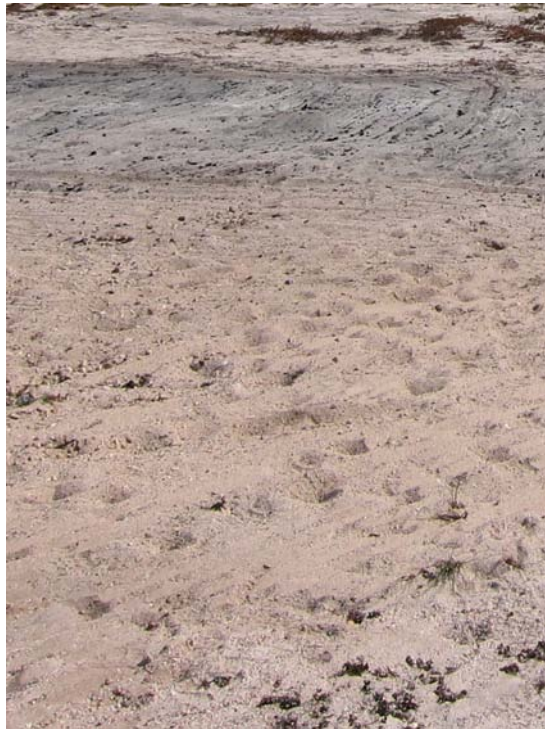
Figure 10. Sump removed from kitchen area and the surface leveled and contoured to original condition. July 2013.

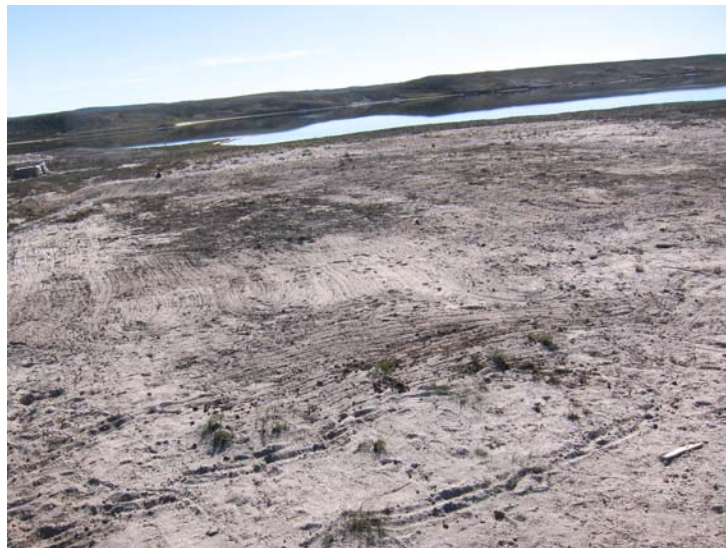
Figure 11. Demonstrating leveling and contouring to original state at the site of the fuel berms. July 2013.

Itza Lake Camp was situated on top of an esker with an adjacent air strip. The ground surface is highly stable from erosion and any infrastructure had little to no impact on the level ground surface. As part of the A&R Plan Mega ensured that areas where camp infrastructure had been erected were returned to their natural state (i.e. contouring and leveling of the ground surface). For instance figure 11 demonstrates leveling of the site around the fuel berms where sand had been piled up around the edge of the berms.

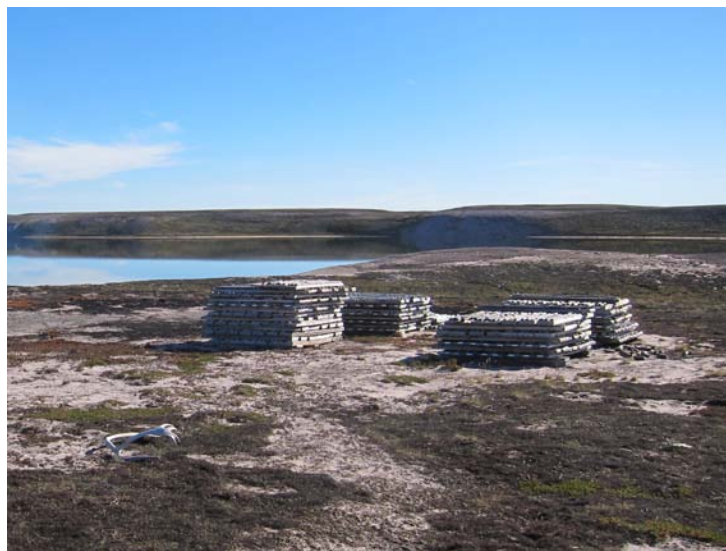
Figure 12. Core piles belonging to NexGen Energy left at Itza Lake Camp. July 2013.

Four core piles remain at the Itza Lake Campsite (Figure 12) and are the property of NexGen Energy. NexGen Energy should be contacted in relation to any matters pertaining to core storage.

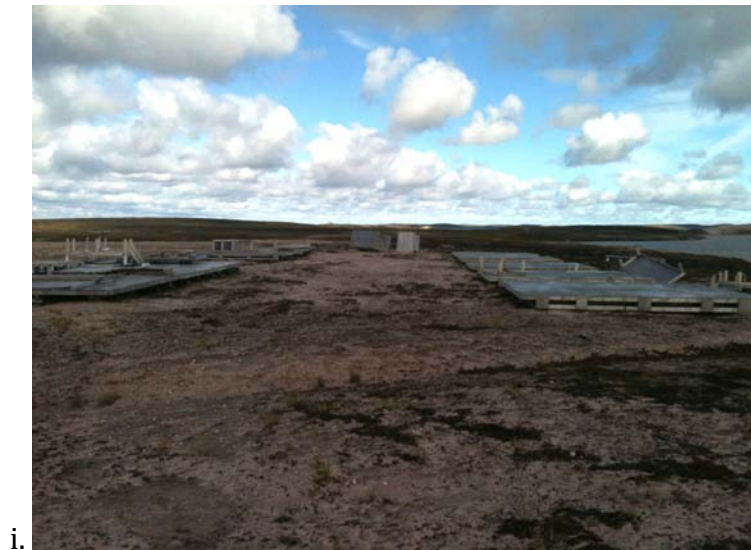
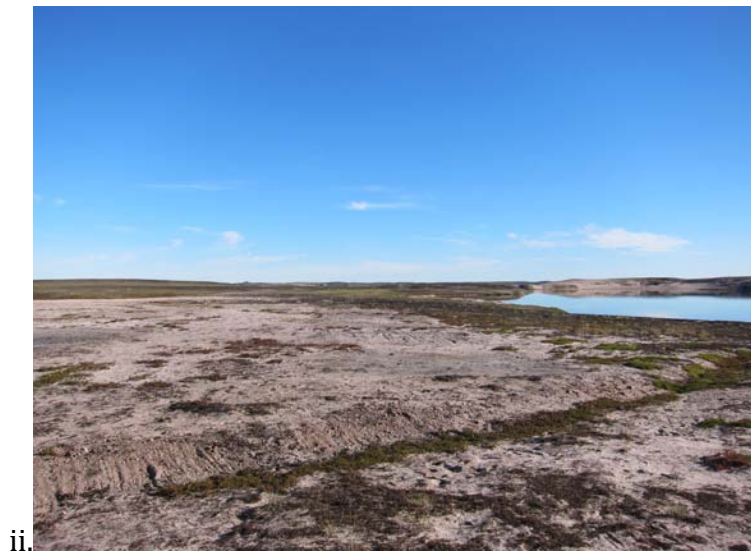
Figure 14. (i) North view of camp showing kitchen, accommodation and latrine structures (before). (ii) North view of camp showing the removal of structures at the conclusion of the A&R Plan work (After).

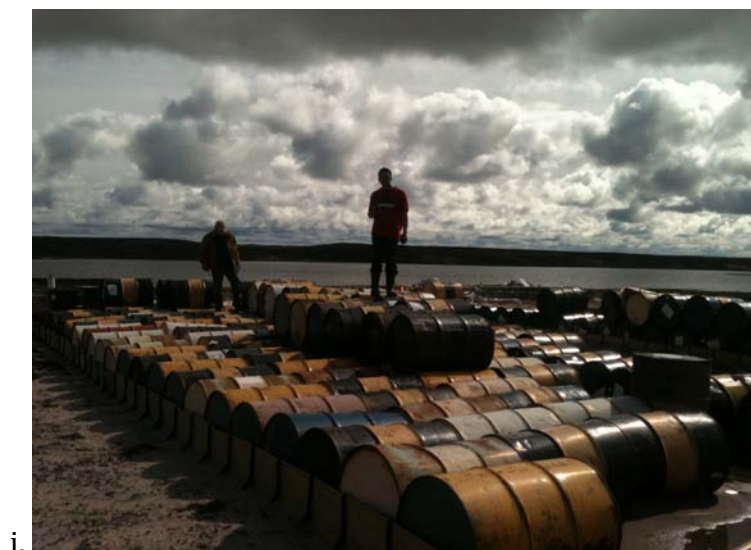
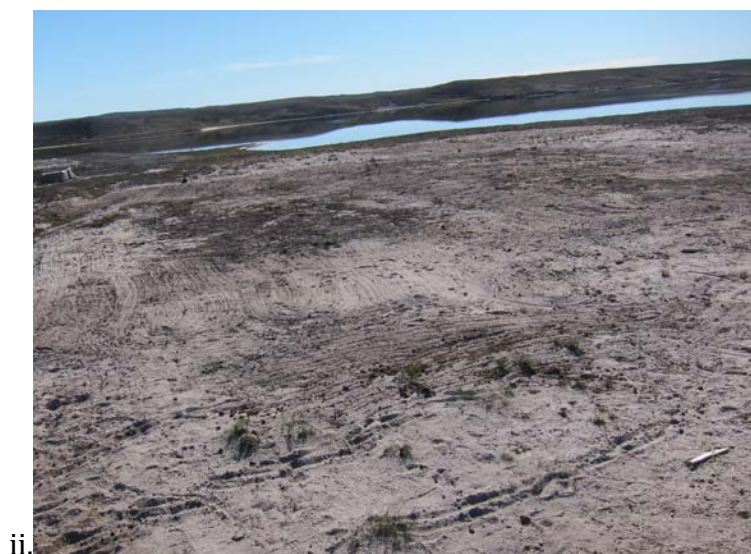
Figure 15. (i) View of fuel berm area, taken in August 2012, showing fuel in berms (Before). (ii) View of fuel berm area at the conclusion of A&R Plan showing the removal of fuel from site (After).

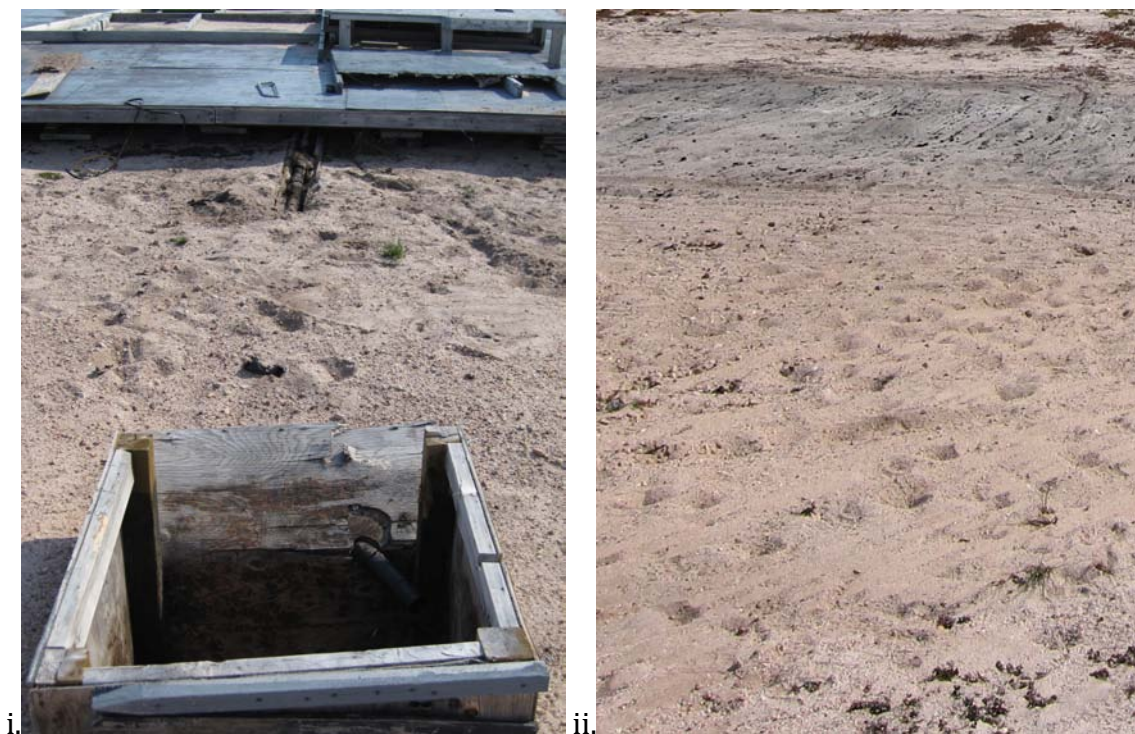
Figure 16. (i) Kitchen sump located on the west side of kitchen structure (Before).  
(ii.) Kitchen sump removed and area re-contoured at the conclusion of the A&R Plan (After).

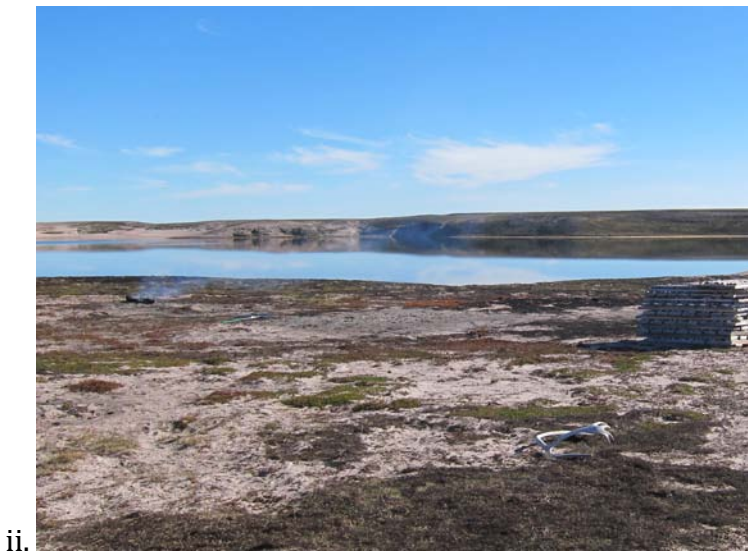
Figure 17. (i.) Steel grain bin used for storage at camp (Before). (ii) Site where the steel bin was located fully removed (After).

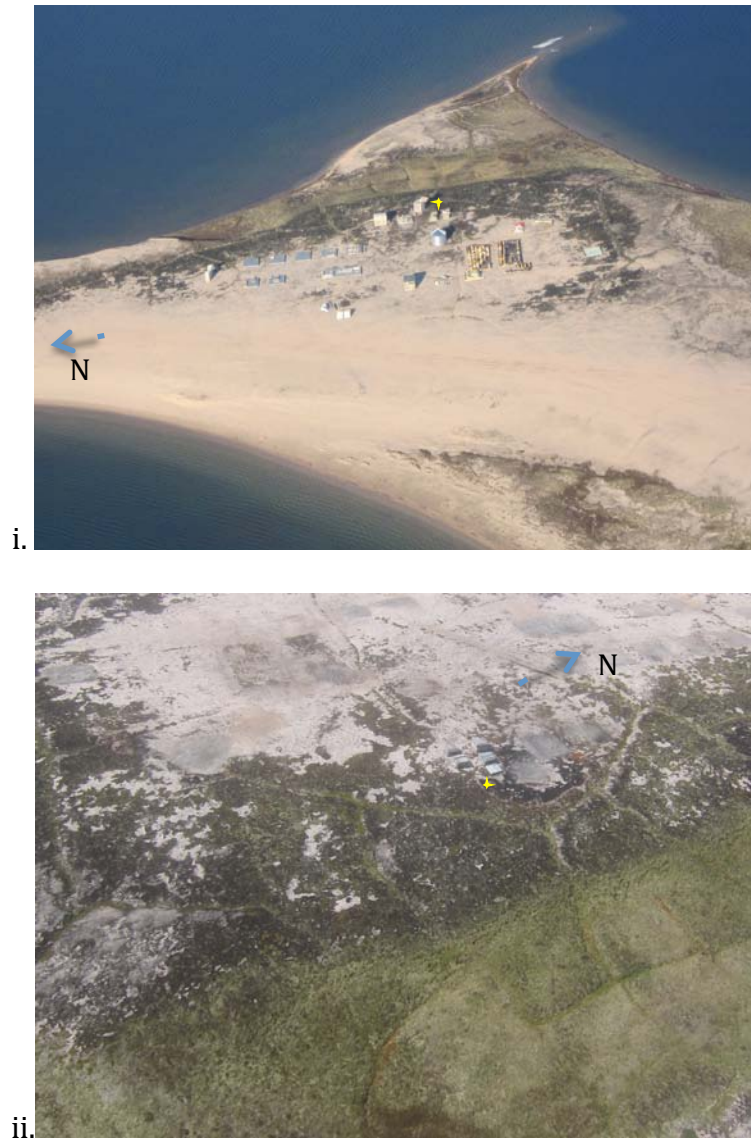
Figure 18. (i) Aerial view of the camp with all structures in place (Before). (ii) Aerial view of camp at the conclusion of the A&R Plan work showing all structures and equipment removed (After). Note: Yellow star indicates a common reference point and also North direction arrows are added for reference.
