# **2013 Annual Report**

**Final Abandonment and Reclamation**

**Itza Lake Camp**

**Mega Uranium Ltd.**

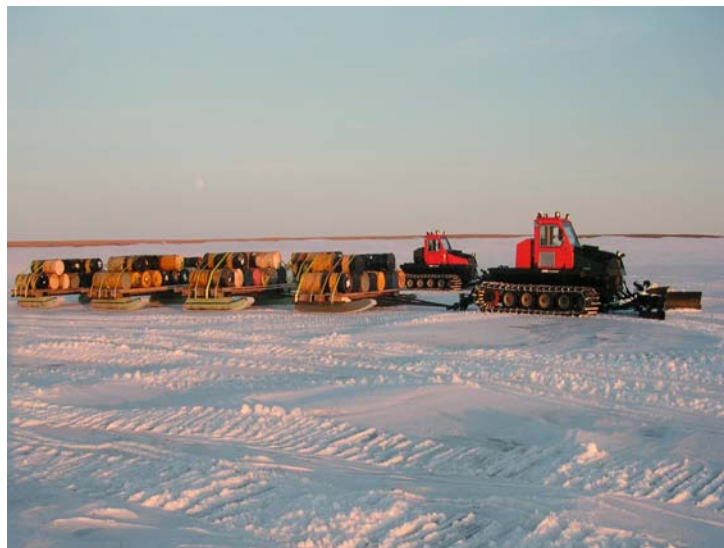
At the time of the start of the A&R Plan there were nearly 200 drums (45 gallon) of fuel (Diesel and Jet B) cached onsite in approved fuel berms. The majority (180 drums) of the fuel was removed during phase 1 of the A&R schedule using Sno-Cats overland from Baker Lake, NU. (Figure 3)

Figure 3. Sno-Cats loaded with drums of fuel at Itza Lake Camp. May 2013.
