FISHERIES ASSESSMENT OF STREAMS AND LAKES IN THE ULU PROJECT AREA, NUNAVUT

ECHO BAY MINES LTD.
Edmonton, Alberta

November 1996

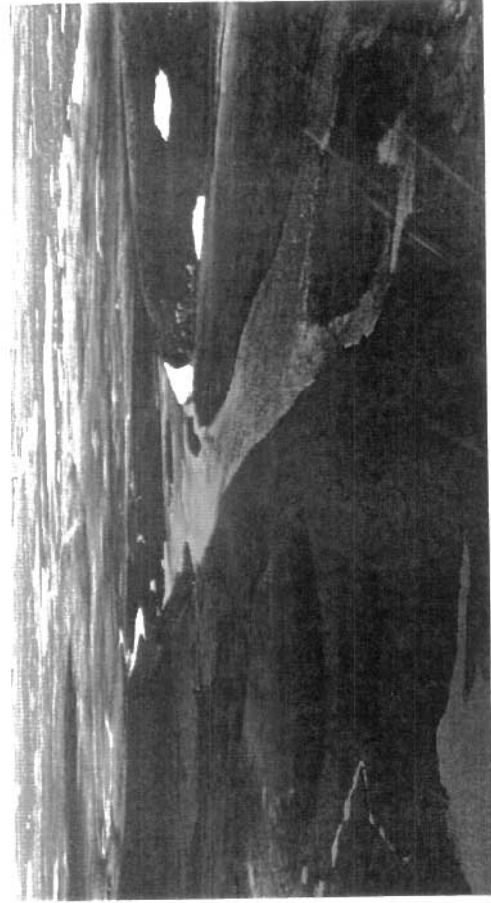
Plate 7 Route 1 - Stream 20.4 looking upstream at bend in the river immediately west of the esker.

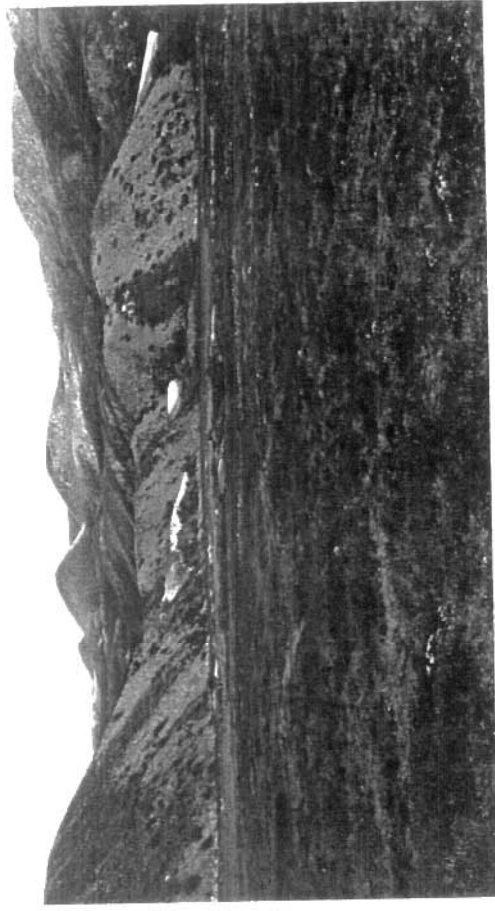
Plate 8 Route 1 - Area angled on Stream 22.5.

At the upstream crossing location the habitat consisted of boulder rapids and deep runs (R1). Instream cover was provided by the pocket water of boulders (Plate 8).

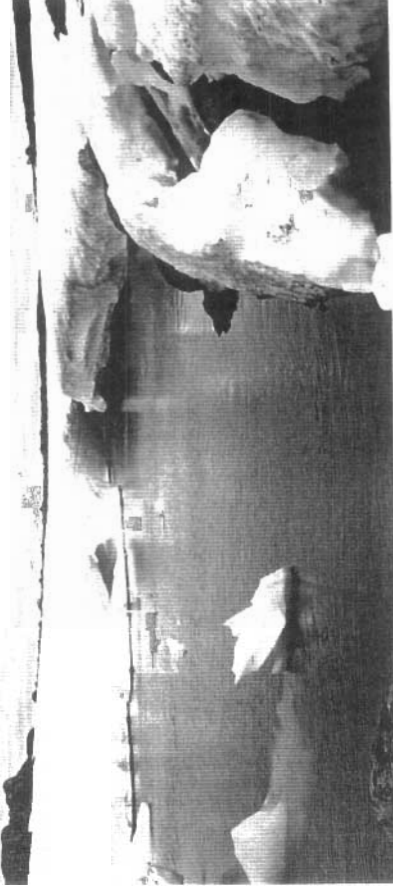
Plate 20 Route 1 - Stream 43.3 upstream of confluence with 43.6.

Stream 43.3 flows underground through a boulder field from its originating lake. Portions of the stream immediately below the boulder field were still ice and snow covered at the time of sampling (mid-June; Plate 20). The stream was sampled near the confluence with Stream 43.6. A large pool was located immediately upstream

of the confluence (Plate 20). Downstream of the confluence, the stream channel consisted of long shallow runs (R3 and R2; Plate 21). There were small deep holes (approximately 50 to 100 cm deep) adjacent to boulders in these runs. Considerable amounts of overflow were present on either side of the stream channel. Instream cover was limited to the pocket water of boulders and small areas of terrestrial grasses that were inundated.

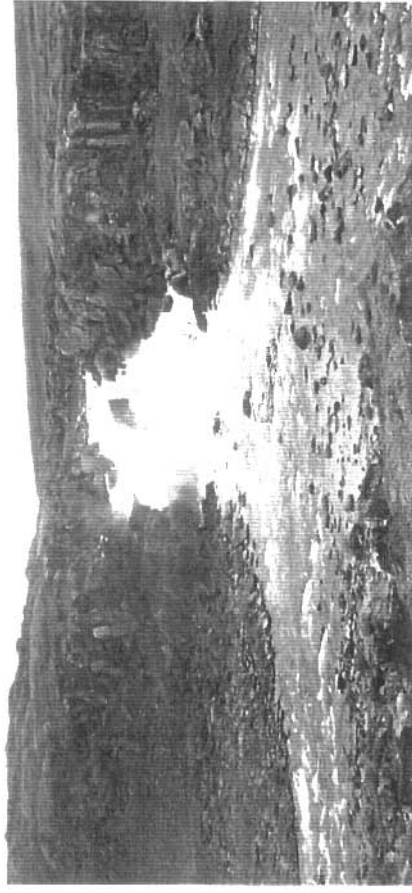
Plate 44 Route 1 - Falls which block the Hood River, at downstream end of section which was boat shocked with the Avon.

An area encompassing approximately 4.5 km upstream and 5 km downstream of the 1996 winter road crossing was examined in June 1996. This reach of the Hood River is confined by a long chute and rapid at the upstream end (Plate 43) and a second set of rapids and falls at the downstream end of the sampling area (Plate 44). Along its length, the Hood River has a wide flood plain that is periodically constricted at bedrock outcroppings, which correspond with abrupt changes in elevation. The chutes and falls shown in Plates 43 and 44 are a good example of this channel constrictions and elevation changes.

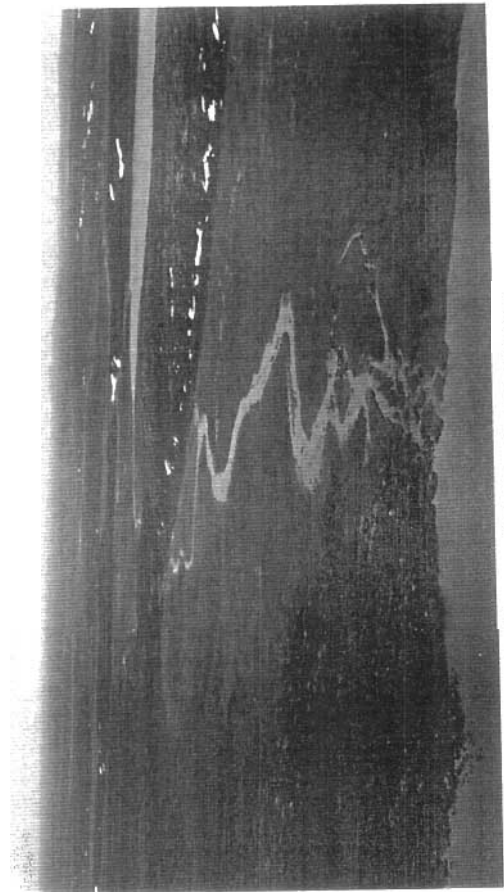
Plate 83 Route 4 - Stream 23.7 looking downstream. Note: dispersed overland flow on either side of mainstem channel (center of picture).
