BASELINE AQUATIC STUDIES PROGRAM IN THE ULU PROJECT AREA, NUNAVUT (1997)

Prepared for
ECHO BAY MINES LTD.
Edmonton, Alberta

by
R.L. & L. ENVIRONMENTAL SERVICES LTD.
17312 - 106 Avenue
Edmonton, Alberta
T5S 1H9
Phone: (403) 483-3499

May 1998

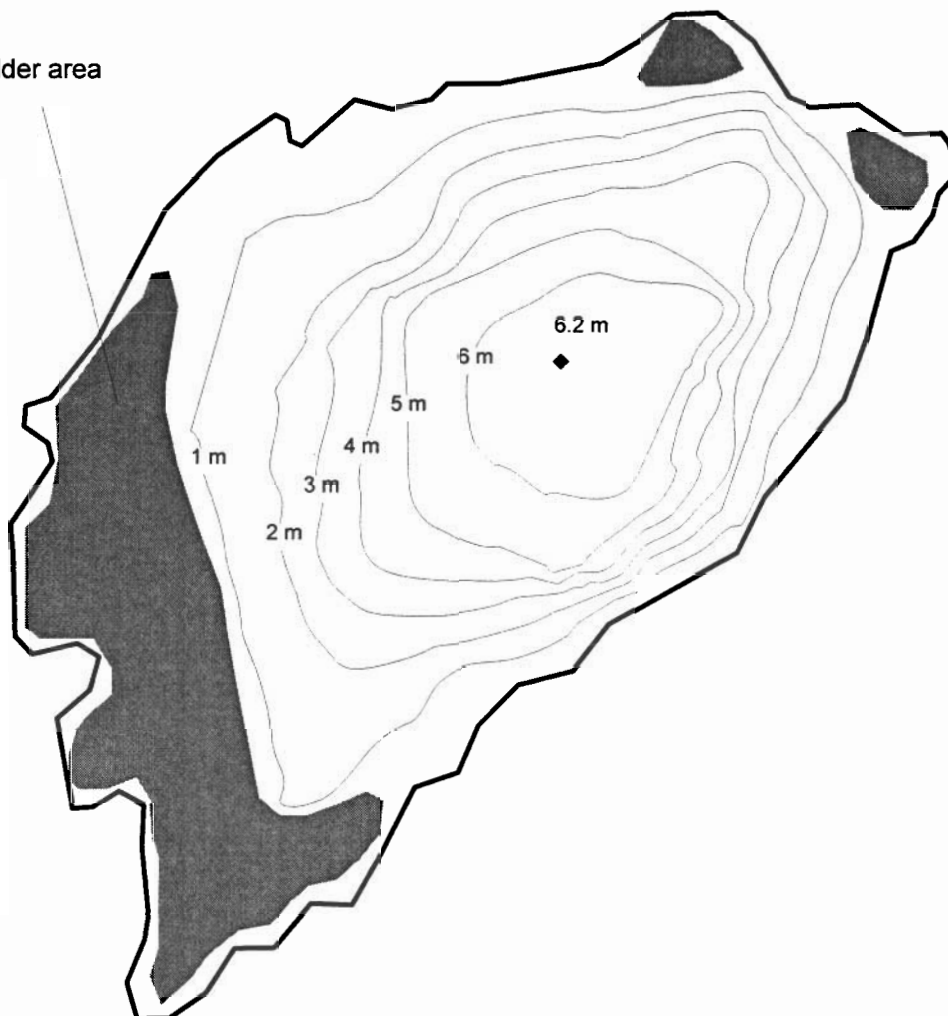
Figure 4.2
Bathymetry of East Lake
Ulu Exploration Area 1997

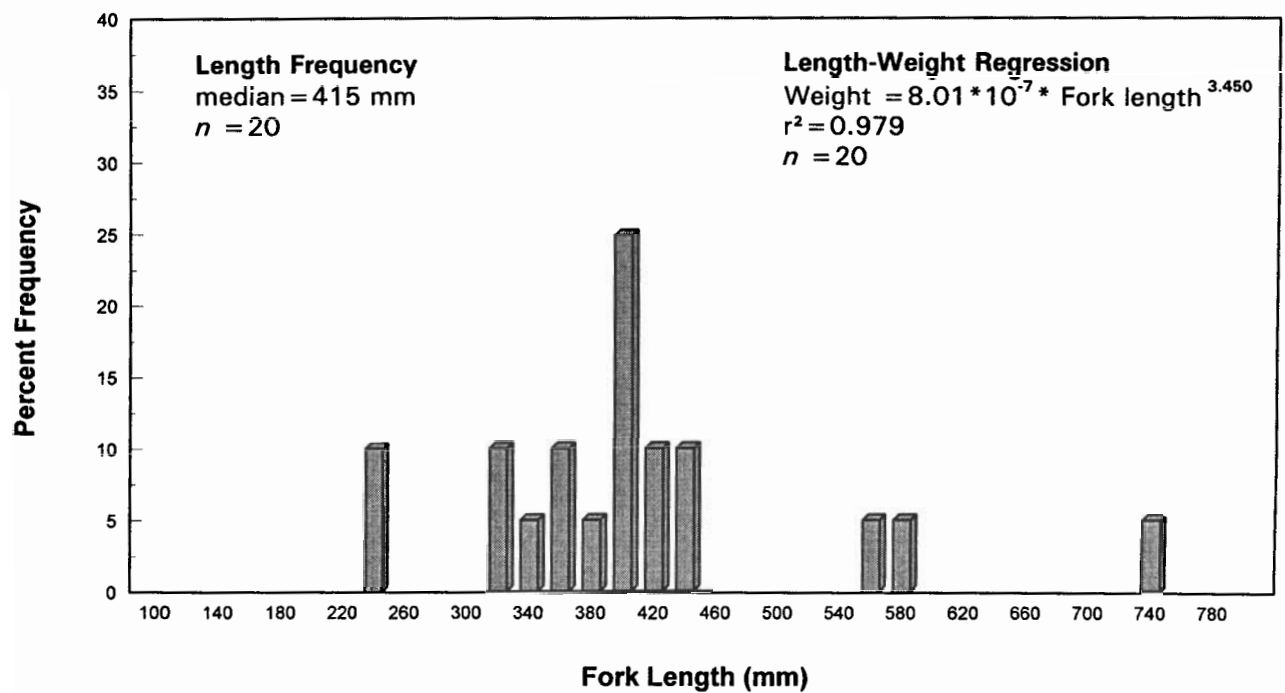
Figure 4.7 Length-frequency distribution and length-weight regression equation for lake trout sampled from Ulu Lake, Ulu Exploration Area (Data for 1996 and 1997 combined).

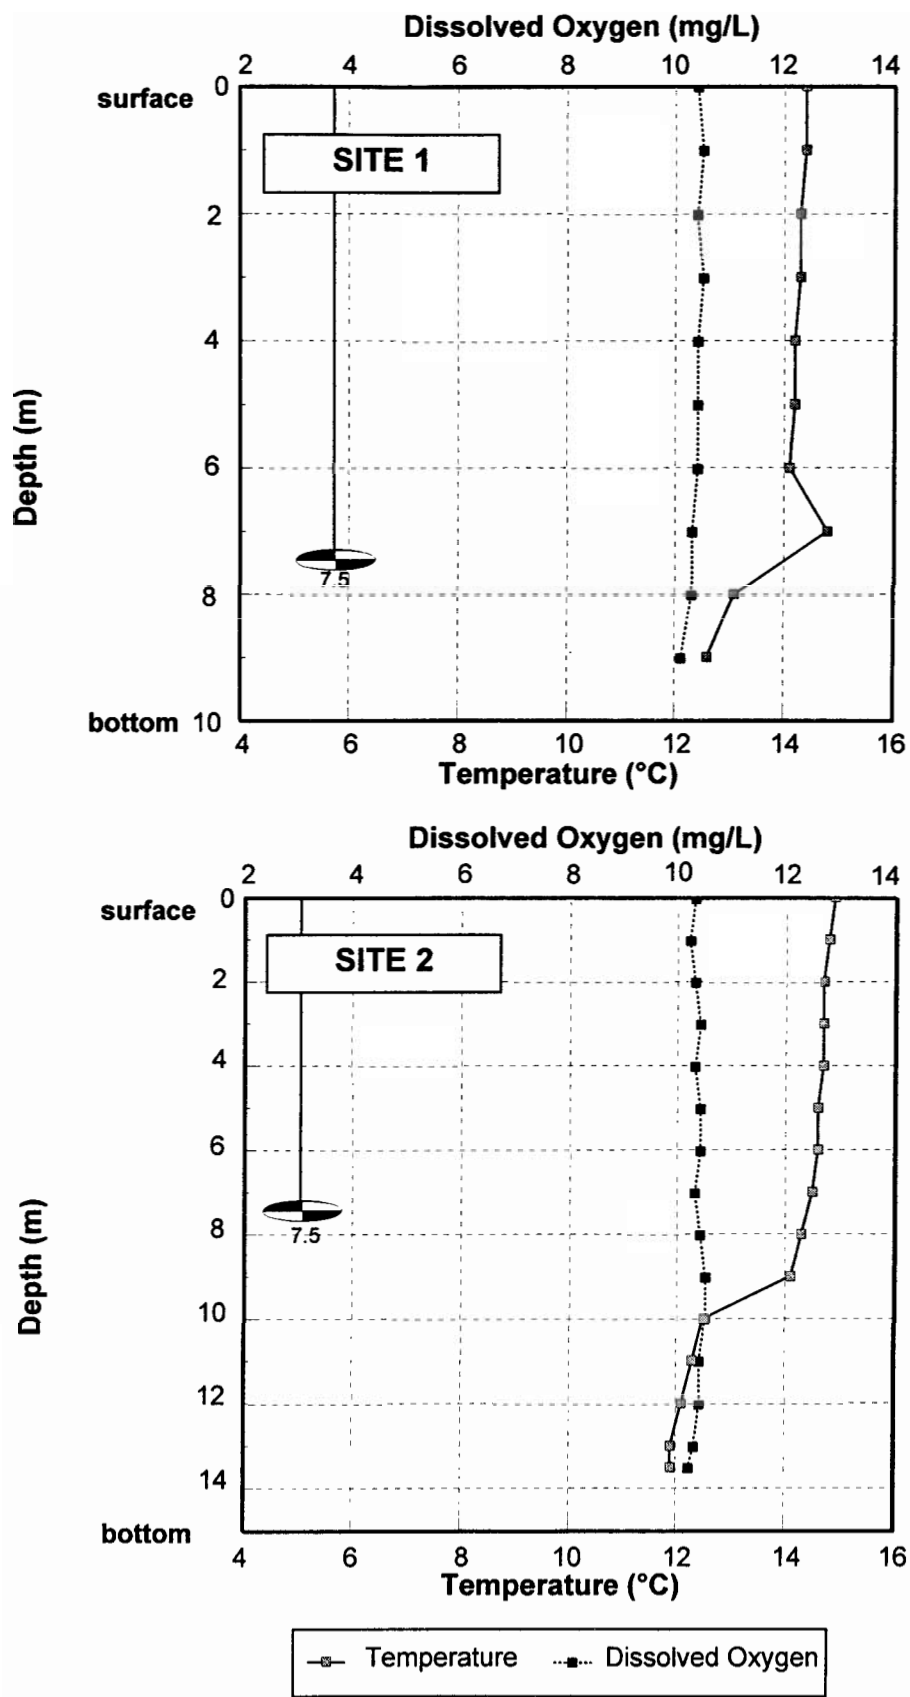
Figure 4.14 Dissolved oxygen and temperature profiles, and Secchi depth reading at Sites 1 and 2 on Reno Lake South on 4 August 1997, Ulu Exploration Area.

Temperature and dissolved oxygen profiles were recorded at two locations on Reno Lake South on 4 August (Figure 4.14; Appendix C1). The temperature profile indicated uniform mixing (i.e., isothermal conditions) at both sites. Water temperatures and oxygen concentrations generally did not vary between the surface and bottom (12.0°C and 10.3 mg/L). Water transparency in Reno Lake South was high at the time of the sampling (7.5 m).

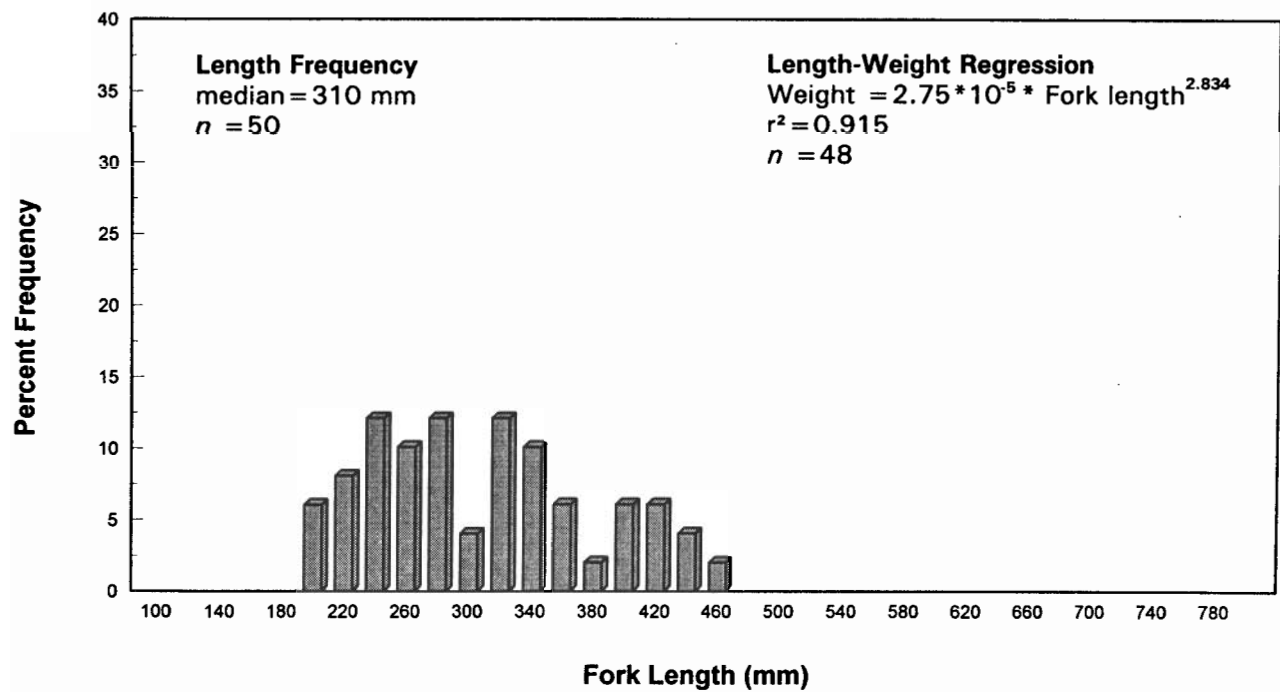
Figure 4.15 Length-frequency distribution and length-weight regression equation for lake trout sampled from Reno Lake South, Ulu Exploration Area (Data for 1996 and 1997 combined).
