**RE: July 11, 2002 Municipal Water Use Inspection - Report**

## MUNICIPAL WATER USE INSPECTION REPORT

Date: July 11, 2002

Licensee: Hamlet of Arviat

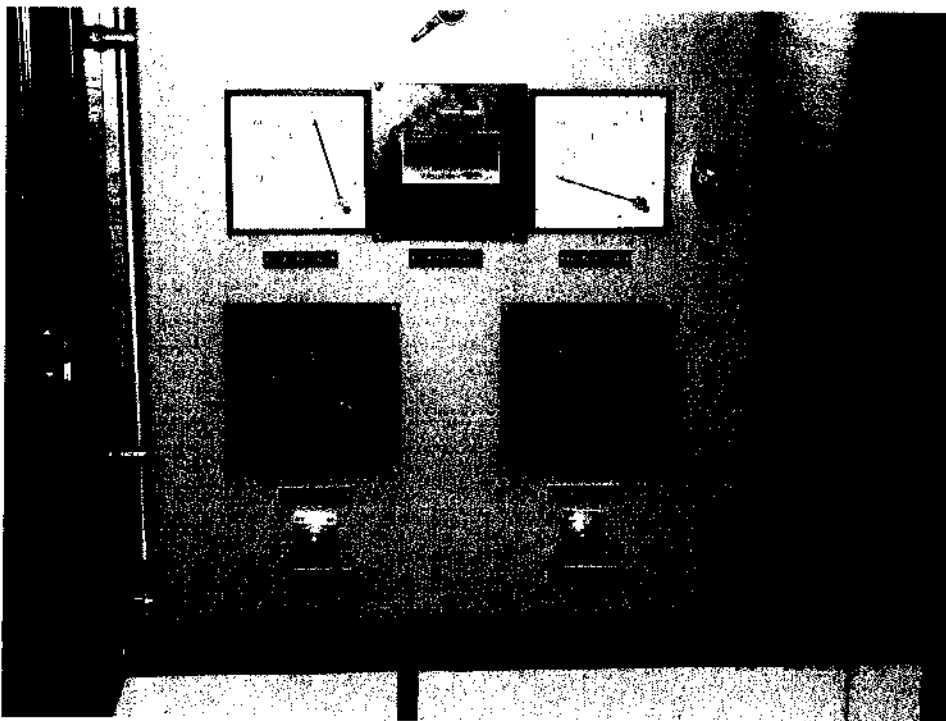
- ☐ **Water Supply:** The Water Intake Facility and water reservoir seemed to be well maintained (Photo 1 & 2). The chlorination system was operational at the time of inspection. Enclosed analysis of water samples taken at the time of this inspection indicate that Turbidity (1.0 NTU vs 5.0 NTU), Nitrate + Nitrite (<0.008 mg/L vs 3.2 mg/L) and pH (6.86 vs 6.5-8.5) are found to be within the *Guidelines for Canadian Drinking Water Quality*.

Photo # 2. Water metres in water intake facility metre (# 1. 258635000) metre (# 2. 526860700).

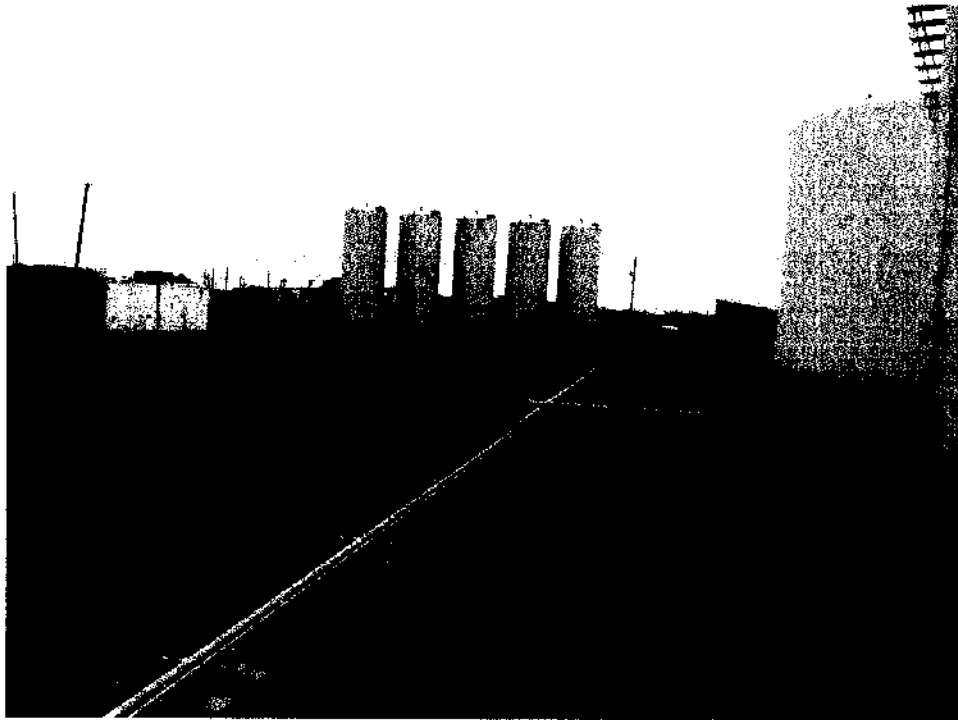
- ☐ **Fuel Storage:** At the time of inspection the berm surrounding the Tank Farm appeared to be in good condition with no breaches. The containment liner of the berm was not visible. The area within the tank farm berm was dry with no staining from fuel or oil (Photo 11 & 12).

Photo # 11. Tank Farm berms appear in good condition.
