August 24, 2001 Municipal Water Use Inspection - Report

MUNICIPAL WATER USE INSPECTION FORM

Date: 2001/08/24 Licensee Rep. (Name/Title): Paul Pudlat / Foreman
Licensee: Hamlet of Coral Harbour Licence No.: unlicensed

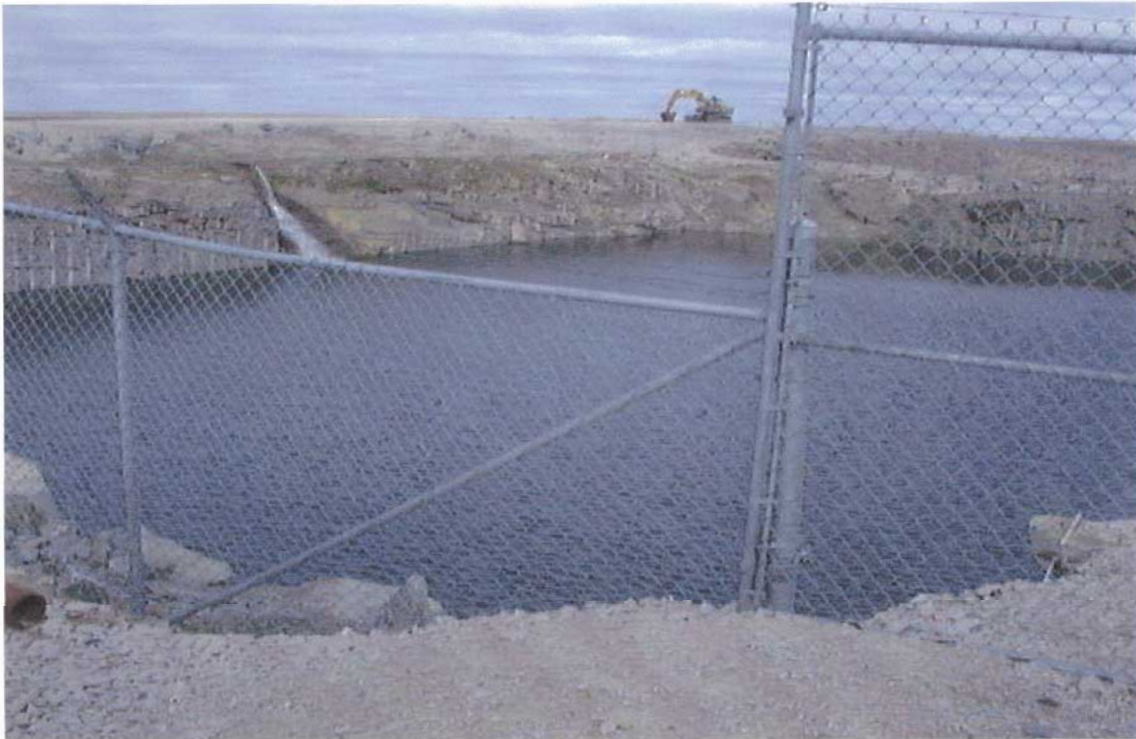
- **Water supply:** No concerns were noted regarding the water intake and supply facilities, especially since the commissioning of the second reservoir has solved issues of water shortage. In parallel, the attached analytical results relating to a sample collected from the first reservoir (figure 1) indicate that all tested parameters meet the *Guidelines for Canadian Drinking Water Quality*, save for two exceptions: a field pH of 9.3 versus the 6.5-8.5 aesthetic objective, and a turbidity value of 1.9 Nephelometric Turbidity Unit (NTU) hovering between the 1 NTU maximum acceptable concentration and the 5 NTU aesthetic objective.

Comments: No concerns noted at the water intake and supply facilities. Second municipal water reservoir commissioned last year; no more water shortage concerns. Refilling operations ongoing at the time of the inspection; subsurface link between the two reservoirs allows simultaneous refill. Reservoirs overfilled in efforts to flush the 'older' water. Chlorination in use.

figure 1. Refilling operations at the first municipal water reservoir; 2001/08/24.

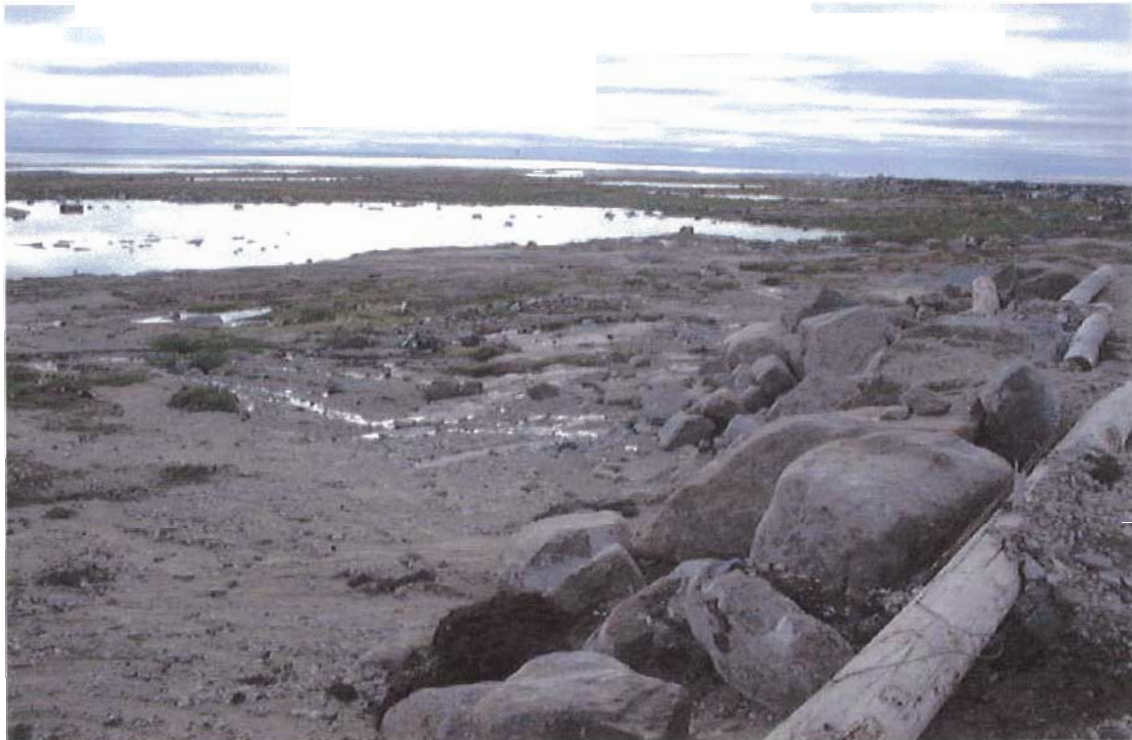
- **Sewage disposal:** While it reportedly overflows wintertime, the level of the initial sewage lake was quite low at the time of the inspection (figure 2). In fact, flow was not noticeable from either the outflow of the initial sewage lake (figure 3), or along the densely vegetated path of effluent discharge into the second sewage lake (figure 4). This being said, the attached analytical results relating to a sample taken from the shoreline of the second sewage lake (figure 5) reveal that all tested parameters comply with the *Canadian Water Quality Guidelines for the Protection of Freshwater Aquatic Life*, save for pH (field value of 9.9 versus the 9.0 threshold). Nevertheless, the Microtox sample, which constitutes a reliable toxicity indicator (IC₅₀), shows that half of light-producing bacteria were inhibited by a sample concentration of 49.2%, whereas 50% and over is considered non-toxic. Thus, in an attempt to pinpoint the cause of the toxicity attributed to the sewage effluent discharge, a wider range of parameters will be sampled during the next municipal water use and waste disposal inspection.

figure 2. Truck dumping point, sewage disposal facility; 2001/08/24.

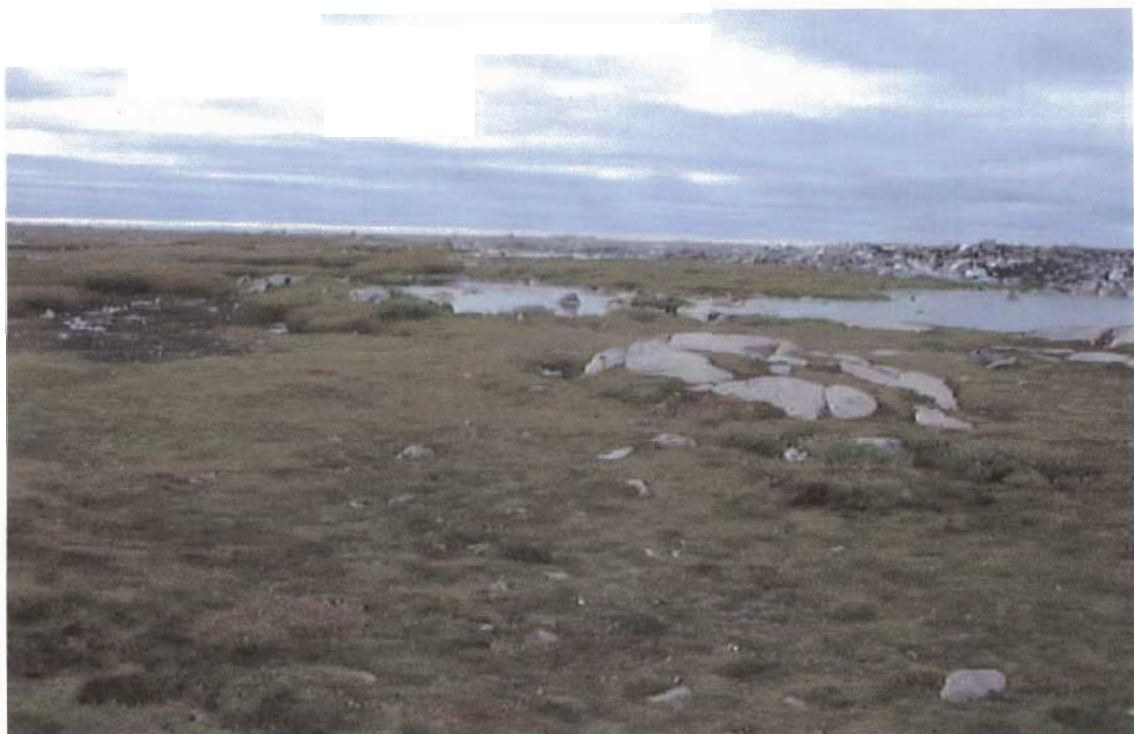
Comments: Sewage disposal facility consists of a series of lakes connected by dense vegetation. No flow noted between the initial lake and the second lake immediately downstream. Unfenced solid waste disposal facility appears well burnt/compacted and covered; however the toe of the wastepile is fairly spread out and pooled water was noted in the area. No particular treatment is provided to hazardous materials; batteries remain in dumped vehicles, and waste oil is stored by the garage. Bulky metal waste disposal site covers an extensive area; plans to compact and relocate further away from the river. Concerns raised regarding the possibility that the path of flow from the waste disposal facilities leads towards the community.

figure 3. Outlet from the sewage disposal facility; 2001/08/24.

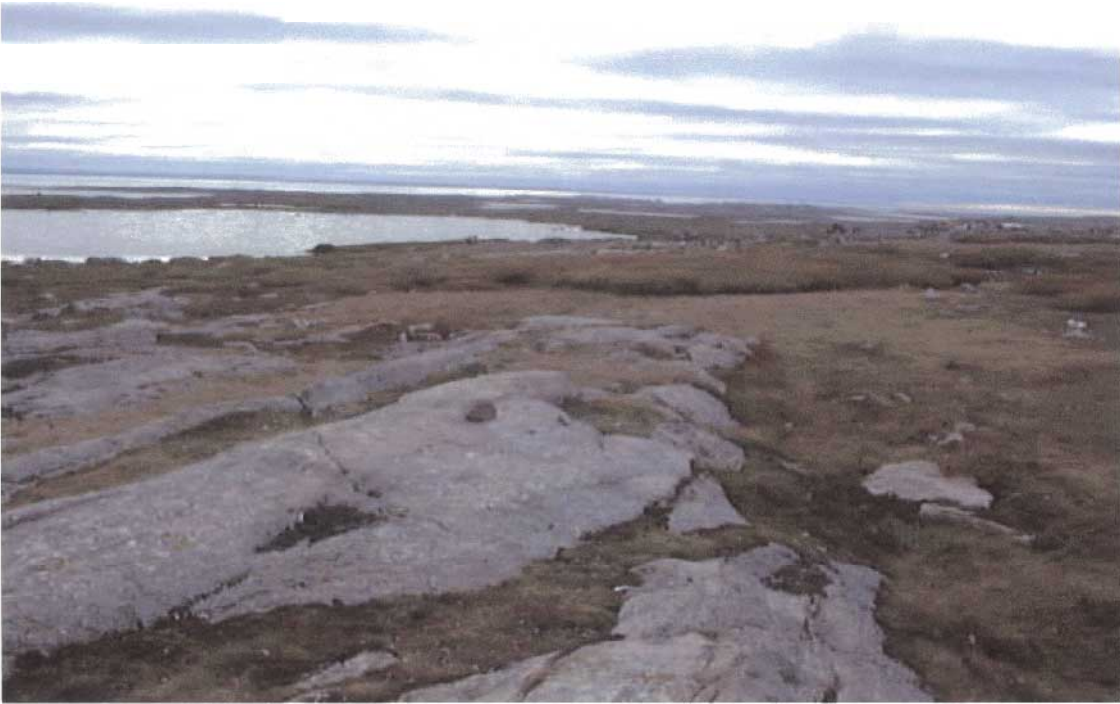
figure 4. Discharge path from the sewage disposal site to the 2nd sewage lake; 2001/08/24.

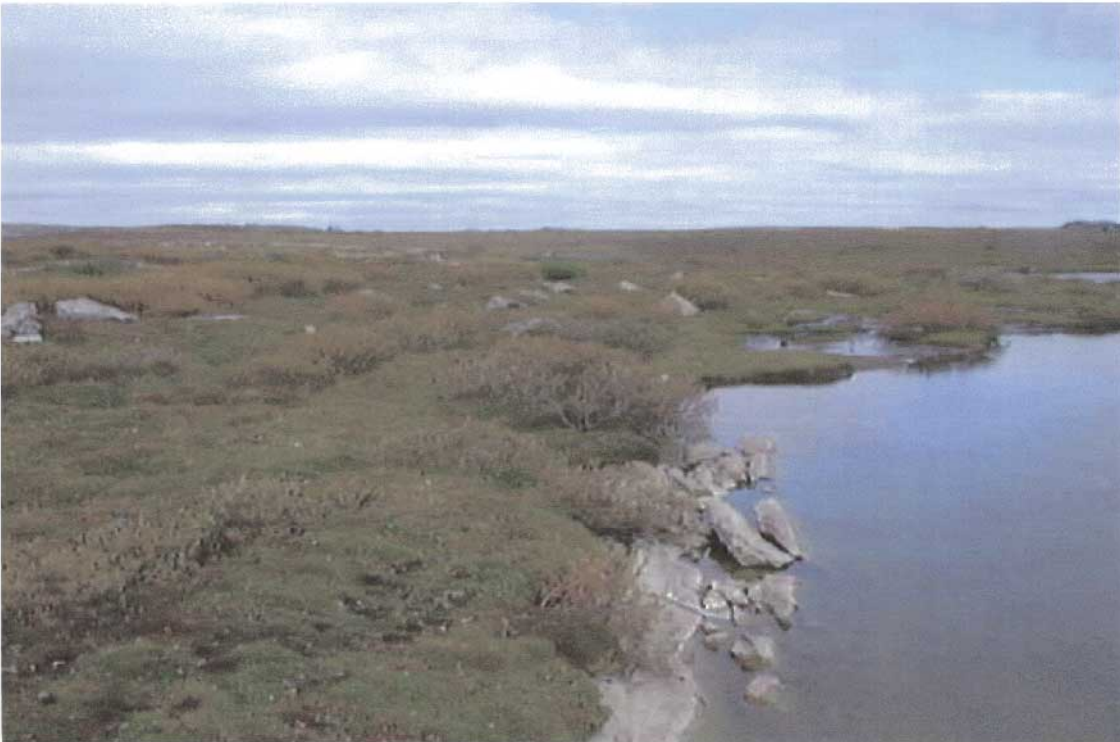
figure 5. Shoreline of the 2nd sewage lake, waste disposal site in background; 2001/08/24.

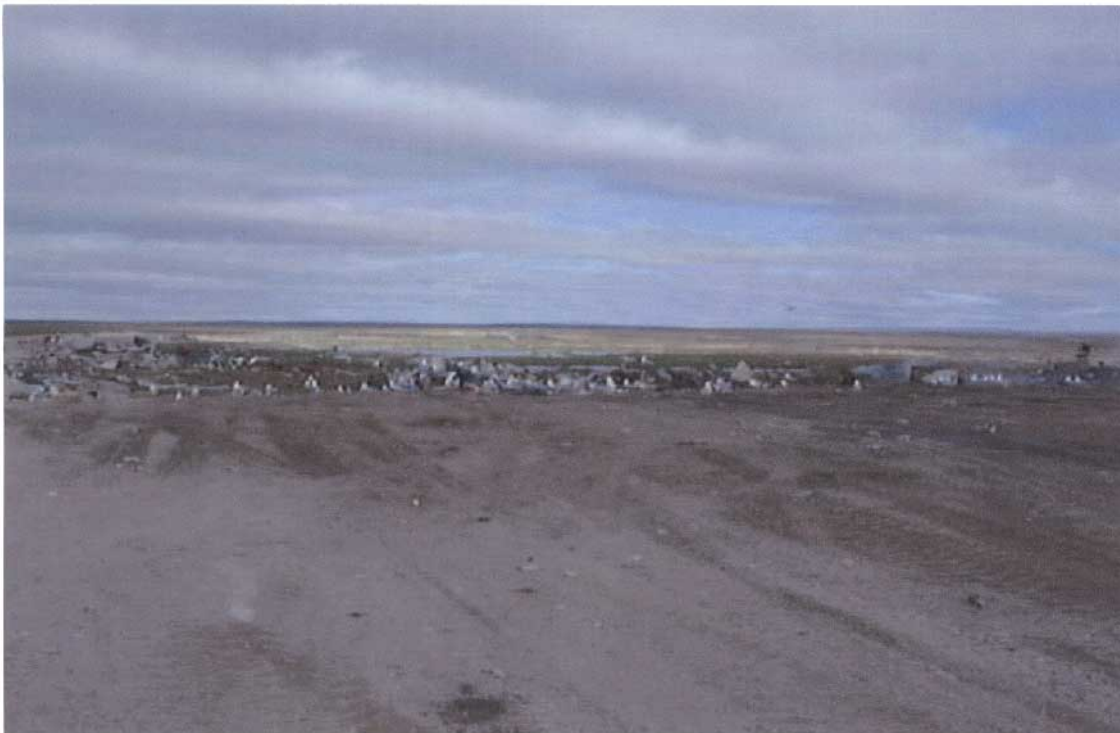
- **Solid waste disposal:** Although combustible household wastes appear well compacted and covered (figure 6), a fair amount of windblown waste was nonetheless observed beyond the perimeter of the solid waste disposal facility. Consequently, it was mentioned that the Hamlet plans to carry out a fencing project once the required resources become available. Further, it was reported during the inspection that the Hamlet plans to acquire, in the near future, a waste oil furnace. Also, since no particular storage area or form of containment are at the moment dedicated to hazardous materials, the use of a sealift container for their temporary storage prior to proper disposal was suggested. Given the fact that the presence of pooled water along the toe of the solid waste disposal facility was noted, the Inspector underlines that the above improvements would significantly reduce the likelihood of waste being deposited in waters. Accordingly, the attached analytical results relating to a leachate sample collected from the main pond (figure 7) indicate that concentrations of copper ($5 \mu\text{g/L}$ vs $4 \mu\text{g/L}$), iron (2.36 mg/L vs 0.3 mg/L), and zinc ($130 \mu\text{g/L}$ vs $30 \mu\text{g/L}$) exceed the *Canadian Water Quality Guidelines for the Protection of Freshwater Aquatic Life*. Lastly, it was mentioned that the Hamlet also diligently intends to compact and relocate the bulky metal wastes disposal site (figure 8) further from a nearby watercourse.

figure 6. Solid waste disposal facility; 2001/08/24.

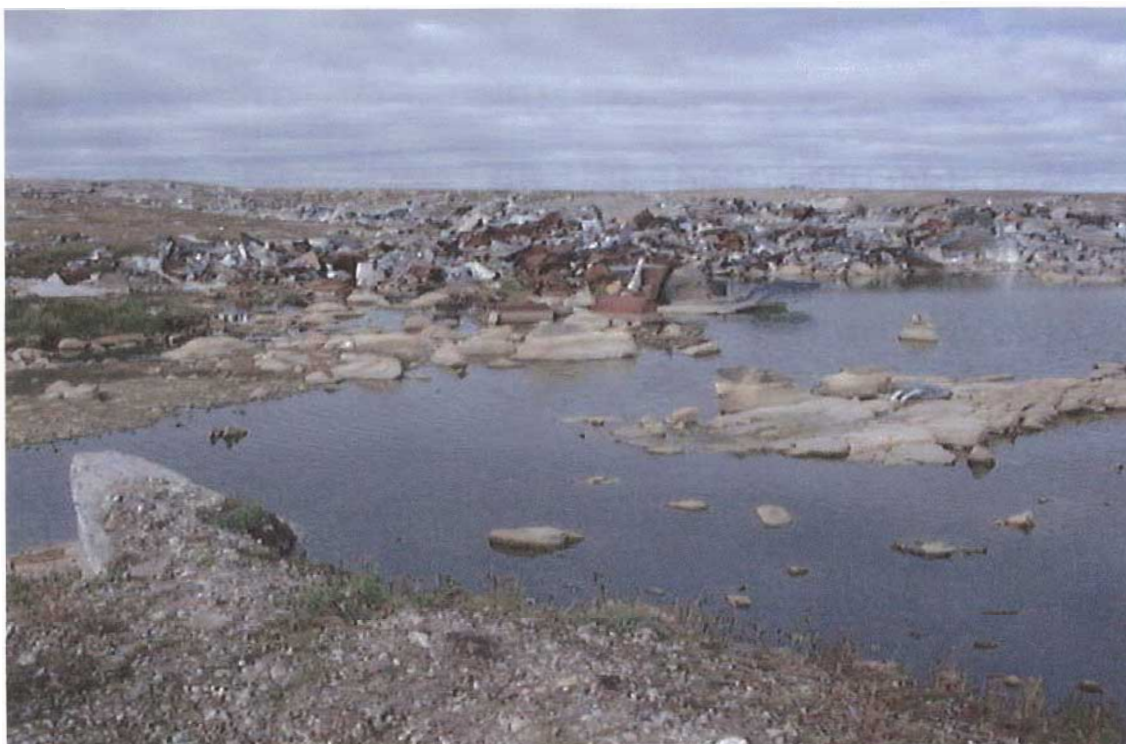
figure 7. Pooled water along the toe of the solid waste disposal facility; 2001/08/24.

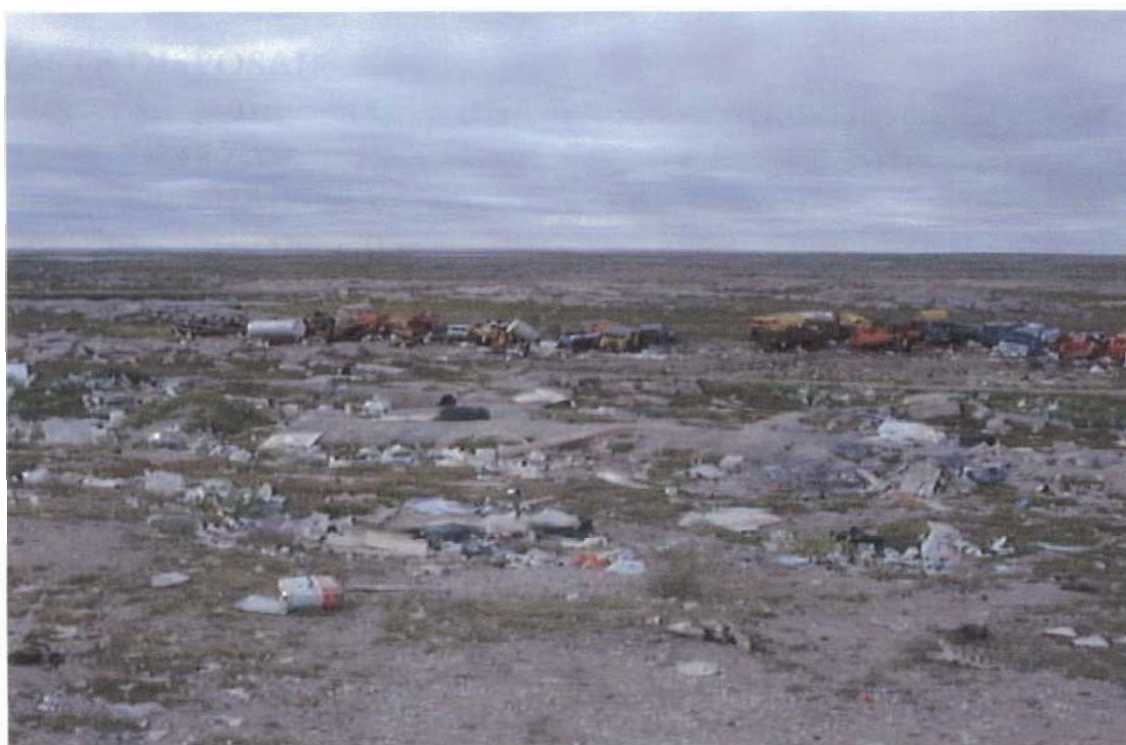
figure 8. Bulky metal wastes disposal site; 2001/08/24.

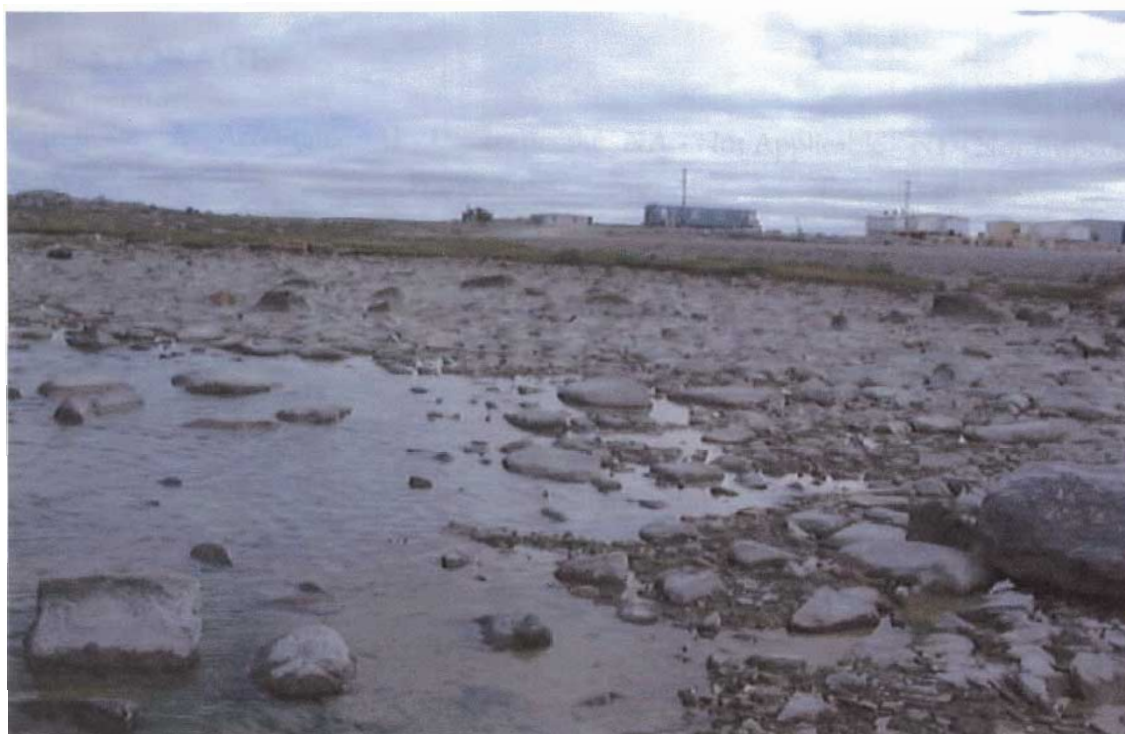
In related matters, due to voiced concerns regarding the possibility that the path of flow from the waste disposal facilities heads towards the community, a sample was taken from a lake presumably along the path of discharge (figure 9). As such, the attached analytical results reveal that all tested parameters meet the *Canadian Water Quality Guidelines for the Protection of Freshwater Aquatic Life*, and that the associated microtox sample did not denote toxicity.

figure 9. Lake presumably in the discharge path from the waste disposal sites; 2001/08/24.
