**WATER LICENCE INSPECTION FORM**☒ Original
☐ Follow-Up Report

Licensee	Licensee Representative
Community and Government Services	Megan Muckpah-Gavin
Licence No. / Expiry	Representative's Title
3AM-GRA1631	Municipal Technical Officer
Land Authorization No. / Expiry	Land Authorization Expiry
NA	NA
Date of Inspection	Inspector
July 20, 2022	WRO. Kyle Amsel
Activities Inspected	
<input type="checkbox"/> Camp <input type="checkbox"/> Drilling <input type="checkbox"/> Mining <input type="checkbox"/> Construction <input type="checkbox"/> Reclamation <input type="checkbox"/> Fuel Storage <input type="checkbox"/> Roads/Hauling <input checked="" type="checkbox"/> Other: Municipal <input type="checkbox"/> Other:

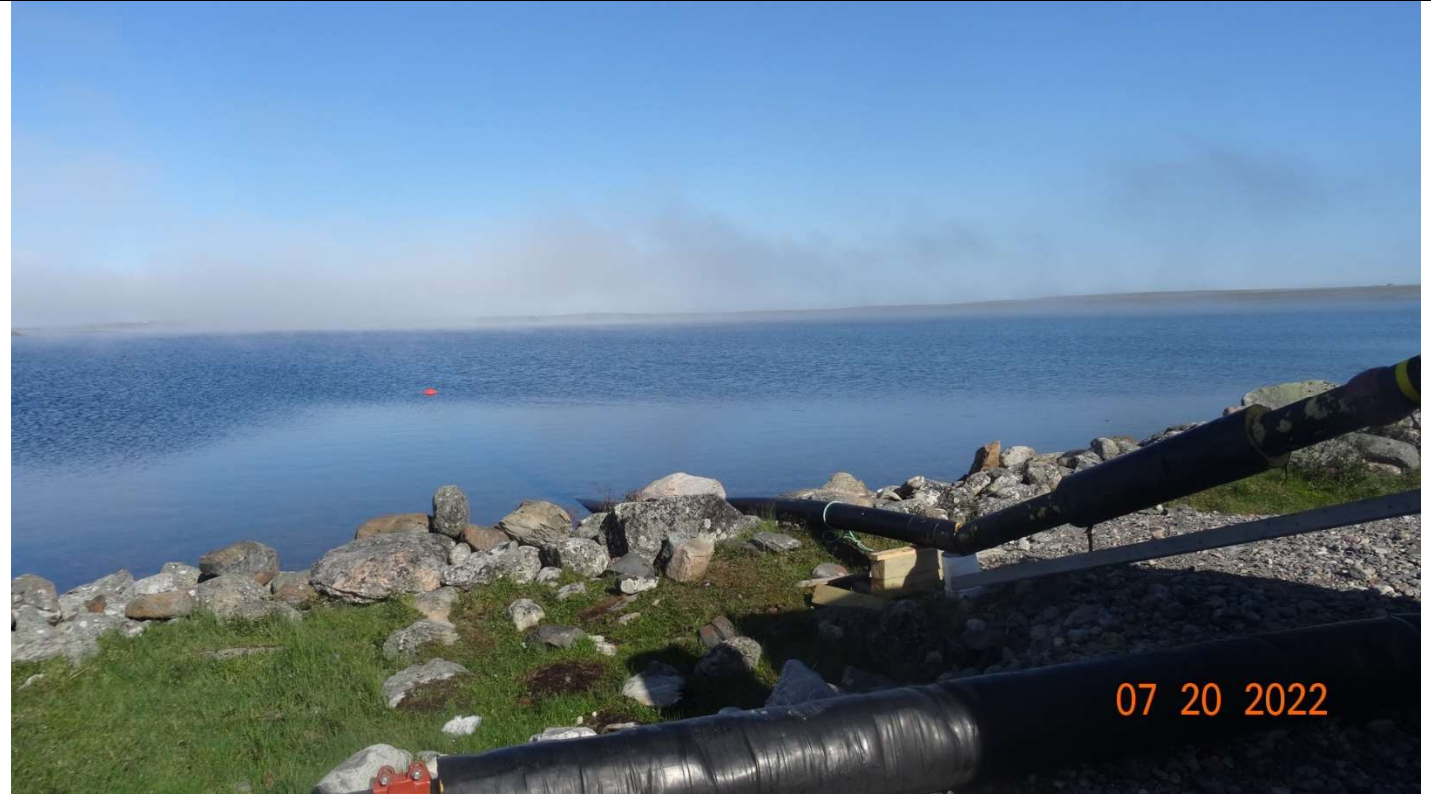
Photo 2

- At Lower Landing Lake pumping station (GRA-7) (Photo 1)
 - This pumping station is used to replenish Nipissar Lake.
 - Representatives stated a screen is on the end of the pipe satisfying Part D Item 6 of the Licence.

Description:
Water Intake Line from Lower Landing Lake. GRA-7

- Signage is not present at the site failing to comply with Part B Item 5 of the Licence.
 - Representatives explained the water level of Lower Landing Lake is checked with the use of a rotary laser transit placed on a benchmark and a receiver on a grade rod to measure the height of Lower Landing Lake. The Lake level is taken at the beginning of the season and weekly until pumping from Lower Landing is completed. This satisfies Part J Item 7 of the Licence.

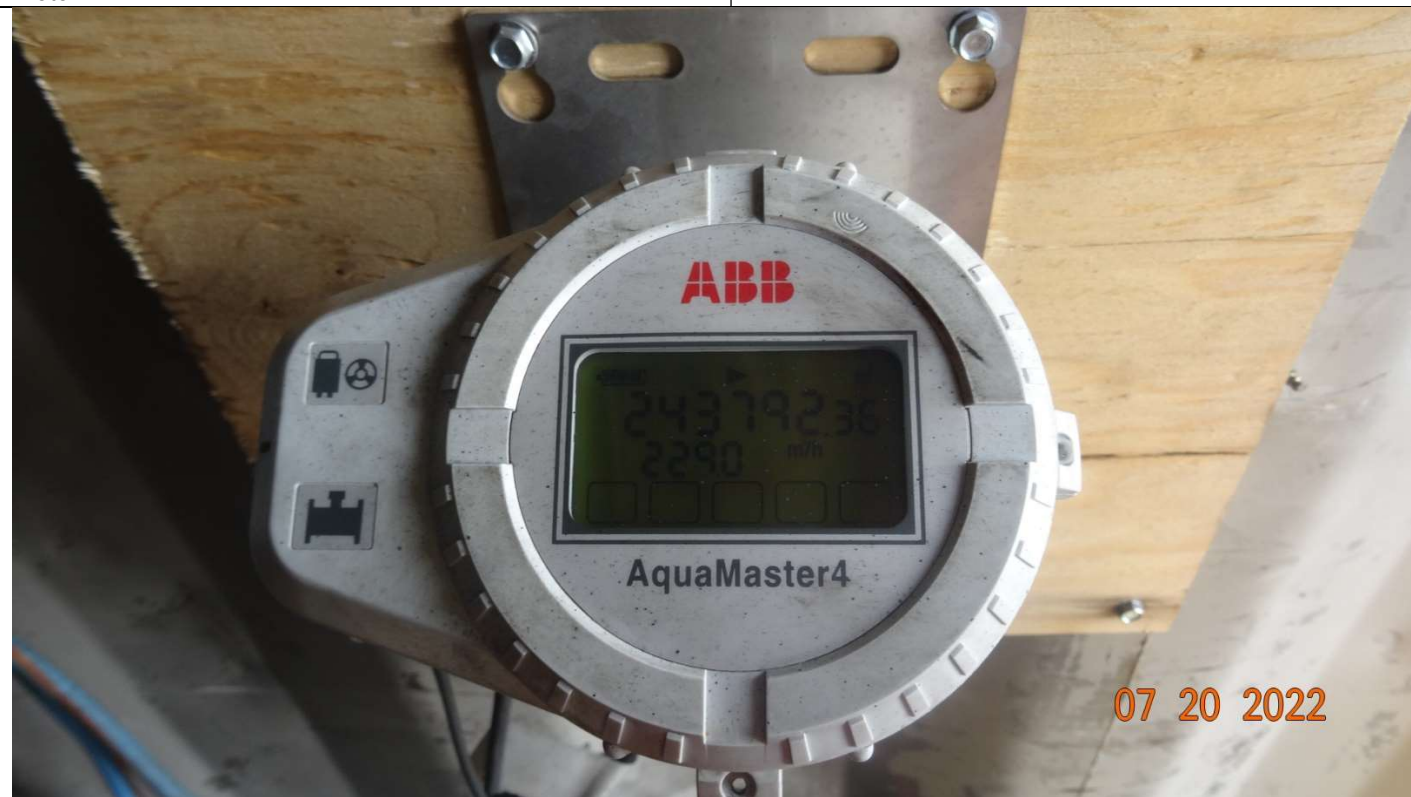
- A flow meter is present with a total amount and an hourly rate. At 0913hrs the meter read 243,794m³ and an hourly rate of 230m³/hr satisfying Part B Item 4 of the Licence. Extrapolated, the pump may pump 5,520m³/day not exceeding the limits in Part D Item 4 of the Licence. (Photo 2)

Water meter at GRA-7, Lower Landing Lake.

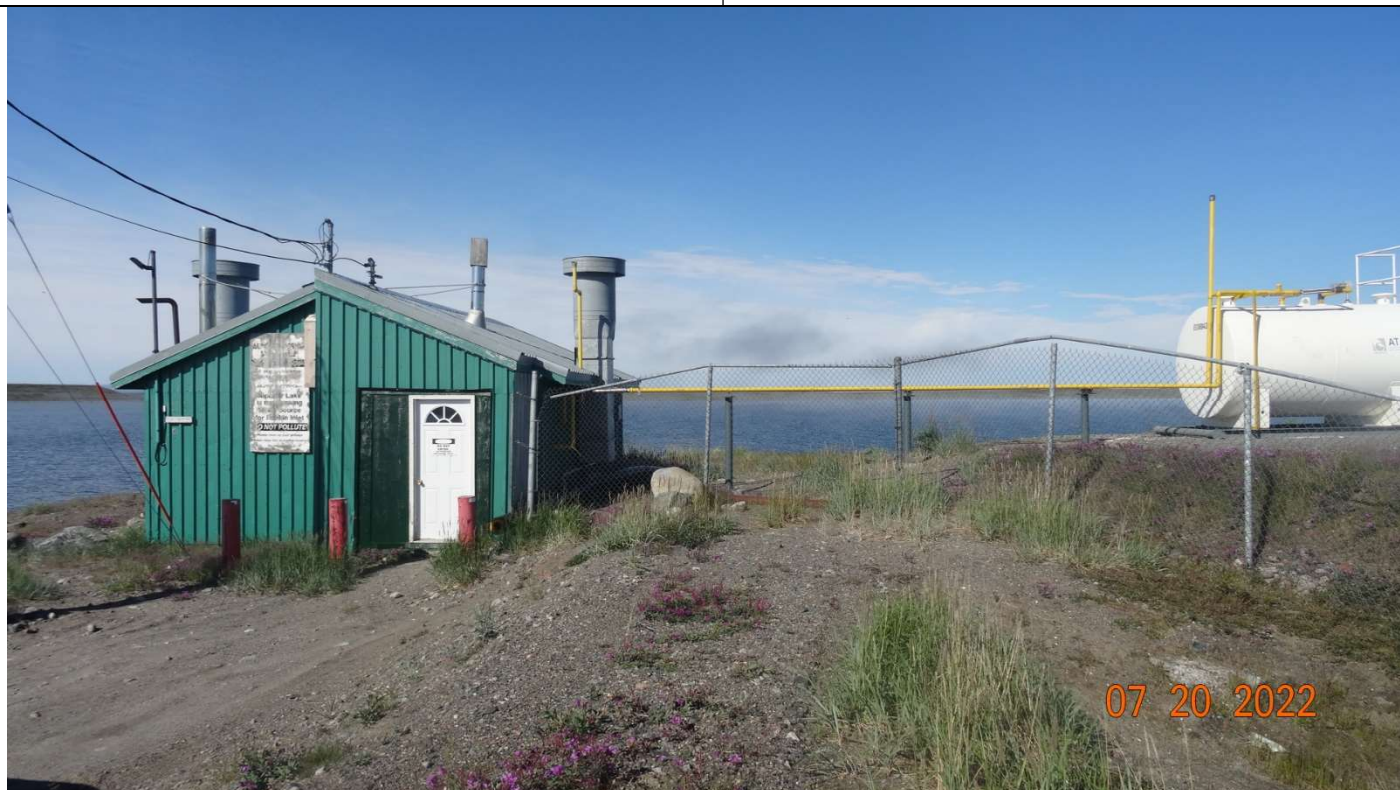
Photo 3

- Nipissar Lake Water intake (GRA-5) (Photo 3)
 - This pumping station is used to supply water to the Hamlet of Rankin Inlet.
 - A Flow meter is present with total amount and hourly rate. At 0929hrs the meter read 6,418,950m³ and an hourly rate of 76.58m³/hr. (Photo 4)

Nipissar Pump House.

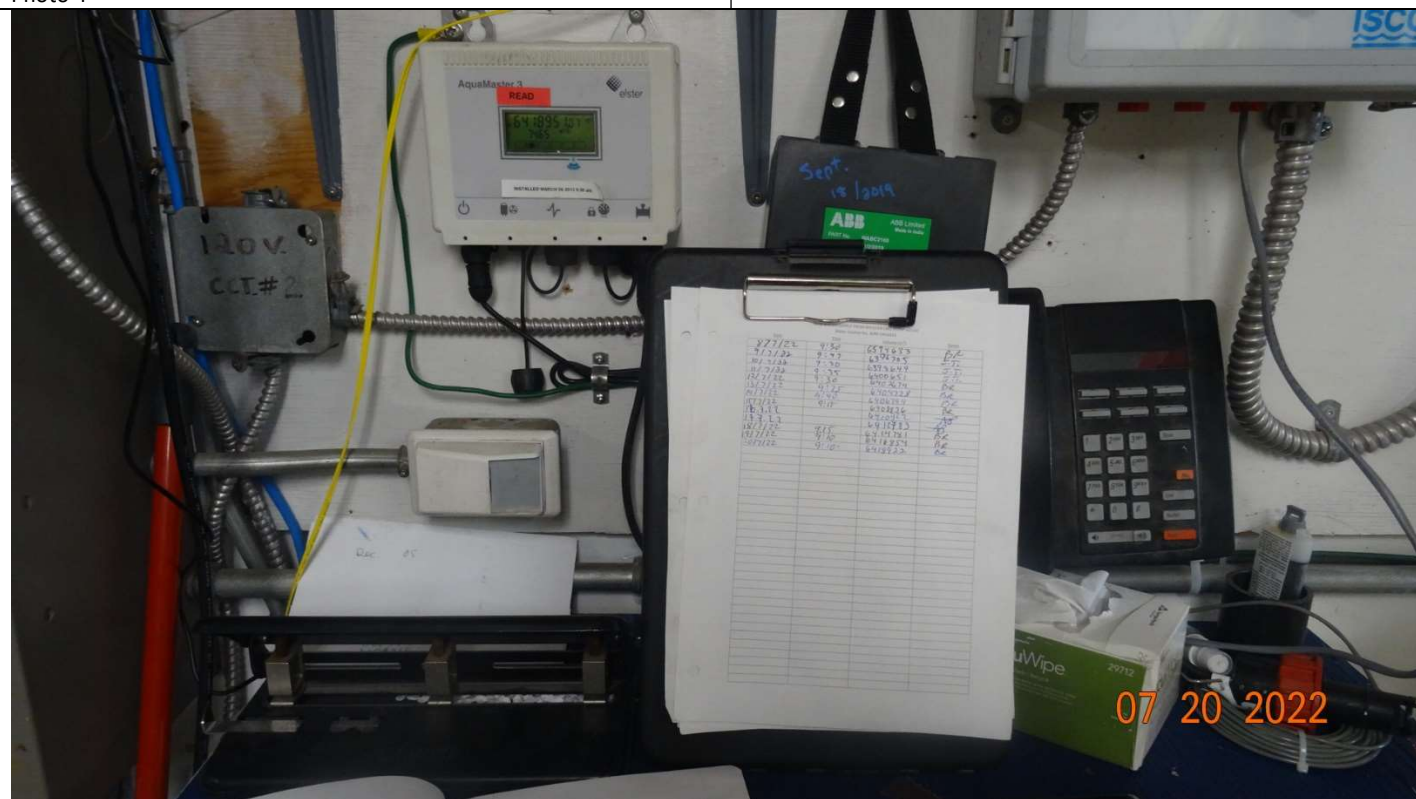
Photo 4

Water Meter at Nipissar Lake and monitoring log.

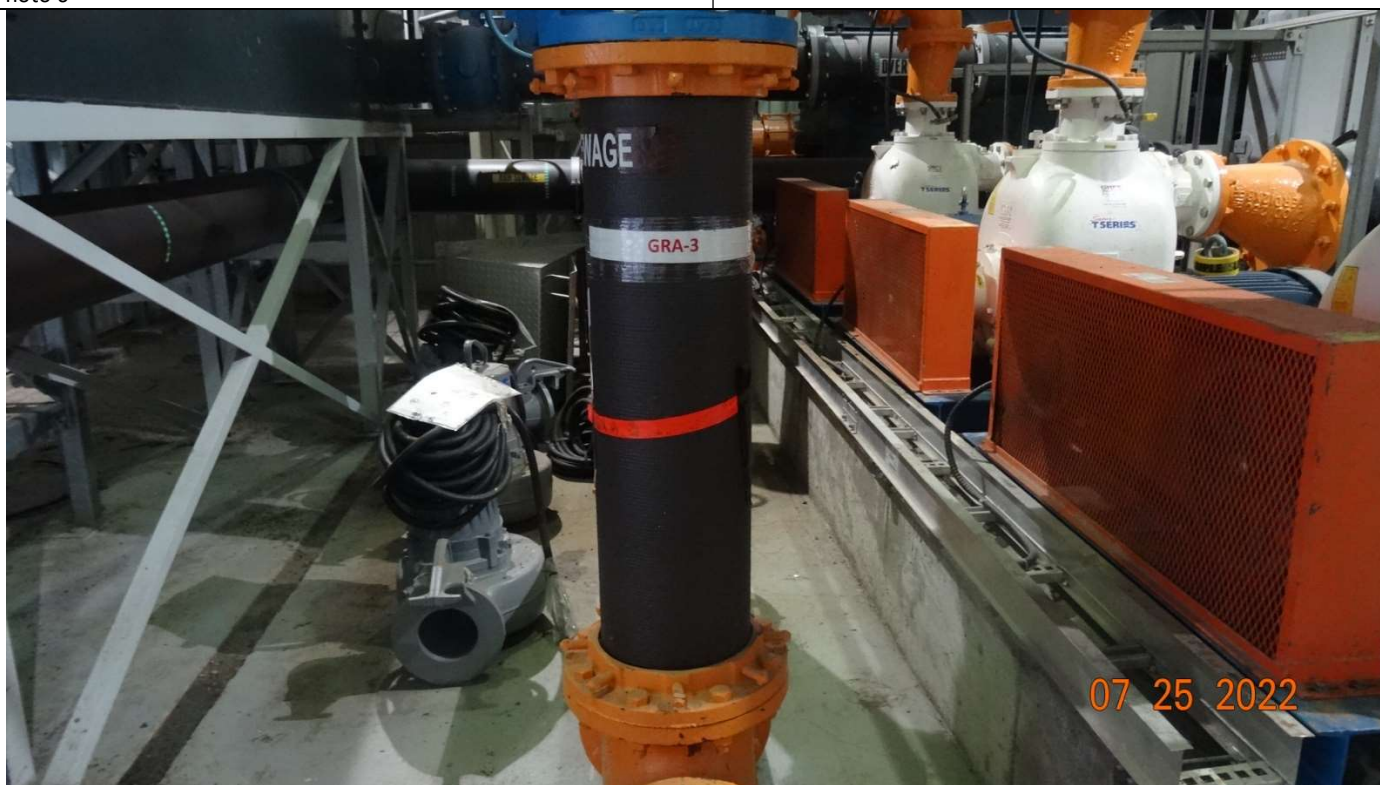
Photo 6

GRA-3 signed by representative and shown to Inspector On July 25, 2022.

- b. Spill 2021-200 occurred in 2021 at this location. The site is remediated to the satisfaction of the Inspector.
5. Sewage Treatment Plant
- a. Here raw sewage has sludge and larger particulate removed. The sewage is then discharged into the marine environment.
- b. GRA-3 is not signed to the satisfaction of the Inspector as the writing is fading and not clearly legible. (Photo 5)
6. Overall facilities appeared maintained.
7. On July 25, 2022 Representative Steve Fitzpatrick showed the Inspector the monitoring stations which were missing signage. The signage was posted appropriately and meets the requirement of Part B Item 5 of the Licence. (Photo 6)
