Project No: Y22101066

**Subject: Nipisar Lake Fuel Spill, Assessment and Remediation
Rankin Inlet, NU
ISSUED FOR CLIENT REVIEW**

EBA Engineering Consultants Ltd. (EBA) was commissioned by the Government of Nunavut, Department of Community & Government Services (CGS), to conduct assessment and remediation work at the fuel spill site at Nipisar Lake in Rankin Inlet, NU.

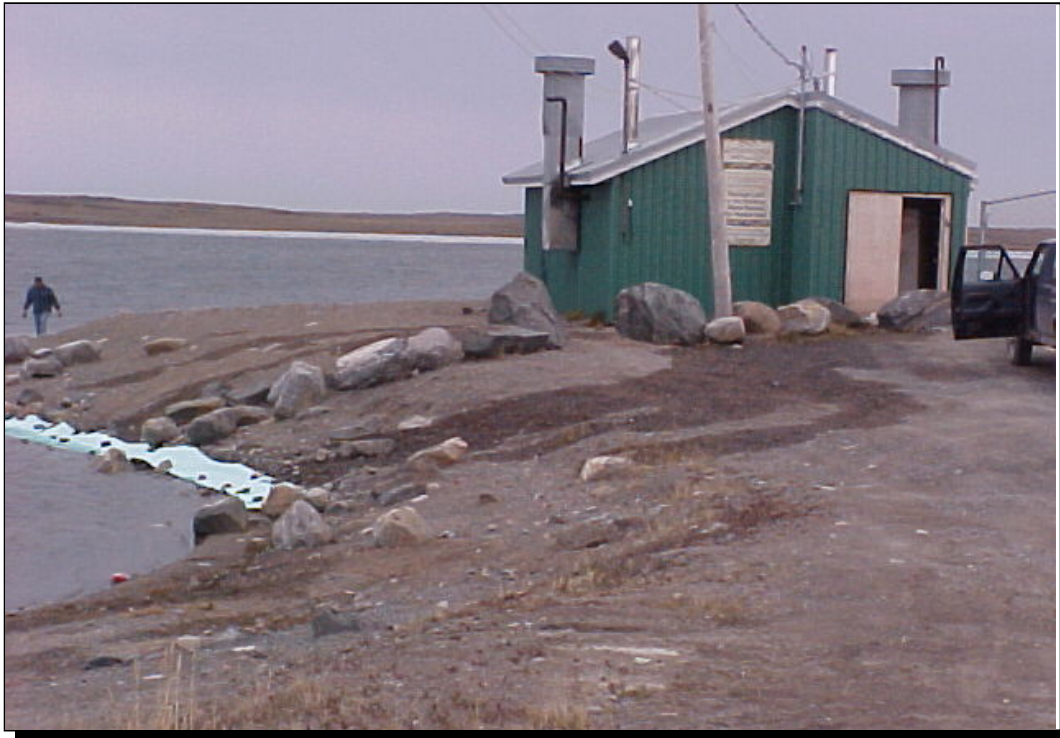
Photo 1
(CGS photo: June 30th, 2008) Surface staining prior to excavation activities

Based on the photographs provided by CGS employee Mark Gordon, the surface staining from the fuel spill appeared to commence at the north side of the pump house and migrate below and to the east of the pump house, southward to the lake. Excavation work completed at the time of EBA's arrival on July 4th included the length of the south and east walls of the pump house to 1 m below grade (mbg), and extended to approximately 2 m from the shoreline (approximately 13 m north/south) by approximately 22 m wide (east/west). Refer to Figure 2 for the detailed site plan.

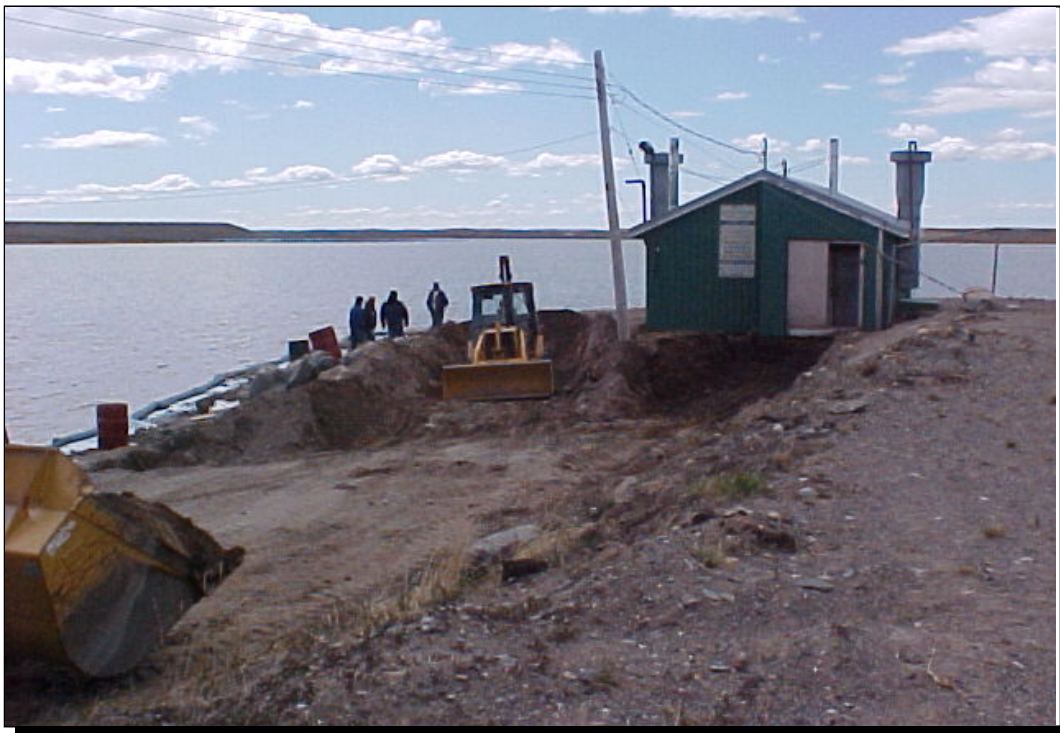
Photo 2
(CGS photo: June 30th, 2008) Initial excavation activities

Efforts were made by CGS employees to contain the spill and minimise the amount of product reaching the water source. The leaking pipe was repaired to prevent additional release of product, and sorbent boom socks were reportedly placed on the beach and along the lake shore to capture free floating hydrocarbon product. Excavation activities were initiated prior to EBA's arrival on site, performed by the local Hamlet contractors and CGS staff. Reportedly approximately 26 loads of impacted soil were removed by an 8 m³ capacity truck, and deposited at the Hamlet's landfill to await transport to a landfarm.

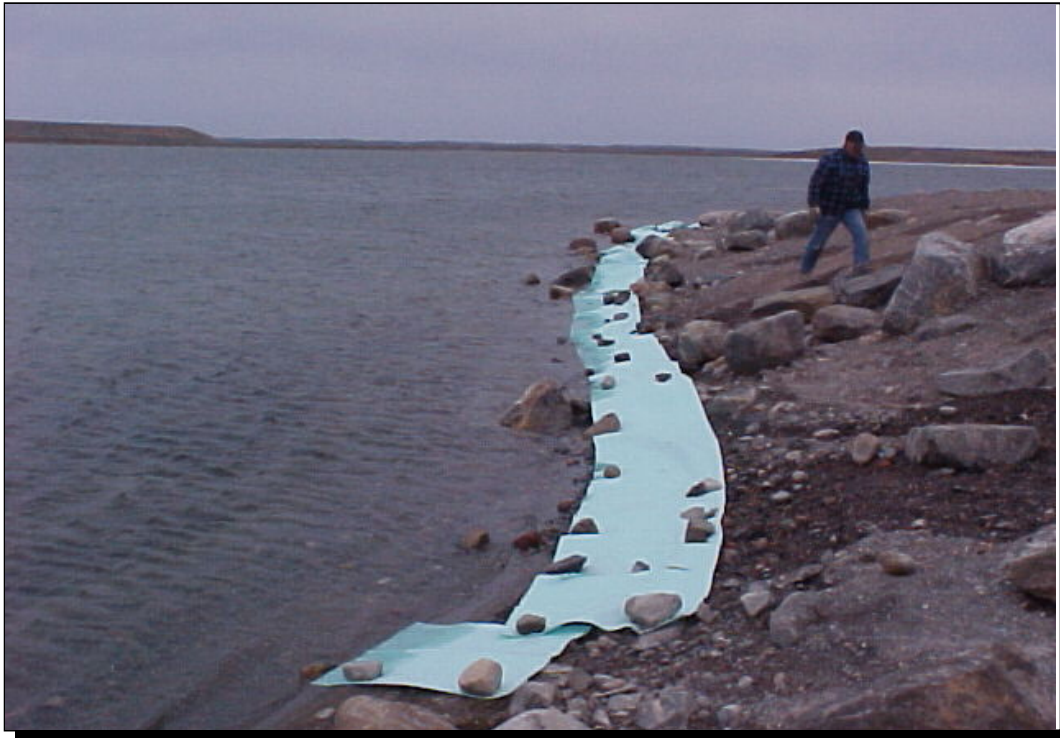
Photo 3
(CGS photo: June 30th, 2008) Sorbent pads on shoreline

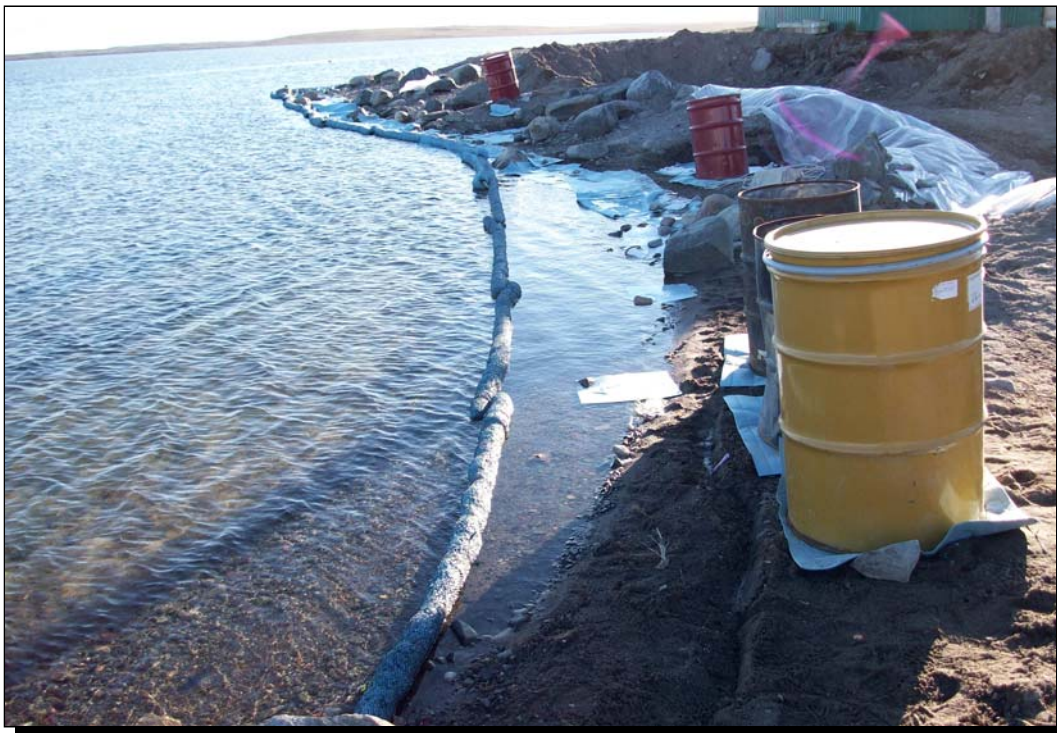
Photo 4
(EBA photo: July 4th, 2008) Sorbent boom around shoreline

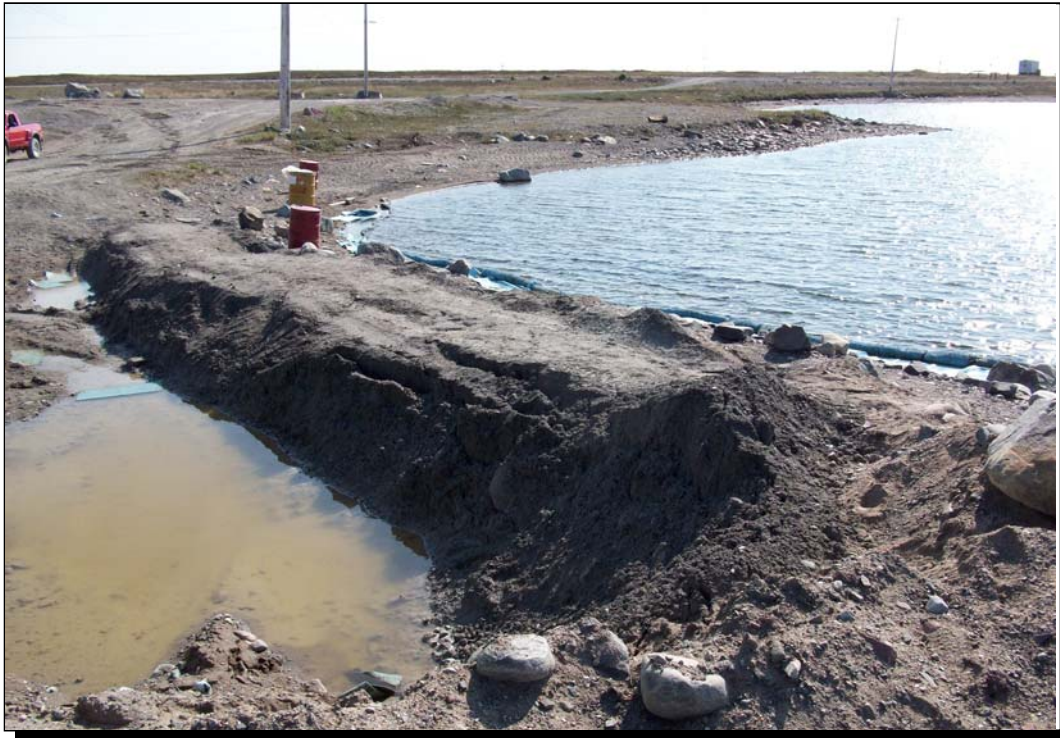
Groundwater was observed to be collecting in the southwest area of the excavation, occasionally observed to have a visible sheen. Sorbent pads were placed on the accumulated water when sheen was observed. To prevent this groundwater from migrating to the lake, a 20 m long containment wall was constructed to approximately 0.6 m above lake level on the south end of the excavation, on July 5th, 2008. Construction materials for the containment wall included clay and gravel fill.

Photo 5
(EBA photo: August 1st, 2008) Clay containment wall

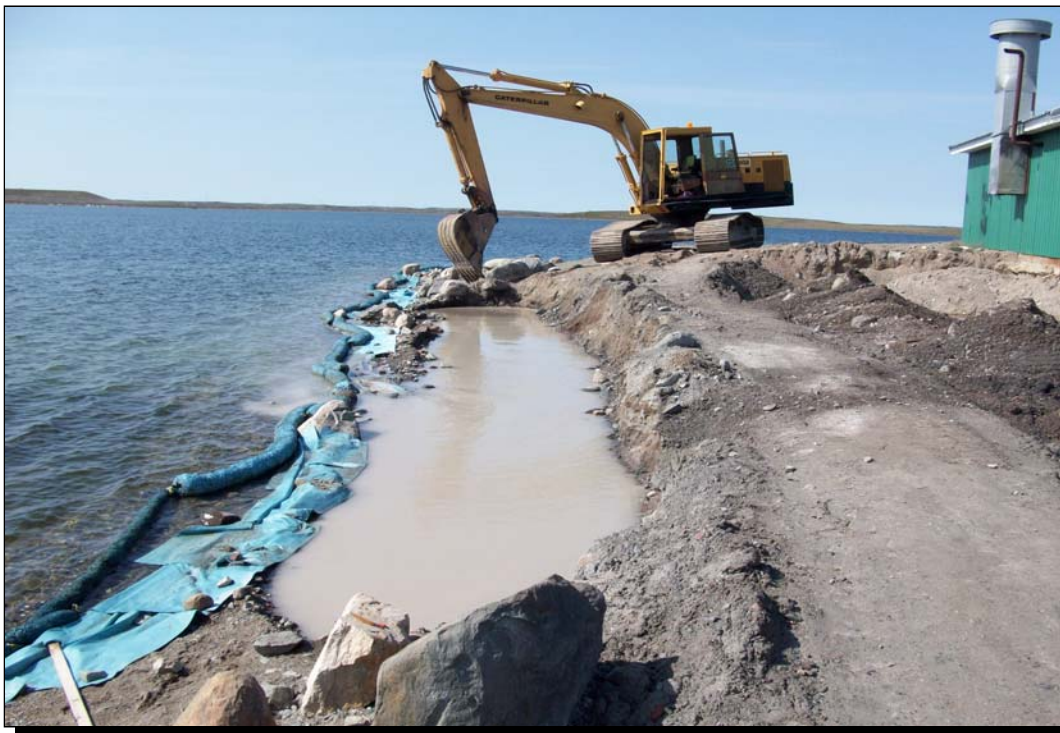
Additional excavation was performed south of the containment wall to address the remaining impacts in the beach sand. Depth of excavation achieved was approximately 0.5 mbg. As a result of the excavation, the shoreline was advanced by approximately 2 m to the north, towards the containment wall. A sheen was initially observed on the water following the excavation and as such, sorbent pads were positioned to address this.

Photo 6
(EBA photo: August 3rd, 2008) Excavation of beach, south of containment wall

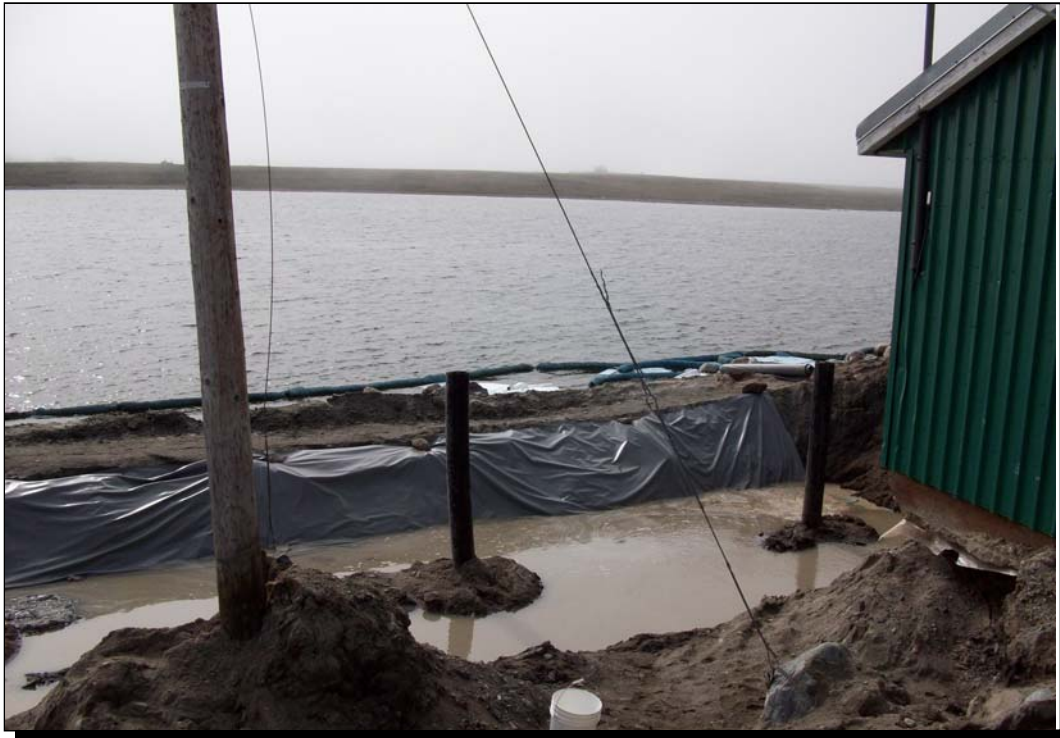
Photo 7

Three (3) monitoring wells were installed in the southern end of the excavation area for future monitoring and potential groundwater treatment purposes. Wells were constructed of 0.24 m diameter PVC pipe, perforated in the bottom 0.5 m, installed to grade. Wells were installed at the lowest grade of the excavation where groundwater was observed to be accumulating. The size of well casing was selected to facilitate insertion of pump lines for potential future extraction and treatment of accumulated groundwater, if necessary.

(EBA photo: August 1st, 2008) Monitoring wells in trench and geomembrane on clay containment wall.

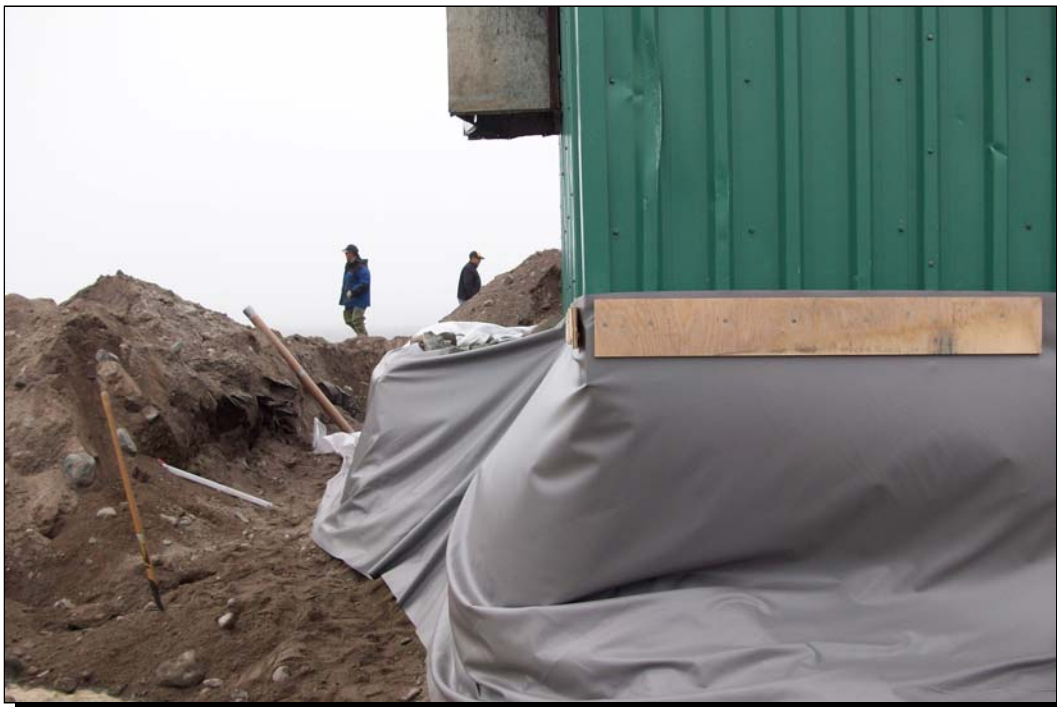
Photo 8

- An impermeable, 16mil geomembrane liner was installed along the excavation wall on the downgradient side of the perimeter of the pump house. The liner was installed as a protective barrier to prevent leaching of known impacts from under the pump house foundation, into the remediated area.

(EBA photo: August 1st, 2008) Building skirt

EBA recommended that a geomembrane liner be skirted around the perimeter of the impacted walls to contain the impacts. This was conducted using a 16 mil poly liner secured to the pump house, and draped sufficiently that upon backfilling, permafrost would be expected to advance and create a barrier with the liner.

- A geomembrane liner was installed below a portion of the pump house perimeter as a skirt to contain the remaining impacts in the soil below the building. It is anticipated that the permafrost layer will advance over the base of the line to its previous depth (~1.3 mbg) and thus create an impermeable barrier for migration of impacts.

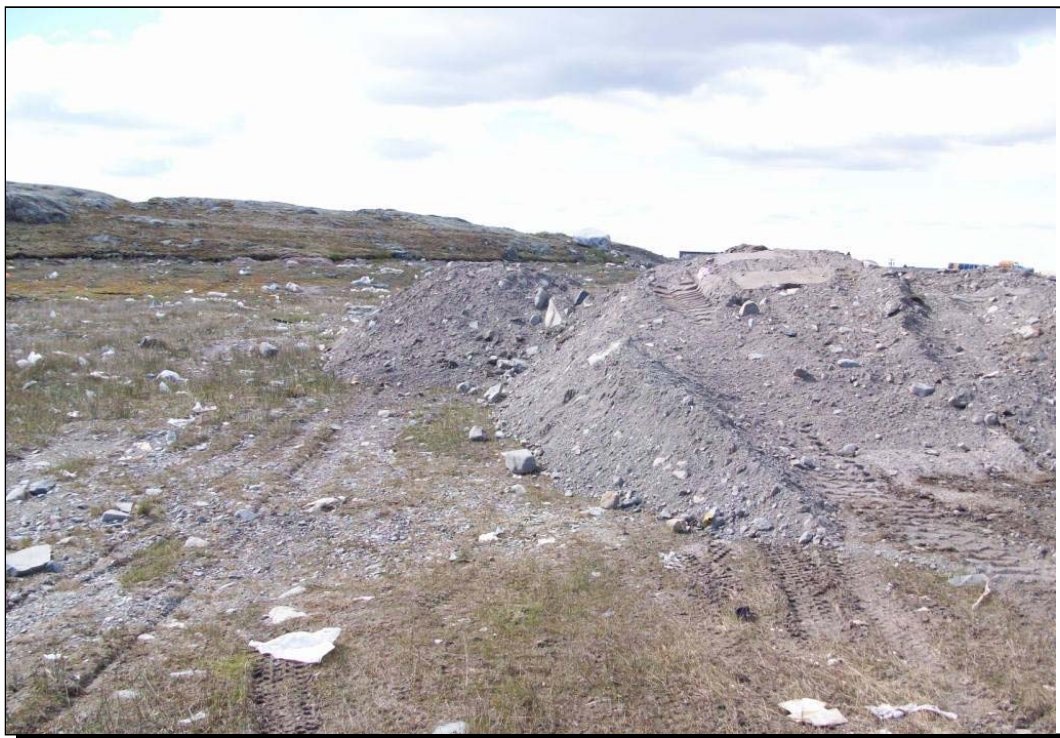
Photo 9
(EBA photo: July 6th, 2008) Impacted soil stockpile at Rankin Inlet landfill

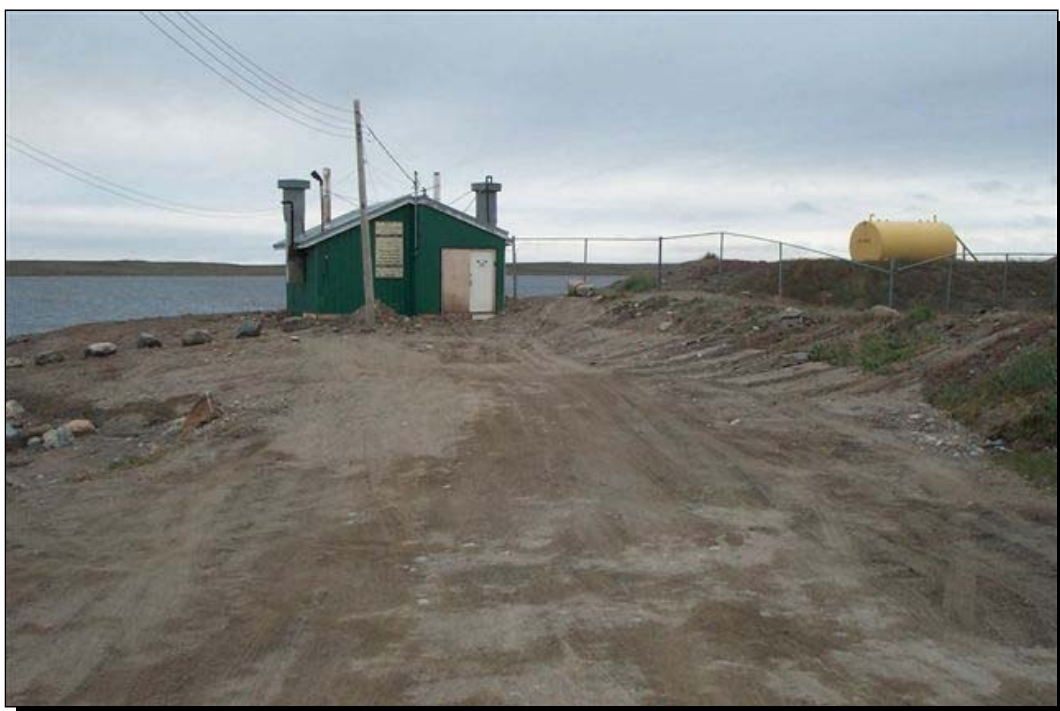
Photo 10
(CGS photo: August 13th, 2008) Post-backfilling activities
