July 12, 2001 Municipal Water Use Inspection - Report

MUNICIPAL WATER USE INSPECTION FORM

Date: 2001/07/12 Licensee Rep. (Name/Title): David Hauili / Director, Municipal Public Works
Licensee: Municipality of Igloolik Licence No.: NWB3IGL9803

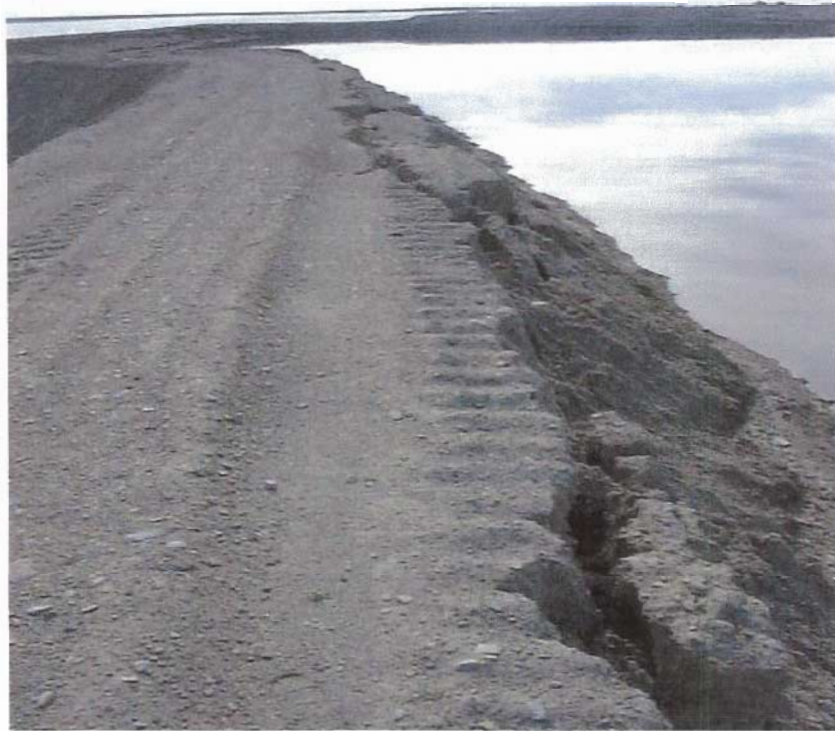
figure 1. Erosion along the inner face of sewage lagoon cell 3; 2001/07/12.

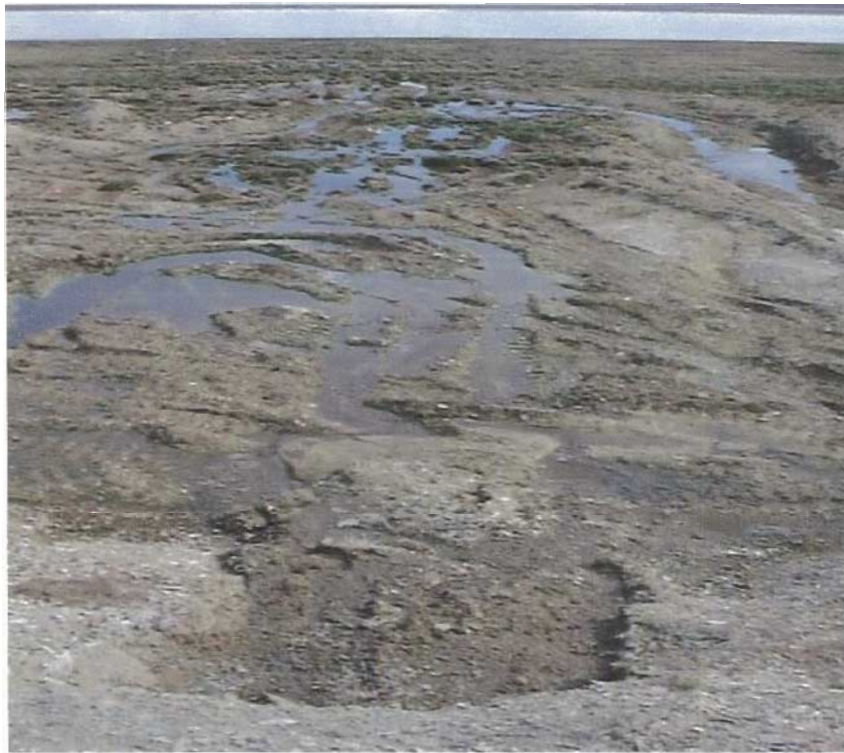
Comments: Signs of erosion, slumping and cracking, were noticeable along the outer berms of two of the three sewage lagoon cells. Sewage effluent seeps through the base of the lagoon berms and flows overland. The honeybag pit is satisfactory condition; a single house still relies on honey buckets. Considerable waste segregation occurs at the unfenced solid waste disposal site. Household wastes are burnt and compacted regularly, covered once to twice per year. Hazardous materials are stored in a sealift container, while waste oil is disposed of via the municipal garage's furnace; an additional furnace has been ordered. The bulky metal wastes disposal facility covers a relatively broad area. No flow of leachate was noted below the dump or metal dump, although pooled water and signs of previous runoff were present. An Operation and Maintenance (O&M) plan for the municipal waste disposal facilities has not been submitted.

figure 2. Seepage and erosion along the outer face of sewage lagoon cell 2; 2001/07/12.

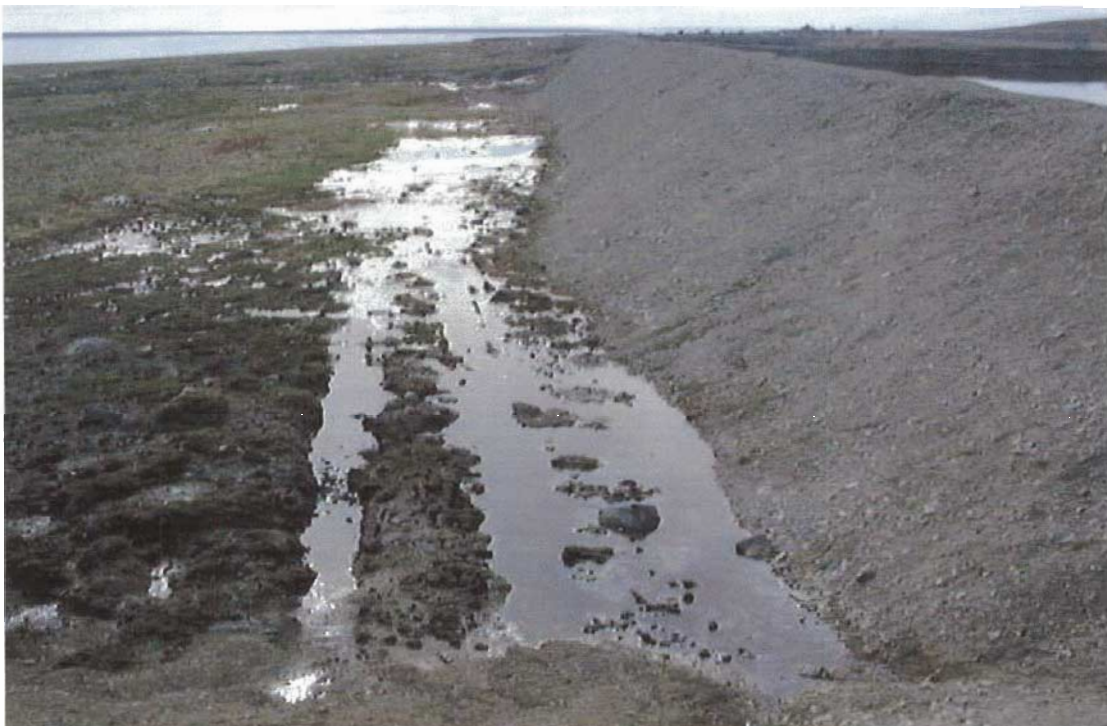
figure 3. Seepage along the outer face of sewage lagoon cell 1; 2001/07/12.

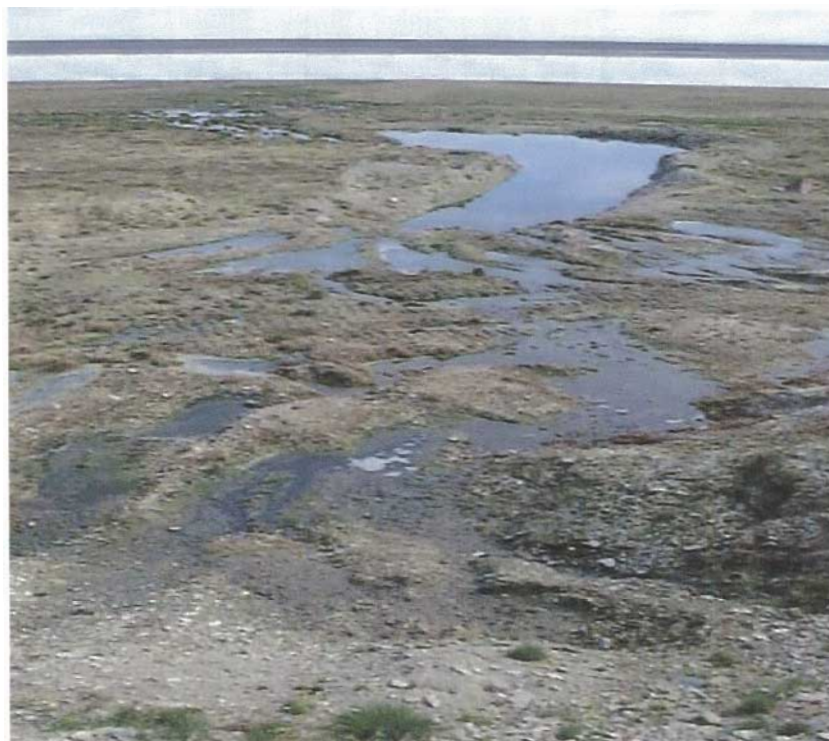
- **Sewage disposal:** During the inspection it was mentioned that, apprehending overflow from the sewage lagoon cells this past winter/springtime, the municipality had restructured the municipal water delivery calculation in order to decrease the volume of water use, and therefore waste disposal. The Inspector commends the Licensee for taking such a proactive stance, and shares its concerns relating to the impact the high fluid level may have on the integrity of the sewage lagoon berms. Indeed, undeniable signs of erosion were observed along the outer berms of two of the three sewage lagoon cells. As such, cracking of the inner face of cell 3 (figure 1), and slumping of the outer face of cell 2 (figure 2) were noted. However, the berms of cell 1 seemed intact, and seepage along the toe of its berm (figure 3) was the most effective of the three sewage lagoon cells. Accordingly, sewage effluent was sampled along the main discharge path from cell 1 (figure 4). The attached analytical results relating to a sample taken roughly 10 metres from the outer berm reveal that although pH, biological oxygen demand (BOD₅), and total suspended solids are well within licenced thresholds, the concentration of faecal coliform (63 000 CFU/100ml) potentially breaches Water licence NWB3IGL9803 effluent quality standards (10 000 CFU/100ml), set at a station just prior to entering the ocean.

In addition, levels of ammonia (52.5 mg/L vs 2.2 mg/L) and iron (1.43 mg/L vs 0.3 mg/L) exceed the *Canadian Water Quality Guidelines for the Protection of Freshwater Aquatic Life*. Moreover, the Microtox sample, which constitutes a reliable toxicity indicator (IC₅₀), shows that half of light-producing bacteria were inhibited by a sample concentration of 23.3%, whereas 50% and over is considered non-toxic.

figure 4. Effluent discharge from sewage lagoon cell 1; 2001/07/12.

This being said, it was related that plans were underway to build an additional sewage lagoon cell before freeze up, and that an engineer from Community Government and Transportation (CG&T) was expected during the summer pertaining to sewage disposal considerations. At the time of the inspection, the Inspector outlined the need for the Licensee to inform the Nunavut Water Board (NWB) as soon as possible when major water use or waste disposal works are planned; even though the Licensee was told by CG&T officials that their department would handle the work and the dealings with the NWB. The Inspector acknowledges that the Licensee has since notified the NWB, and trusts that in light of the Licensee's generally conscientious approach to waste management, the application can be processed in a timely manner and thus avoid possible complications next winter/springtime.

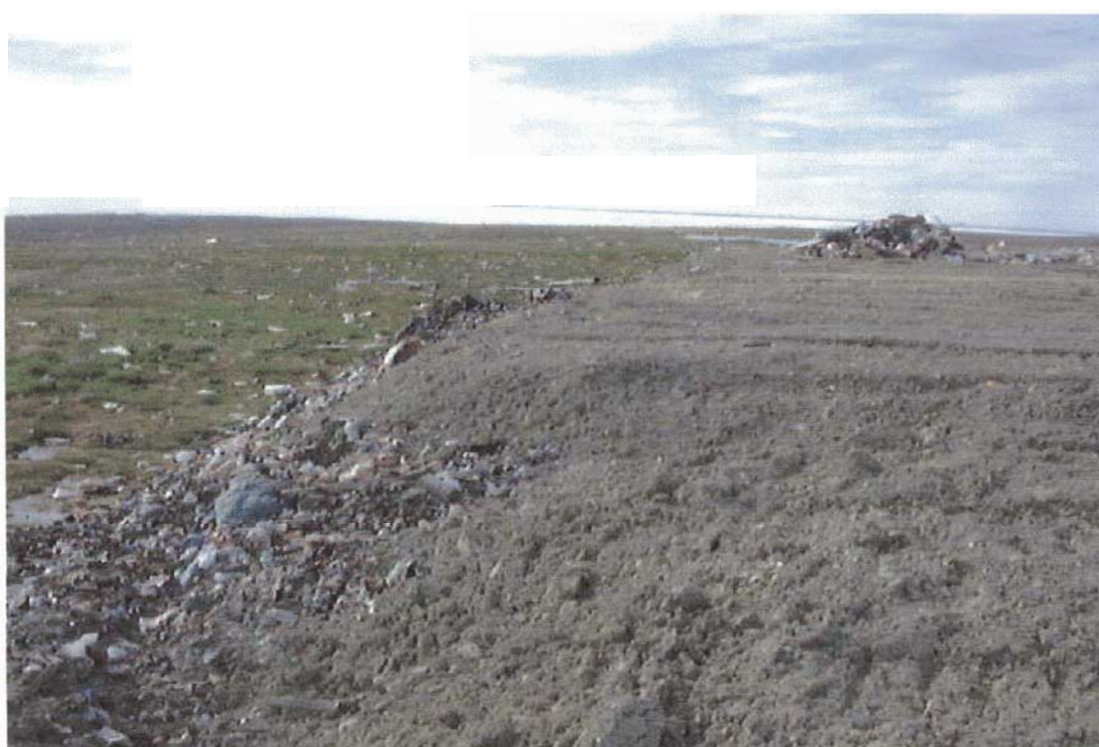
figure 5. Solid waste disposal facility; 2001/07/12.

- **Solid waste disposal:** Other than the installation of a perimeter fence which would minimize the extent of windblown garbage, no obvious improvement appeared necessary at the very adequately managed solid waste disposal facility (figure 5). In parallel, should the Licensee wish to proceed with its plan to bury some of the bulky metal wastes (figure 6) along the roadside to the cemetery area, notification ought to be provided to the NWB so as to ensure that leachate prevention measures are sufficiently assessed.
- **Non-compliance of Act or Licence:** As was pointed out during the inspection, the Licensee has not provided the NWB with an Operation and Maintenance (O&M) plan for municipal the waste disposal facilities, nor 1998, 1999, and 2000 Annual Reports.

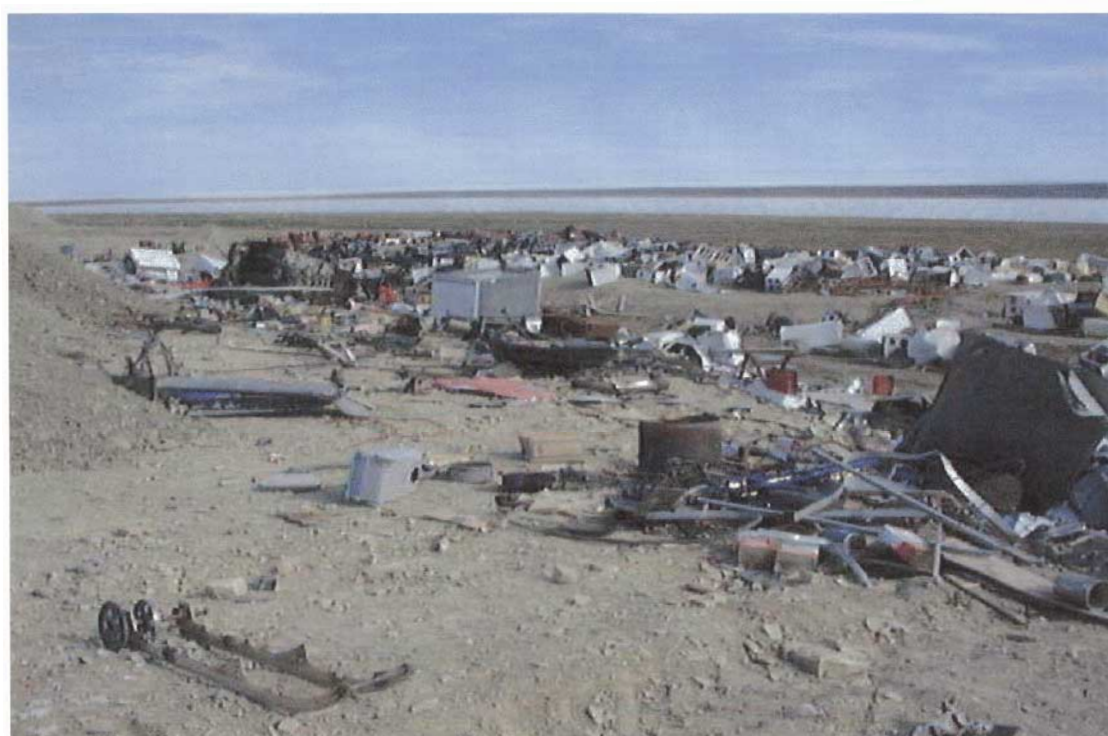
figure 6. Bulky metal wastes, solid waste disposal facility; 2001/07/12.
